Peninsula Harbour Submerged Aquatic Vegetation (SAV) and Cap Movement Study: 5 Years Post-cap Survey

April 25, 2018

Prepared for:
Environment and Climate Change Canada

Prepared by:
Dr. Robert F. Foster
Brian Ratcliff

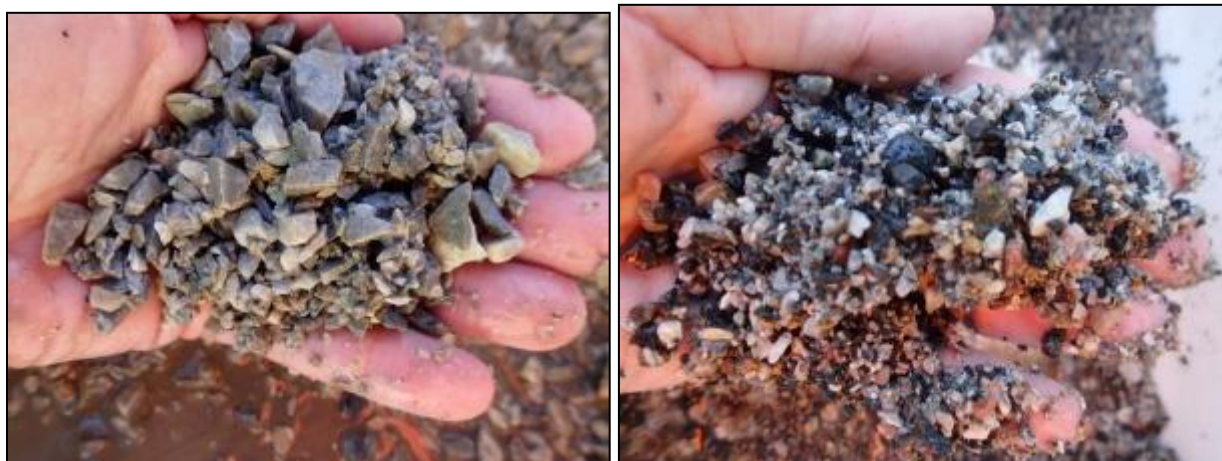
Figure 9. Coarse (Ponar # 18, left) and medium (Ponar # 19, right) sand capping material.

As in 2012-2013, angular coarse sand derived from crushed Manitoulin Island limestone could be easily distinguished from more rounded, multi-coloured medium sand derived from local granite (Marathon area sources) in samples taken by ponar grabs (Figure 9). See Table 1 for a summary of the 32 ponar grabs taken in 2017 and Appendix 4 for map and photos of ponar grab samples. Ponar grab samples taken outside the cap zone, had easily distinguished fine-textured sediments, with silt present in deeper water and fine sand in shallow water east of the cap zone (Figure 10). Several ponar grab samples within the cap zone had a range of particles sizes with some silts mixed in with medium or coarse sand (Appendix 4).

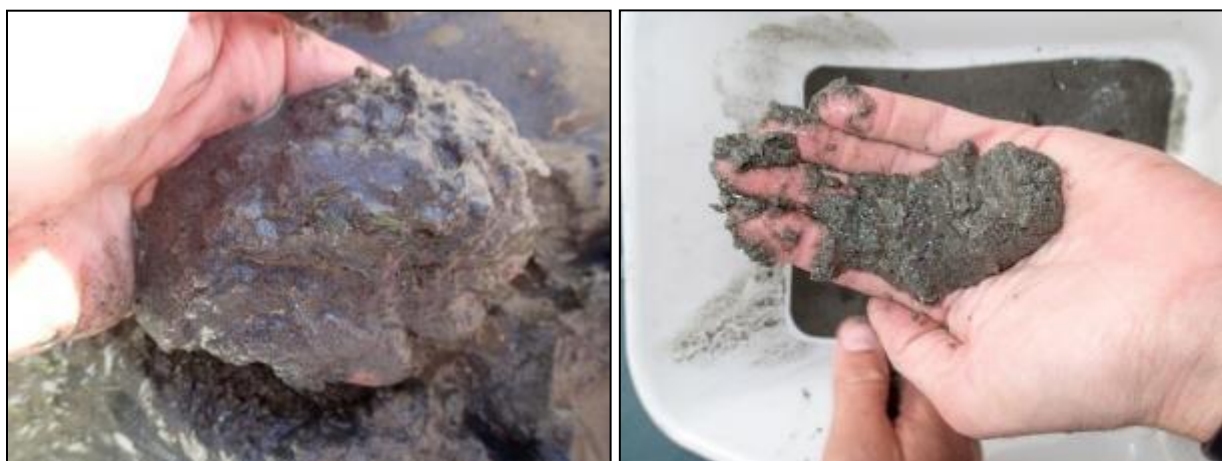
Figure 10. Silty (Ponar #15, left) and fine sandy sediment (Ponar #32, right) from outside the cap zone.

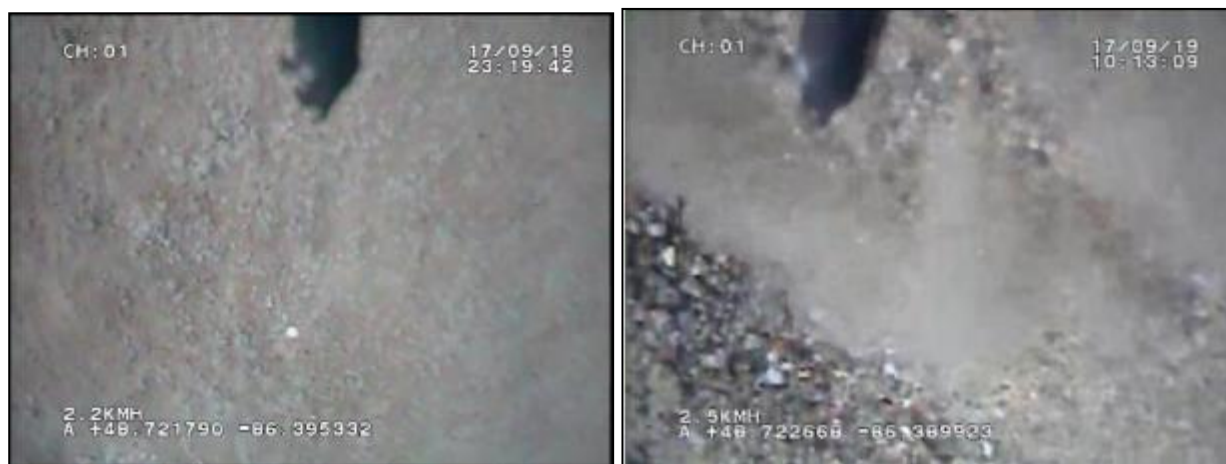
Figure 11. Coarse sand cap with overlaying silt (left) and medium sand cap (Image #509c)(right).

As in 2012-13, underwater video was generally capable of differentiating between capped and uncapped areas (Figure 11, Figure 12), but with some limitations. It was often difficult to differentiate between coarse and medium sand in the cap when overlain with silt. The ability to differentiate substrates in the underwater video varied with water depth, video speed, and homogeneity of substrate. Water clarity was generally very good in Peninsula Harbour and colour video was shot with ambient light. At water depths greater than about 15 m, supplemental LED lighting and infra-red video was required (it automatically changes modes), although this varied with time of day and degree of cloud cover. Sediment type was often more difficult to differentiate at these greater depths, and approximately 22% of the cap was greater than 16 m deep. Survey speed was generally kept to below 2 km/hr, and reduced where necessary to ensure that the video was interpretable. Video could also be paused post-hoc in the viewing software to examine individual frames in more detail where necessary.

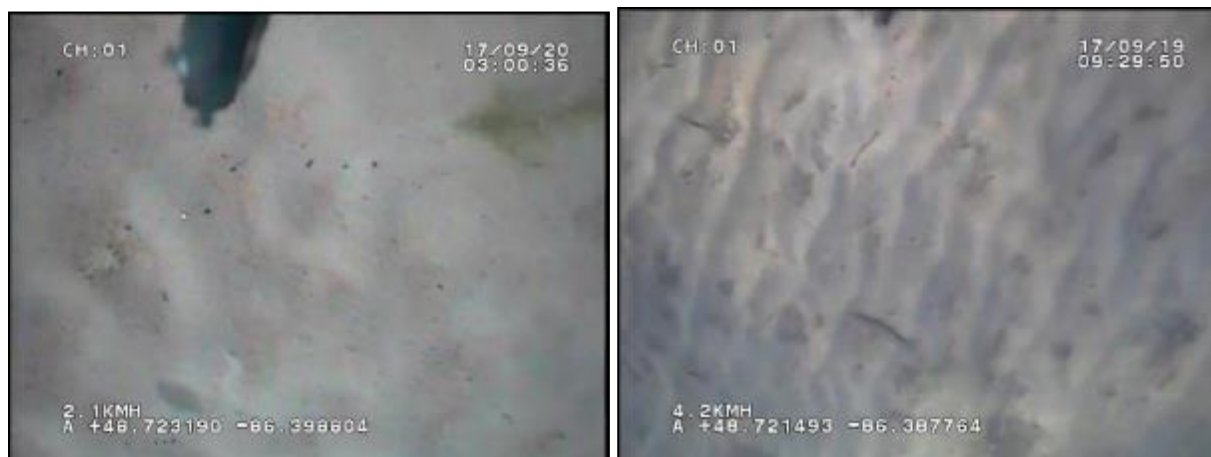
Figure 12. Uncapped silt (left) and uncapped fine sand (right).

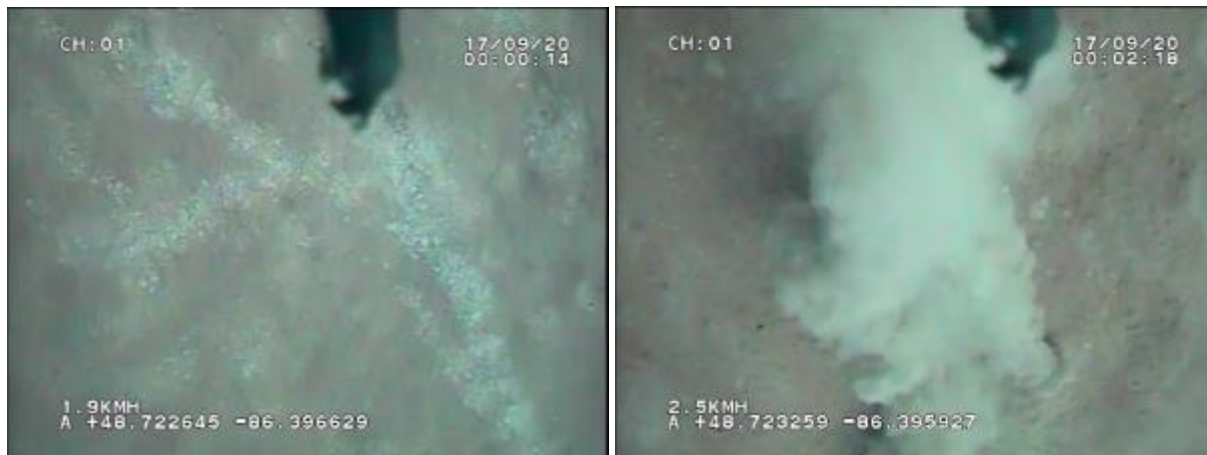
Figure 13. 2017 Cap material with silt (left) and silt plume disturbed by camera (right).

The layer of silt overlaying the coarse and medium cap is mainly from natural sedimentation, which is estimated to occur at a rate of approximately 2 mm per year (AECOM 2009b; ENVIRON 2008). At this rate, approximately 10 mm of silt would expect to have been deposited over top of the cap since 2012. Video footage of exposed cap substrate in 2017 indicates, that naturally occurring rates of silt deposition are either lower than previous estimates, or that the spatial distribution is unequal, perhaps due to currents or wave energy.

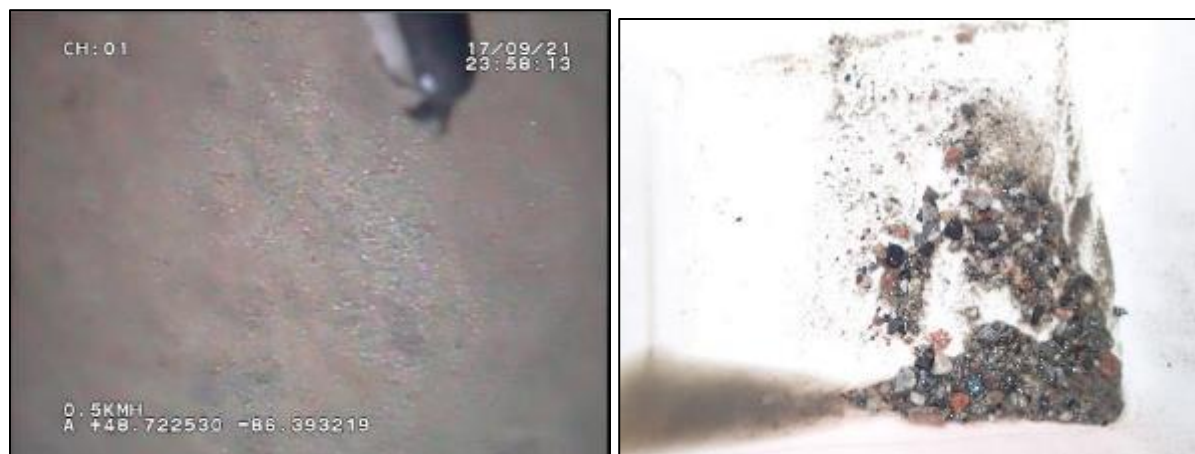
Figure 14. Video image (left) at 18 m and Ponar #31 grab sample (right) with medium sand cap and silt.

As in 2012-2013, the greatest constraint in determining substrate type using underwater video was that for much of cap area there was a thin layer (typically several mm) of silt over the medium and coarse sand cap material. This appeared to be more extensive and thicker in 2017 than previously. Substrate type was particularly difficult to discern at depths where infra-red lighting was required, although this was confirmed at a small number of locations using ponar grabs. Underlying substrate was routinely exposed by disturbing the upper layer of sediment with the downrigger ball attached to the camera during surveying. The resulting plume of sediment also helped confirm the silty texture of the upper sediment (Figure 13). Representative ponar grabs confirmed that the substrate types were consistent with interpretation based on the video imagery (e.g., Figure 14)

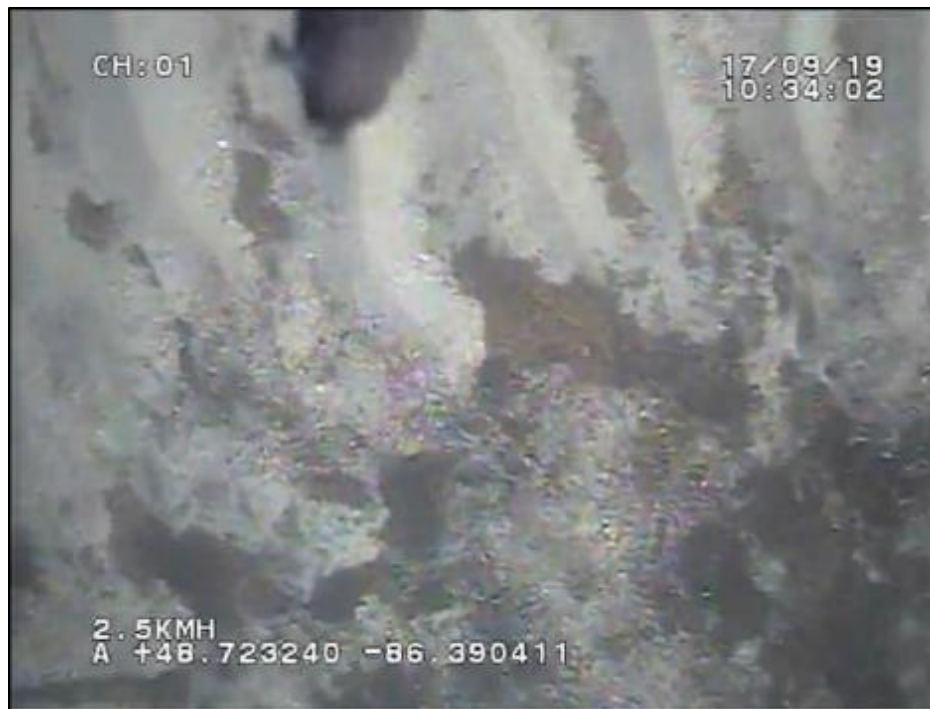
Figure 15. Substrate at margin of medium sand cap in approximately 2 m water depth (Image 719), with cap material at bottom of photo and non-cap scalloped sand outside cap (upper portion of photo).

Based on video interpretation of substrate, upper layers of the cap area are still covered by the medium or coarse sand cap (Figure 15) that are often overlain by a silt of varying thickness, especially in deeper areas. Cap material is presumed to be present below the silt, which was confirmed in the locations where ponar grabs were taken or where the upper silt was disturbed by the video camera. This was somewhat difficult to confirm directly by video interpretation of substrates in deep water. However, it generally appeared that most of the medium and coarse sand deposited in the cap area had remained in situ.

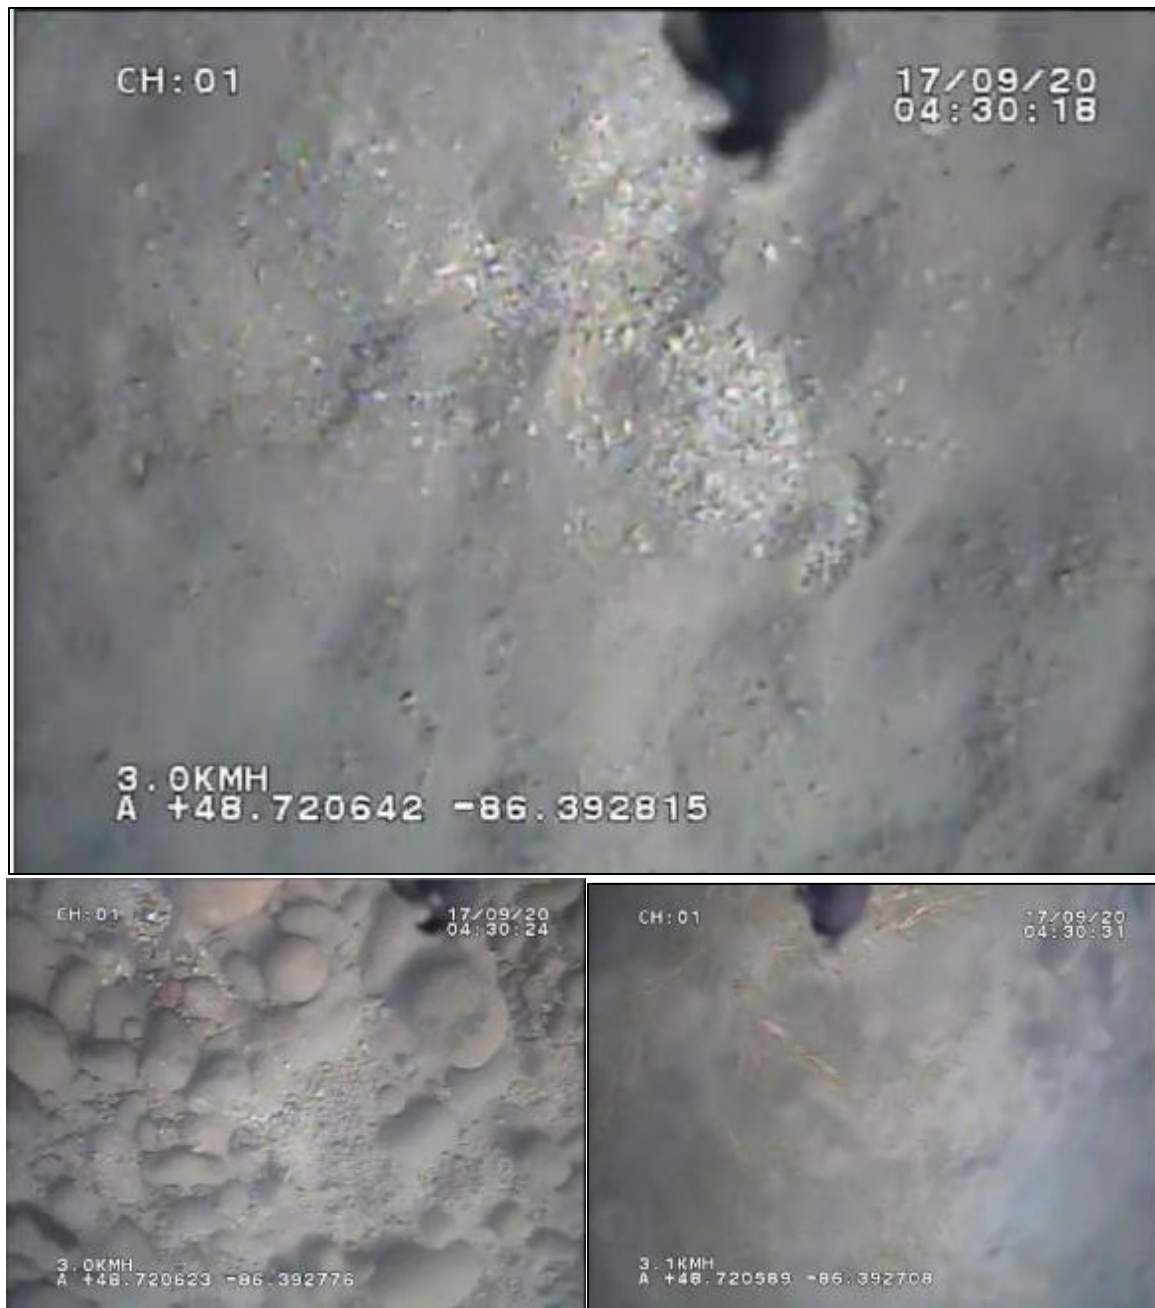
Figure 16. Coarse sand capping material within cap (Image 4084), approximately 5 m away just outside cap (Image 4085 lower left) and 5 m further outside cap (Image 4086, lower right).

There was little evidence of cap mobilization in shallow waters to the southeast of the cap along the gently sloping southeast sand shore. Underwater video showed a fairly clear demarcation along most of cap margin with no cap material apparent beyond the 3-m transition zone at the edge of the cap and submergent growth outside the cap (Figure 16, Figure 17). Overall, the distribution of sediments types observed in 2017 (Figure 21), did not appear to differ significantly from 2013 (Figure 22).

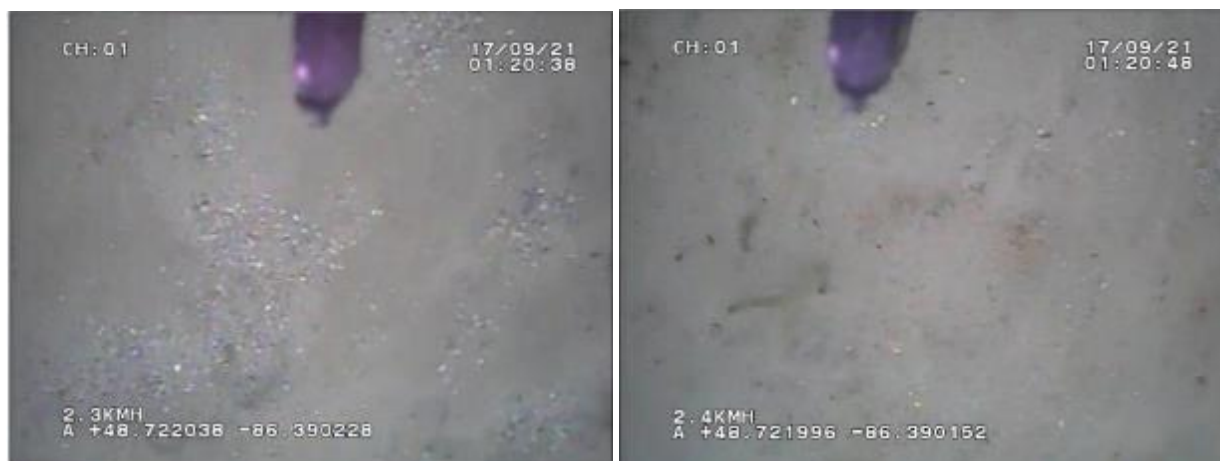
Figure 17. Substrate with medium sand cap at southeast cap margin (left) and approximately 5 m outside cap (right).

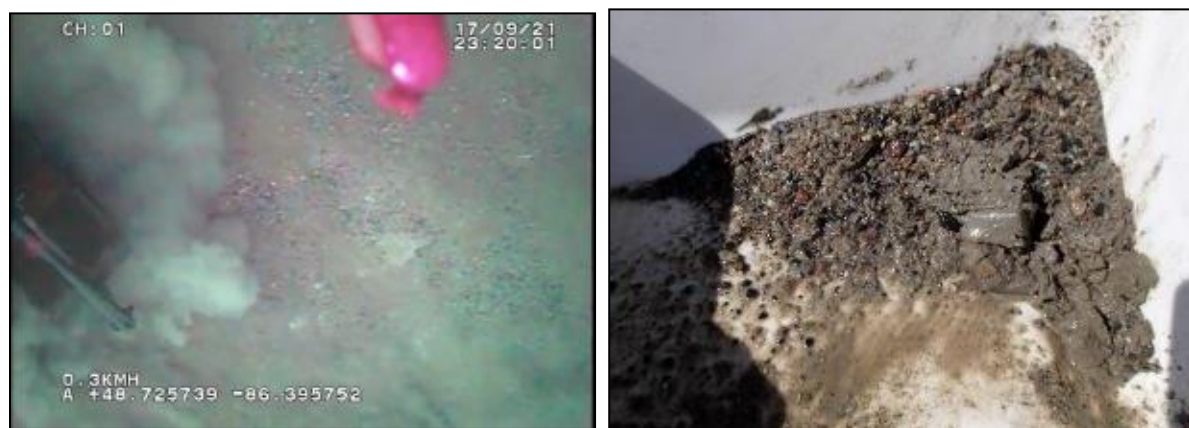
Figure 20. Video image (left) at 18 m and Ponar #26 grab sample (right) with medium sand cap and silt.

There may have been some limited movement along deeper edge of cap area, but it is difficult to compare pre-capping conditions in deeper adjacent waters with post-capping conditions due to limited video and unreliable substrate data from acoustic mapping prior to the capping operation (AECOM 2009a; Foster and Harris 2011). Ponar grabs taken along the edge of the cap in deeper water (24, 27) had minimal amounts of cap material in them compared to grabs taken at the cap's edge or within the cap in deep water e.g., grabs 25, 26 (Appendix 4; Table 1, Figure 20).

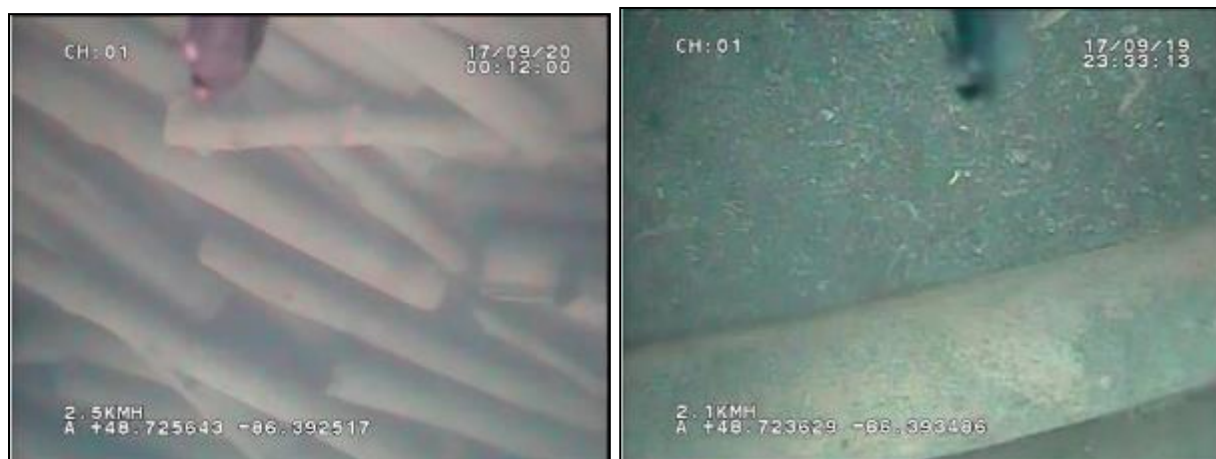
Figure 38. Abundant pulp logs in deep water outside cap zone (Image #1693, left) and bark deposits associated with pulpwood logs (Image 1305, right).

Underwater video showed extensive amounts of pulpwood and bark on the bottom of Jellicoe Cove in and near the cap (Figure 38, Figure 39,) from log booming in Peninsula up until 1987 (AECOM 2012). In 2017, logs were observed in 4.8% (n=124) of the 2561 interpretable images in the cap. This is approximately half the abundance of logs within the cap that were observed in 2013 (8.4% of 2560 images)(Figure 43). Much of the difference is from fewer logs observed in 2017 in deeper water (>20 m) in the northwest part of the cap, where visibility was poor in 2017. Frequency of logs in video from outside the cap remained similar in 2017 compared to 2013. In 2017, 9.5% of the 2863 images from outside the cap had visible logs compared to 9% of the 2482 images from outside the cap in 2013. Occurrences of logs within the cap were generally sparse; most of the large concentrations of logs were found outside of the cap to the northeast (Figure 42).

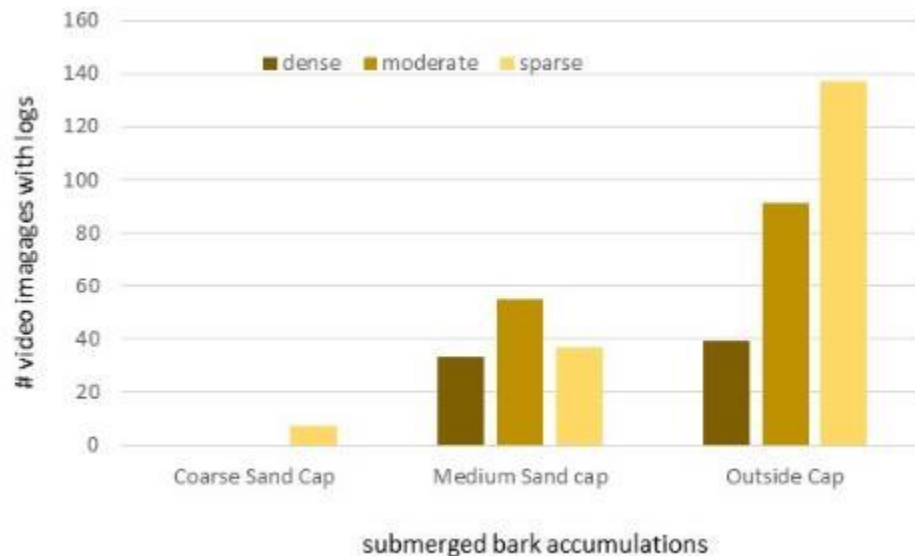
Figure 40. Abundance of submerged bark in and outside the Jellicoe Cove cap.

In 2017, bark was observed in 5% (132/2561) of the cap images, compared to 9% (267/2863) images outside the cap. Bark was typically associated with pulpwood logs, often accumulating in sheltered depressions amongst or immediately adjacent to logs (Figure 42). Bark was also observed on firmer, sandy substrates; it may have been present on siltier substrates in deeper water where it had been covered over with a flocculent layer of silt. In 2013, bark was observed only in about 1% of the cap images and 5% of images from 4.8% outside the cap (Figure 43), despite a similar number of images. Small woody debris was rare throughout the cove, with sticks visible in only one image in 2017; sticks were rare in video images from 2013 as well. The cause of this apparent increase is unknown, since there have been no recent inputs of bark to Jellicoe Cove. Most of the apparent increase in bark in interpreted images was in the southeast

corner of the cap in approximately 6-8 m of water, and it is possible that bark from sources near logs outside the cap has been displaced on to the cap by wave action during storms.
