PFAS Preliminary Site Investigation: RNZAF Base Ohakea

New Zealand Defence Force

June 2017

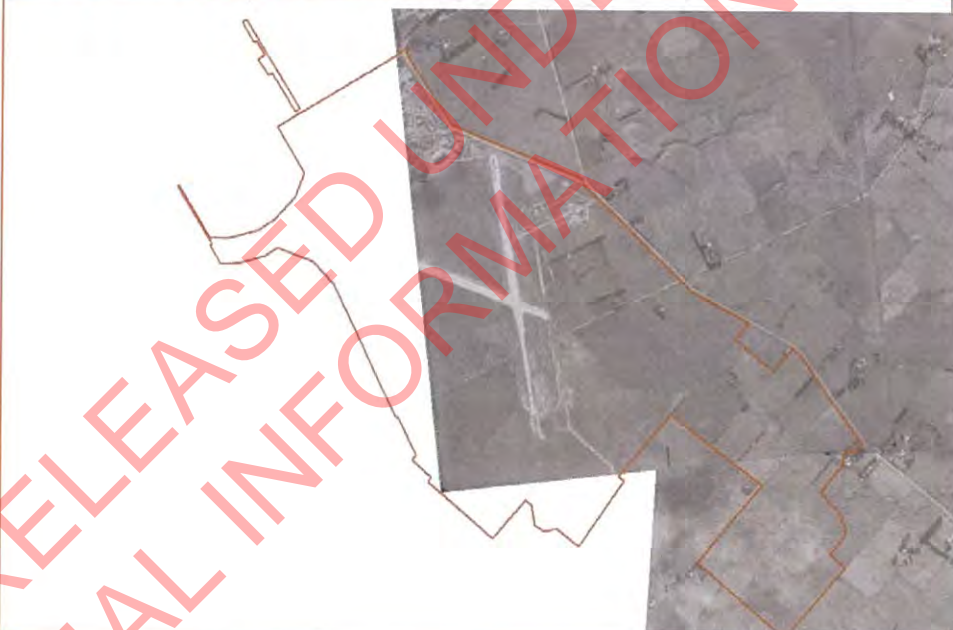
1942 Aerial (NZDF)

The 1942 aerial is limited to the north eastern half of the site. In the north, 3 Hangar and 4 Hangar (HL_78_OHA) can be seen along with the barracks and the residential dwellings. The western and northern sections of the runway are present and construction of the southern portion is underway. There are a series of buildings and constructions in the east of the site, near the current location of the bulk fuel farm and the No 3 SQN Hangar. The surrounding land use is agricultural with a number of associated rural residential dwellings.

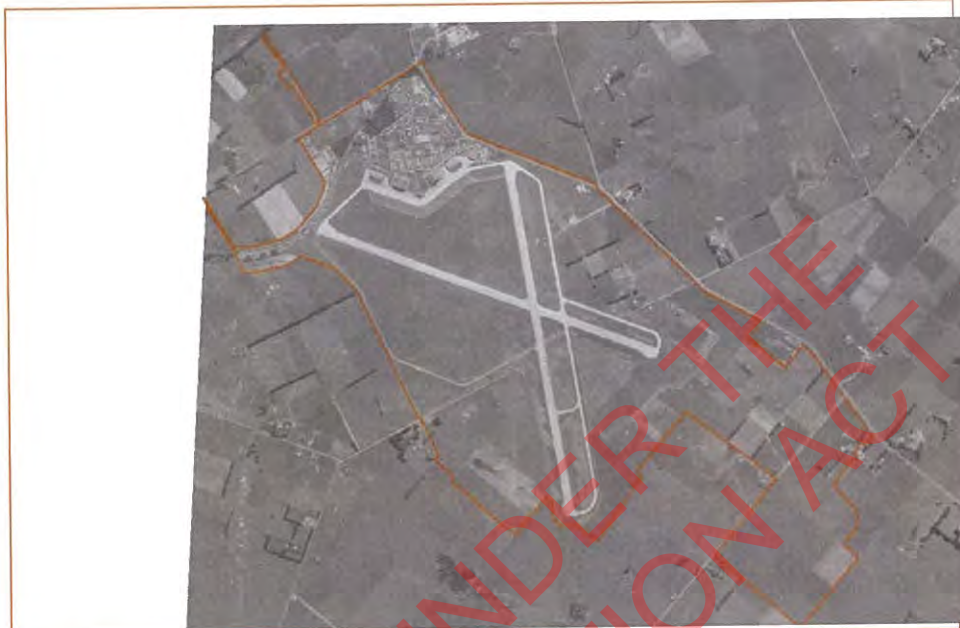
1958 Aerial (NZDF)

Both the east-west and north-south runways are complete and the south western perimeter road is visible. In the north west of the site the hangars, barracks and residential housing are present, however the building currently housing Fire Flight has not been constructed. Some additional buildings have been constructed in this area since the 1942 aerial, including development of the current contractor's yard. The explosive store houses in the north west of the site are present. There is bare earth visible at the confidence course landfill; however it cannot be confirmed if landfilling is occurring. The rifle range landfill is not evident. The buildings and structures in the north east of the site near SH1 have been removed with the exception of a small complex near the main entrance. It appears that the concrete diversion tank is present; however, this cannot be confirmed due to the quality of the photograph. The old incinerator has not been constructed yet and the FTA in the south west is not present. The waste water treatment plant in the north west of the site has not yet been constructed.

The surrounding land use remains relatively unchanged.

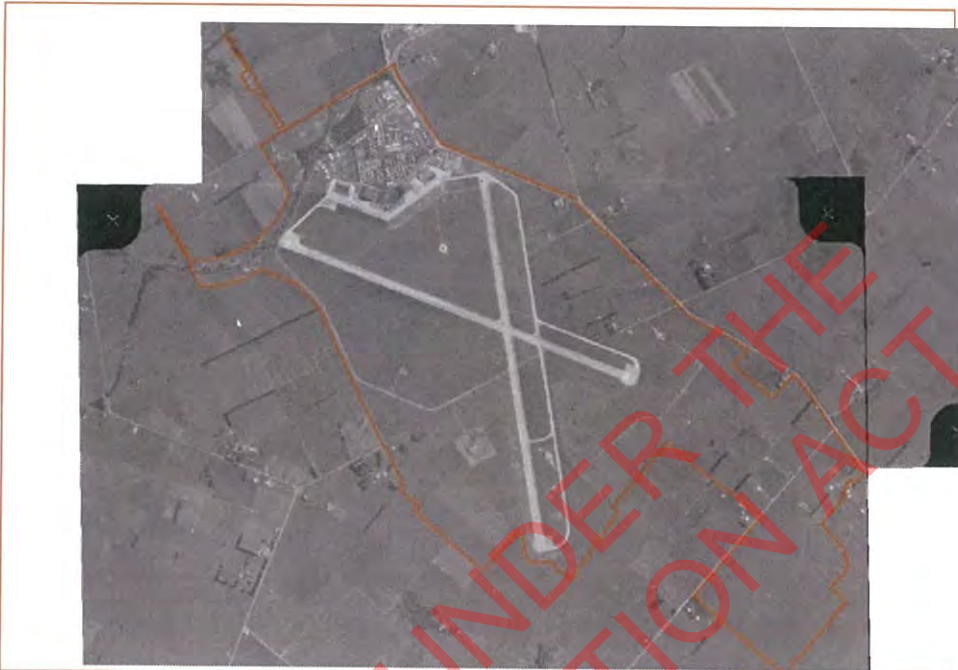
1968 Aerial (NZDF)

In the north of the site, the 1968 aerial is relatively unchanged from the 1958 aerial with the majority of the buildings remaining the same. The Fire Flight building is not present. The diversion tank is present and the incinerator has now been constructed. There is a large circular paved pad in the northwest open area of the runway. This may be used for testing aircraft engines as there is an aircraft on the pad and what appears to be scorch marks on the grassed area around the pad. The grassed area near the incinerator (close to the location of the current gymnasium) is being used to park large 4 engine aeroplanes. There are some construction/earthworks occurring near the eastern end of the rifle range landfill, however the landfill is not present and the area appears to be grassed. There is now a building/structure present at the FTA in the southwest of the site. The waste water treatment plant in the north west of the site is present.

The surrounding land use remains relatively unchanged.

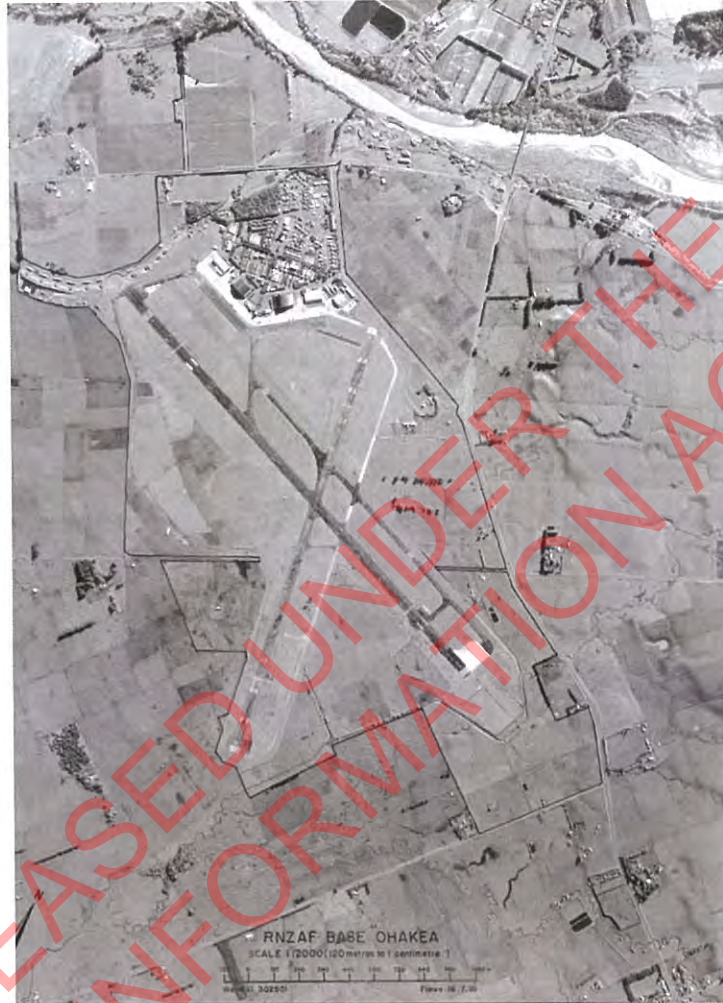
1995 Aerial (NZDF)

In the 1995 aerial the bulk fuel farm is visible in the north east of the site. In the south east of the site there is a small collection of buildings along the perimeter road near the FTA. The Fire Flight complex is now constructed adjacent to the control tower. There are significant earthworks in the vicinity of the rifle range landfill as well as a number of buildings and structures. In the vicinity of the engine run-up pit and the historic incinerator, there are 3 or 4 structures. There appears to be a blackened zone around one of the structures, although the quality of the photograph makes it difficult to determine if this is due to fire training or the incinerator. In the north of the site the majority of the buildings are unchanged from the 1968 aerial. The confidence course landfill is grassed and there is a carpark at the north end. Owing to the poor quality of the photo it is not possible to identify the burn pit that was thought to exist during the late 1980's and early 1990's (see section 3.4.3).

The surrounding land use remains relatively unchanged.

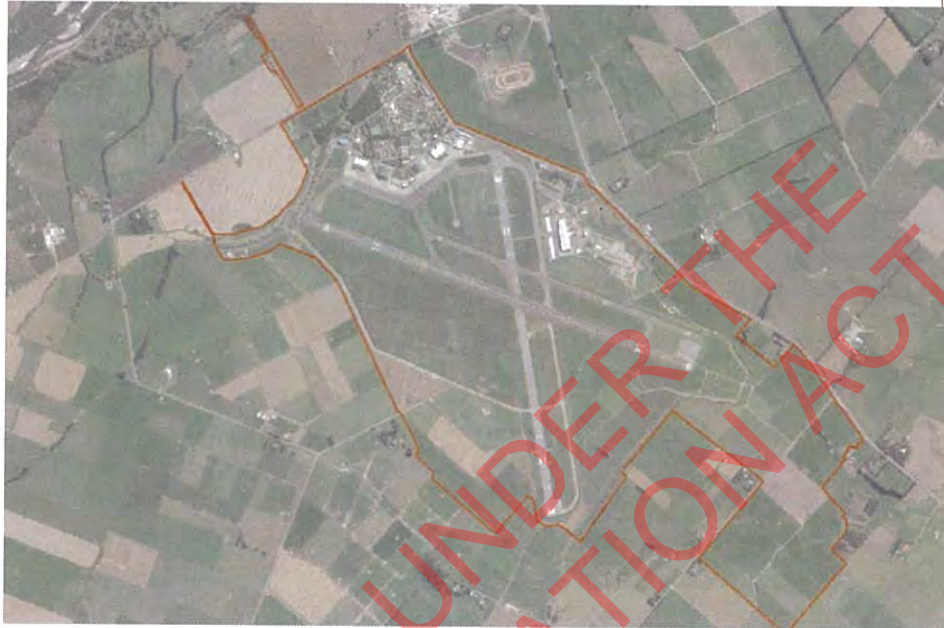
2010-2011 Aerial (LINZ data service)

The 2010/2011 aerial shows the majority of the site much as it is today. In the south west of the site the perimeter road layout has changed so that it runs past the FTA which is now present. The No 3 SQN hangar in the north east of the site has been constructed. The construction of the MSS workshop, helicopter simulator and paint shop has begun, but the buildings are not yet finished. The new Air Movements terminal has not yet been built and 4 Hangar is still present in this location. The gymnasium is present near the incinerator. In the west of the site the rifle range landfill is now a rifle range. Nearby to this, the engine run-up pit has been constructed and there is no evidence of the incinerator that was present in the 1995 aerial.
