INDEPENDENT REVIEW NGONGOTAHĀ FLOOD EVENT 29 APRIL 2018

REPORT DATE;
DECEMBER 2018

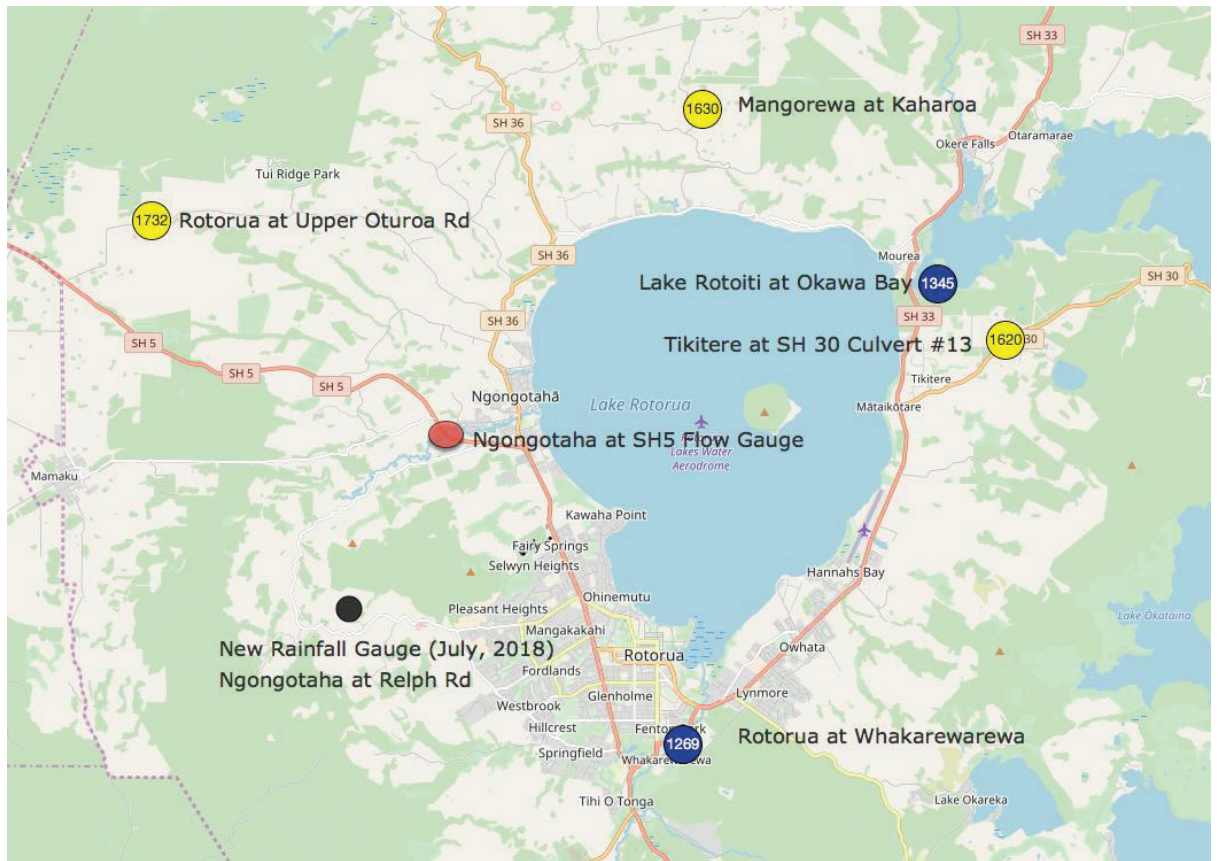
Figure 3: Location of Current Rainfall Gauges in Rotorua and the Ngongotahā Stream Flow Gauge (Numbers in bubbles indicate rainfall depth for year to date at 6 August) (Source - BOPRC website)

At the time of the April 2018 flood event there were no officially monitored (i.e. NIWA or BOPRC) rain gauges in operation in the Ngongotahā catchment. Since the April 2018 event BOPRC have installed a rain gauge in the Ngongotahā catchment at Relph Road (See Figure 3). With no rain gauges within the catchment the Panel has used the closest rain gauges from adjacent catchments to understand rainfall depths and intensities during the event.

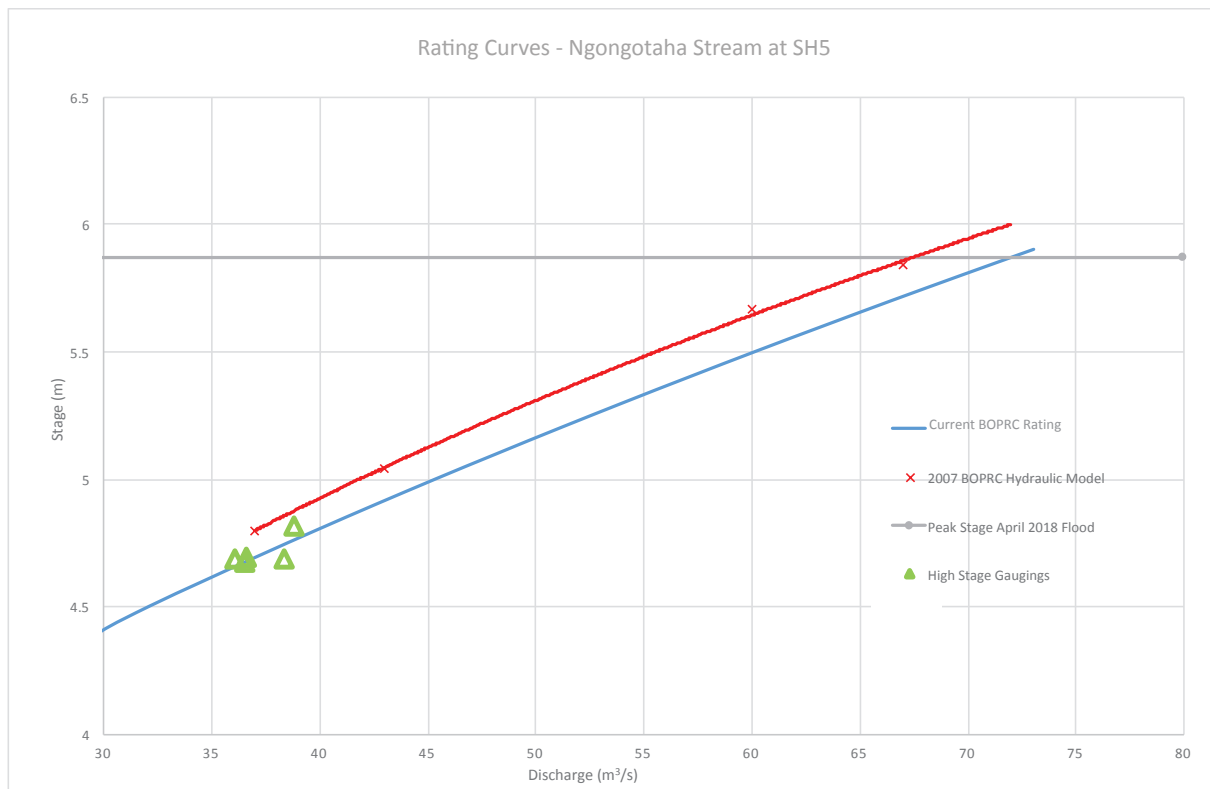
Figure 7: Rating Curves, High Stage Gaugings and Measured Peak Water Level Ngongotahā Stream at SH5

With the somewhat limited high stage gauging information, the method for extrapolating the rating curve becomes particularly important for estimating the size of larger events. At this site BOPRC have used the log-log method for extrapolating the rating curve beyond the measured gaugings. This is an accepted extrapolation method, as described in Section 2.3.3.7 Extensions (Curve Extrapolation) of the 2016 National Environmental Monitoring Standards (NEMS) for Rating Curves. Within this section of the Standard it is also recommended that, whenever possible, two or more methods are used to improve the confidence in the extrapolated portion of the rating curve.

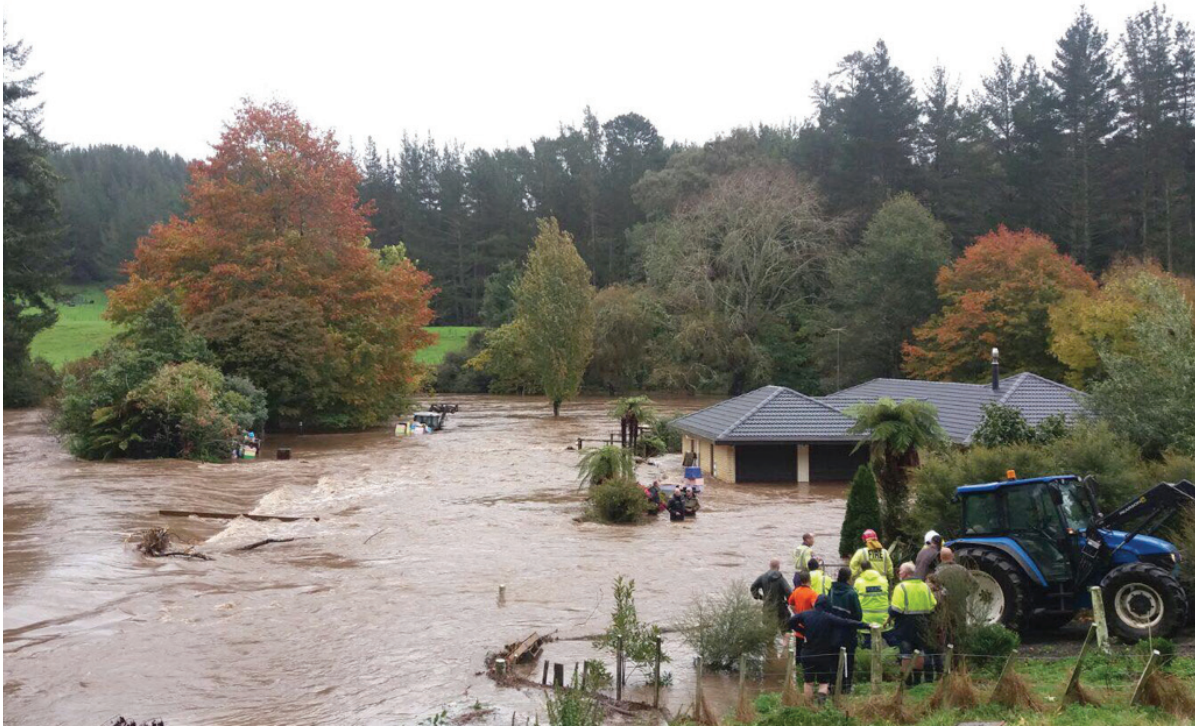
Figure 9: Paradise Valley Road Property Photo taken on 29 April 2018 by resident

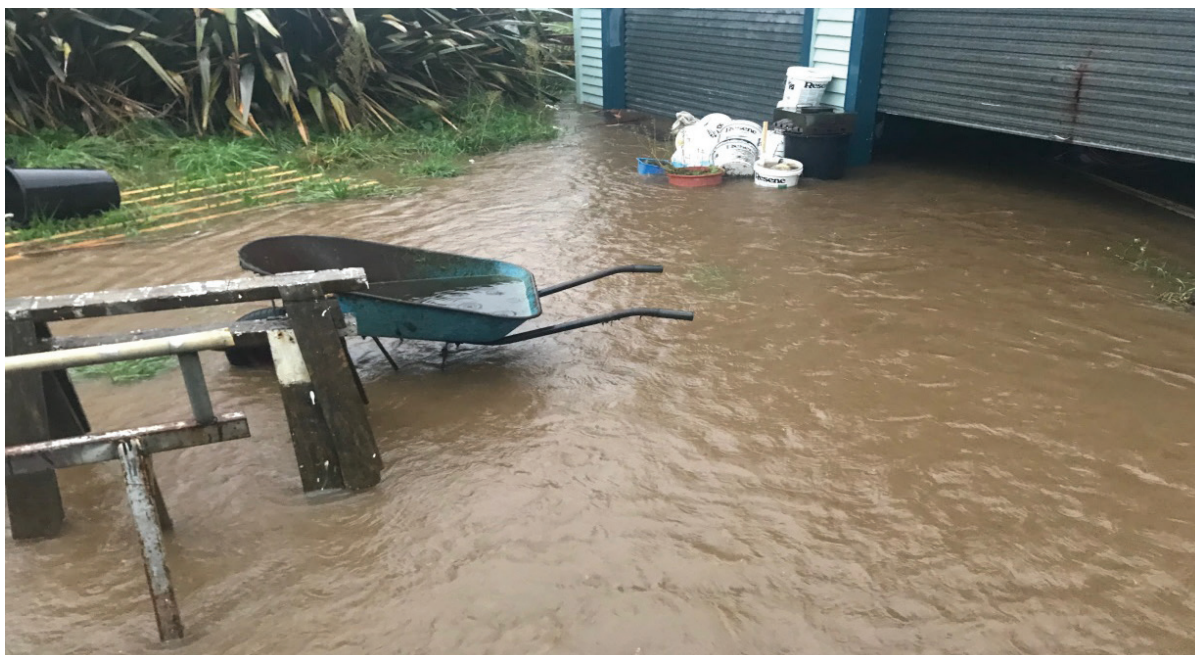
Figure 10: Photo of Western Road Property taken 29 April 2018 by resident

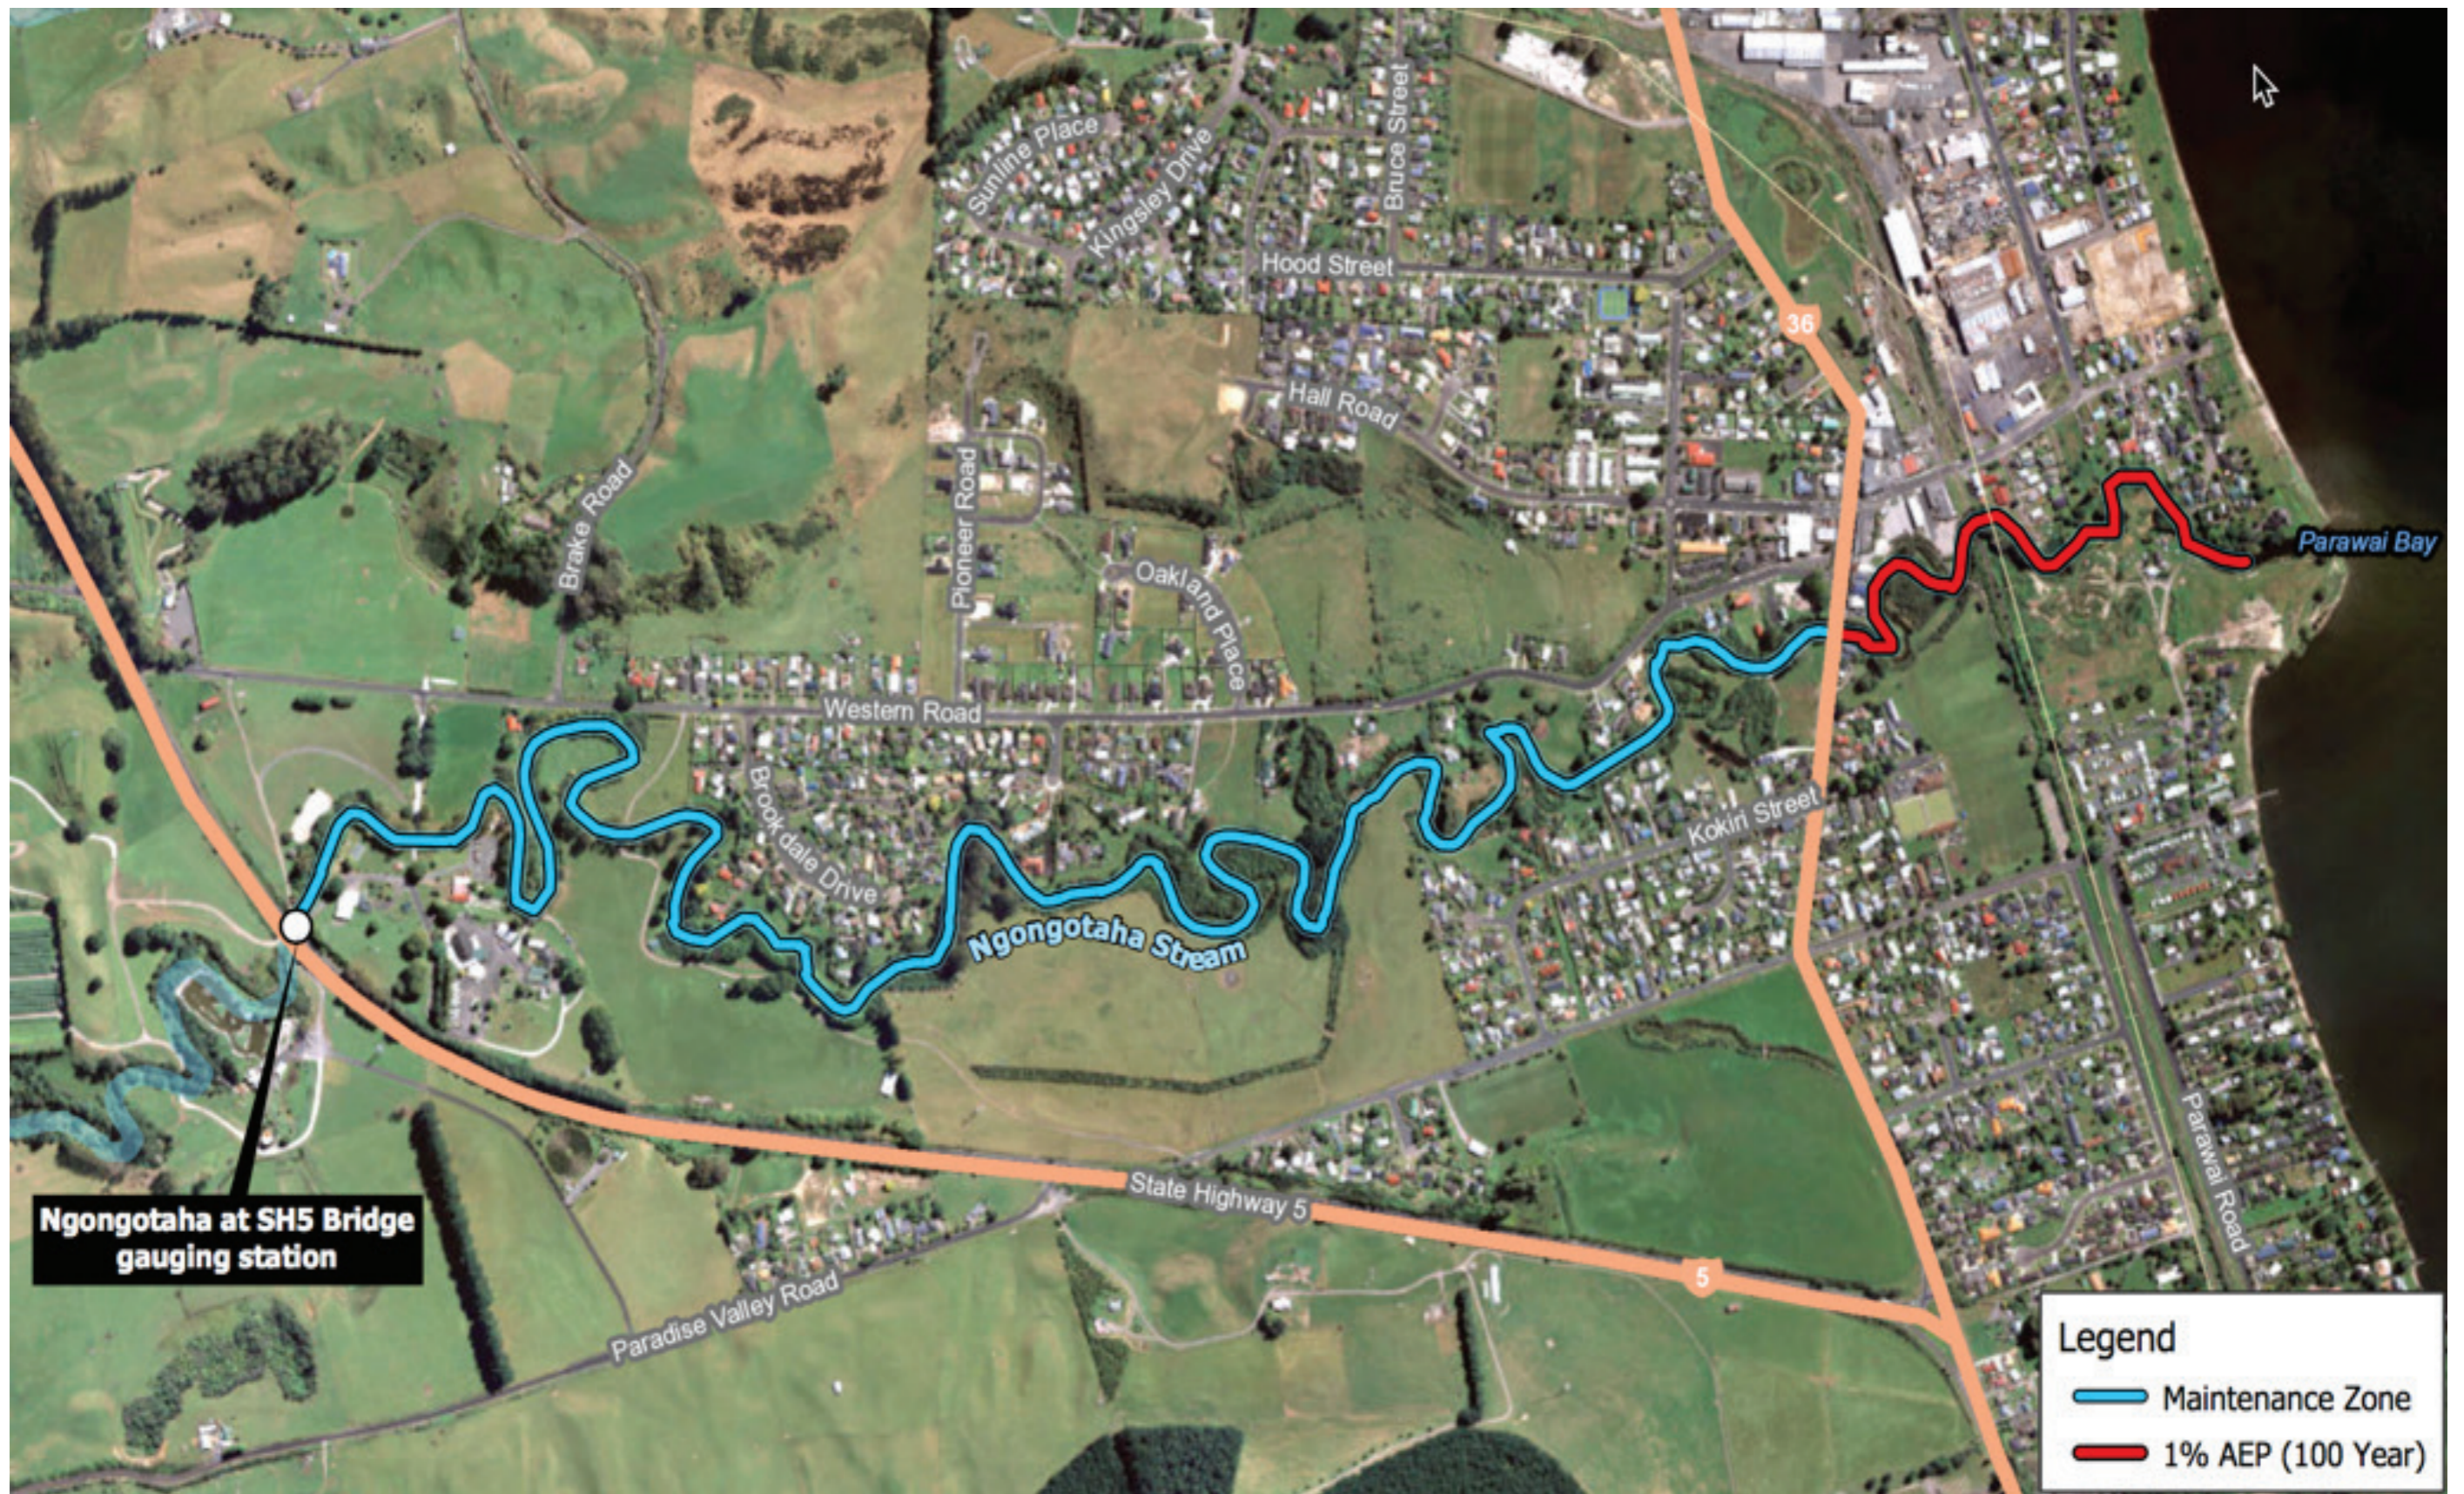
Figure 13: Upper Kaituna Scheme Design Standards (Source – BOPRC)

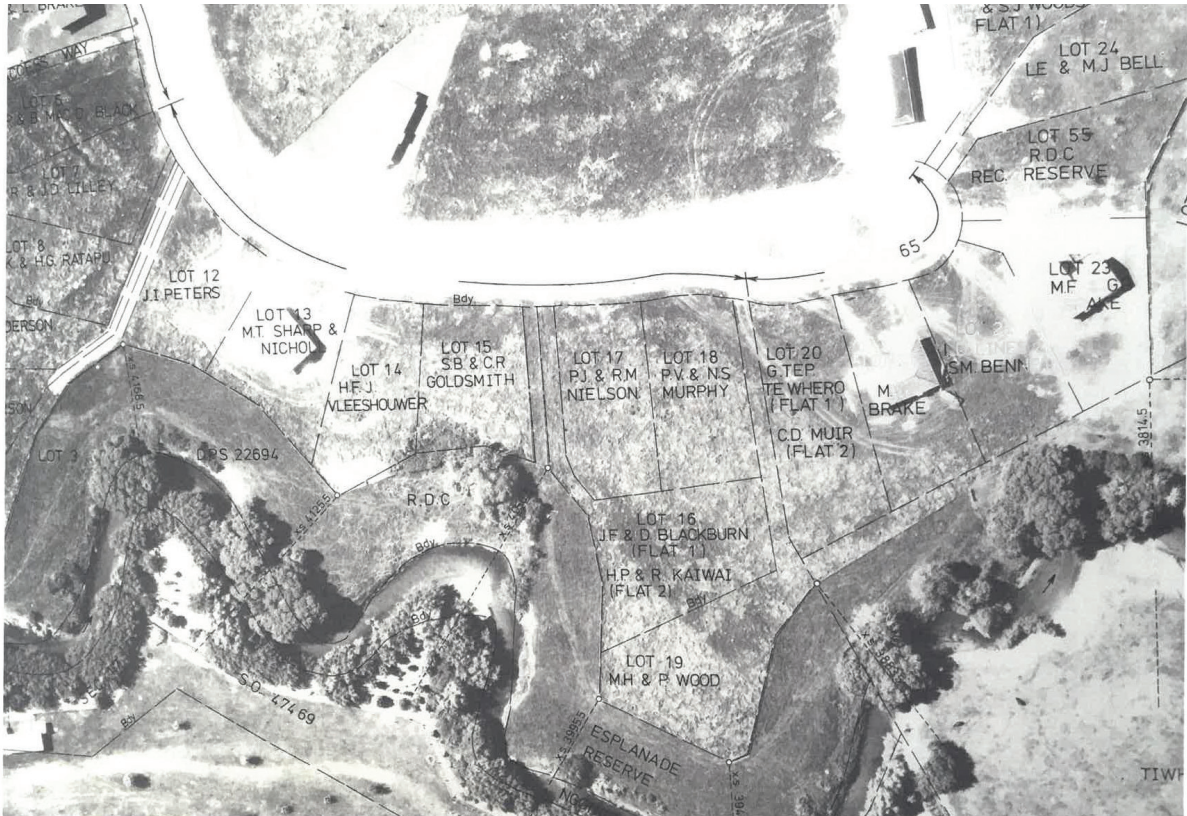
Figure 14: Kaituna Scheme Construction Contract Plans 1981 (Source – BOPRC)

The construction contract for the Ngongotahā works in 1981 included stream improvement works upstream of Ngongotahā Road in the Brookdale Drive/Streamdale Place area which was in the early stages of development at the time (See Figure 14).

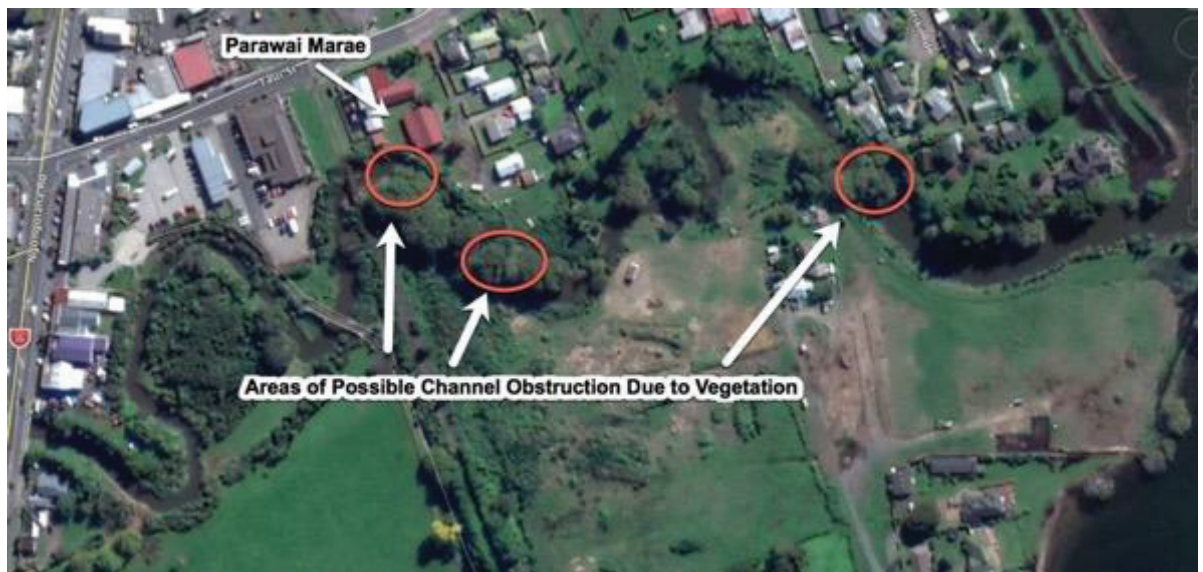
Inspection of the 2017 aerial photograph in Figure 17 suggests three locations where there may have been vegetation obstructing the channel. The reach most affected appears to be adjacent to, and immediately downstream, of Parawai Marae.

Figure 17: 2017 Aerial Photograph Ngongotahā Road Bridge to Lake Rotorua (Source - Google Earth)

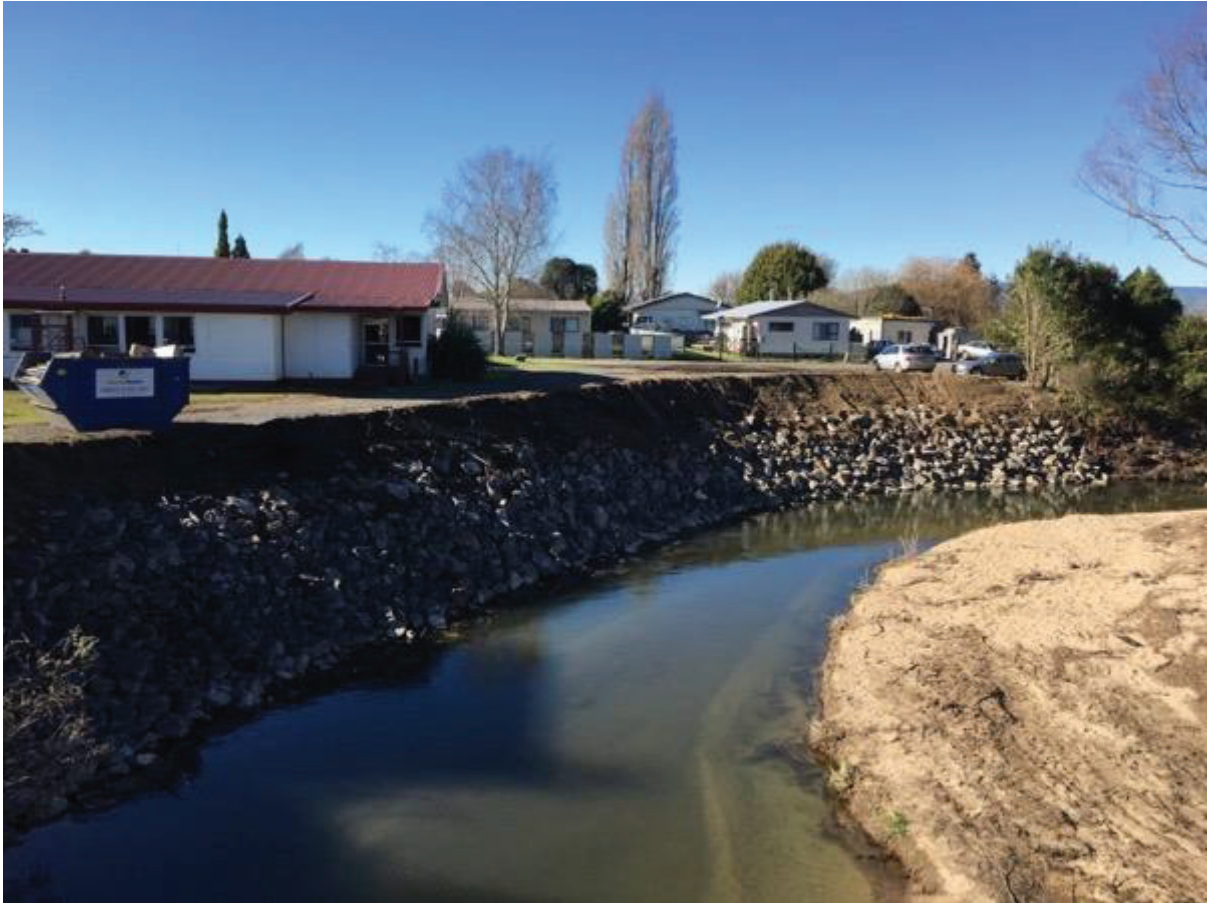
It was noted that the right bank stopbank in the most downstream reach, immediately upstream of the lake, had eroded away during the event. This is a relatively low (<1 m high) stopbank with currently undeveloped land on the landward side of it. The failure of this stopbank is discussed further in Section 4.5.

Figure 19: Rock revetment works and vegetation removal Parawai Marae (Post event)

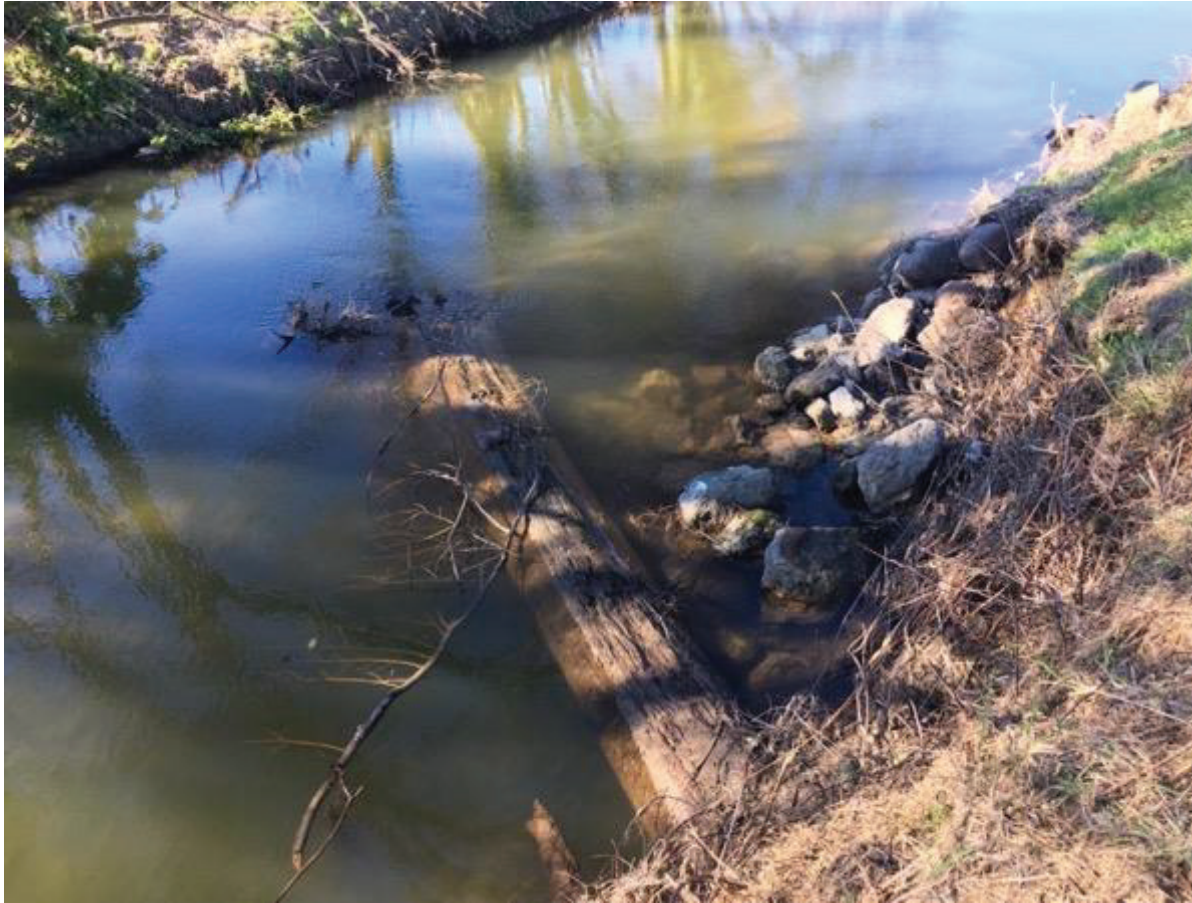
Figure 20: Large woody debris right bank downstream of Parawai Marae

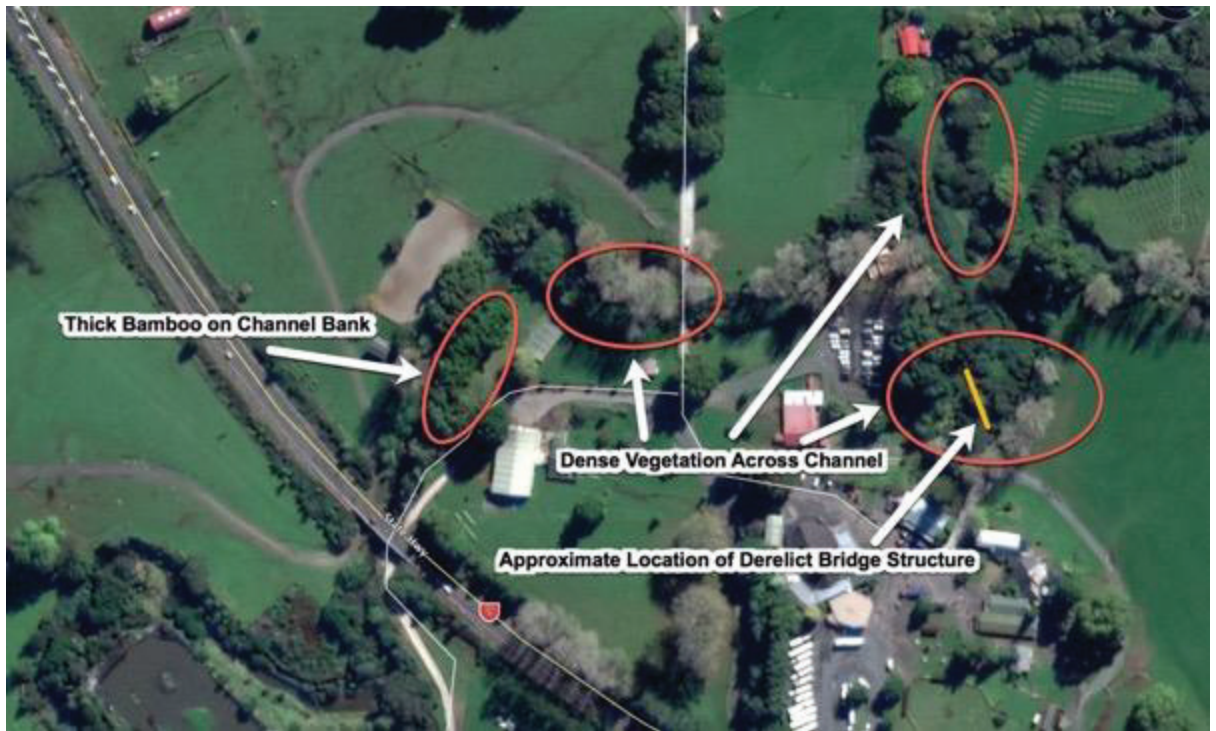
Figure 21: 2017 Aerial Photograph Agrodome Reach (Source Google Earth)

Inspection of the 2017 aerial photographs of this reach (Figure 21 to Figure 24) suggests extensive vegetation encroachment across the stream channel throughout much of this reach and especially so in the upper reach from SH5 through the Agrodome property to Brake Road. As previously noted, this vegetation could be seen as beneficial in terms of slowing down flood waters, minimising bank erosion as well as providing habitat and a food source for aquatic fauna.

However, excessive vegetation, and complete channel blockage would generally be considered adverse in terms of conveyance of flood waters and “keeping channels clear of obstruction” is highlighted as one of the key activities for this reach in the 2018 BOPRC Asset Management Plan.

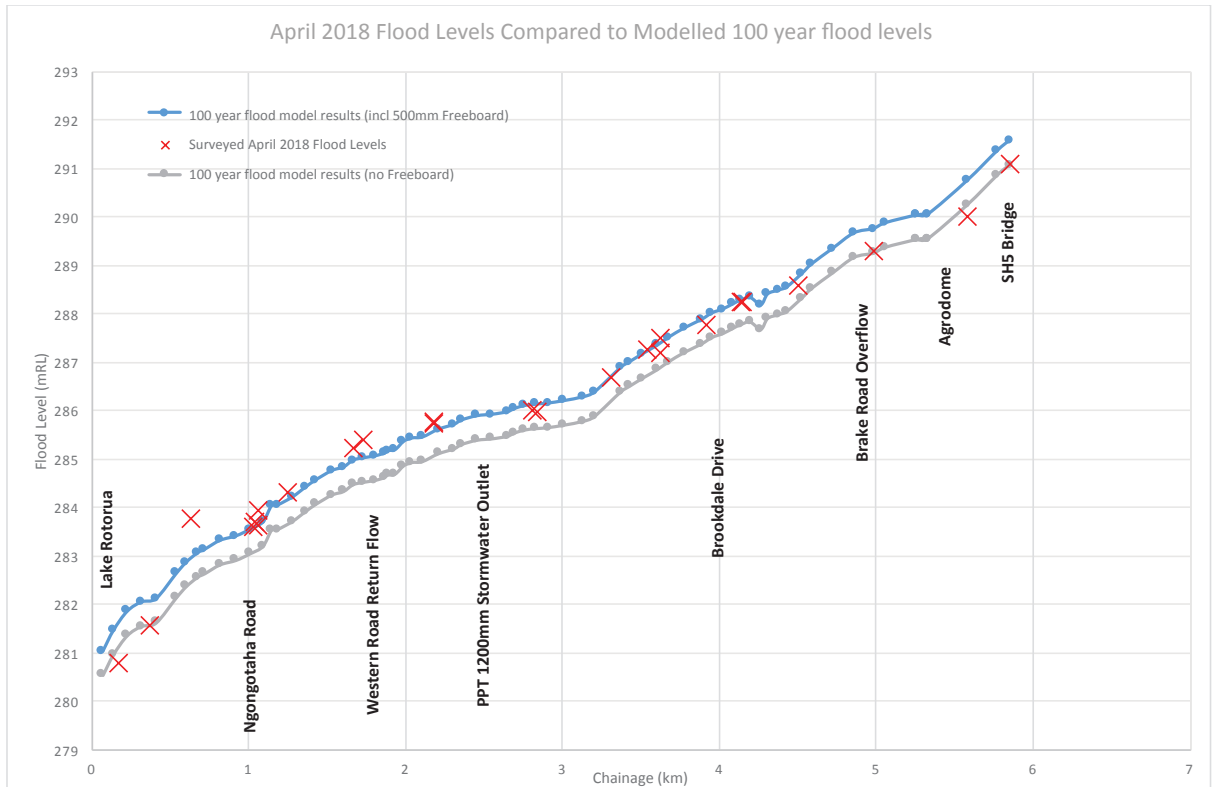
The Panel acknowledges that there is no specific design standard for the channel maintenance in this reach, but it is of interest to compare the surveyed flood levels of the April 2018 event to the design levels presented in the 2007 BOPRC Hydraulic Modelling Report. Noting that the design levels presented in that report were largely determined by the calibration of the December 2005 flood of 33 m³/s being around half the size of the April 2018 event. The comparison of the modelled flood levels to surveyed flood levels is shown in Figure 25.

Figure 25: Flood Level Comparison – Ngongotahā Road to Lake

Secondly, a very key point is that the surveyed flood level at the Brake Road overflow point was approximately equal to the modelled flood level (without freeboard) at this point. This is important in that the flood level at this point determined the quantity of water that overflowed across Western Road, through the properties on Western Road and through the PPTS subdivision. This is discussed in greater detail in Section 5 of this report, but for the purposes of this section it is concluded that the flood levels in Ngongotahā Stream at the Brake Road overflow point were in-line with those predicted by the 2007 BOPRC Hydraulic Model and the resulting overflow was therefore likely to be in the range predicted by BOPRC ($5 - 15 \text{ m}^3/\text{s}$). This was the same range of overflow advised as the required design flow by BOPRC to both RLC and the PPTS developer's design consultants (MTEC now Forbay Ltd) for the overland flow path through the subdivision.

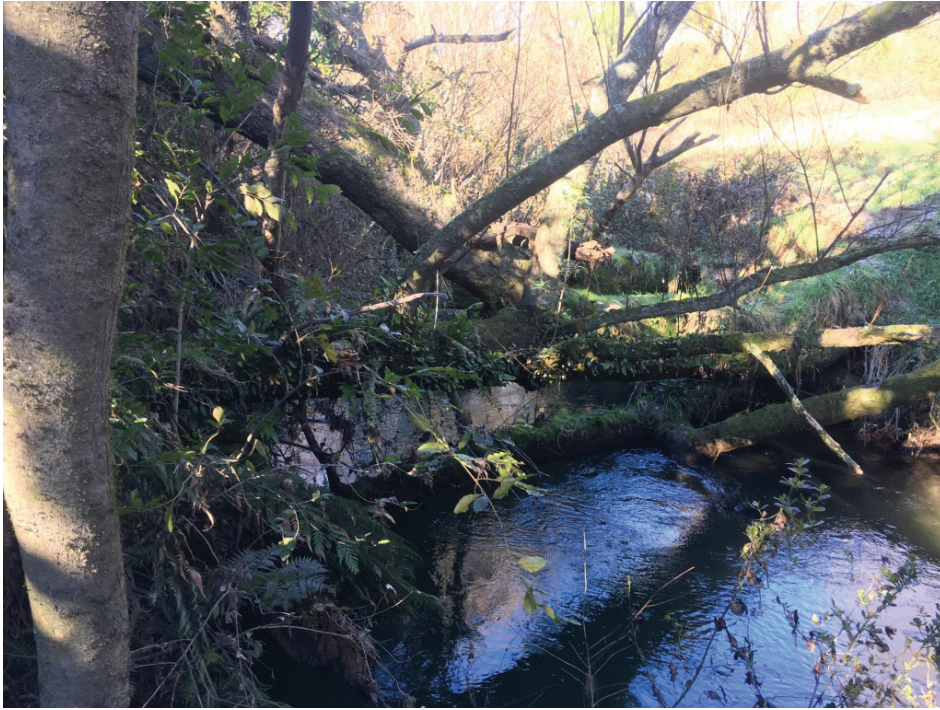
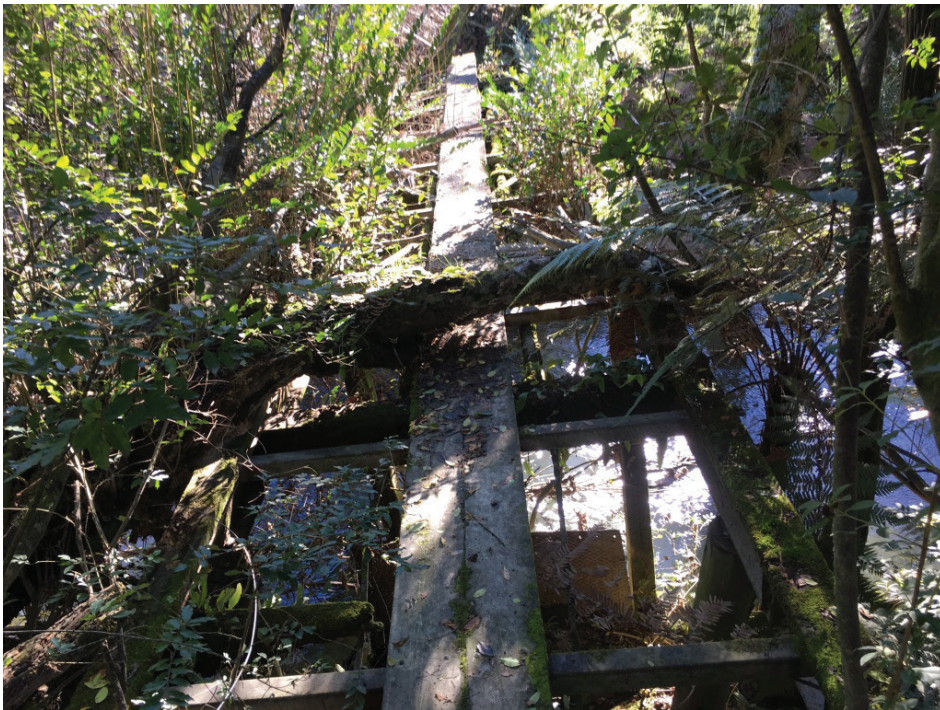
Figure 26: Notable Channel Obstructions Ngongotahā Stream (Agrodome Property)

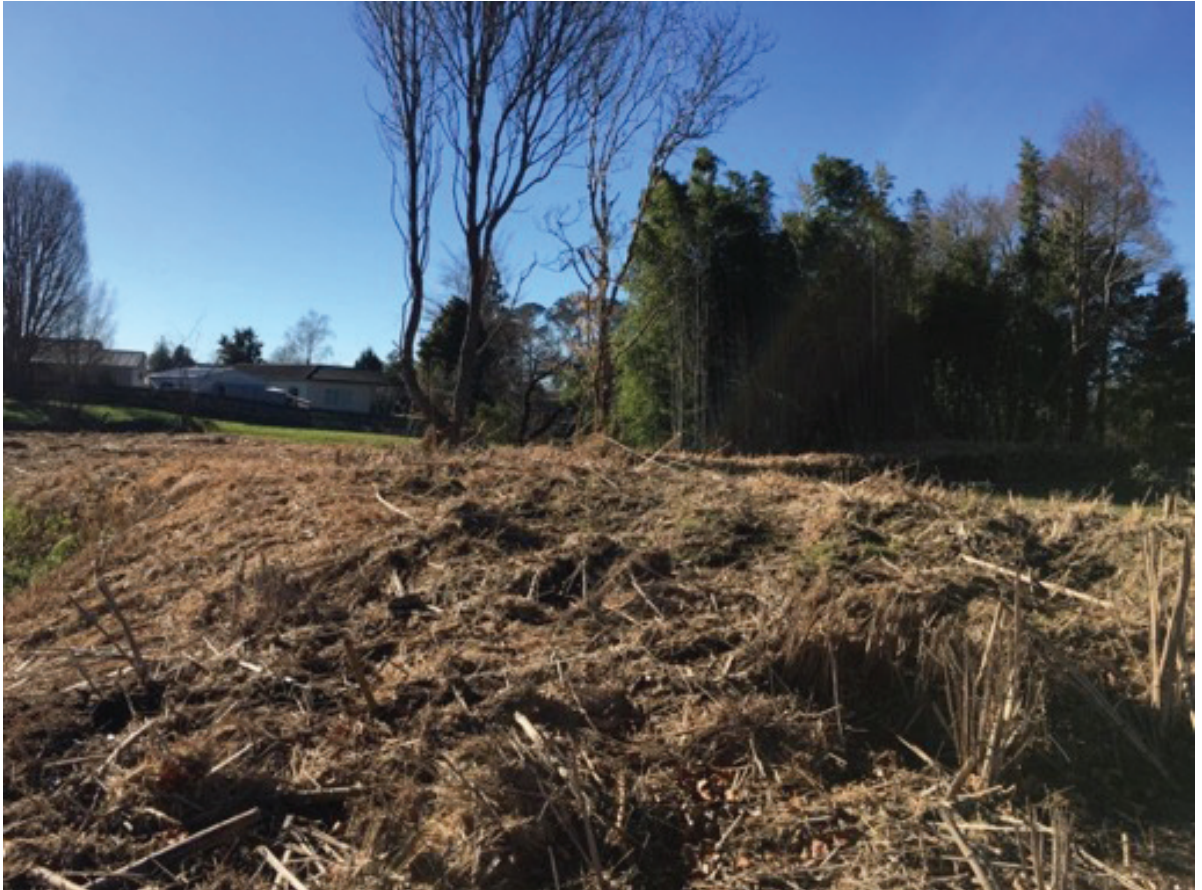
Figure 27: Extensive area of post-flood bamboo clearance adjacent to Brookdale Drive

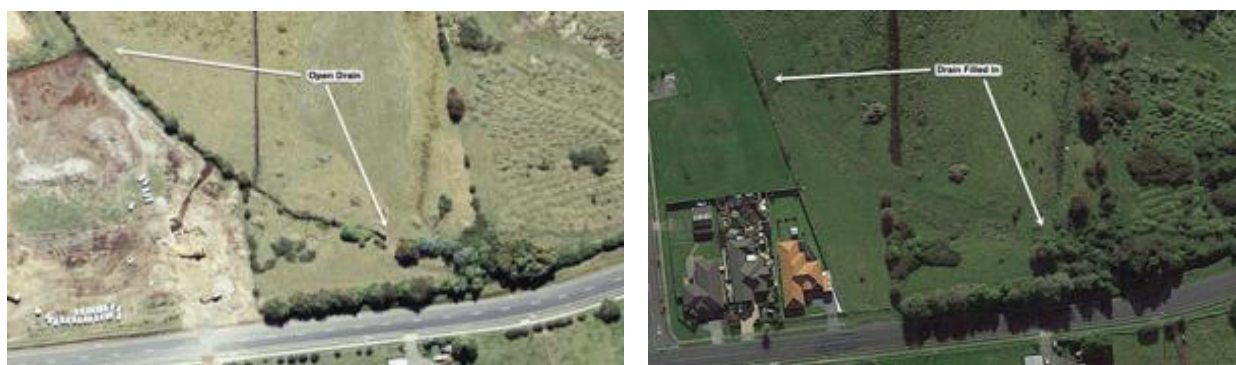
It was also brought to the Panel's attention that the open drain in the Everard Developments property on the eastern boundary of the PPTS development had been filled in sometime in the past five years (see Figure 28). It is understood from discussions with RLC that no consent had been sought for filling in this drain. Prior to the earthworks and infrastructure of the PPTS subdivision being completed this drain, and its 450 mm outlet to Ngongotahā Stream at Elliot Park, served to drain the mostly rural catchments to the north of Western Road. The earthworks and stormwater infrastructure for the development, including the new 1200 mm diameter stormwater pipe into Ngongotahā Stream, in effect intercepted most of the upstream flows that would have previously entered this open drain.

Figure 28: Open Drain to east of Oakland Place 2006 aerial photo (left) & 2016 aerial photo (right) (Source – Google Earth)

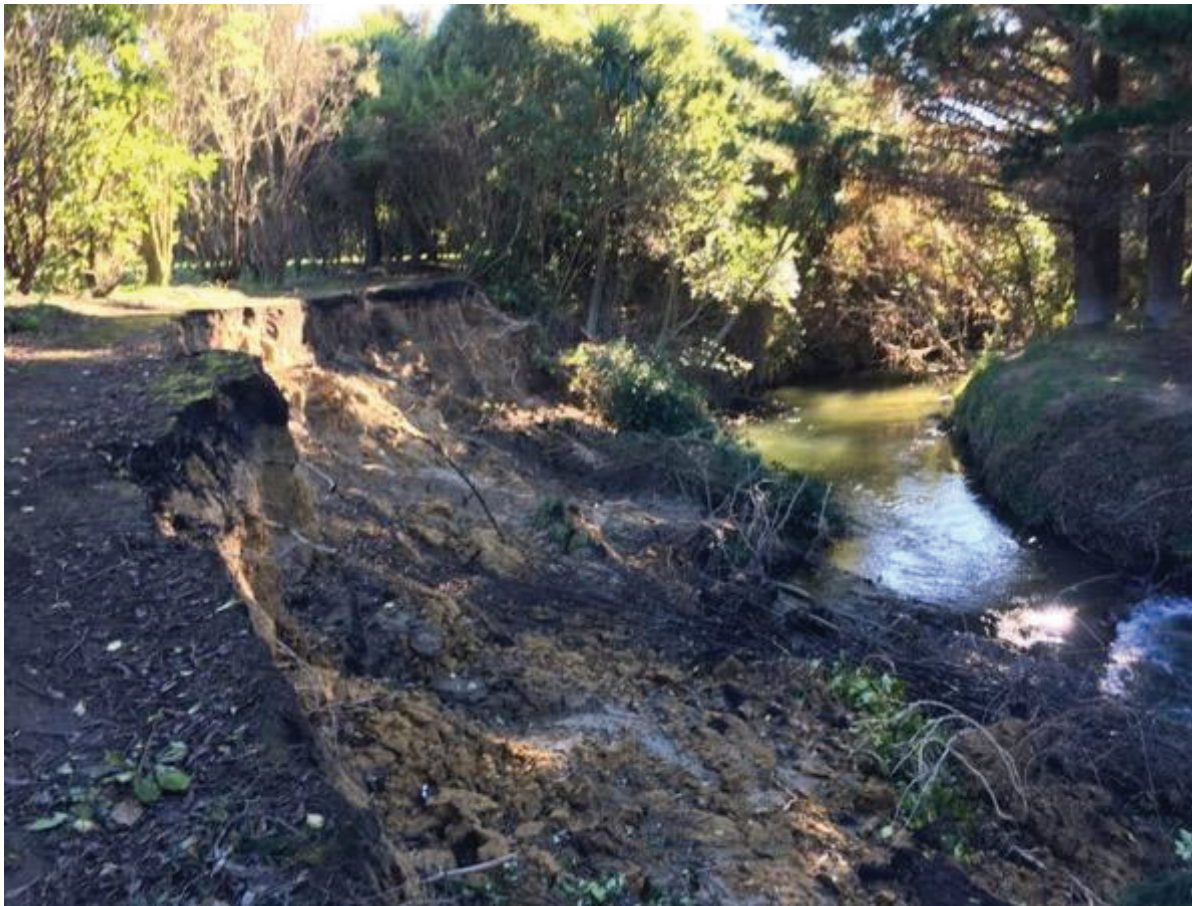
It was observed that there were a number of areas of bank erosion (See Figure 32) that would likely require some remedial works to stabilise. These were especially on the outside of bends and not unexpected given the magnitude of the flood event. The Panel suggests that consideration is given to remedial works that flatten the slopes of the failed banks and then use appropriate smaller vegetation such as carex grasses on the lower banks to provide stabilising effects and native trees/shrubs on the upper bank. In some areas rock rip-rap may be required to provide stability to the toe of the bank to allow the upper bank areas to be stabilised as vegetation grows.

Figure 32: Bank erosion right bank upstream of Ngongotahā Road

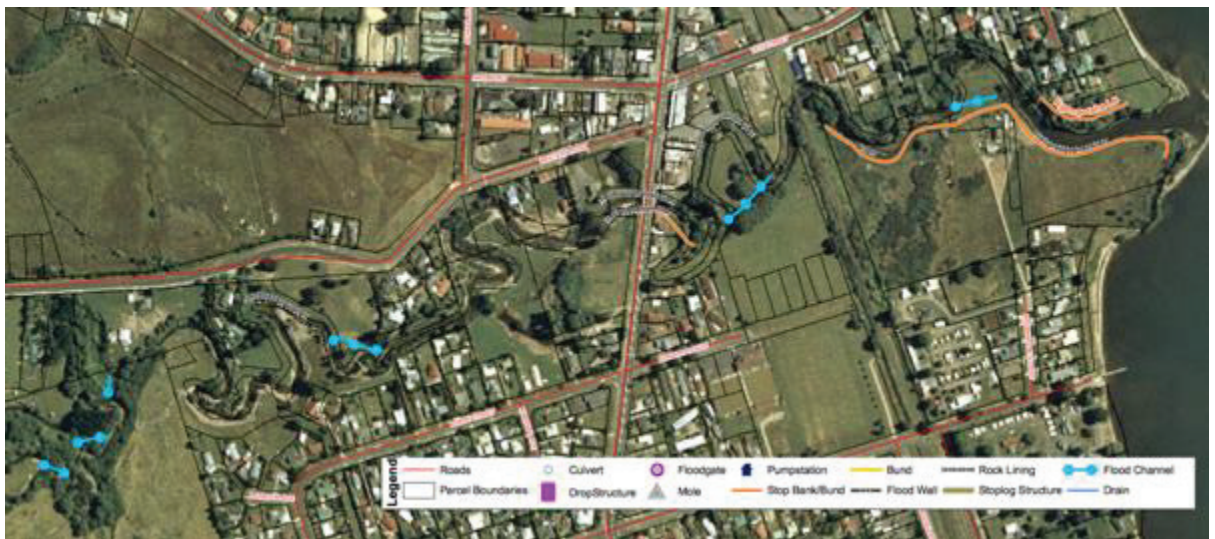
The main structural works within Ngongotahā Stream are within the flood protected area of the Upper Kaituna River Scheme downstream of Ngongotahā Road (See Figure 29). These assets are primarily stopbanks, largely on the right (south) bank with two flood channel overflow paths. There are also several flood channel overflow paths upstream of Ngongotahā Road Bridge as well as rock linings⁵³.

Figure 33: BOPRC Structural Flood Management Infrastructure Ngongotahā Stream

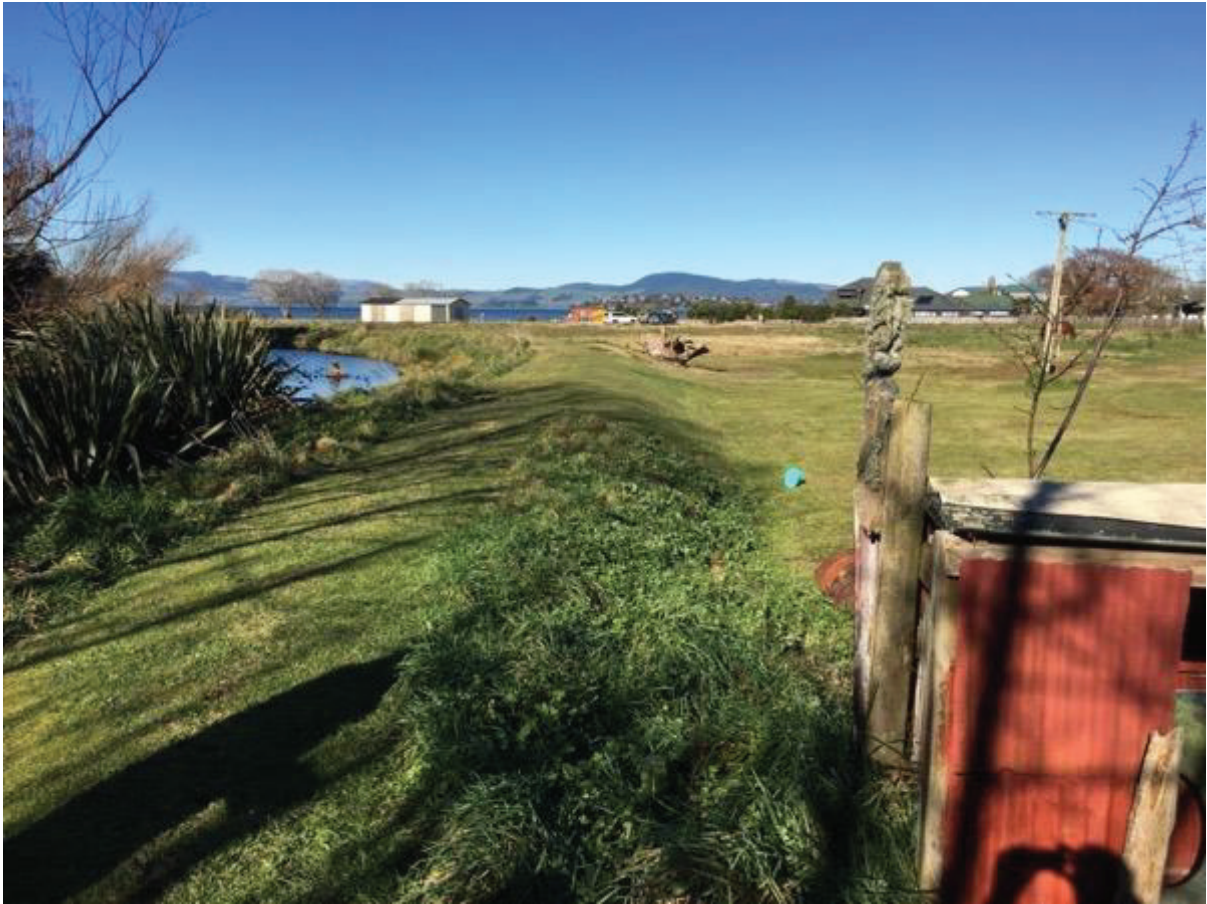
Figure 34: Right bank stopbank near Lake Rotorua

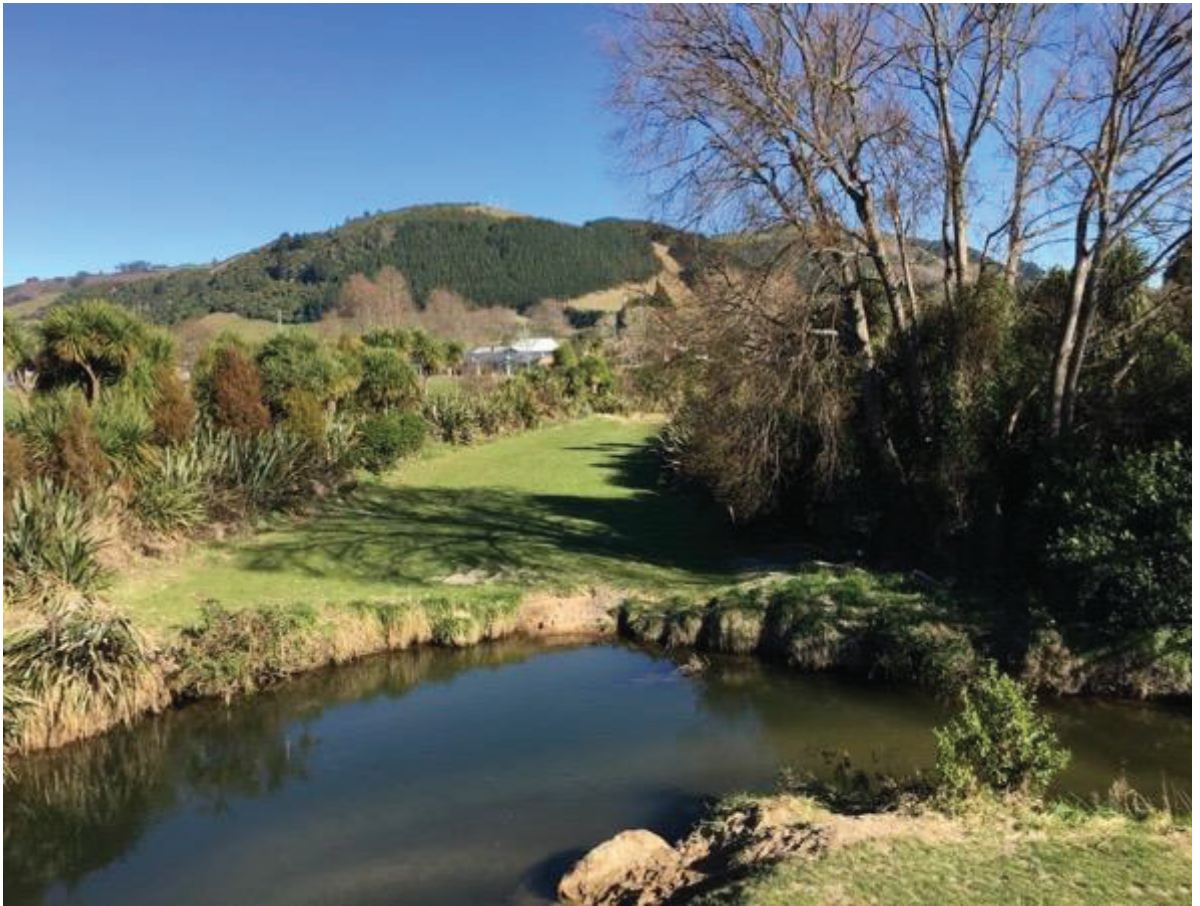
The stopbank on the right bank immediately downstream of Ngongotahā Road Bridge did not appear to provide the required design 100-year + 500 mm freeboard level of protection as evidenced by the flooding that occurred on the property at 268 Ngongotahā Road. It was fortunate that flood waters did not enter the dwelling so damage on the property was less severe than it otherwise could have been.

Figure 35: Floodway downstream of Ngongotahā Bridge

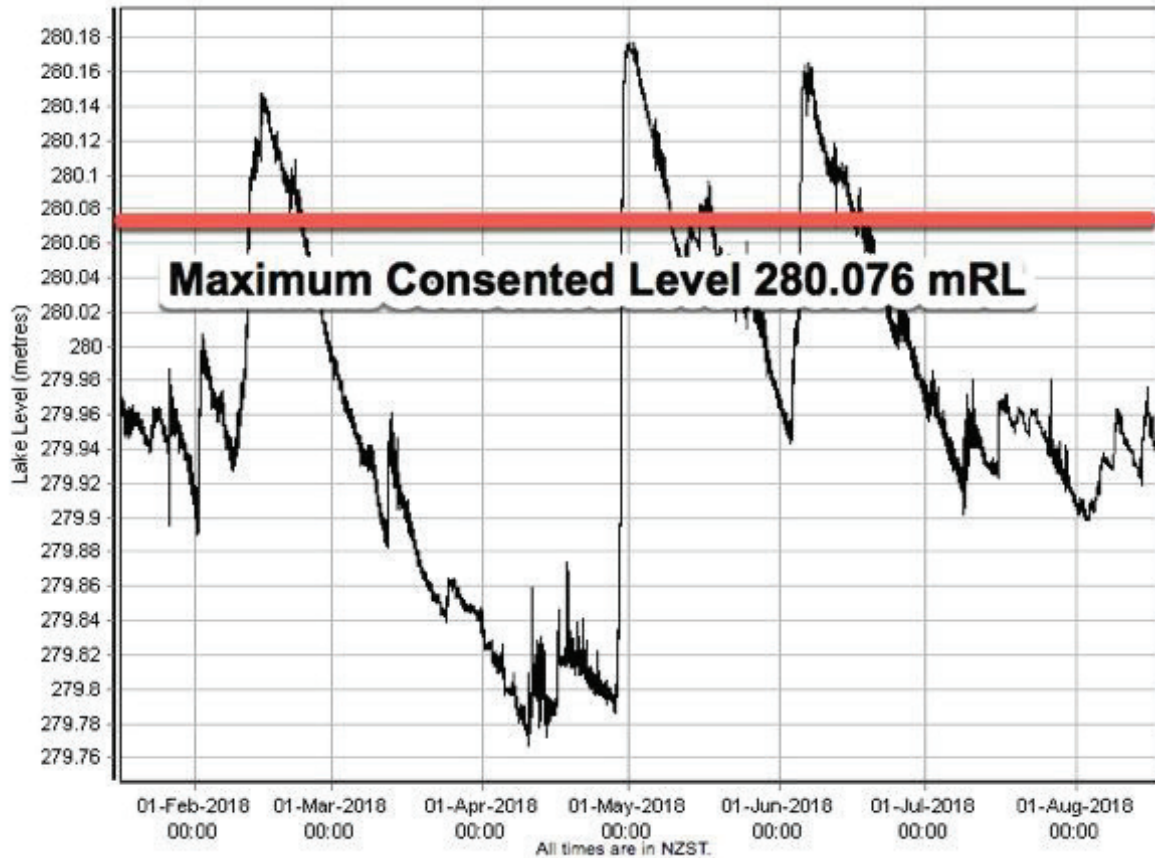
The slightly elevated lake level would have had no effect on the flooding of dwellings within the Ngongotahā catchment. This is due to the relatively steep grade of the channel with a 3 m difference in flood levels between the lake and Ngongotahā Road and a 10 m difference in flood levels between the lake and SH5.

Figure 36: Lake Rotorua Water Levels 2018 (Source – BOPRC Live Monitoring Website)
