INDEPENDENT REVIEW NGONGOTAHĀ FLOOD EVENT 29 APRIL 2018

REPORT DATE;
DECEMBER 2018

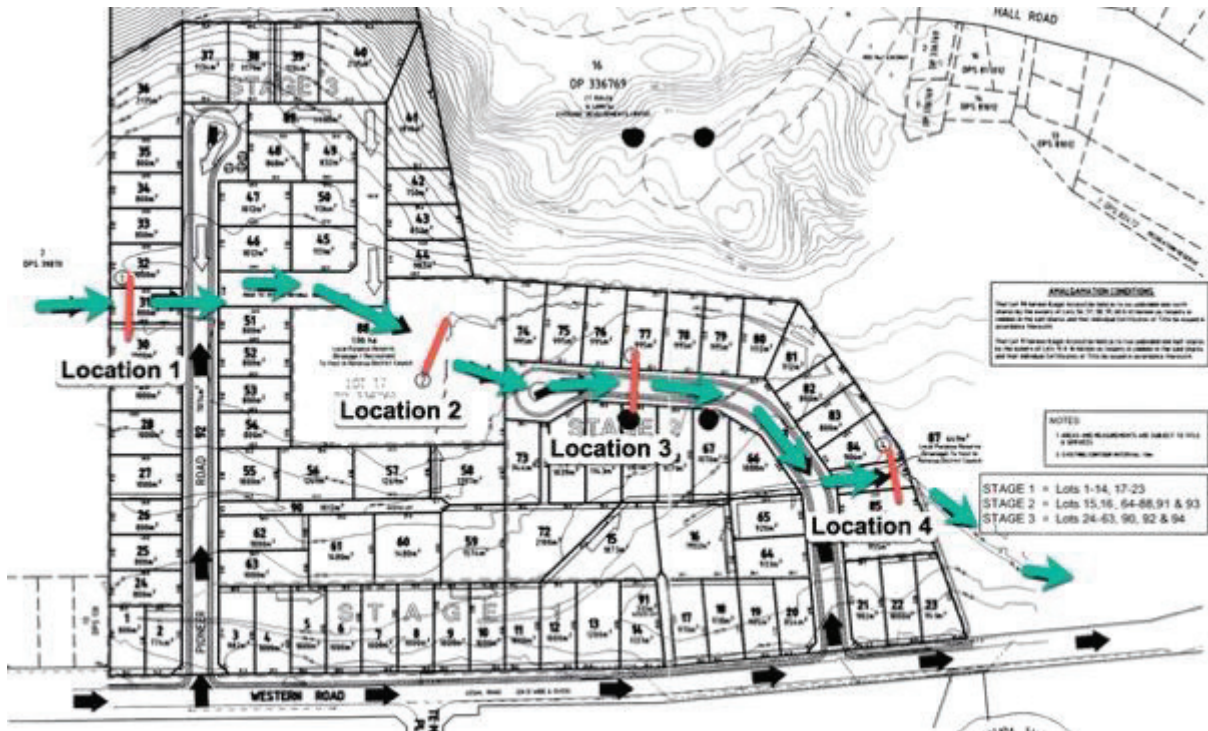
Figure 37: Outline plan of overland flow path and locations where calculations were undertaken (Source – MTEC Drawing 175781-R-P-D002 N.B. colours added by Review Panel for clarity)

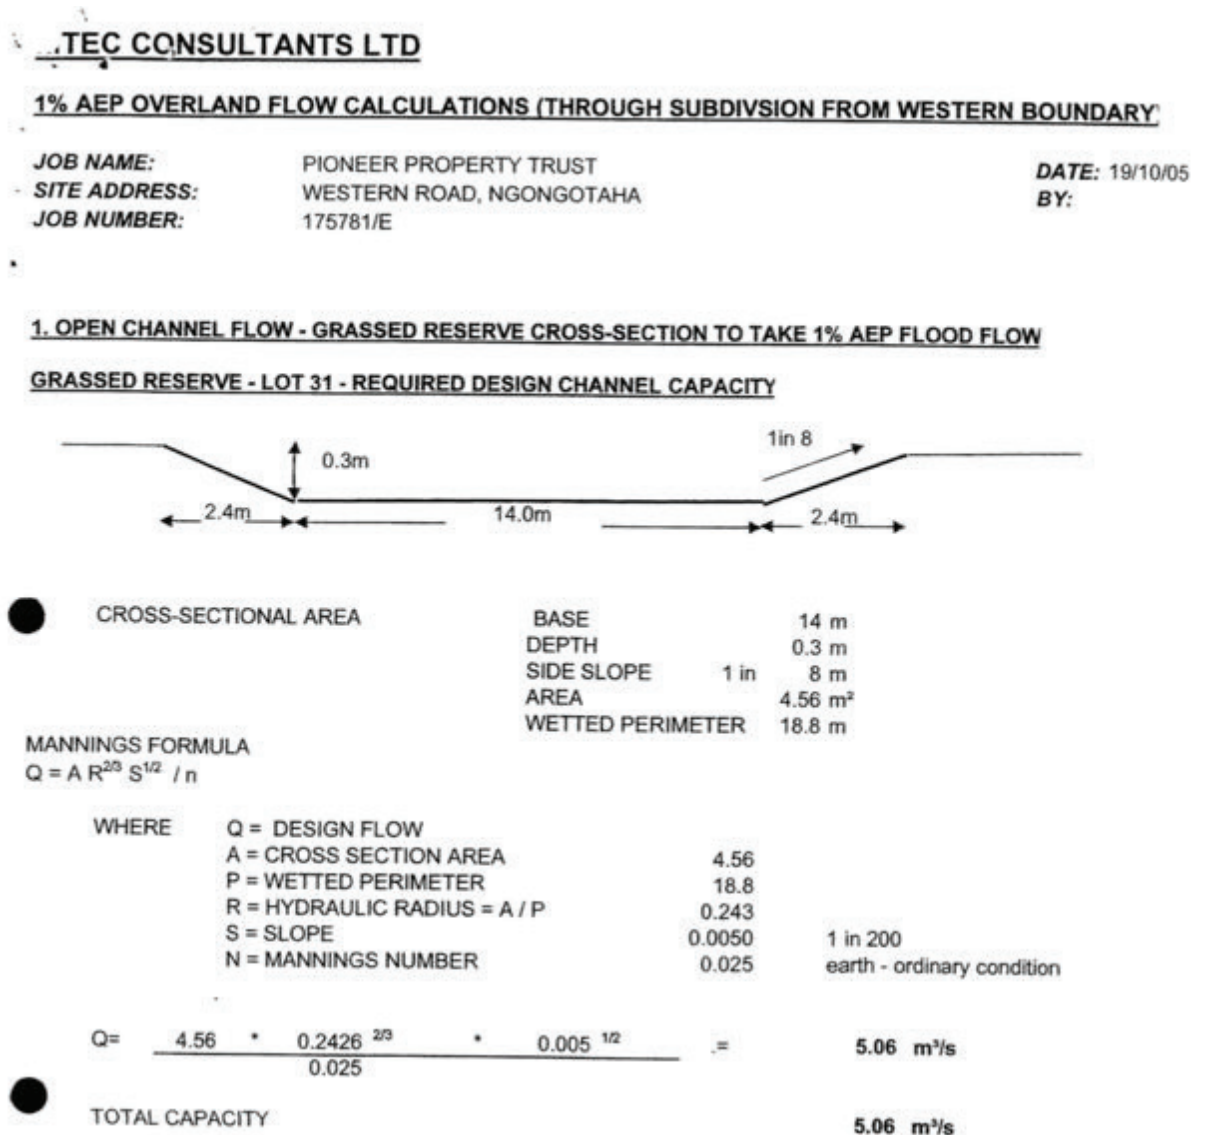
Figure 38: MTEC design cross section and calculations at location 1

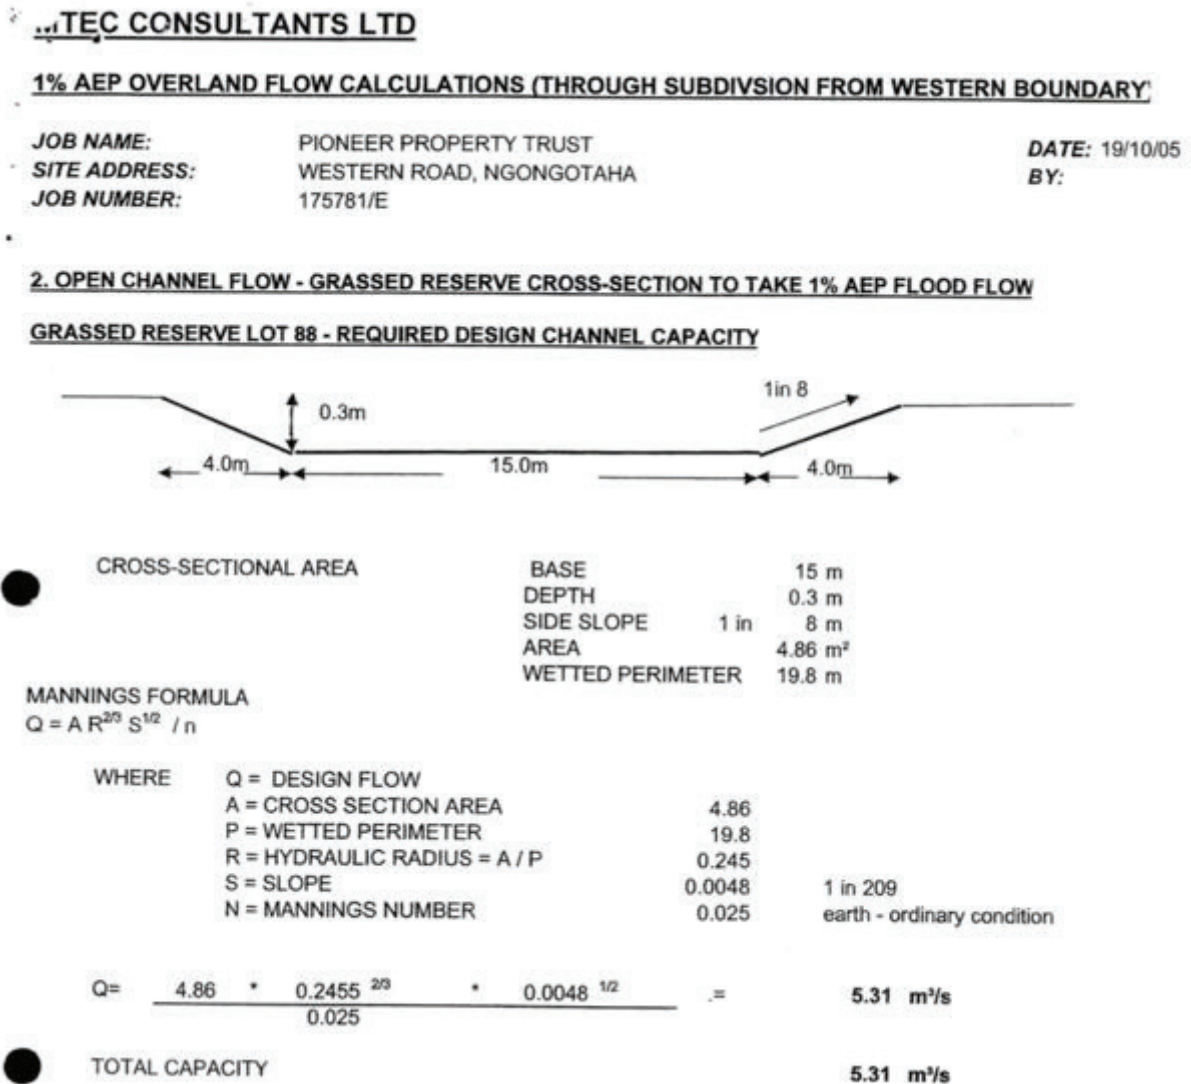
Figure 39: MTEC design cross section and calculations at location 2

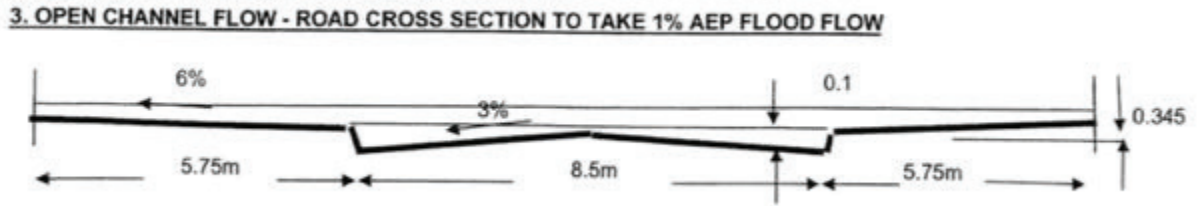
Figure 40: MTEC design cross section at location 3

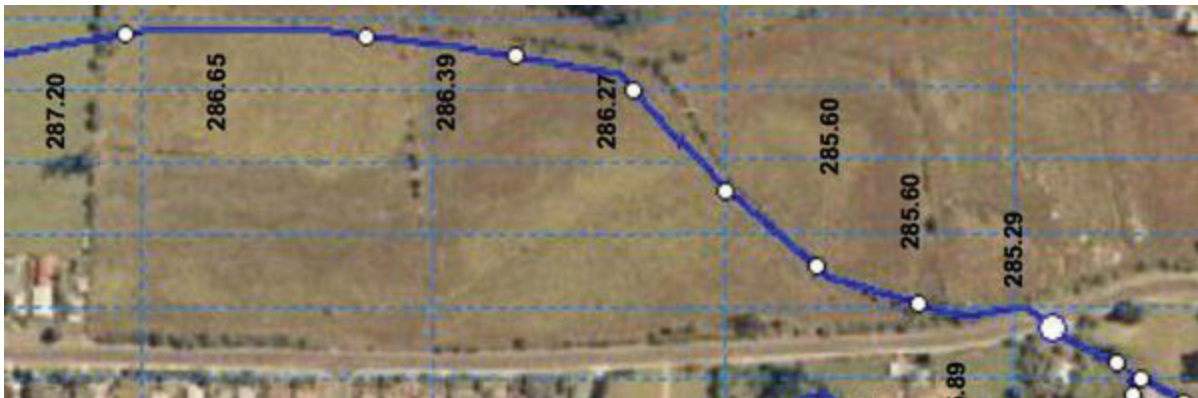
Figure 42: 100-year flood levels with PPTS based on 2007 survey information (Source – BOPRC Modelling Report)

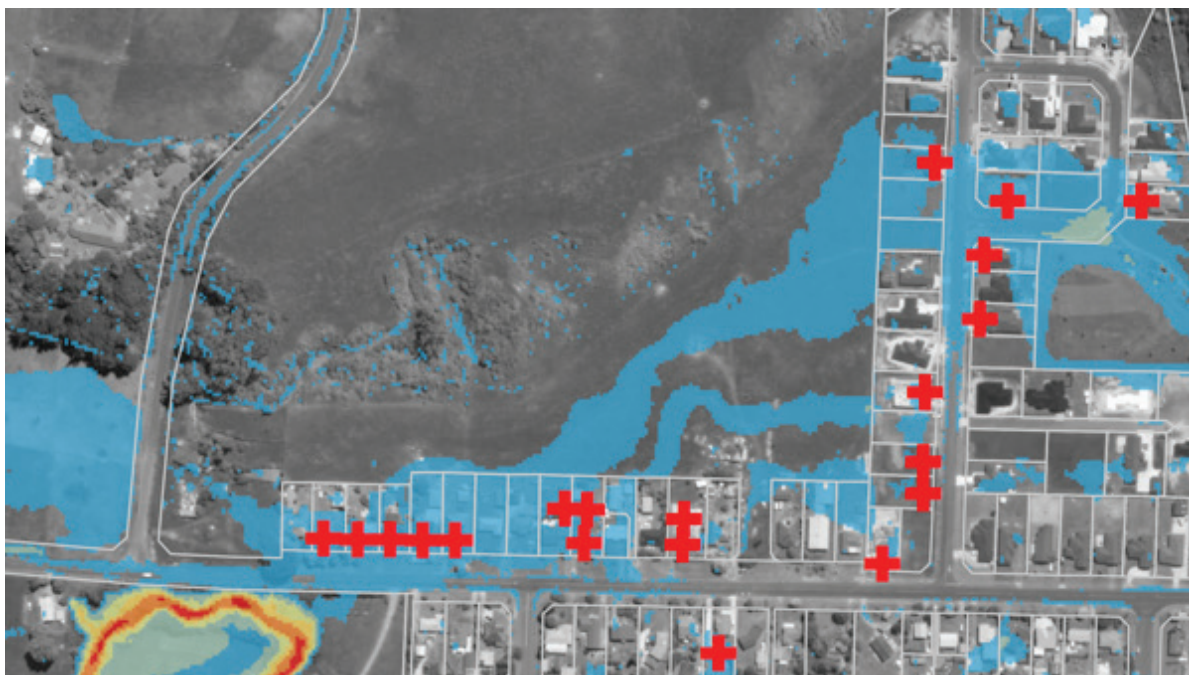
Figure 43: Approximate extent of overland flow path Western Road – Pioneer Road – Mohi Crescent for 72 m³/s flood event in Ngongotahā Stream (Red crosses denote dwellings inundated during April 29 event and subsequently issued with insanitary notices)

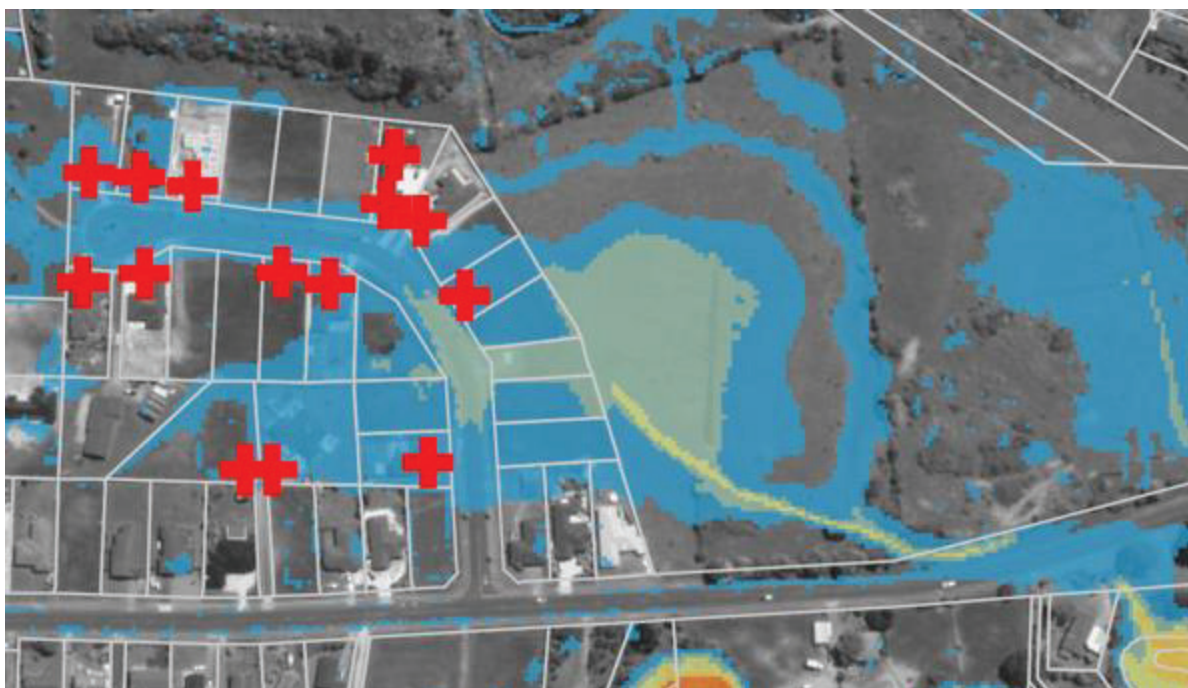
Figure 44: Approximate extent of overland flow path Oakland Place - Western Road (Elliot Park) for 72 m³/s flood event in Ngongotahā Stream (Red crosses denote dwellings inundated during April 29 event and subsequently issued with insanitary notices).

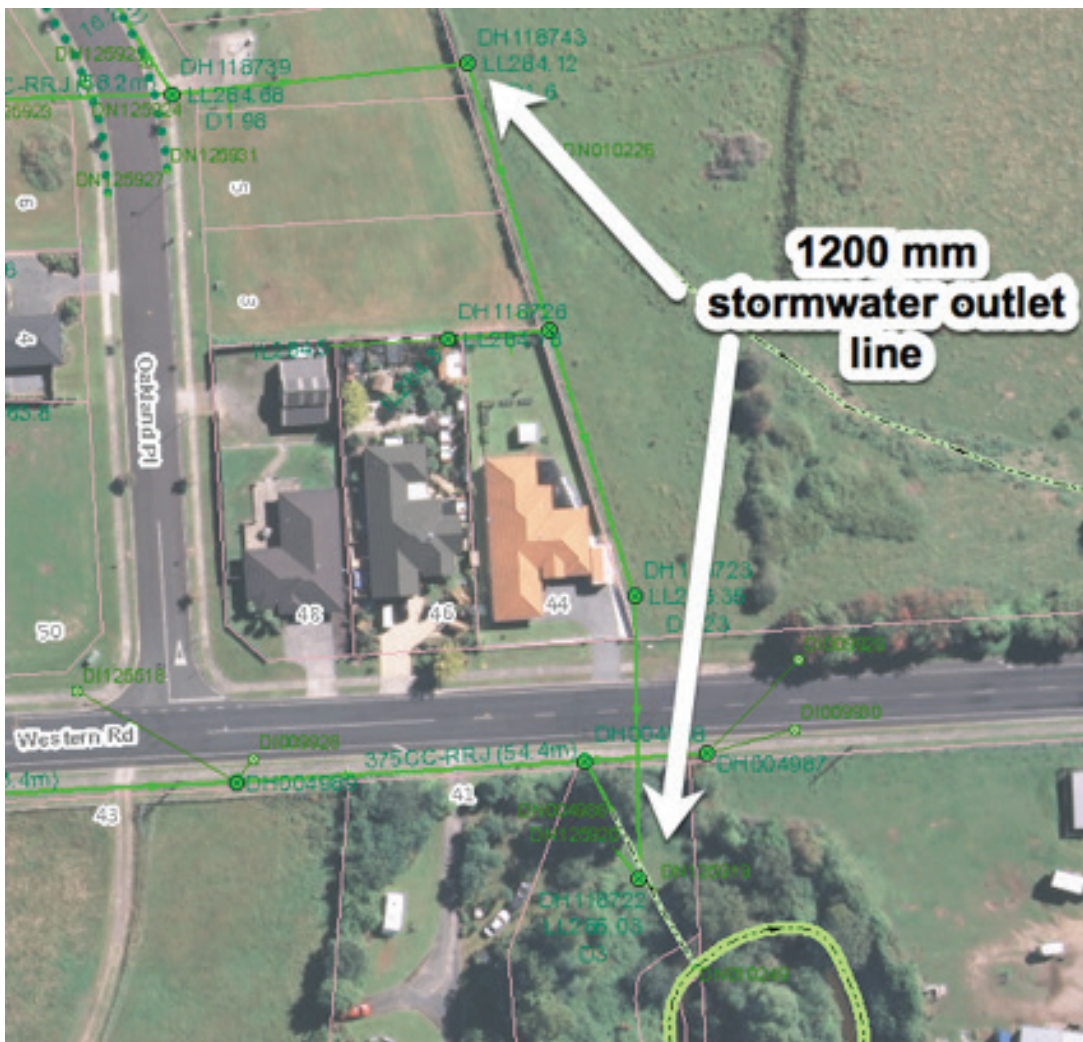
Figure 45: Plan view of 1200 mm stormwater outlet line from PPTS development

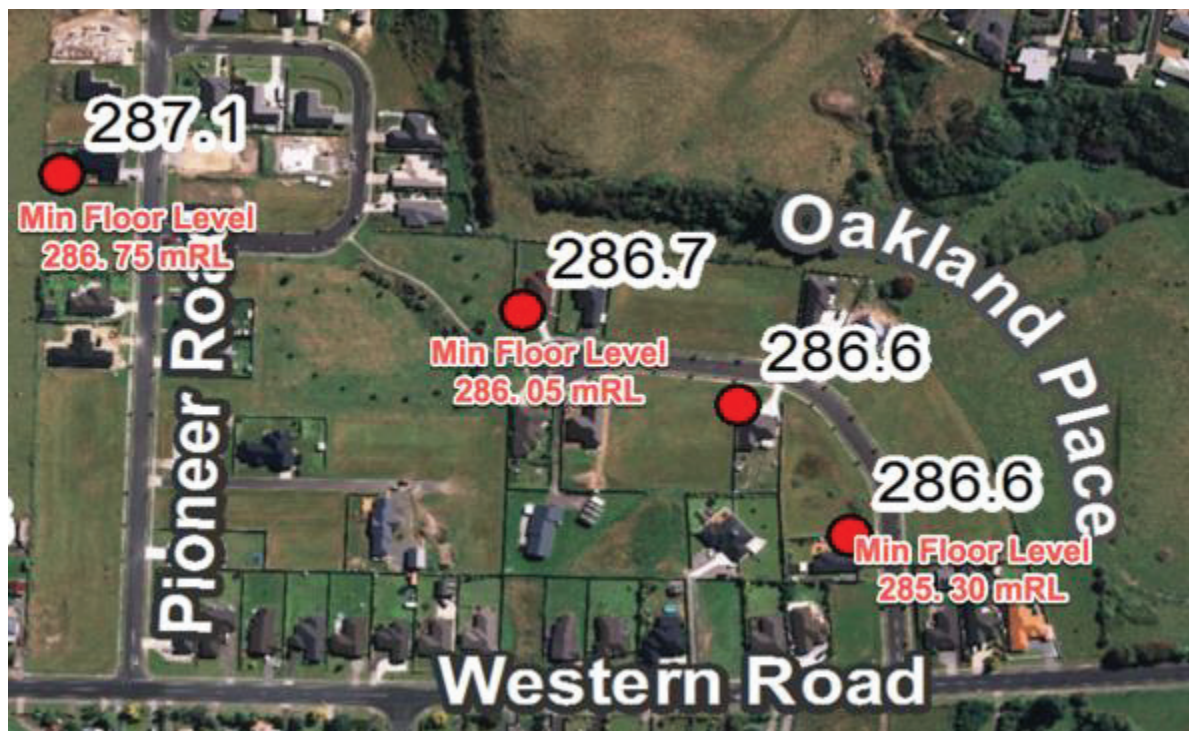
Figure 47: Figure Surveyed peak flood levels PPST April 2018 flood event (Source – BOPRC)
