GREAT HALL PROJECT: DECEMBER CONSTRUCTION PROJECT REPORT

February 14th, 2019

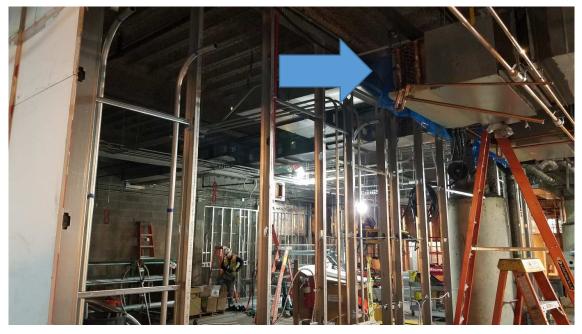
Work in the CMF continued with concentration on the overhead Mechanical, Electrical, and Plumbing (MEP) systems. Priority framing continued in locations throughout the space.

CMF framing and overhead MEP installation. (12/19/18)

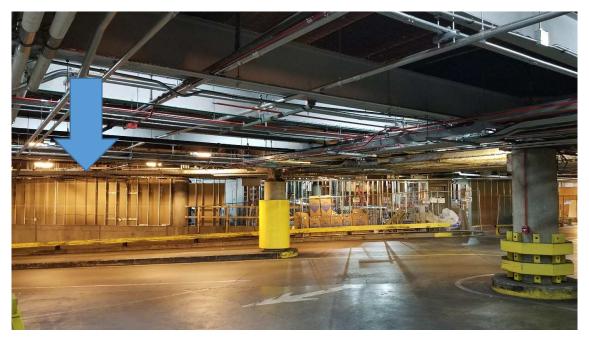
In the electrical/server room, large equipment was brought in and installed including panels and the three-phase transformer. Conduit rough-in to the electrical room is ongoing. In the fan rooms and plenum above the CMF, waterproofing and sealing was completed.

CMF construction site. To the left is the drywall for the electrical/server room. (Looking north, 12/19/18)

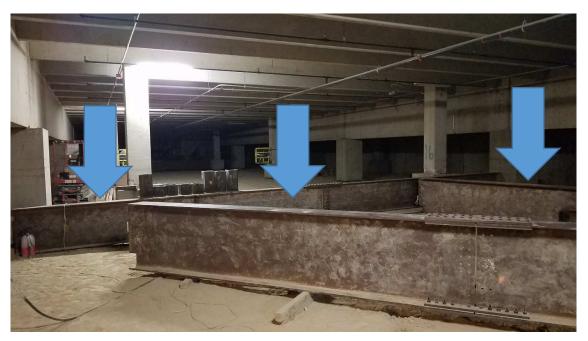
L3: The steel for the escalator pits was brought into the crawl space, and prep work took place throughout December. Beams were laid out, bolted, welded, and angle iron was put in place, all in preparation of the pit erection.

L3 Crawl space with steel for escalator pits. (12/19/18)

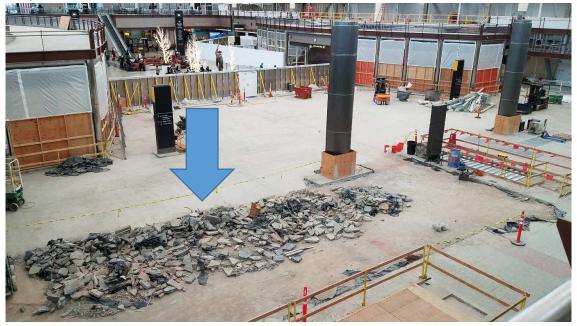
In the plaza, demolition of the terrazzo and topping slab began, and was carried out to roughly 80% completion.

Plaza flooring demolition and AGTS glass removal. (Looking south, 12/19/18)

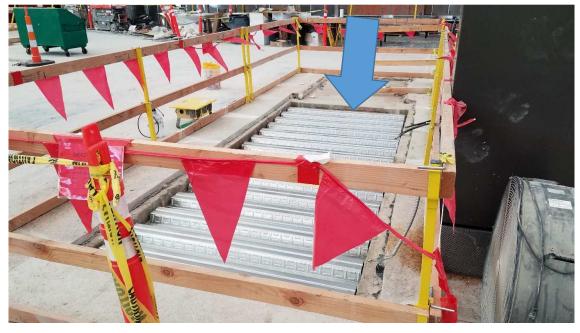
Infill of the pit from the former north bridge escalator was completed with the exception of the infill concrete.

L5 plaza, north bridge escalator pit infill. (12/13/18)

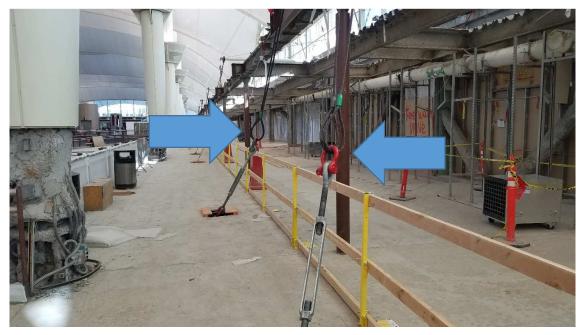
Temporary relocation cables for the clerestory cables have been hung, but are not tensioned yet. Structural steel demolition is on hold pending the cable relocation. On both east and west sides, McCain walls were erected around the large mechanical shafts, and the architectural demo of those areas was completed.

L6 clerestory cable relocation tie-ins hung. (Looking north, 12/19/18)

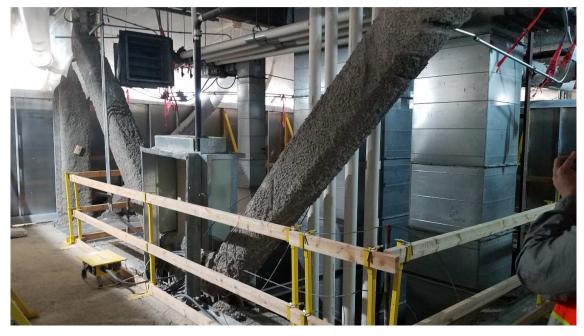
L6 west mechanical shaft architectural demolition. (12/19/18)
