Investigation Summary Report Update 3

Date: 12 December 2017

This investigation is into the activities of heavy vehicle specialist certifier Peter Wastney and was initiated following a crash on 27 August 2017, where the catastrophic failure of a drawbeam on a truck JWN197 resulted in the detached trailer travelling a significant distance before coming to rest against a bank.

RE: Drawbeam failure – Registration JWN197

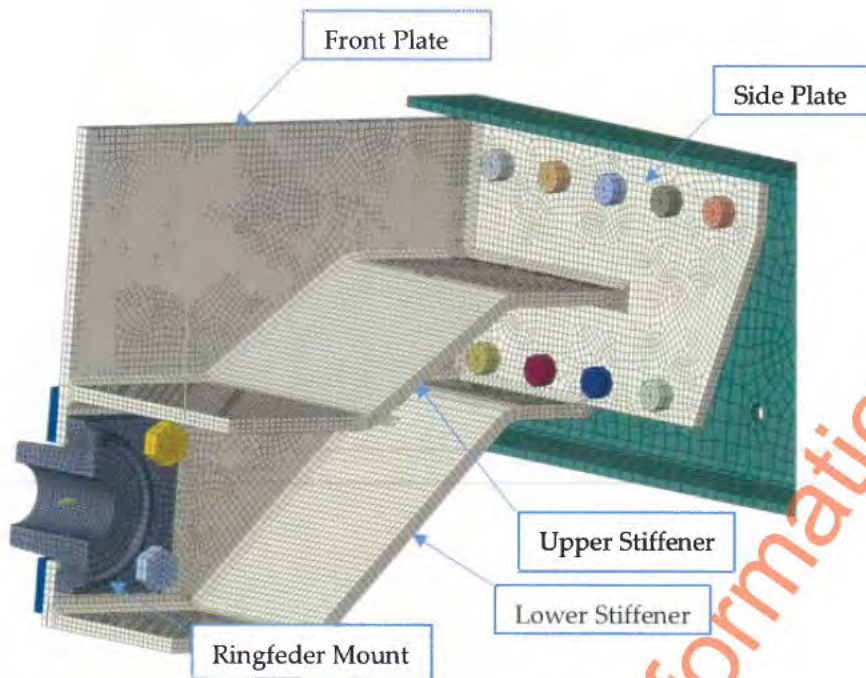
Figure 1 Drawbeam naming convention

For naming conventions used in this report, refer Figure 1.

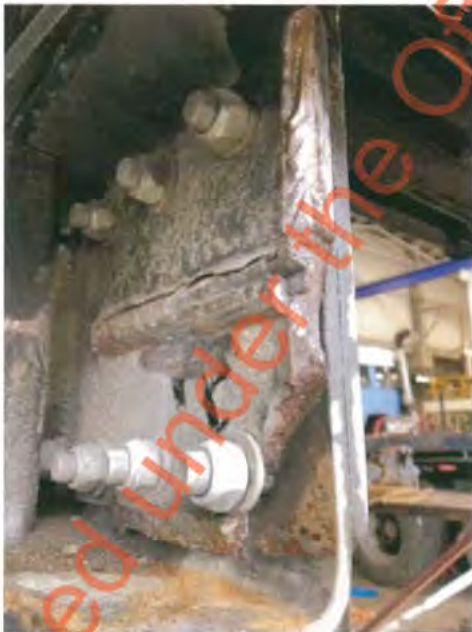
Figure 2 Drawbeam side plates

Inspection of the truck found that the drawbeam front weldment had separated from the side plates which affix the drawbeam to the chassis, Figure 2. The front weldment is made up of the front plate and upper and lower stiffeners, Figure 3.

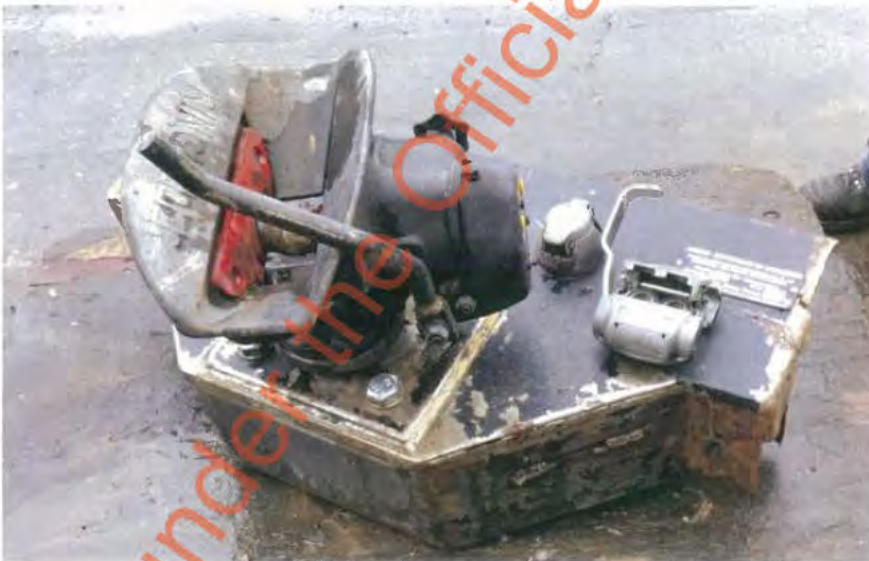
Figure 4 Drawbeam ready for detailed inspection

The drawbeam weldment was water blasted to remove soil and measured in detail. Inspection of the weldment found the separation in the drawbeam had occurred along the edges of the welded connections.

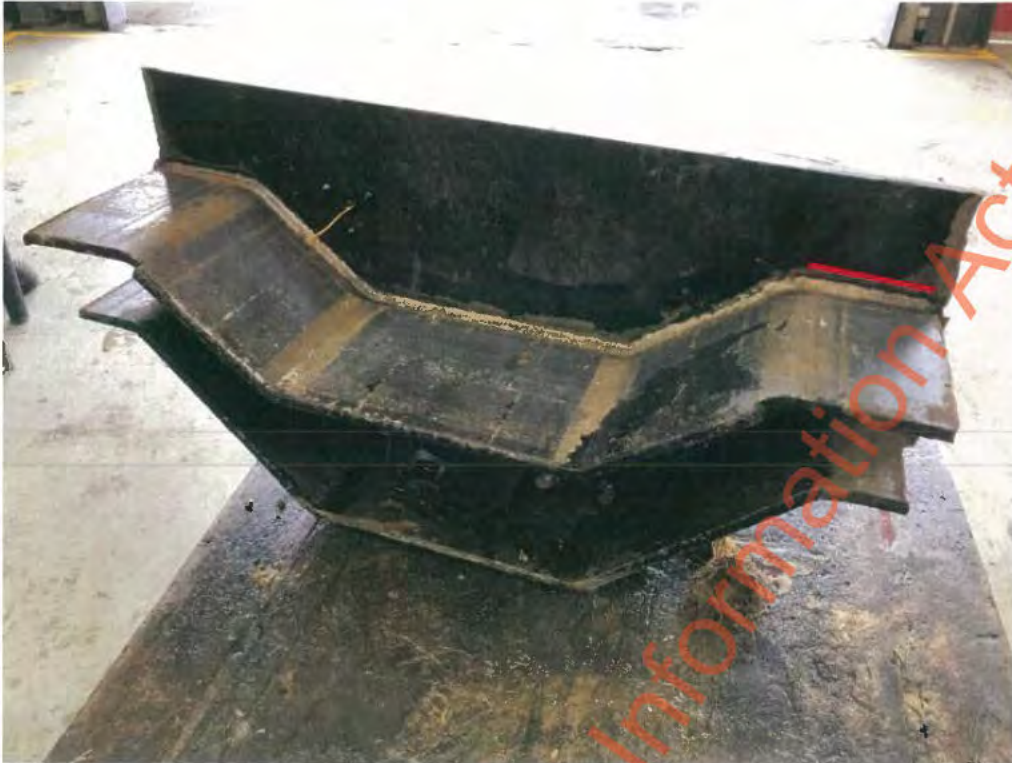
Figure 5 Drawbeam front section rear view, cracks below red line

In addition to the obvious fractures, there were cracks in the upper stiffener; left-hand side welded connection to the front plate, Figure 5 and Figure 6.

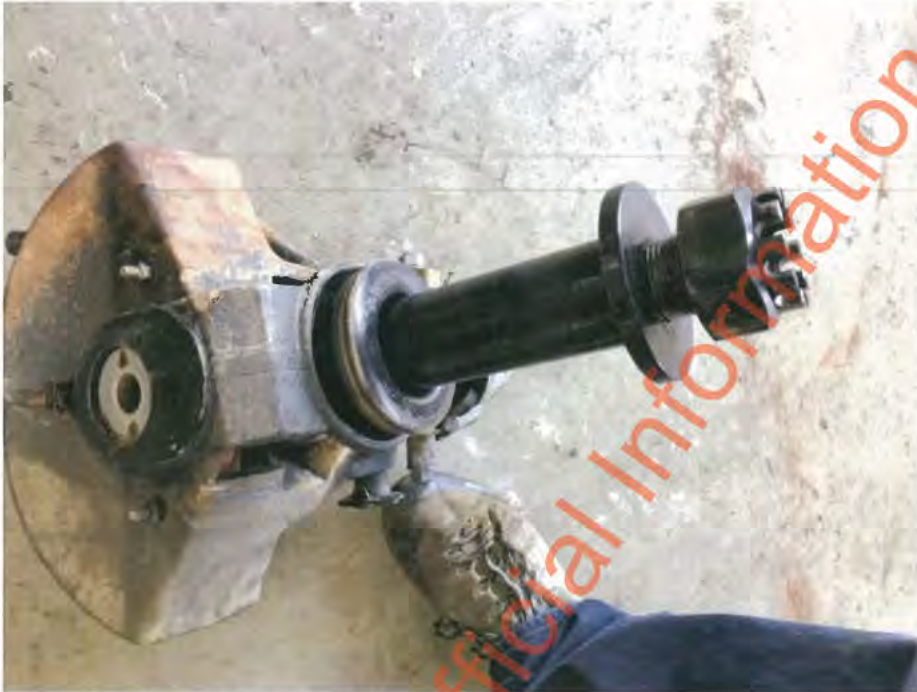
Figure 7 Ringfeder 5050 after removal

The drawbeam coupling, a Ringfeder 5050, was examined and found to be functioning correctly. The bolt group between the coupling and drawbeam was unbolted and found to be in good order.

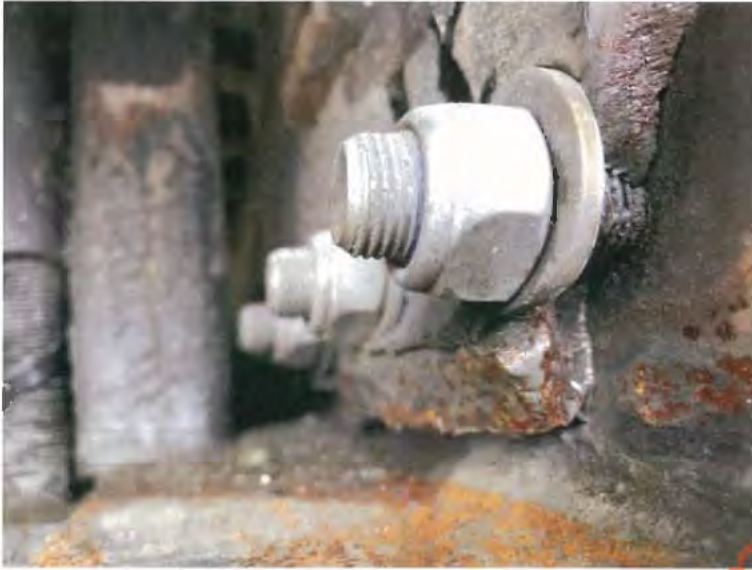
Figure 8 Bolt seating interference

Several of the bolts in the drawbeam were seated incorrectly due to interference between the washers and welded connection, Figure 8.

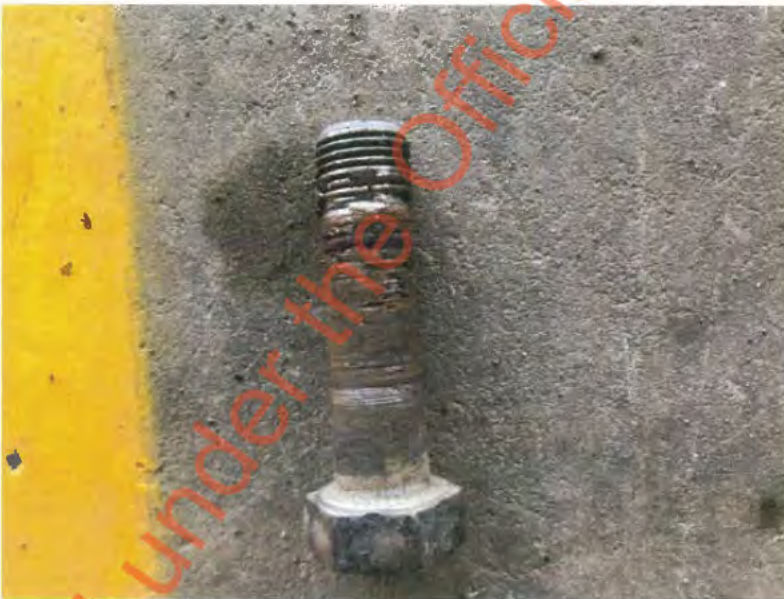
Figure 9 Bend bolt with thread damage

After removal of the bolts seated over the welds, the lower front bolts were found to be bent and showed thread damage, Figure 9.

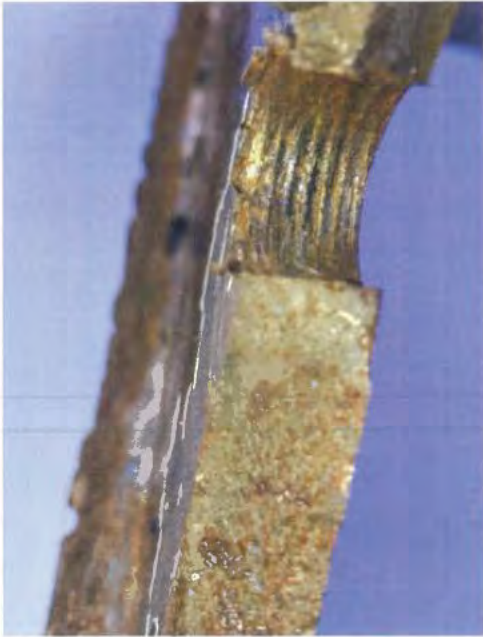
Figure 10 Thread bearing marks

The internal faces of the front lower side plate holes also show the thread bearing marks, Figure 10.

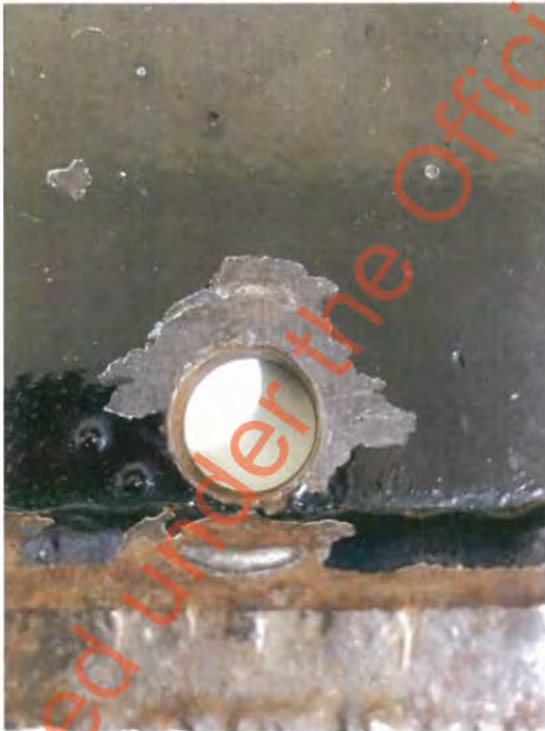
Figure 11 Washer bearing mark

The bearing marks due to interference between a washer and the weld are shown in Figure 11.

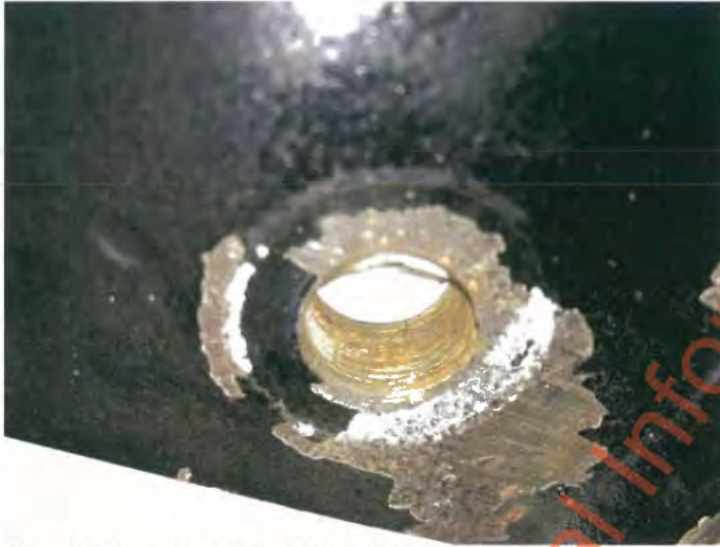
Figure 12 Burrs on right-hand side plate, top front bolt hole

Most holes on the inside face of the side plates had burrs on their edges, Figure 12 and Figure 13.

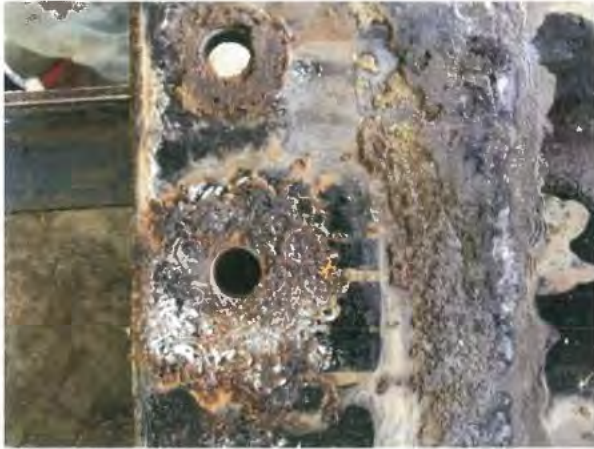
Figure 14 Swarf between drawbeam and truck side plates

It is apparent the drawbeam, chassis and subframe attachment plates were drilled in situ to facilitate alignment. While this is reasonable practice, a significant amount of steel swarf

was left between the plates, Figure 14. This swarf would affect the ability to maintain torque in the bolt group. The swarf accumulation would be difficult to identify during the inspection but does speak to the competency of the fabricator.

AS 3990:1993 states all defects on the surfaces of contact which prevent the solid seating of the bolt joint component shall be removed, clauses 10.3.4.3 and G1.2.1. This includes burrs, weld interference, and other defects such as swarf.

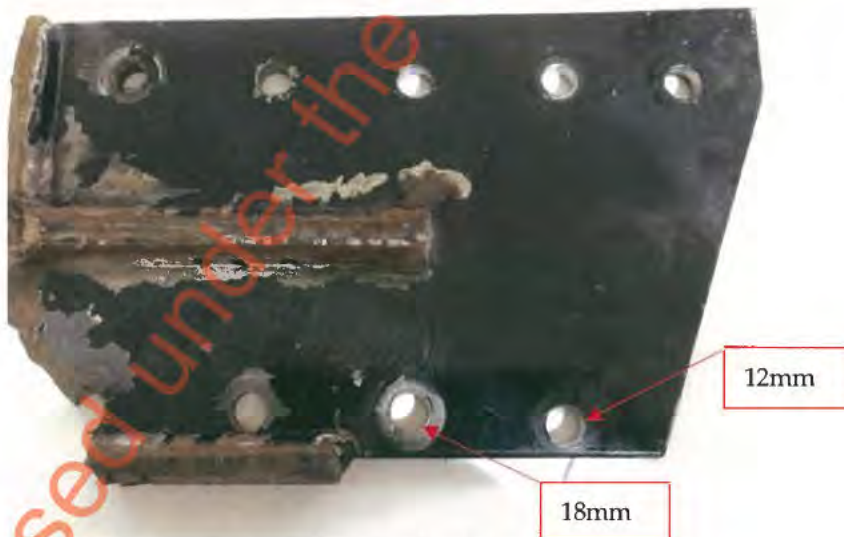
Figure 15 Bolts not meeting minimum edge distance

AS 3990 specifies a minimum edge distance from the centre of the fastener to the edge of the plate, typically 1.5 times the nominal diameter of the fastener, clause 9.6.2. For an M16 bolt, this would mean a minimum edge distance of 24mm. Two lower rear bolt holes on both sides of the drawbeam fail to meet this criterion, Figure 15.

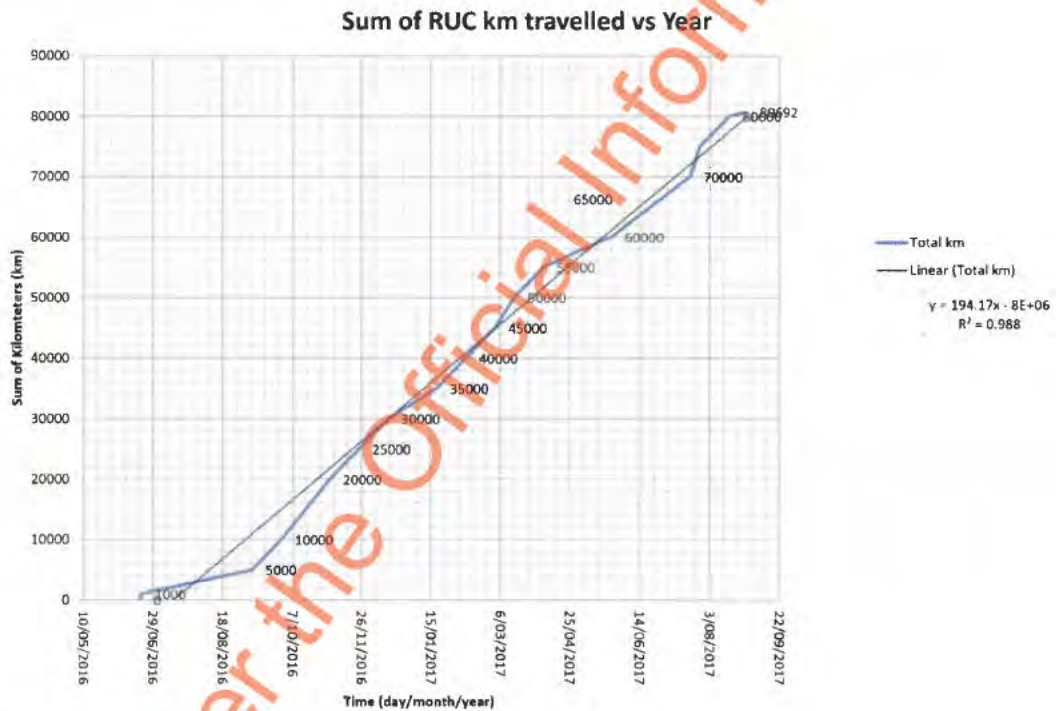
Figure 16 RUC history graph

A review of the trucks road user charges (RUC) history and the vehicle hubometer established the kilometres travelled by the vehicle since entering service, Figure 16. The RUC history shows the use of the vehicle has been relatively constant. At the time of the accident, the truck had travelled approximately 80,000 km.

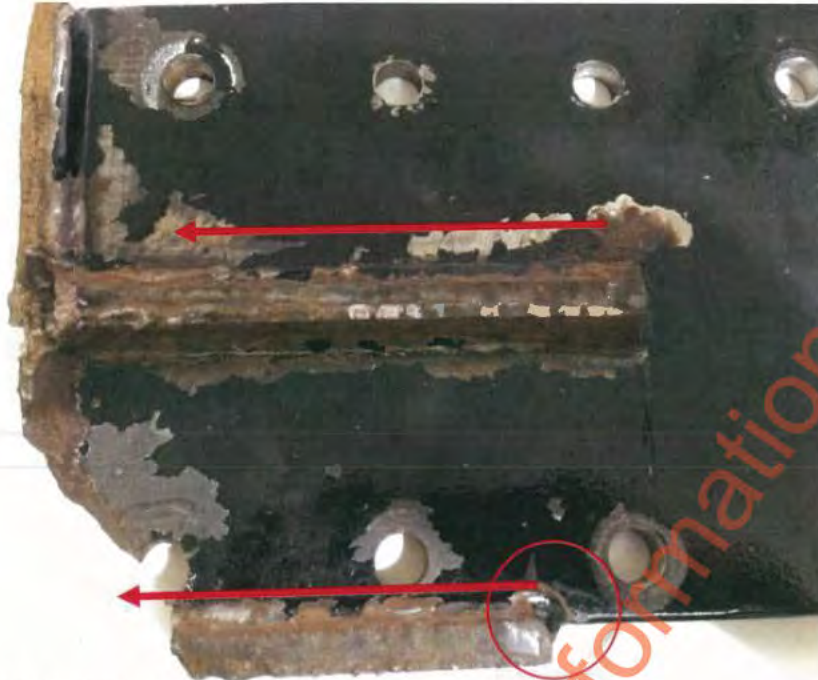
Figure 17 Side plate fatigue progression and initiation point (red circle)

Evidence of fatigue in the drawbeam weldment was found (Figure 17). The fracture between the upper and lower stiffeners and side plate has occurred at the base of the weld toe in the parent metal; this is a typical area for crack initiation and propagation (Hobbacher, 2006). The crack initiation point seems to be located at the rear bottom stiffener plate, refer Figure 17 and Figure 18.

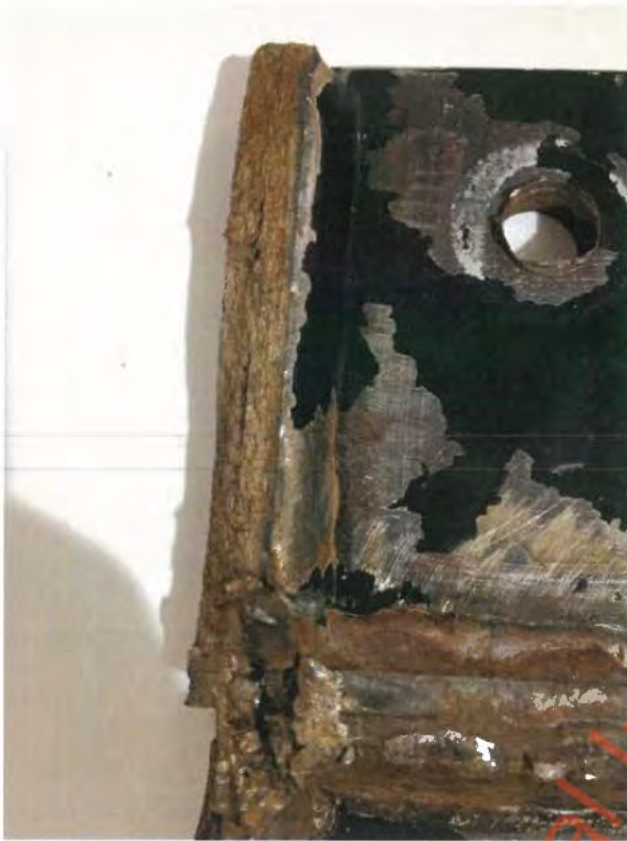
Figure 19 Plate rupture markings, stage III

Stage 3 rupture indicators were on the front face of the drawbeam, Figure 19 and Figure 20.

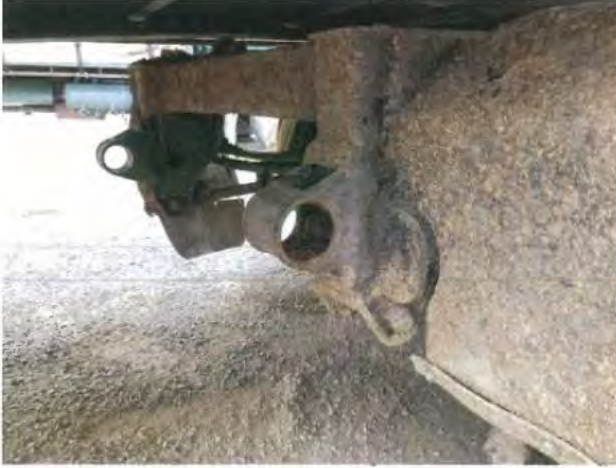
The trailer dolly, drawbar and hinge connection were examined and found to be in reasonable order given the accident. The drawbar tow-eye and trailer hinge attachments showed no evidence of failure.

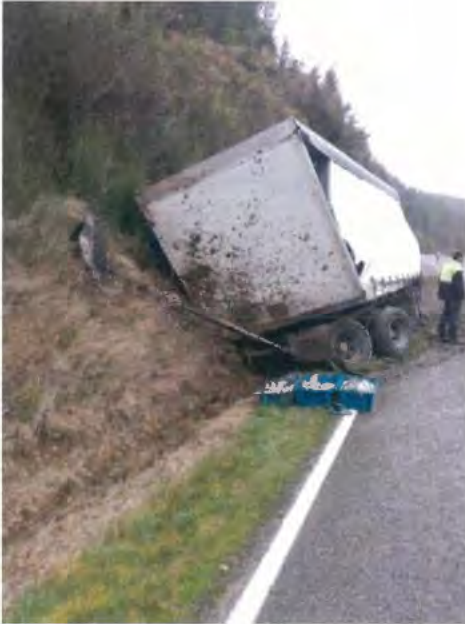
Figure 21 Accident scene photo

Several photos provided that were taken before the vehicle recovery commenced, show the drawbar and front segment of the drawbeam still attached, Figure 21 and Figure 22.

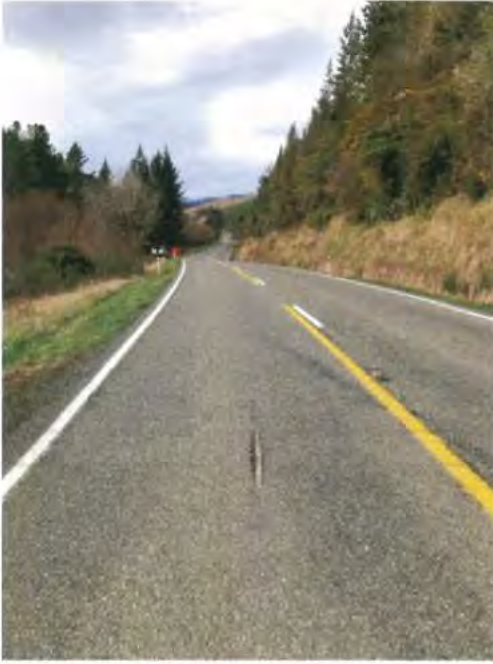
Figure 23 Road section where accident occurred

The road segment where the accident occurred is on an off-camber downhill gradient with a slight left-hand bend. The speed limit for a heavy vehicle is 90 km/hr.

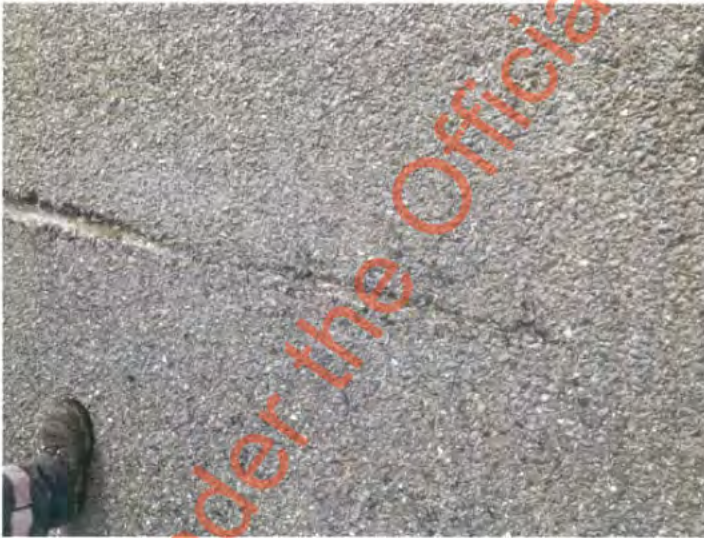
Figure 24 Groove on road surface

At the location where the trailer is reported to have separated from the truck, a prominent groove was found in the centre of the road lane, Figure 23 and Figure 24.

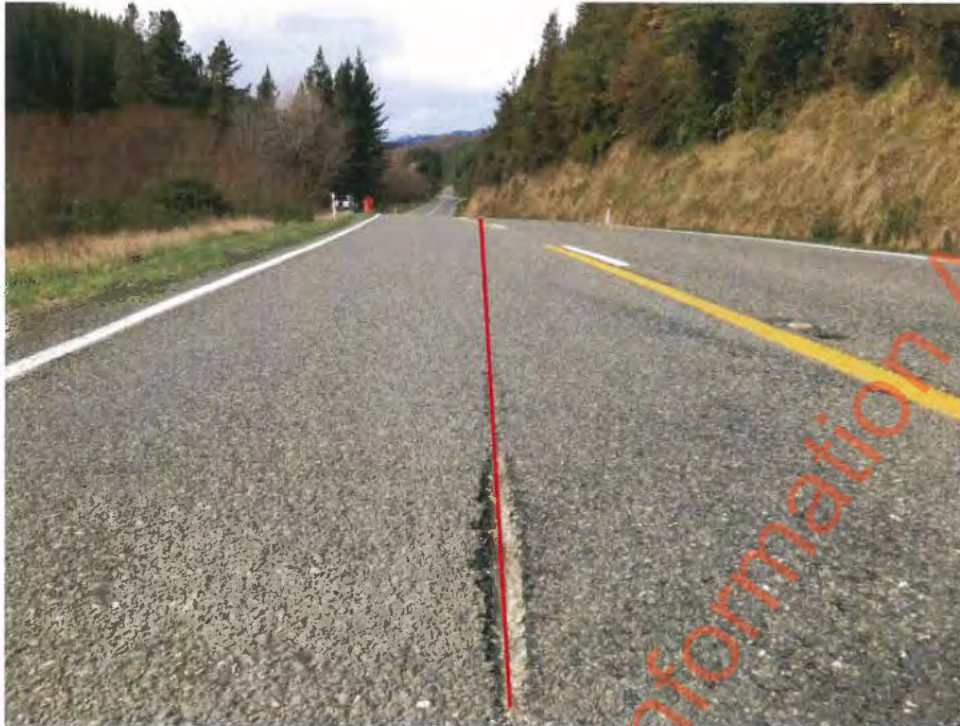
Figure 25 Groove centre line to embankment impact point

The groove's direction projects to the impact point between the trailer and the right-hand embankment where the trailer came to rest, Figure 25.

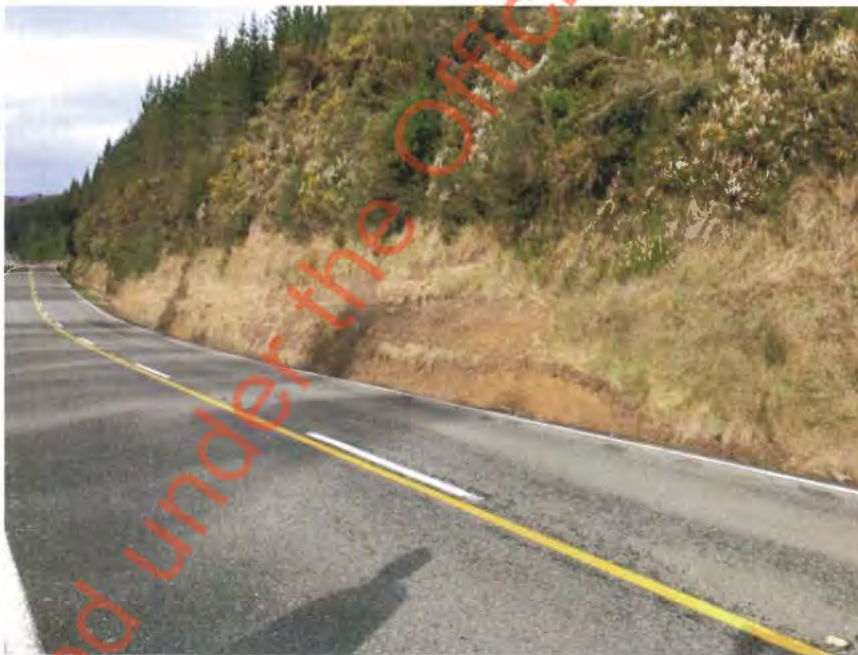
Figure 26 Embankment collision marks

The trailer skidded along the embankment for approximately 40 metres before coming to rest, Figure 26.

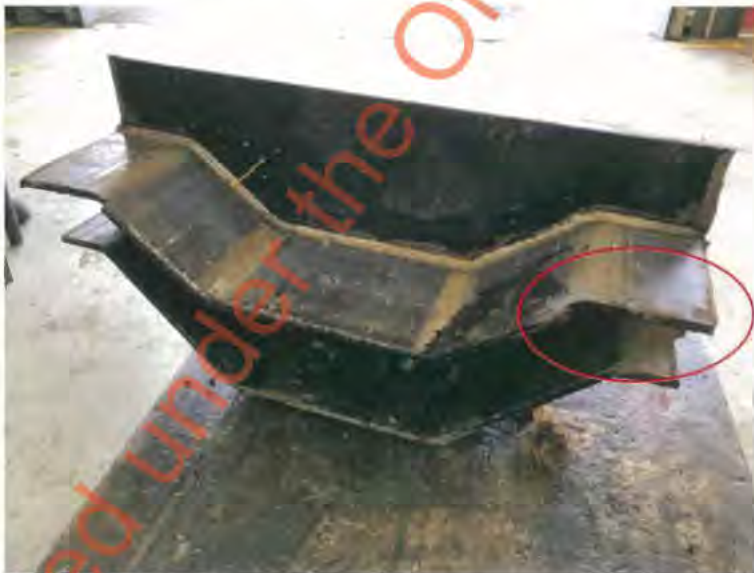
Figure 27 Cut-out in top stiffener

One area which may indicate some modification was a 10mm cut-out in the upper stiffener connection to the side plate. The cut-out is not identified in the drawing provided by the certifier, however, given the proximity between the upper stiffener and the crane attachment, it is likely this is as manufactured.

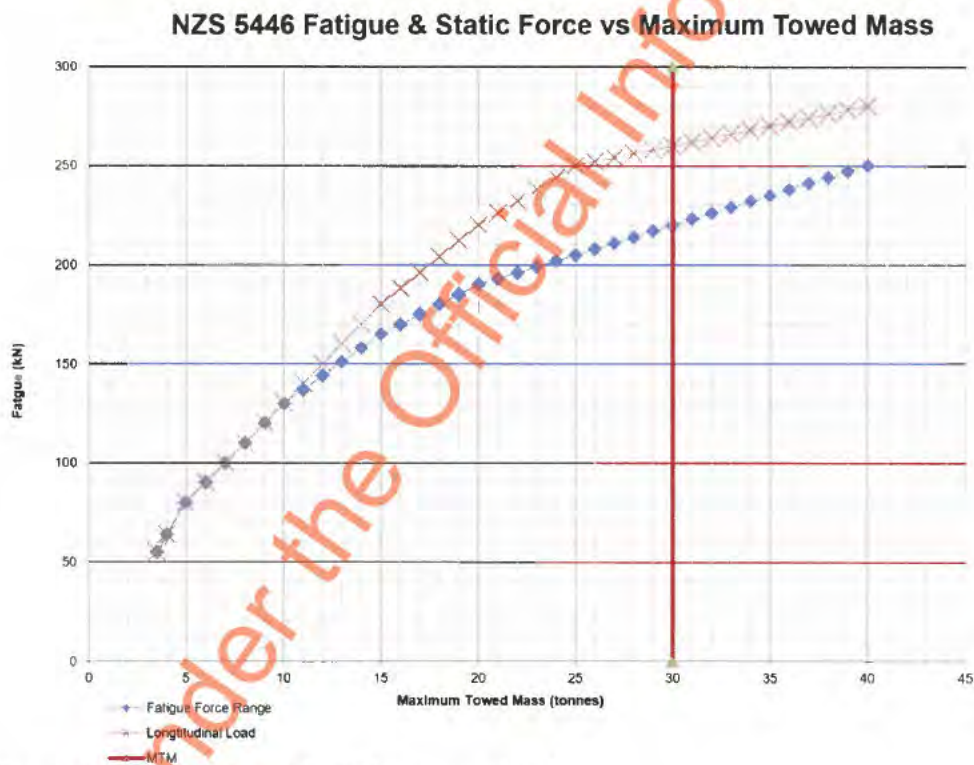
Figure 29 NZS 5446 Fatigue & Static Force versus MTM

Given a certified maximum towed mass of 30,000kg, the longitudinal force and fatigue force range is 260kN and 220kN respectively, Figure 29.

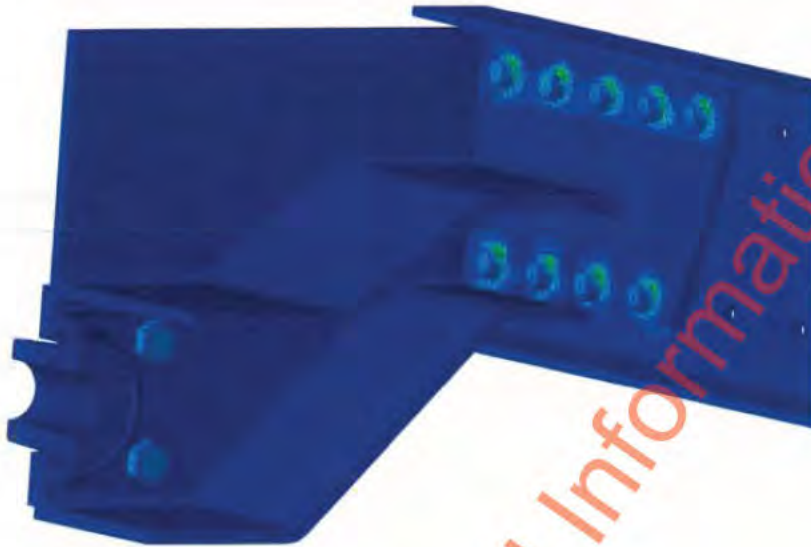
Figure 30 von Mises stress showing bolt pre-tension

The bolt pre-tensioning is applied in the initial step of all analysis, Figure 30. The bolt pretension was confirmed by measurement of von Mises stress in the bolt elements.

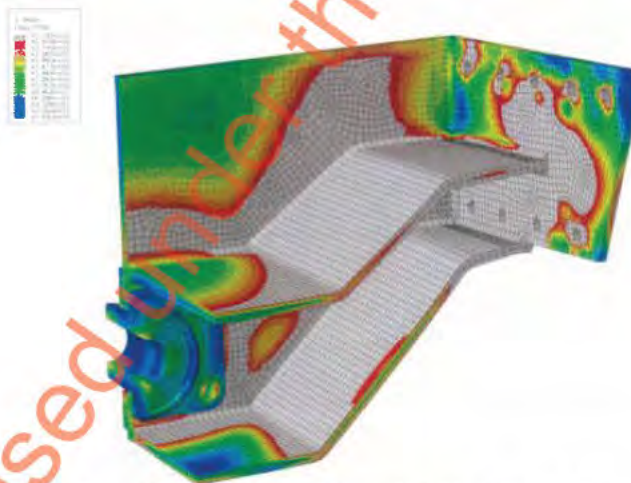
Figure 31 von Mises stress, drawbeam 260kN load, areas in grey exceed 250 MPa

A 260kN load (for a 30,000kg MTM trailer) is applied to the Ringfeder attachment. The applied load caused large areas of the drawbeam to exceed the material yield stress, Figure 31.

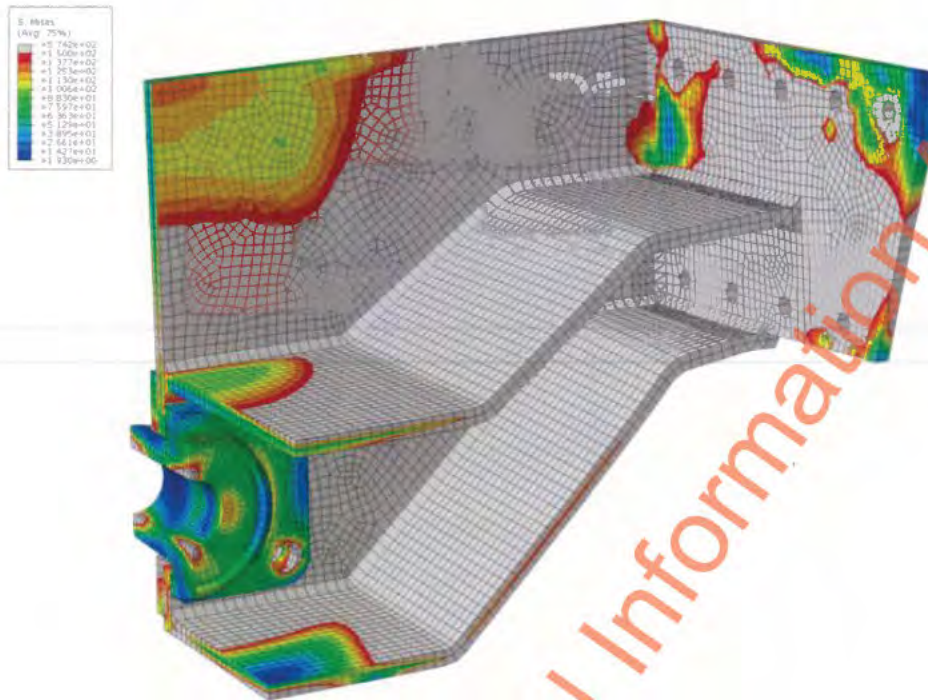
Figure 32 von Mises stress, drawbeam 260kN load, areas in grey exceed 150 MPa

Large areas also exceed the maximum permissible stress of 150 MPa, Figure 32.

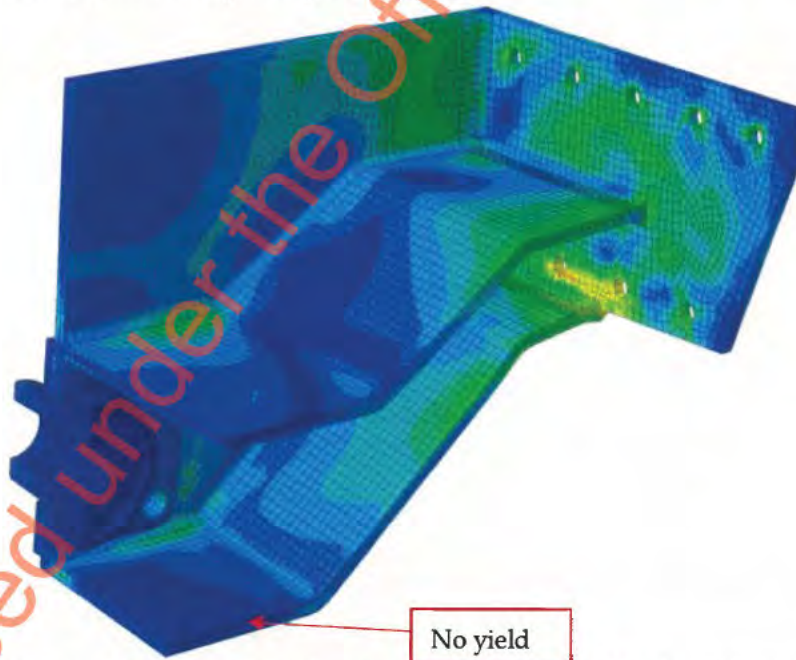
Figure 33 Areas showing plasticity after removal of load (colour other than indicator)

After load removal, the finite element analysis showed areas of the drawbeam had permanent deformation (plastic yield).

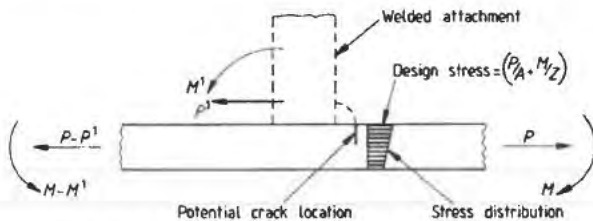
Figure 38 Reference stress in parent metal – BS 7608:1993

Provided the direction of the principal stress does not change significantly over the course of the stress cycle, the relevant cyclic stress should be taken as the maximum range through which any principal stress passes in the parent metal adjacent to the potential crack location, Figure 38. The same approach is taken in AS 3990. Tension stress is considered positive, and compression stresses negative.

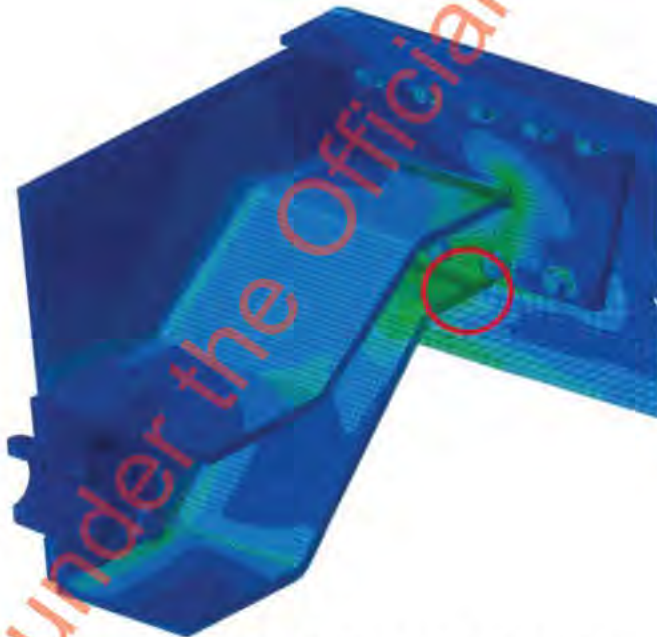
Figure 39 Forward (tension) direction 110kN load, 265 MPa red circle

The stress in the drawbeam with the load in the forward direction, at the bottom flange to side plate rear connection, was 265 MPa of compressive stress, Figure 39.

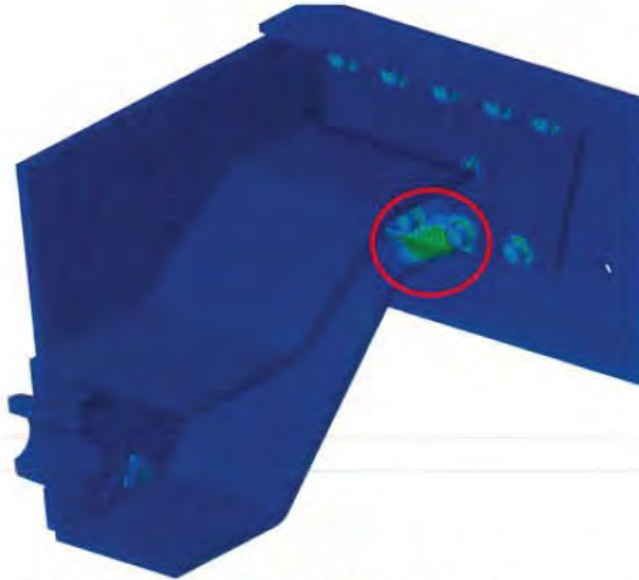
Figure 40 Residual stress from 110kN load, red circle

After removal of the load, a permanent deformation was predicted. This can be seen in the residual stress, Figure 40.

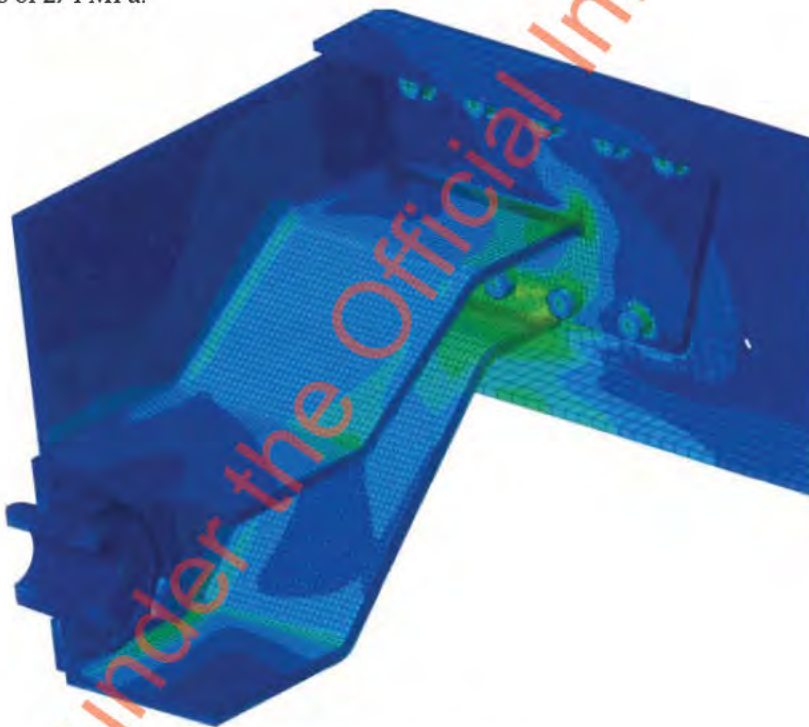
Figure 41 Rearward (compressive) 110kN load, 274 MPa

Under compressive load, the connection of interest is under tension and has a developed stress of 274 MPa.

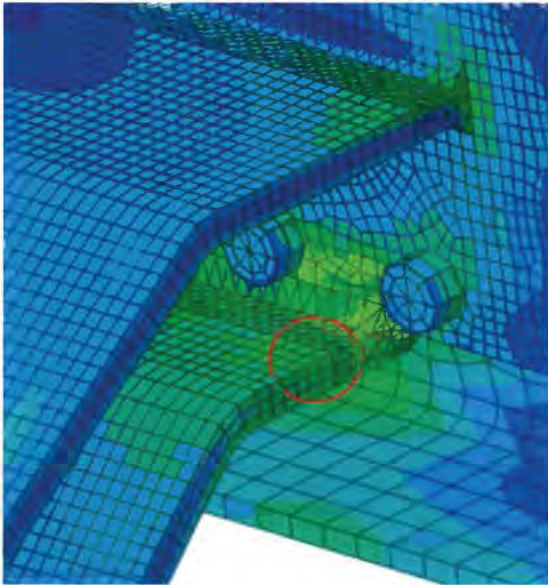
Figure 42 Stress measurement area

Given stress-life fatigue is calculated using nominal stress the stress concentration at the weld to parent interface is not used. Instead, as recommended by NAFEMS, the stress is taken in the parent metal adjacent to the weld, Figure 42 (NAFEMS, 2017a).

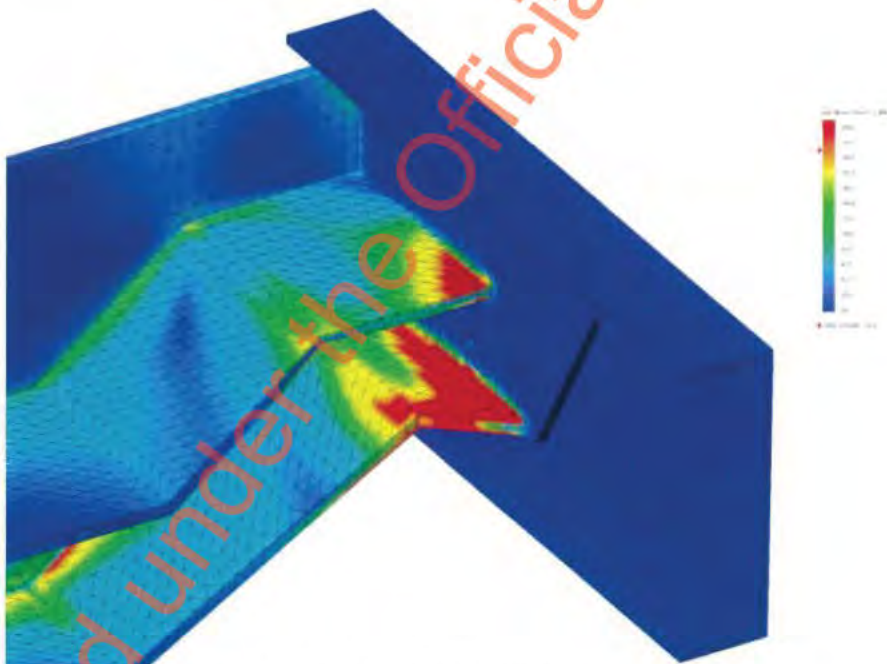
Figure 44 Certifiers drawbeam analysis - 220kN, rear view

Refinement of the finite element mesh was carried out in order to improve the accuracy of the results; this is good practice. Mesh improvement and convergence studies are an important part of validating FEA.

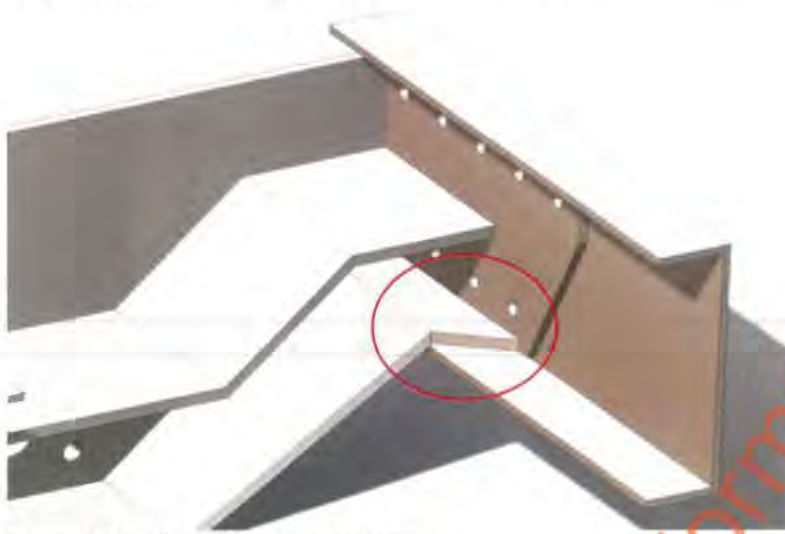
Figure 45 Certifiers drawbeam, rear view

The certifiers model has a different lower stiffener with extended rear gussets than the inspected drawbeam, Figure 45.

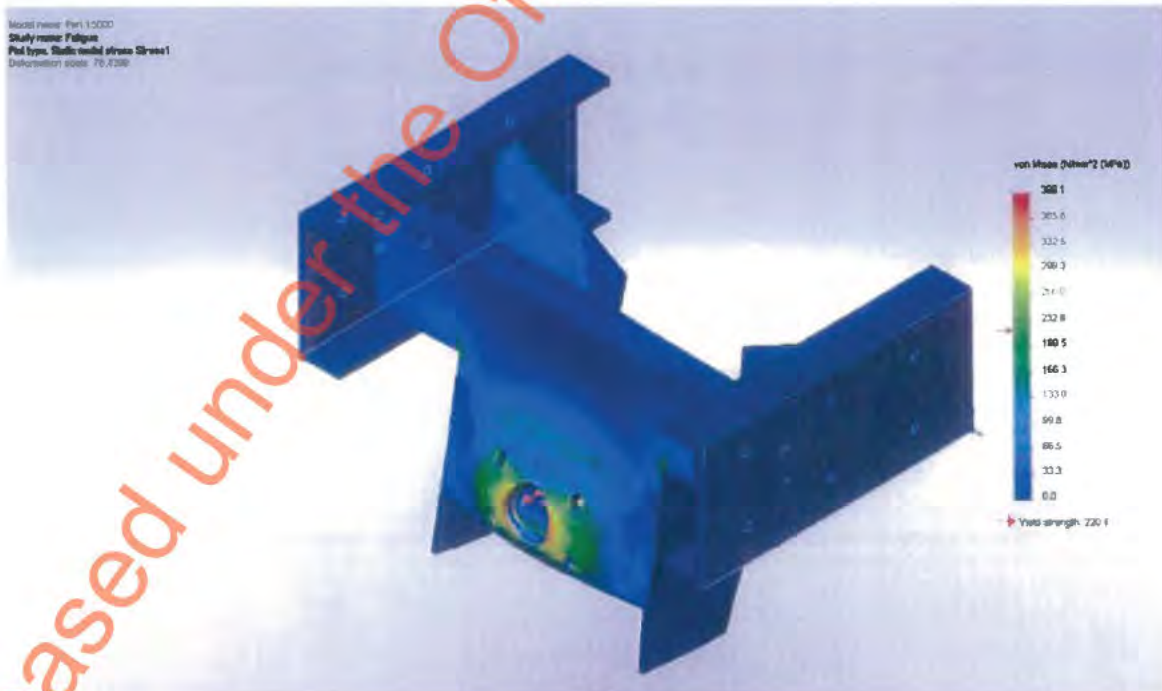
In particular the image below is from your certification file for LT400 348824. For fatigue compliance stress should be no more than 60% of yield strength according to AS 3990, however the FEA image shows stress levels above yield. Is this correct, and if so why did you proceed to certify the drawbeam?

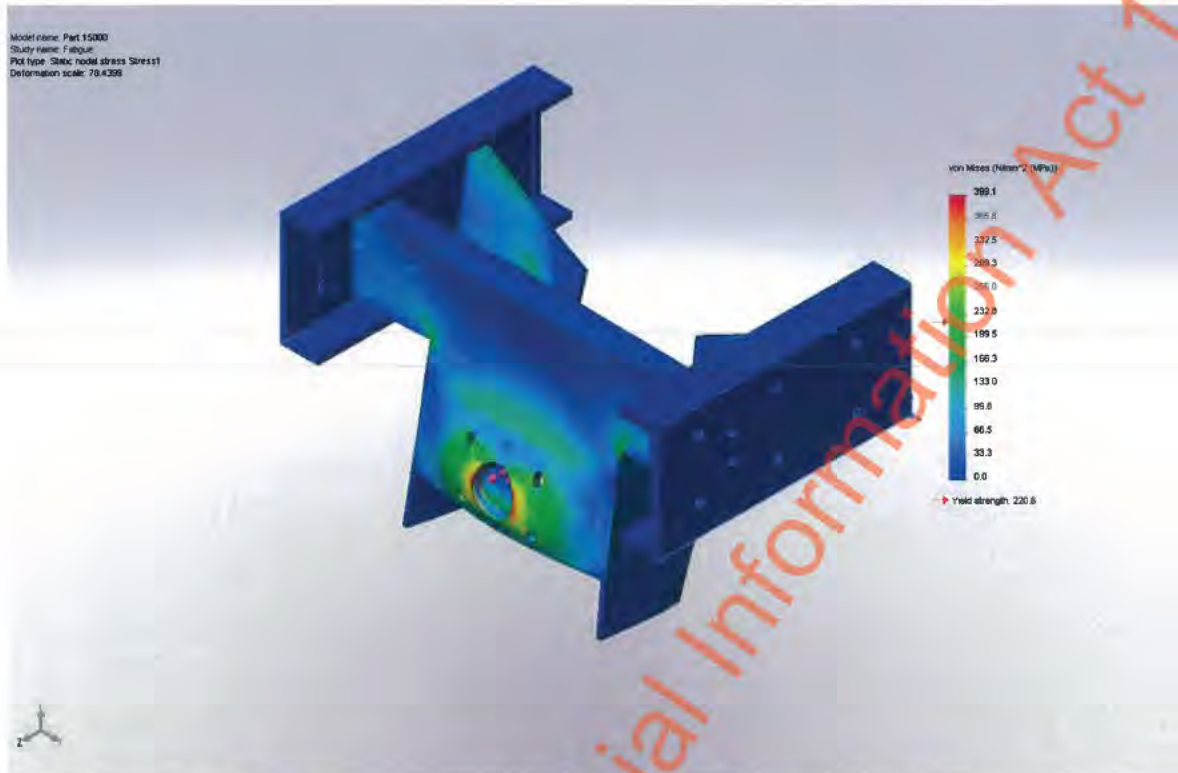
This plot shows the loading as prescribed by NZS 5446 applied to the area bounded by the towing coupling flanges. This is not quite correct, as this area is clamped by the flanges. A more representative result would be obtained by applying this load as a rigidly applied load, or by modelling the actual coupling onto the drawbeam. However, both of these methods have drawbacks. It can be shown that so long as the section being bolted through is at least 16mm thick, there is no problem in the section of the drawbeam contained within the coupling flange meeting NZS 5446 loading. In analysing this plot, therefore, the stresses bounded by the coupling flange may be ignored. In this case, it can be seen that drawbeam stresses are actually within the 60% threshold of Yield Stress. If you have concerns about the strength of this drawbeam, perhaps you should also check Mills Tui File 197607, as the drawbeam was unchanged from this original certification.

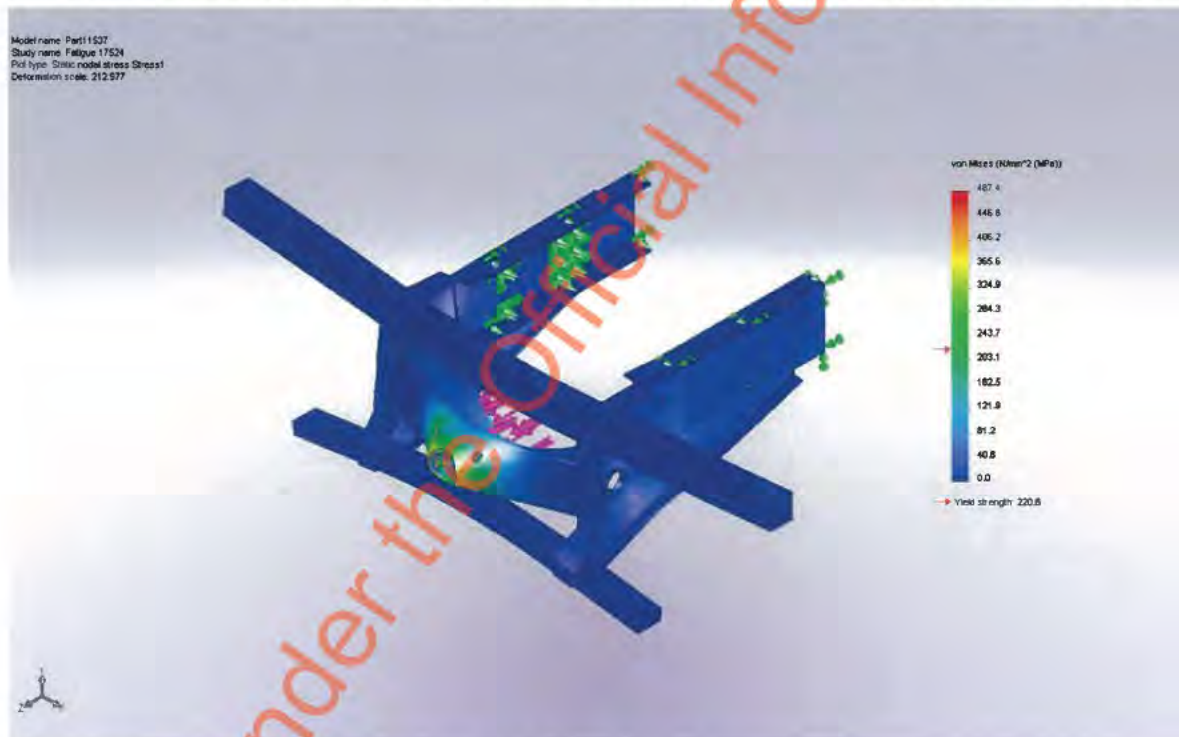
This plot shows the loading as prescribed by NZS 5446 applied to the area bounded by the towing coupling flanges. This is not quite correct, as this area is clamped by the flanges. A more representative result would be obtained by applying this load as a rigidly applied load, or by modelling the actual coupling onto the drawbeam. However, both of these methods have drawbacks. It can be shown that so long as the section being bolted through is at least 16mm thick, there is no problem in the section of the drawbeam contained within the coupling flange meeting NZS 5446 loading. In analysing this plot, therefore, the stresses bounded by the coupling flange may be ignored. In this case, it can be seen that drawbeam stresses are actually within the 60% threshold of Yield Stress.

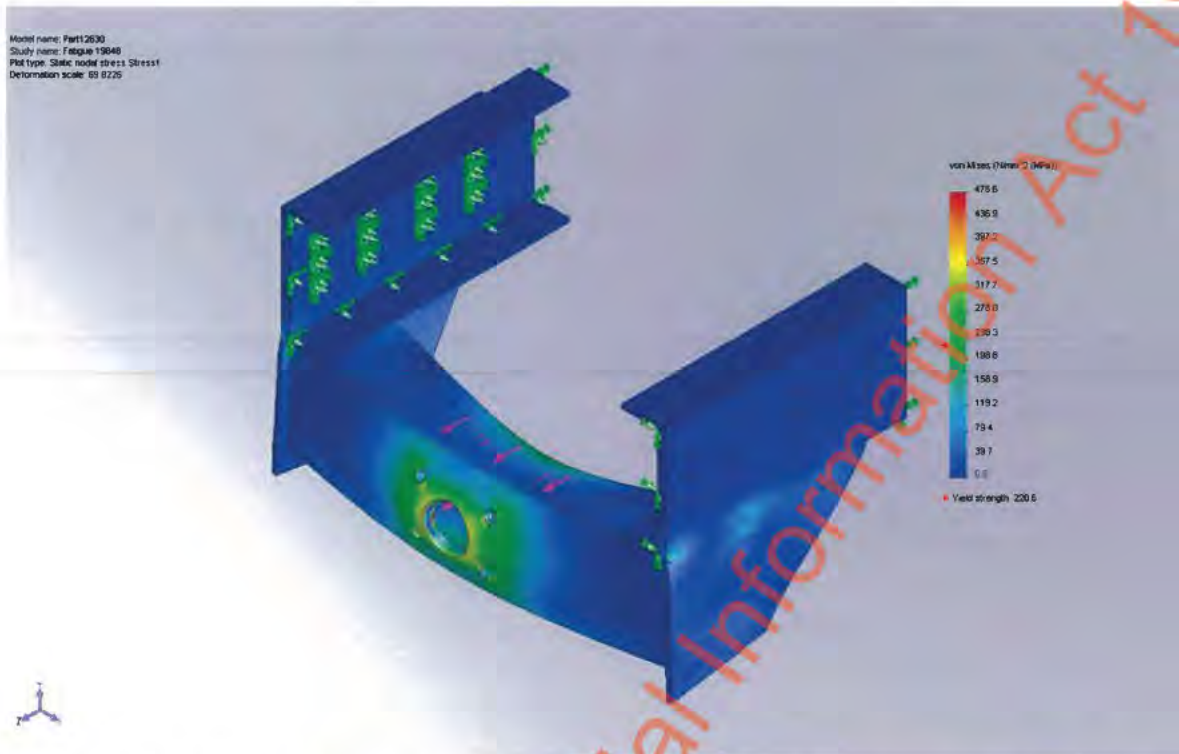
This plot shows the loading as prescribed by NZS 5446 applied to the area bounded by the towing coupling flanges. This is not quite correct, as this area is clamped by the flanges. A more representative result would be obtained by applying this load as a rigidly applied load, or by modelling the actual coupling onto the drawbeam. However, both of these methods have drawbacks. It can be shown that so long as the section being bolted through is at least 16mm thick, there is no problem in the section of the drawbeam contained within the coupling flange meeting NZS 5446 loading. In analysing this plot, therefore, the stresses bounded by the coupling flange may be ignored. In this case, it can be seen that drawbeam stresses are actually within the 60% threshold of Yield Stress.
