Investigation Summary Report Update 3

Date: 12 December 2017

This investigation is into the activities of heavy vehicle specialist certifier Peter Wastney and was initiated following a crash on 27 August 2017, where the catastrophic failure of a drawbeam on a truck JWN197 resulted in the detached trailer travelling a significant distance before coming to rest against a bank.

RE: Drawbeam failure – Registration JWN197

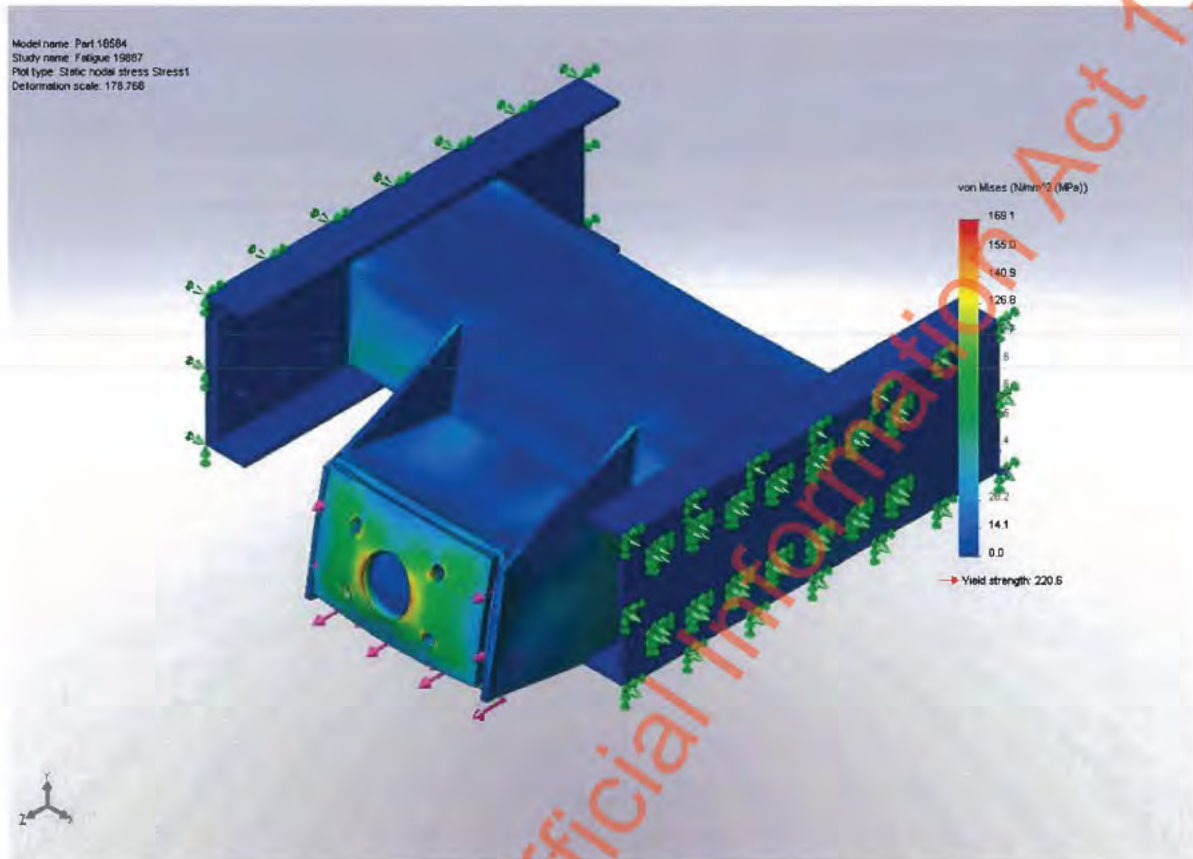
This plot shows the loading as prescribed by NZS 5446 applied to the area bounded by the towing coupling flanges. This is not quite correct, as this area is clamped by the flanges. A more representative result would be obtained by applying this load as a rigidly applied load, or by modelling the actual coupling onto the drawbeam. However, both of these methods have drawbacks. It can be shown that so long as the section being bolted through is at least 16mm thick, there is no problem in the section of the drawbeam contained within the coupling flange meeting NZS 5446 loading. In analysing this plot, therefore, the stresses bounded by the coupling flange may be ignored. In this case, it can be seen that drawbeam stresses are actually within the 60% threshold of Yield Stress.

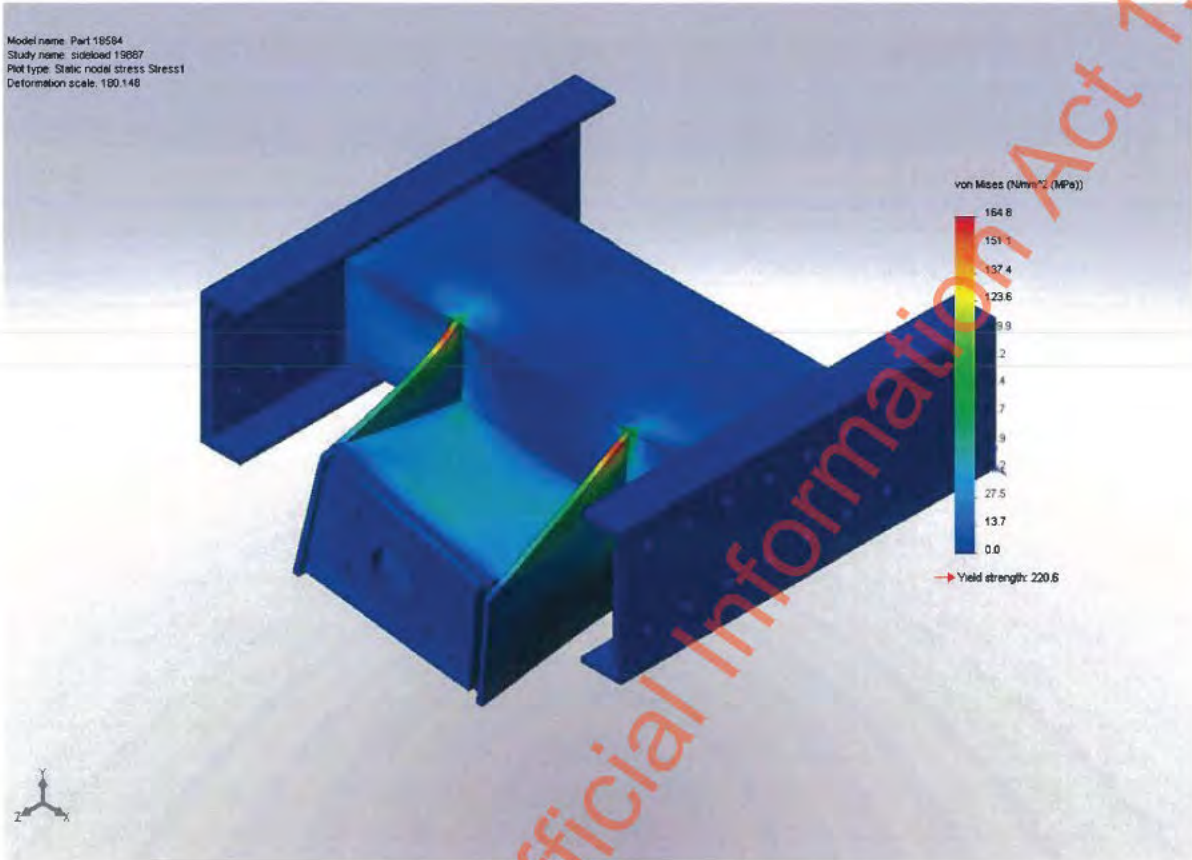
This was in small surface areas of the Gussets. Although the analysis was carried out for 220 mPa yield, manufacture for this new drawbeam was from 300 mPa Yield plate, so this design was accepted as being within the allowable limits.

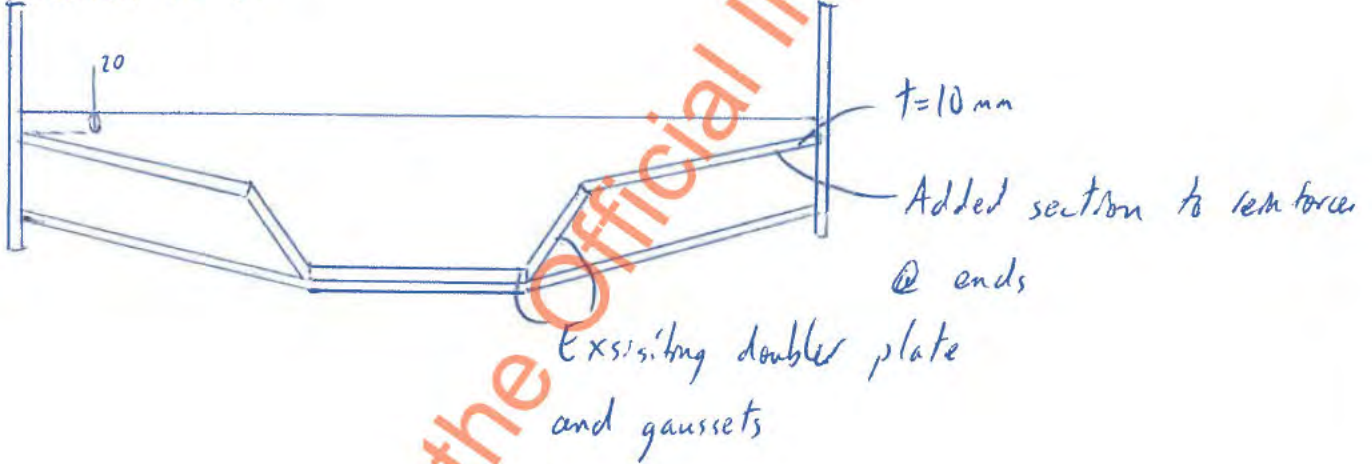
High mileage with
 High fatigue
 decided to scrap
 beam and give new
 beam

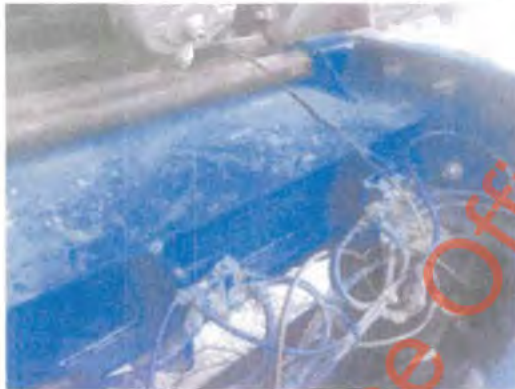
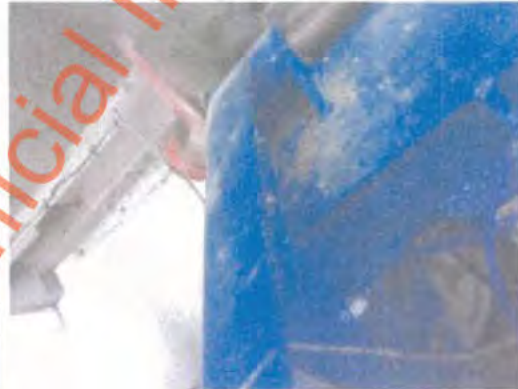
Photo of fabricated drawbeam

This is to certify that the new Drawbeam Certification, as shown in the photo and Drawing 5775-19288, as fitted to the above vehicle, has been manufactured to comply with NZS 5446:2005 for a maximum Towed mass of 30,000kg. Original Certification was 5775-18635.

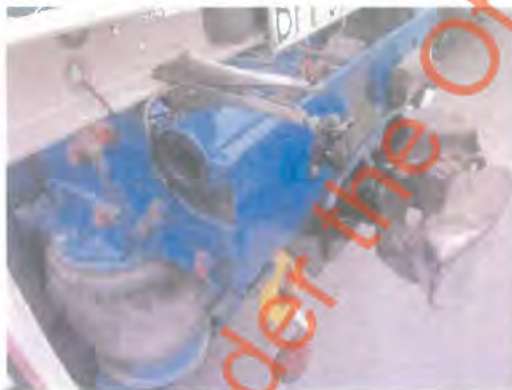
Photo of fabricated drawbeam.

This is to confirm that the mounting of the Drawbeam, attached to Subframe, has been completed in accordance with NZS5446 for a 30 Tonne MTM Rating. Assembly is re mounted complete from ██████████ which was certified 5775-17452. This vehicle had travelled 53,000 km since Drawbeam was fitted new.

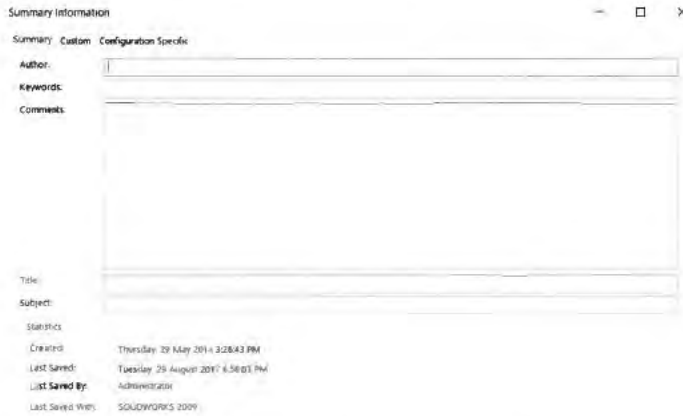
Figure 4 SolidWorks Summary information - 17452

The 17452 SolidWorks file was created on the 29th of May 2014, the same day as the initial certification on [REDACTED]. The file was last saved on the 29th of August 2017 which is 2 days after the JWN197 accident date, Figure 4.

Overlaying the SolidWorks CAD files shows that both drawbeam designs, 17542 and 18877, are identical. The only differences are in the truck chassis dimensions and the bolt group detail. The SolidWorks stamp dates and suppressed features in the SolidWorks model tree also support this conclusion, Figure 4 and Figure 5.
