New Zealand Aluminium Smelters Limited

SCL GROUNDWATER STATUS

2020

Date: 29 March 2021

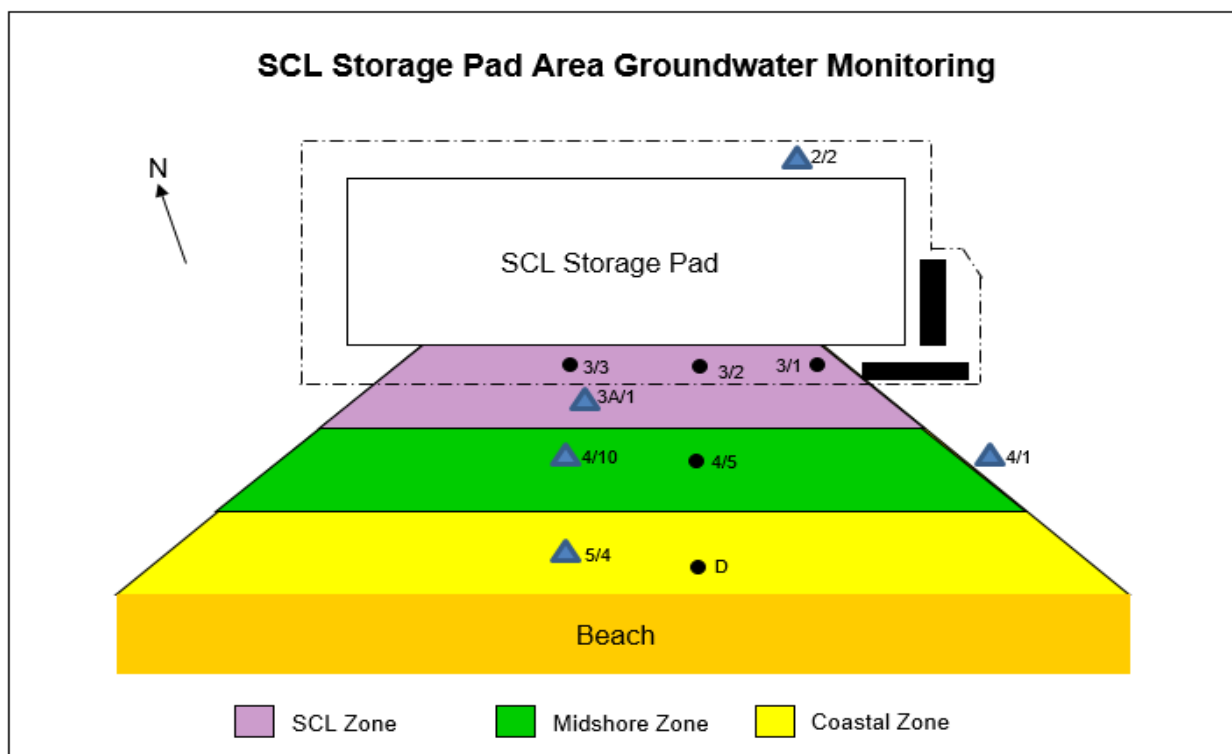
3.2 SCL Monitoring Bore Locations

The SCL pad is located approximately 85 metres from the beach. Monitoring bores are located between the SCL pad and the beach. The locations of the bores monitored are shown in the following diagram (not to scale).

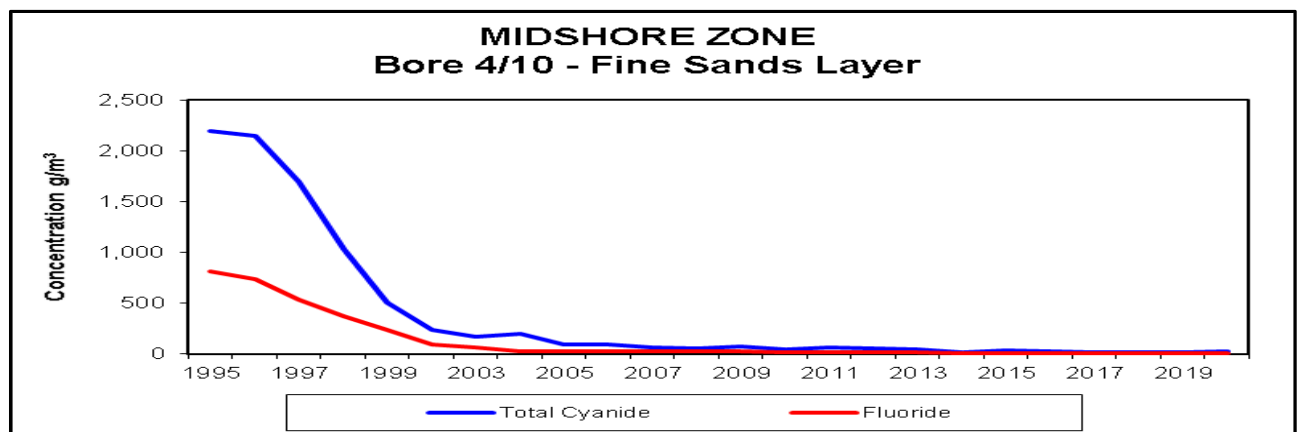
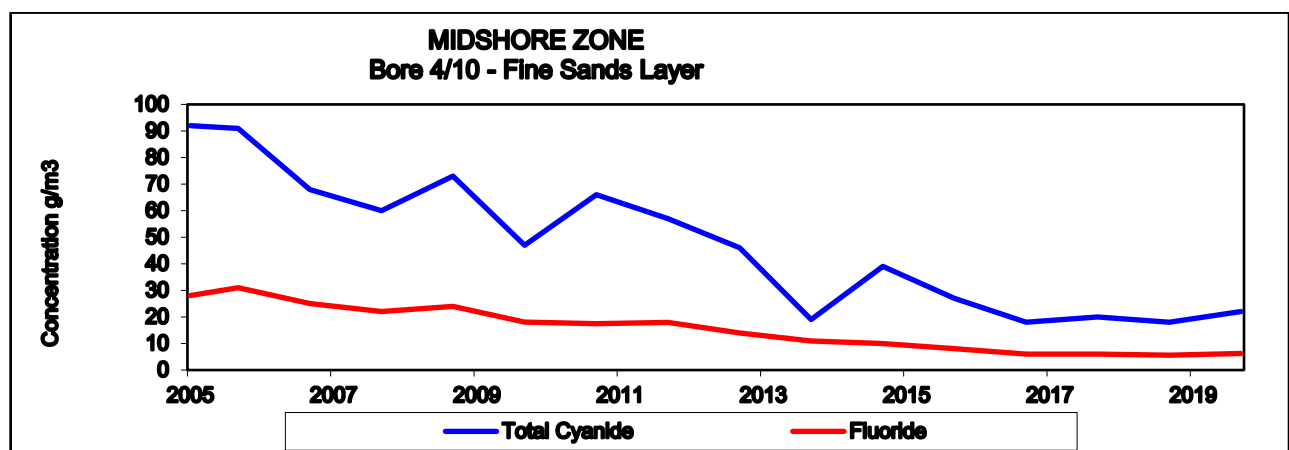
4.3.1 Results for Bore 4/10

Both fluoride and cyanide levels have decreased significantly since monitoring began in 1995 and nearing the background values found in Bore 2/2. Total cyanide is higher than background but is much lower than that in the underlying fine sands layer. A spike in concentration for the analytes was observed for:

- fluoride in 2010/2011 which corresponds to a spike seen for bores in the SCL Zone occurring 3 years prior.
- cyanide in 2015 which corresponded to the spike observed for the SCL Zone bores in 2011. The underground discharge pipe was replaced in 2015 due to potential leakage.

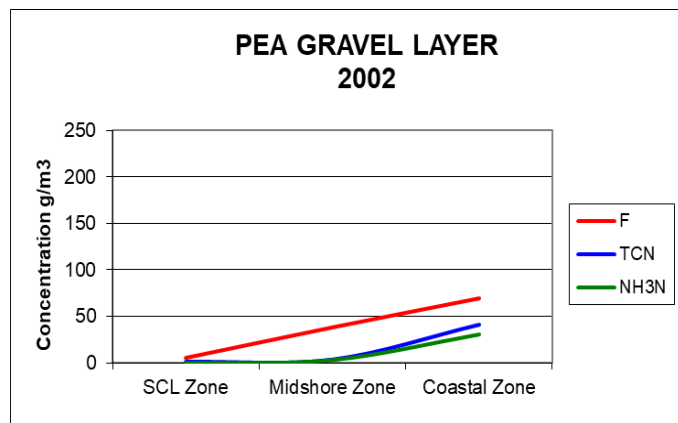
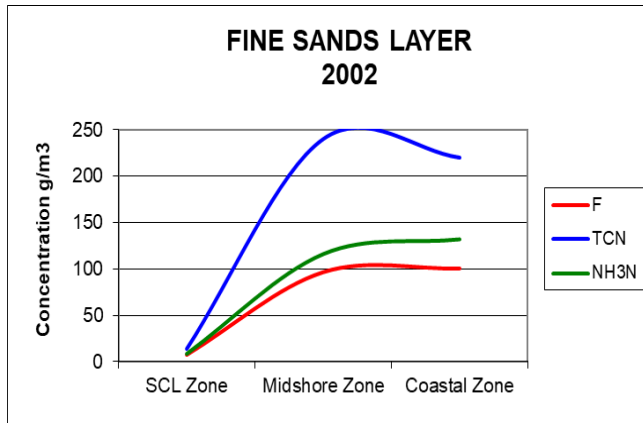
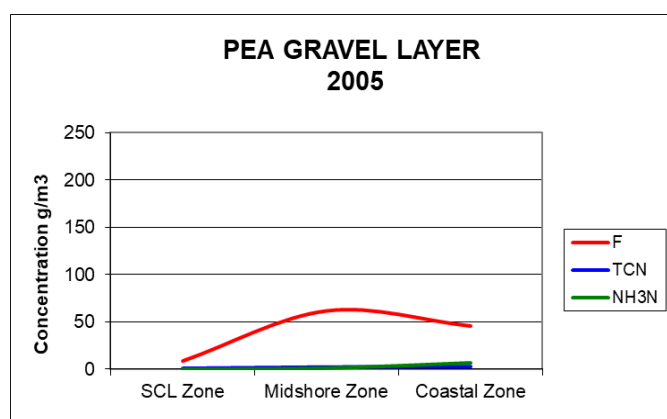
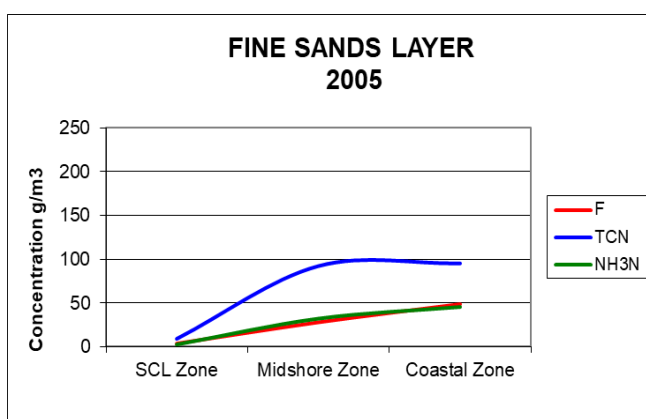
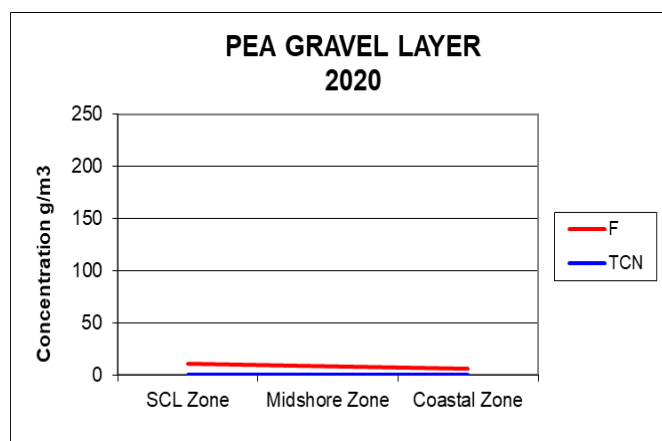
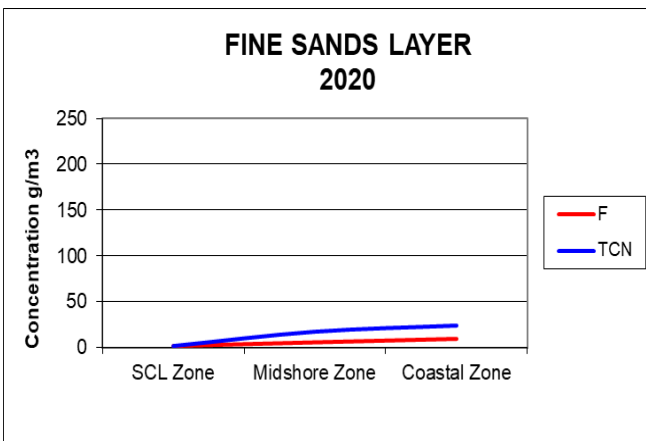
4.5 Comparison of Zones over Time

Comparison of Zones for the reporting years 2002, 2005 and 2020 are displayed below to show the general recovery of the groundwater over time.

Both the pea gravel and find sand layers show great recovery from the 1990s groundwater contamination for all zones. The shallower pea gravel layers are showing less contamination than the fine sand layers which is expected due to the higher permeability in the pea gravel.

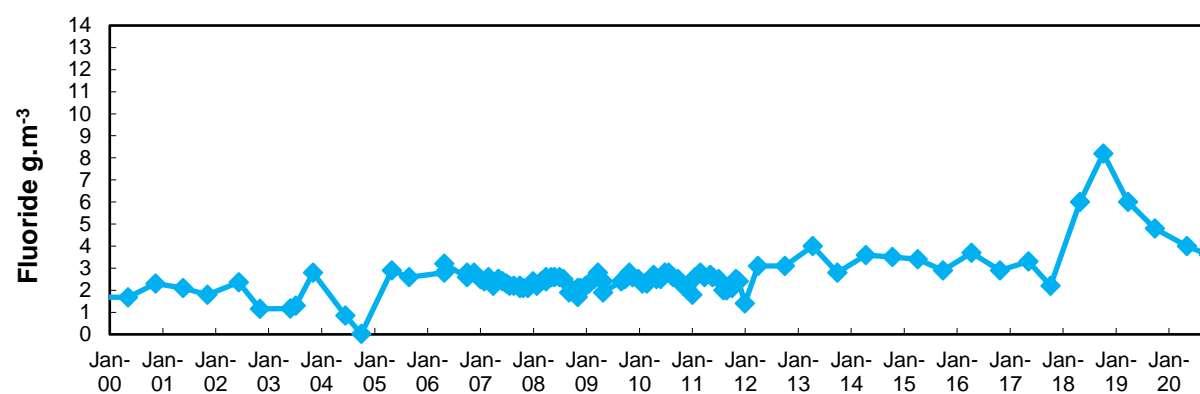
Bore A22 Fluoride

Bore **A22** is located southwestwards of the general pile and showing similar fluoride concentration to Bore **A21**.

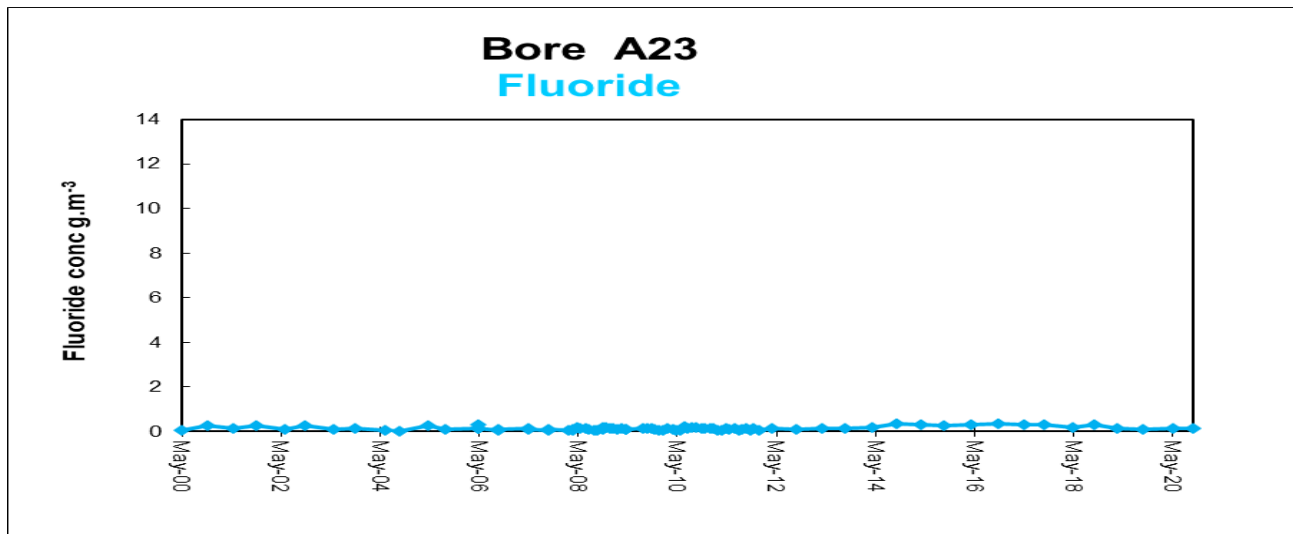
Bore **A23** is located upstream (north) of the carbon piles. Typical fluoride values are less than 0.5 g/m³.

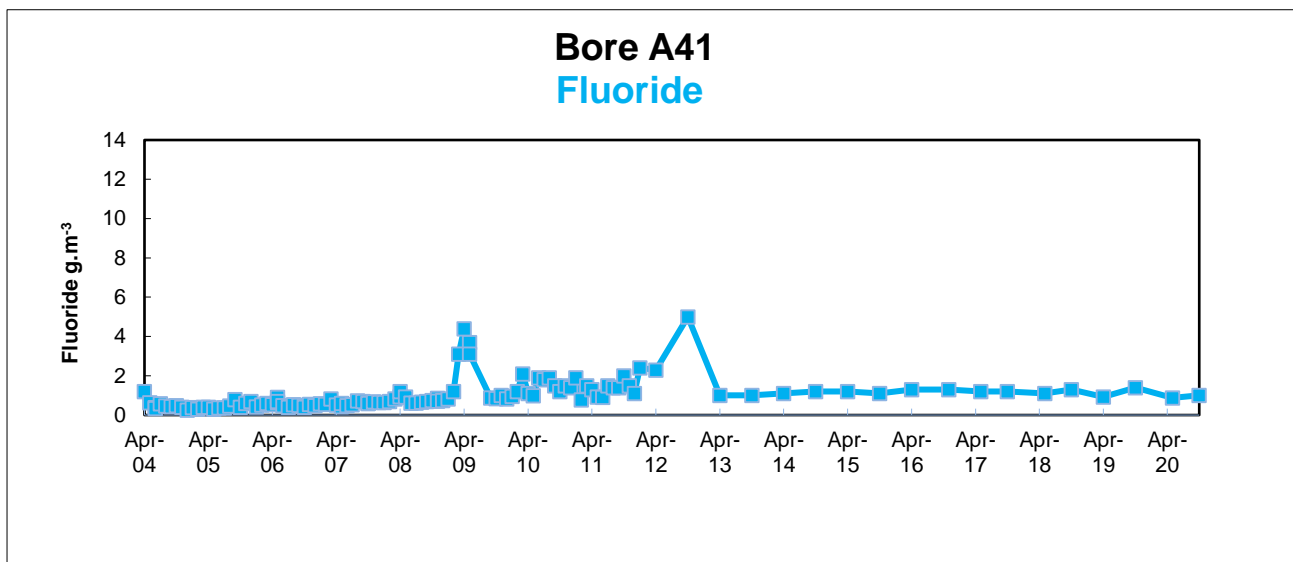
Bore **A41** is located upstream of Haysom's dross cell and continues to show low levels of fluoride.

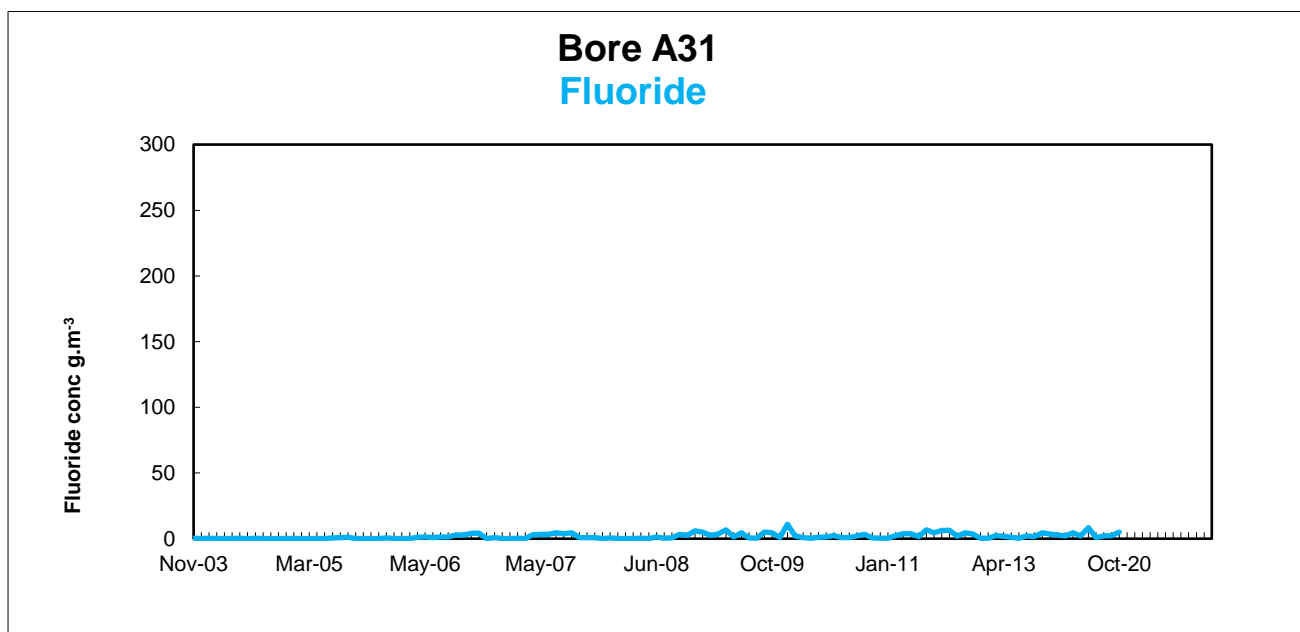
Bore **A31** is in the corner of the landfill south of the capped carbon pile. Levels are similar to back ground levels seen in bores north of the landfill.

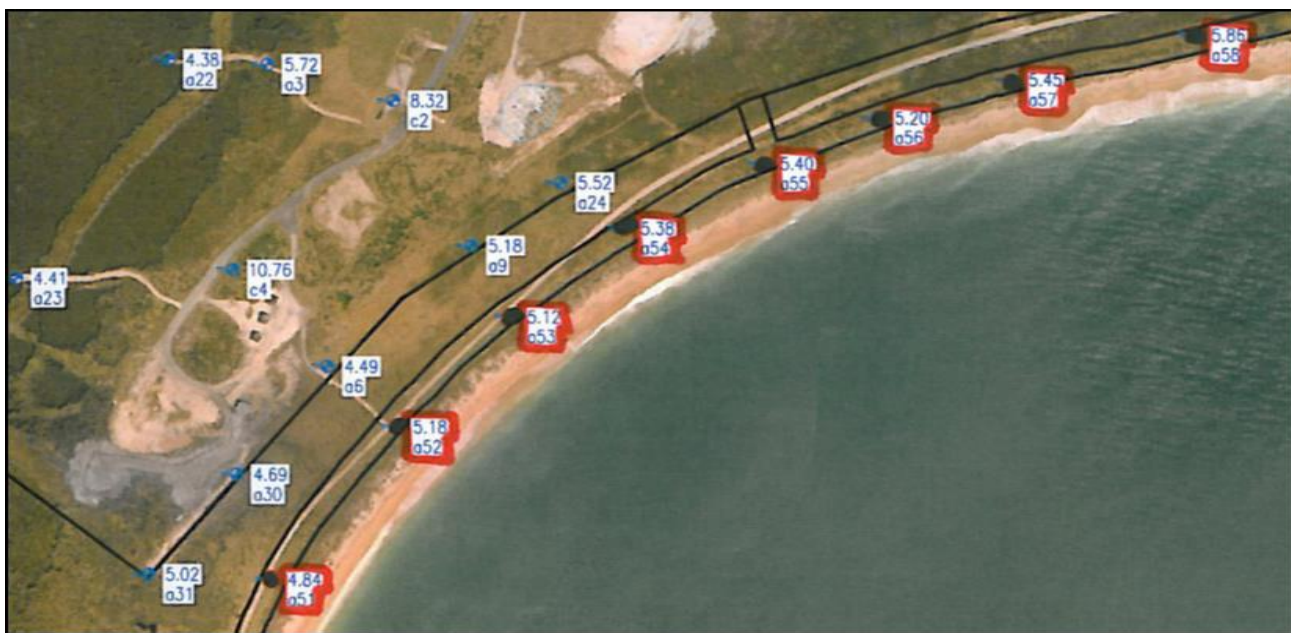
Coastal Bores A51-58

In 2009 eight coastal bores were installed as elevated fluoride levels were observed south of the landfill (Bores **A30**, **A31** and **A6**) and due to historical issues relating to Haysom's gross leaching to groundwater. A large part of the carbon pile was capped in 2009 to stop the leachate entering groundwater from one carbon pile. The location of these bores can be viewed below.

Elevated fluoride levels were observed in six of the eight coastal bores upon installation in 2009. There has been a general decrease in fluoride, or otherwise stable levels of fluoride, since that time.
