## OBSERVATION REPORT

PARKSIDE I AND II, ELDERLY HOUSING

BRANFORD HOUSING AUTHORITY

DB FILE 9693

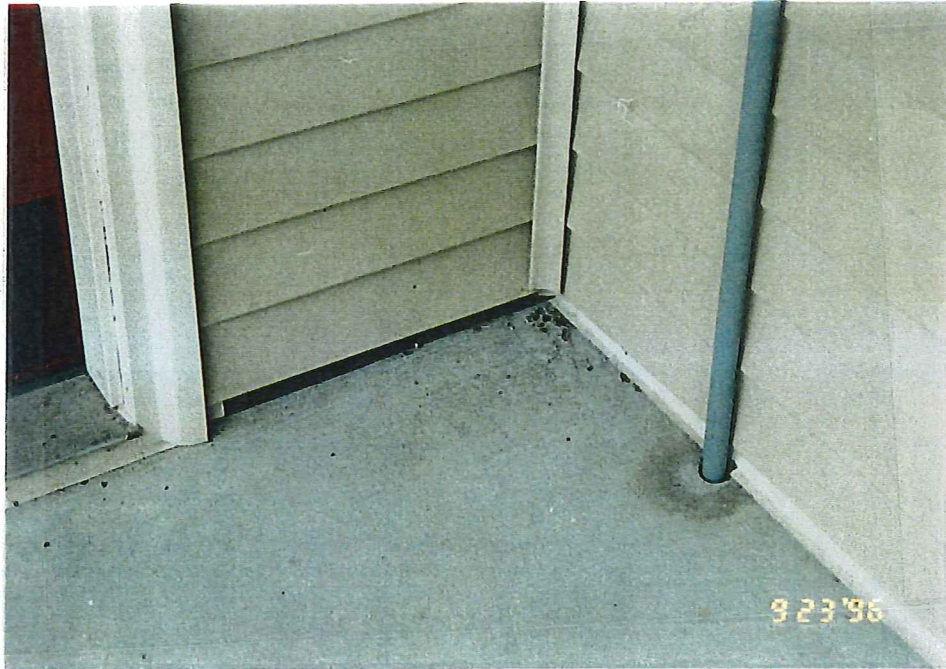
SIDING VERY CLOSE TO WALKWAY, SECOND FLOOR.

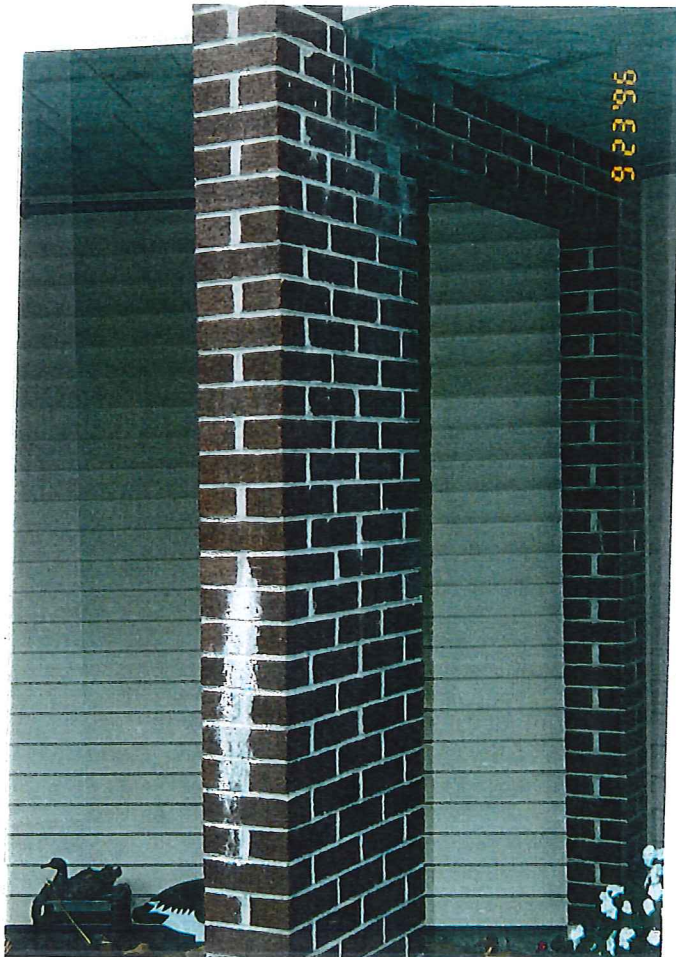
EFFLORESCENCE IN PIER.

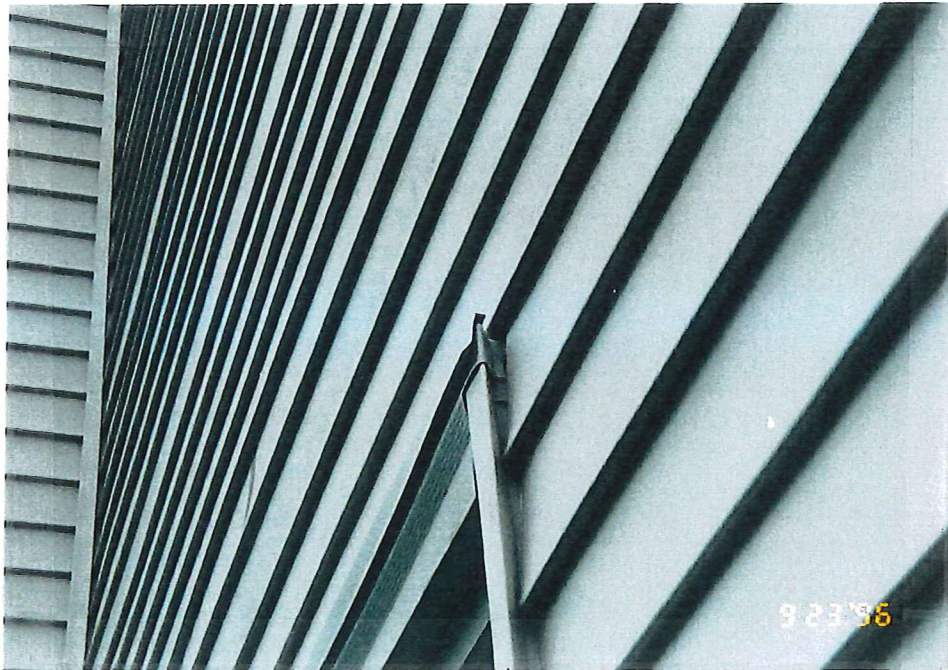
WINDOW HEAD FLASHINGS APPEAR TO BE PROPER.

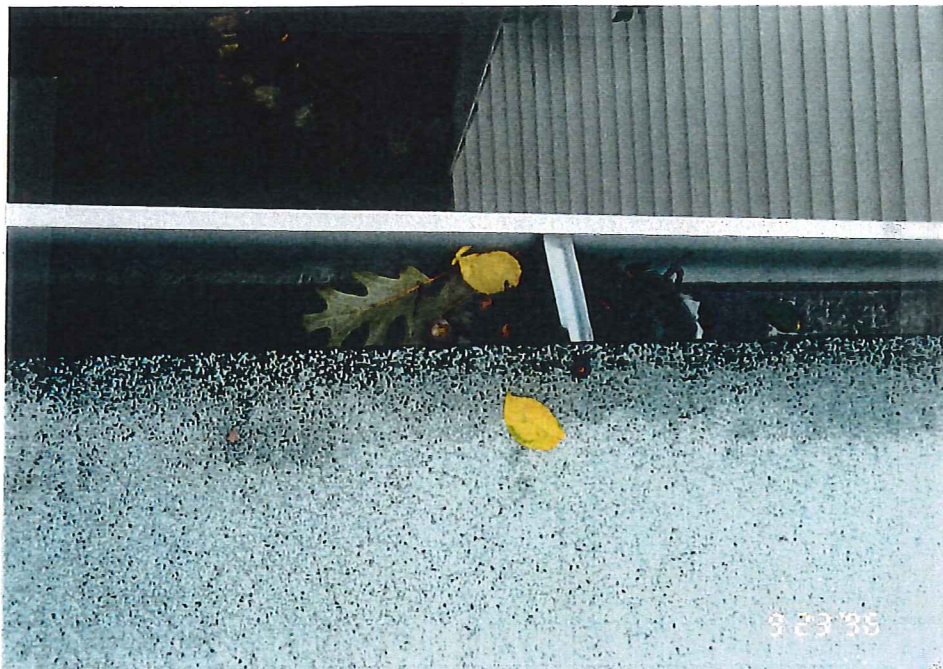
ROTTED DEBRIS IN GUTTER.

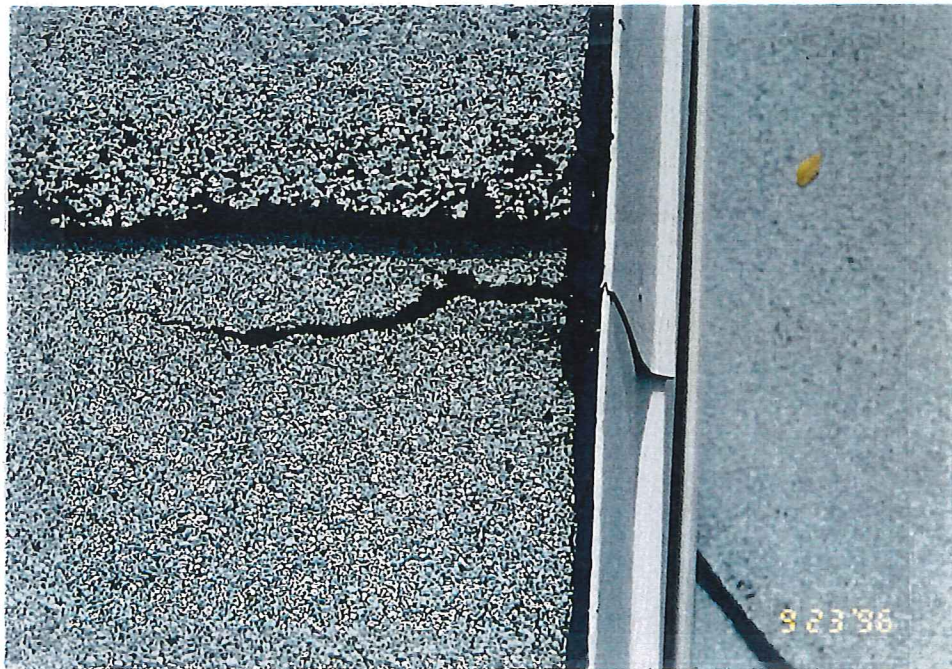
TEARS IN ROOFING.

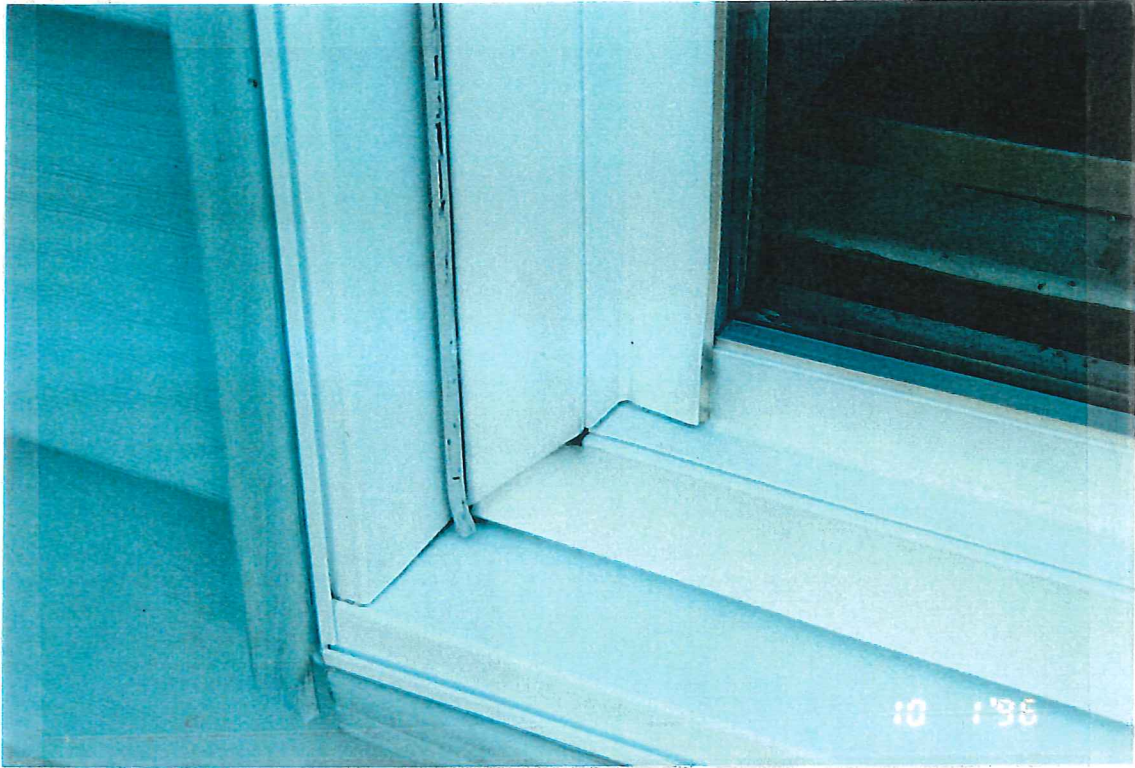
OPEN JOINTS IN WINDOW VINYL CLADDING.

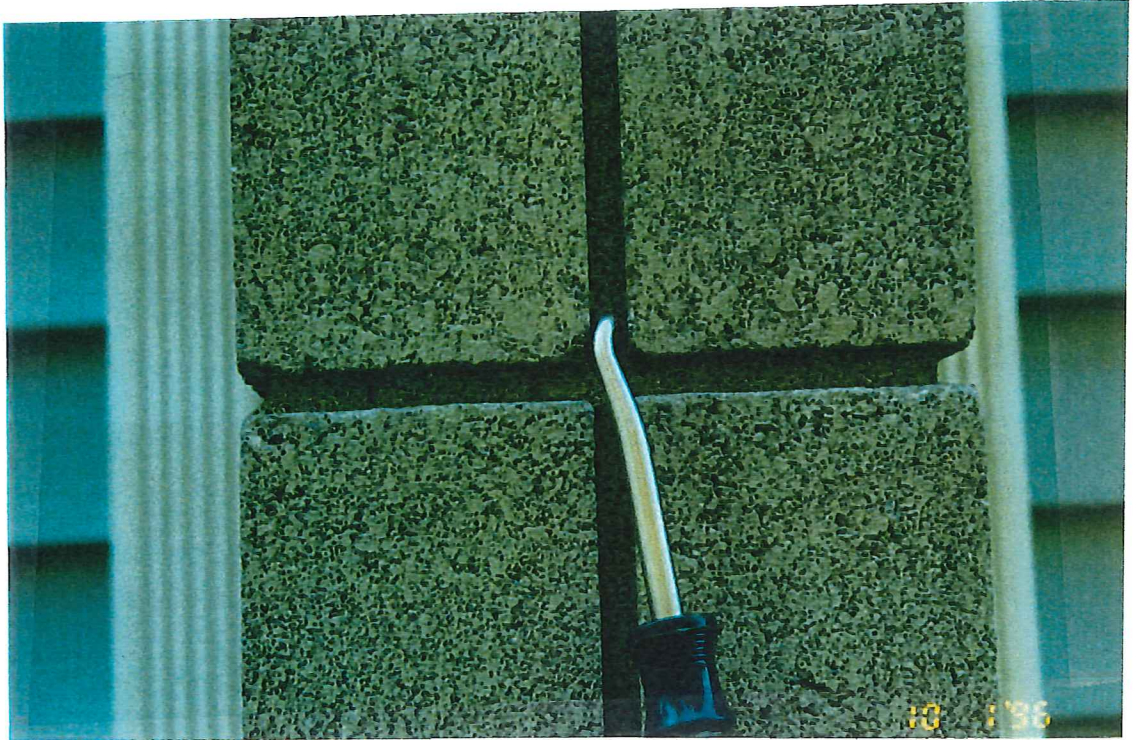
SMALL VOID IN MORTAR JOINT.

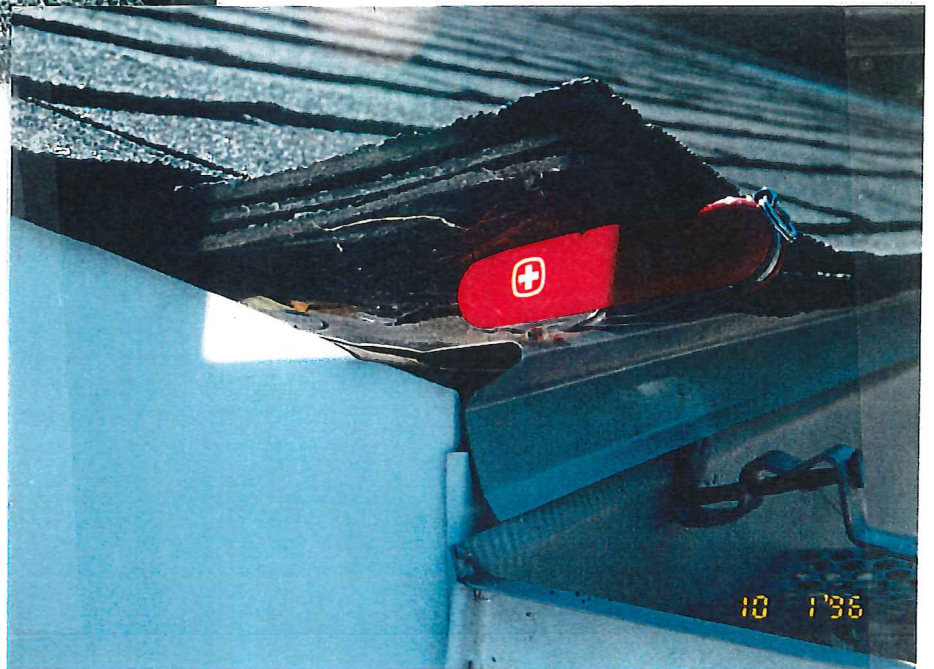
SHOWING PLYWOOD SHEATHING UNDER SHINGLES; NO  
UNDERLAYMENT OF EAVE FLASHING.
