Loudoun County Department of Fire, Rescue, and Emergency Management

SIGNIFICANT INJURY INVESTIGATIVE REPORT 43238 MEADOWOOD COURT MAY 25, 2008

September 2008

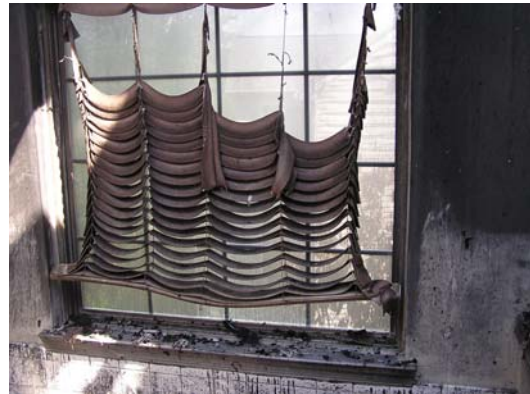
Figure 17: Master Bathroom (Post-Fire)

Figure 16 illustrates the Master Bathroom pre-fire; Figure 17 shows the highlighted window, post-fire.

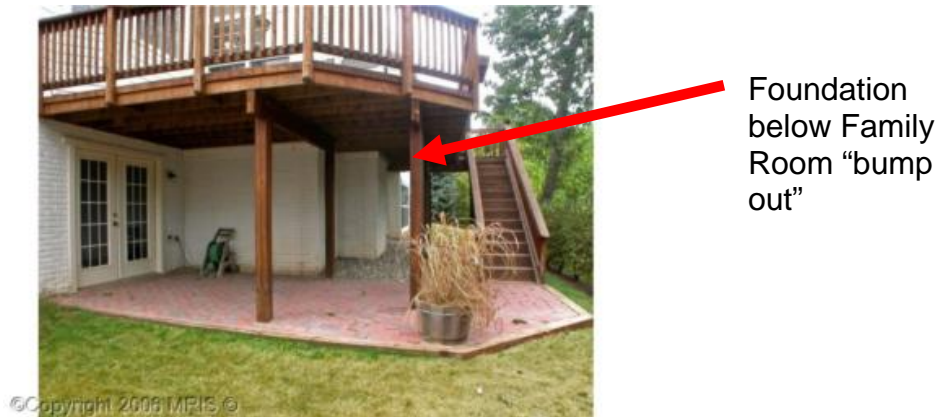
Figure 22: Side Charlie

From the Officer's vantage point at the C/D corner, the topography of the lot, the large deck, and construction features of the structure limited the Officer's ability to view portions of the first floor, particularly from the Sunroom toward Side Bravo (see Figure 22). Since the Officer was unable to see all of Side Charlie, the Officer did not observe the fire in the Sunroom on the first floor.

Recommendation: Reiterate the importance of visualizing the entire structure prior to making entry. Clearly, this will not always be feasible, particularly with larger homes, odd lots, and different types of occupancies (e.g., multi-family, commercial, educational, industrial, etc.). In instances where the first-arriving officer cannot visualize all sides of the structure, interior fire suppression operations should not commence until the officer receives a report from the opposite side of the structure, unless an obvious life safety issue exists (e.g., visible victims requiring immediate assistance).

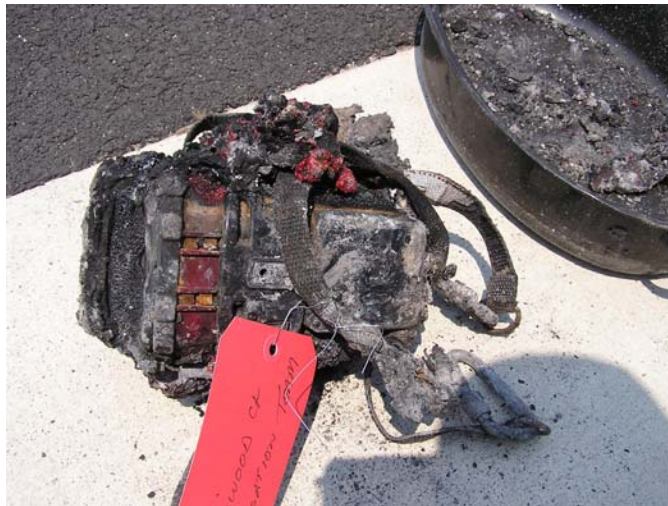
Figure 25: Tower 6 TIC

During the investigative process, the Team recovered the TIC in the Master Bedroom under a window on Side Delta (see Figure 25).

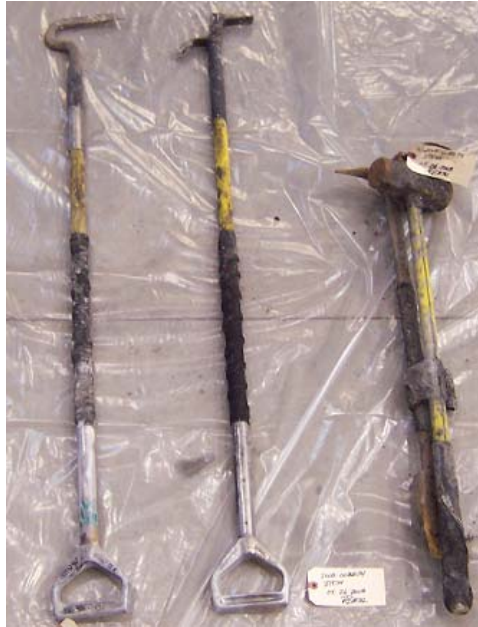
Figure 26: Gear Photo 027

Figure 26 illustrates the tools carried into the structure by the crews of Reserve Engine and Tower 6. In addition, all four personnel carried a flashlight. The flashlights were heavily damaged; the Tower Officer's flashlight lens had completely disintegrated.

In post-incident interviews the Tower Firefighter indicated that, in retrospect, the sledgehammer was not the most appropriate tool for a residential structure fire.

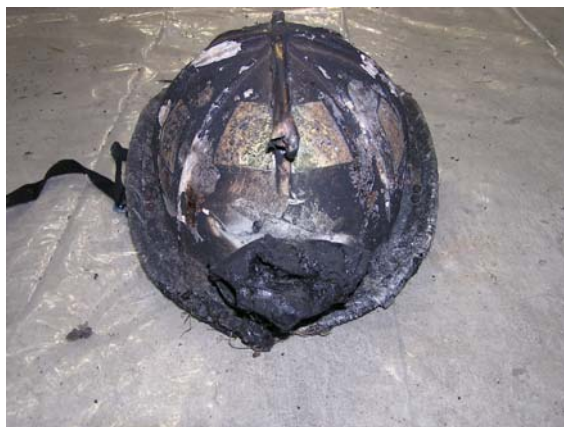
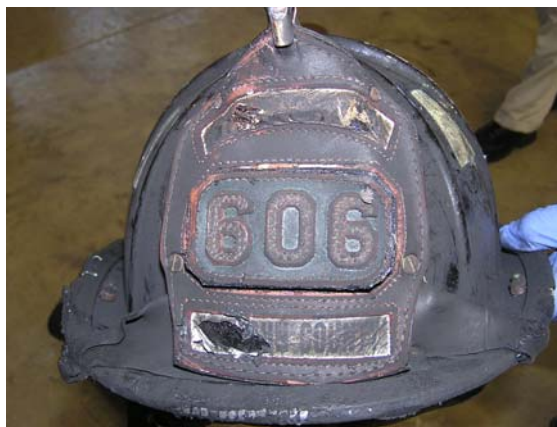
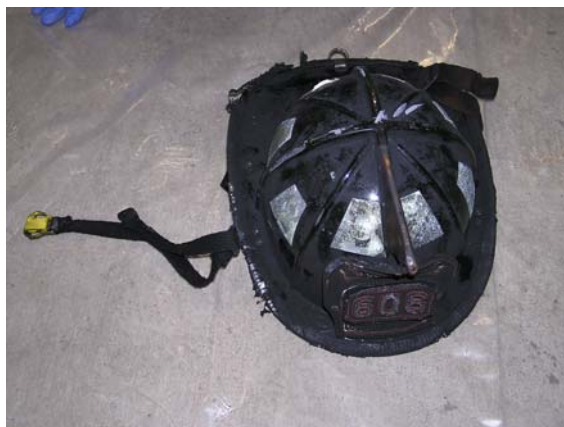
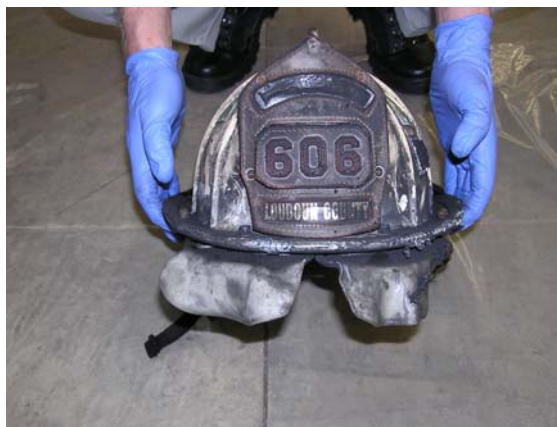
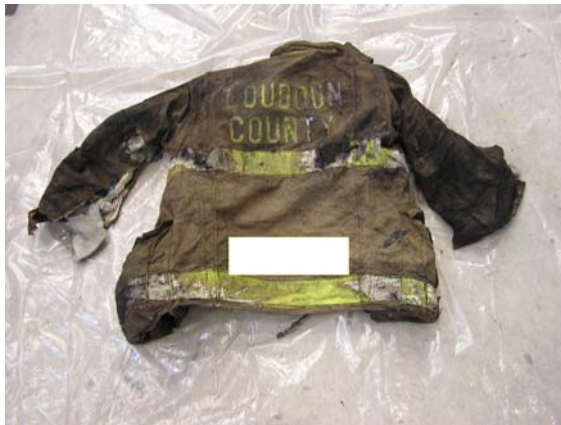
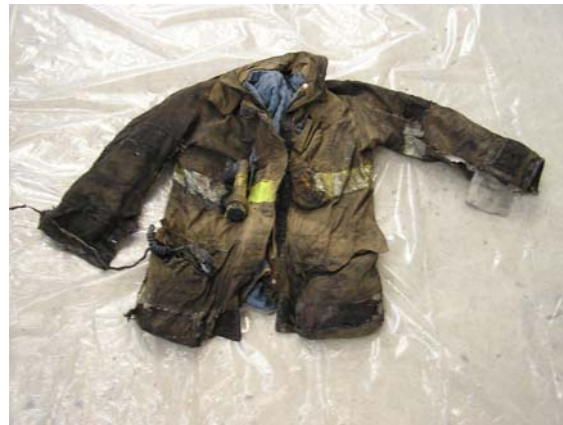
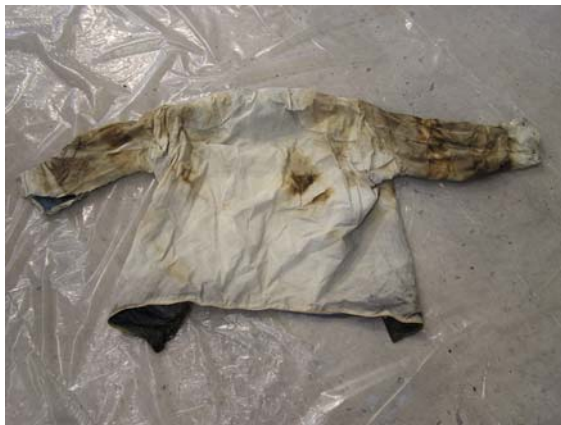
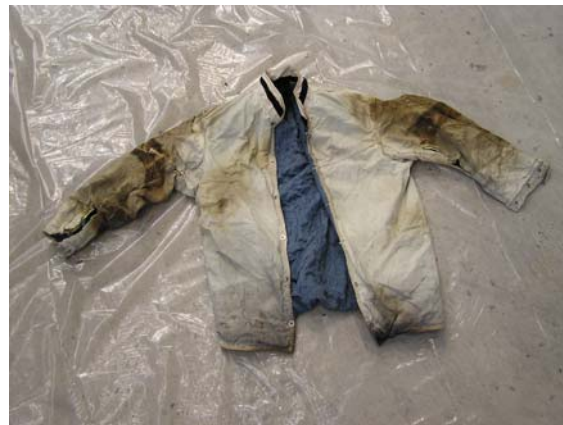
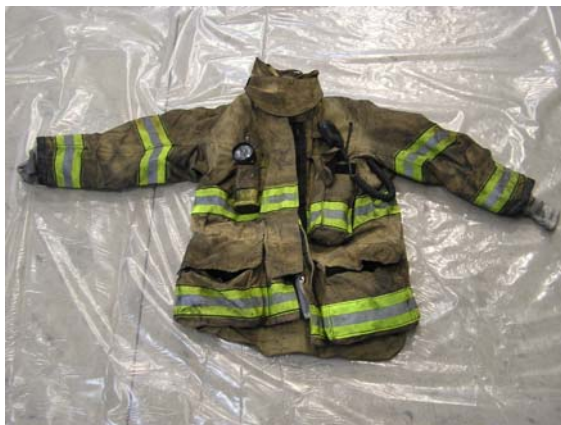
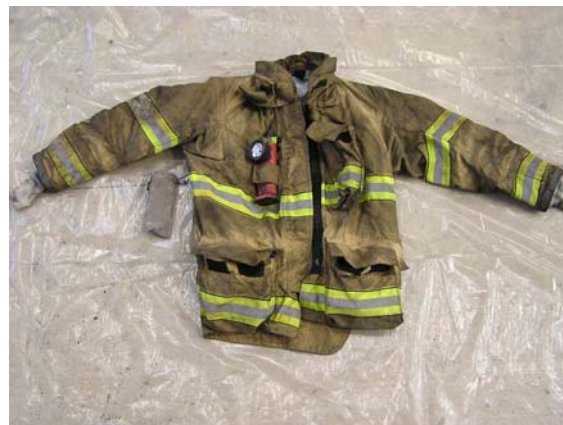
- The specific damage noted to the trim with its complete deterioration, particularly on Tower Officer's protective coat and pants suggests exposure temperatures that were well in excess of 600° Fahrenheit for several seconds. The reflective marking damage combined with edge bead melting of helmet materials, bubbling and extension of eye shields on the protective helmets worn by the Reserve Engine Officer, Reserve Engine Firefighter and Tower Firefighter also confirm exposures at these levels. The damage to the helmets, hoods, and portions of the protective clothing, and other components worn by the firefighters do support the characterization of the firefighters being exposed to a flashover.

The following photos are included to illustrate the variations in heat exposure sustained by each of the injured firefighters.

Recommendation: Reinforce the importance of proper PPE usage during emergency operations to ensure that personnel receive the highest protective benefit possible. Three of the four burned firefighters sustained some level of burn injury to their ears. The investigation revealed these three firefighters did not deploy their ear flaps.

Recommendation: Modify gear specifications to relocate the reflective striping away from compression areas and require additional layers of thermal protection on the bunker coat sleeves. For further discussion, see page 114, Additional Considerations.

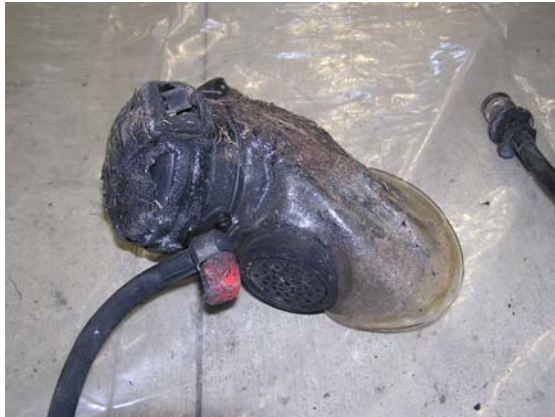
Figure 39: Tower Officer

- The Officer's SCBA regulator and facepiece were in such a condition that they were unable to be tested (Figure 39).
- There was significant damage to the facepiece; the lens was grossly disfigured from high heat or flame exposure.
- The regulator was still attached to the lens and the low pressure air line of the reducer.
- The entire cover was distorted from exposure to high heat.
- The latch was not operational.

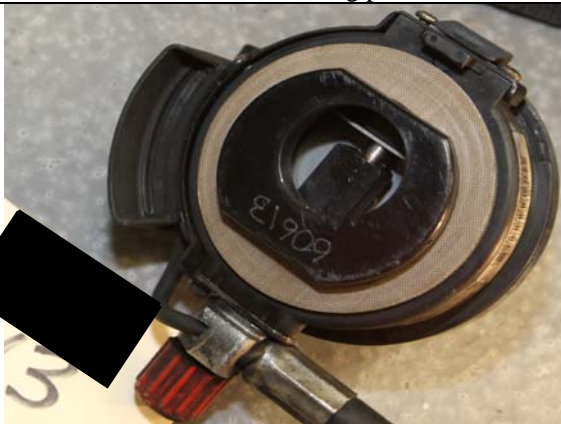
<p>No visible damage to hose, purge knob is smoke stained with no visible damage, turns as it should. Latch moves freely, no visible damage. HUD wire and HUD visor intact, no visible damage. Gasket intact, no apparent damage. Regulator sn visible on body of regulator, the number 60613 is etched on the inside of the locking plate.</p>

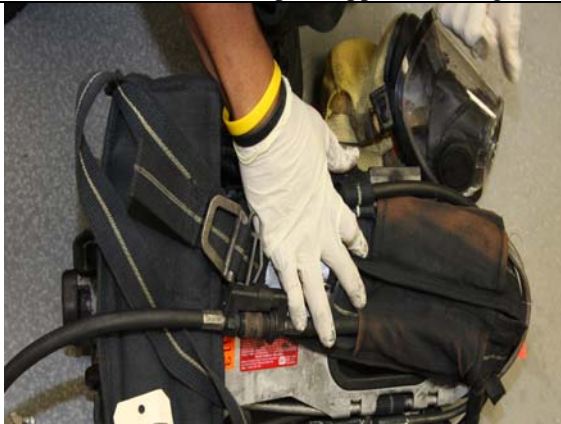
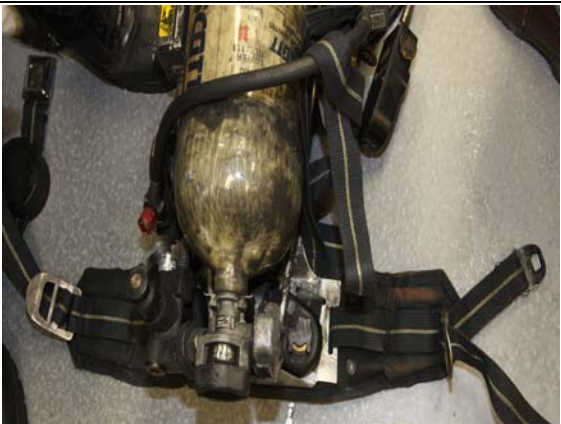
<p>Backframe / Straps: No apparent damage, some surface discoloration on the frame. Shoulder harness assembly has some minor discoloration. Waist to shoulder strap, no apparent damage.</p>

<p>Female waist strap has regulator holder attached, no apparent damage. Male waist strap no apparent damage, buckles operate normally and lock securely. Cylinder retention strap / buckle locked, no damage. Back part of latch plate slightly blistered.</p>	<p>Adjustable clip for retention strap blistered.</p>

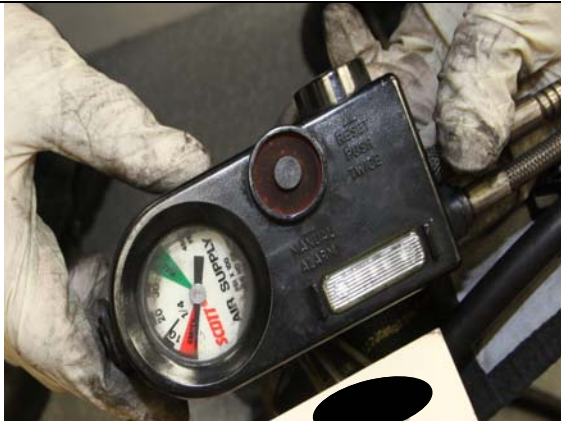
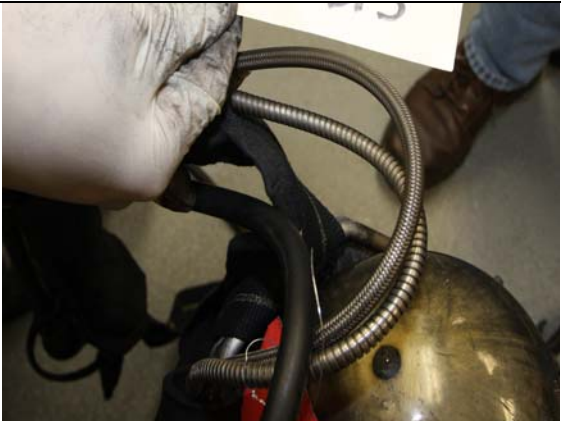
P.A.S.S. / Console:	
Pak-alert no visible damage. Console cover has some debris, rubber seal looks intact. Console gauge is visible, no smoke stain. Gauge lens does appear slightly disfigured, both emergency activation button and reset button have smoke stains.	Both the pak-alert wire harness and gauge line are slightly discolored where they go under the shoulder harness sleeve. Gauge retaining strap present and undamaged.

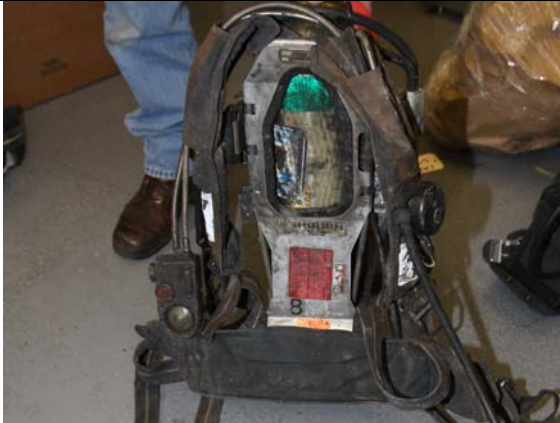
Cylinder (continued):	
Backside of cylinder appears good, no blistering of labels or green stripe.

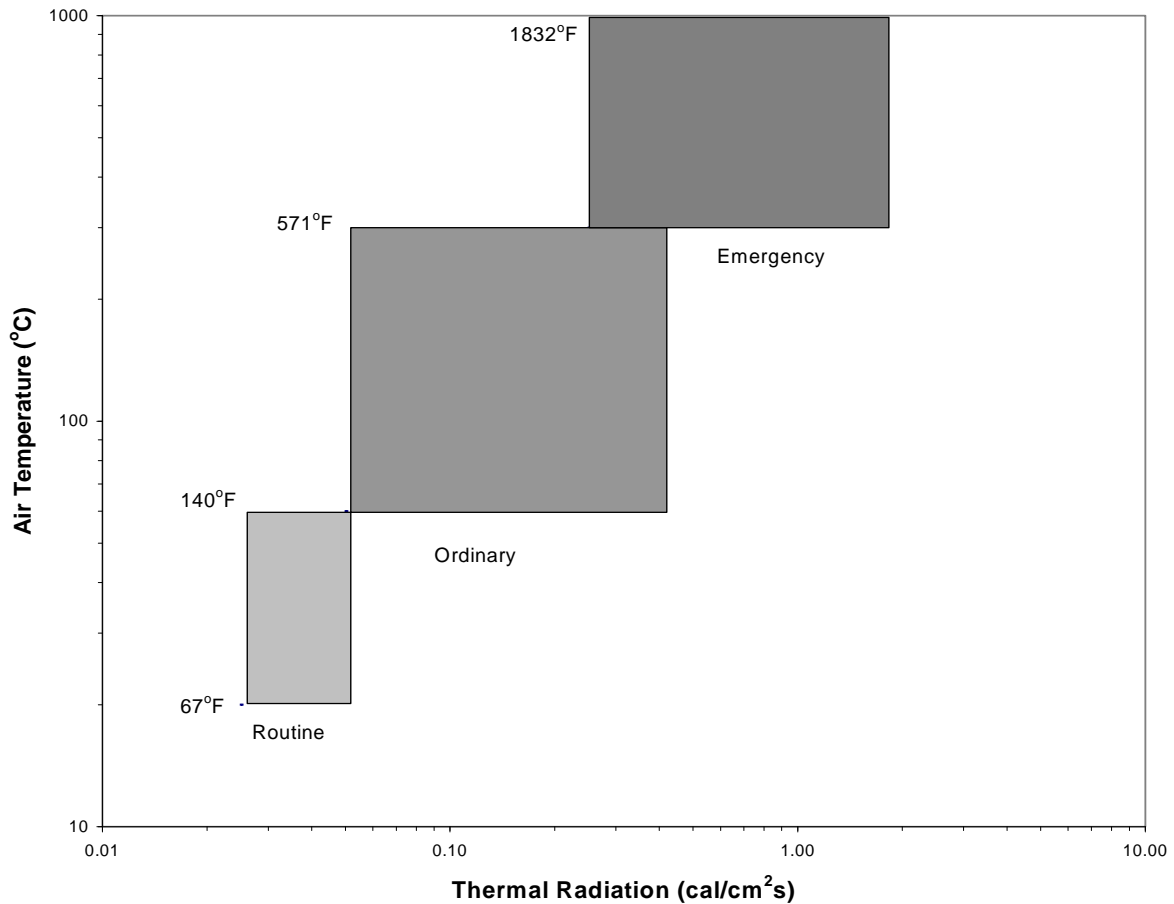
Figure 151. Range of Thermal Conditions Faced by Firefighters

The relationship between increasing thermal radiation (expressed in $\text{cal/cm}^2\text{s}$) and the resulting rise in air temperature (expressed in degrees Celsius and degrees Fahrenheit) is presented in Figure 151. Possible structural fire fighting situations are illustrated in this figure:^{1,2}
