Collision Reconstruction Report

COLLISION RECONSTRUCTION

HR No. HR-2016-055

Case No. 16-005442

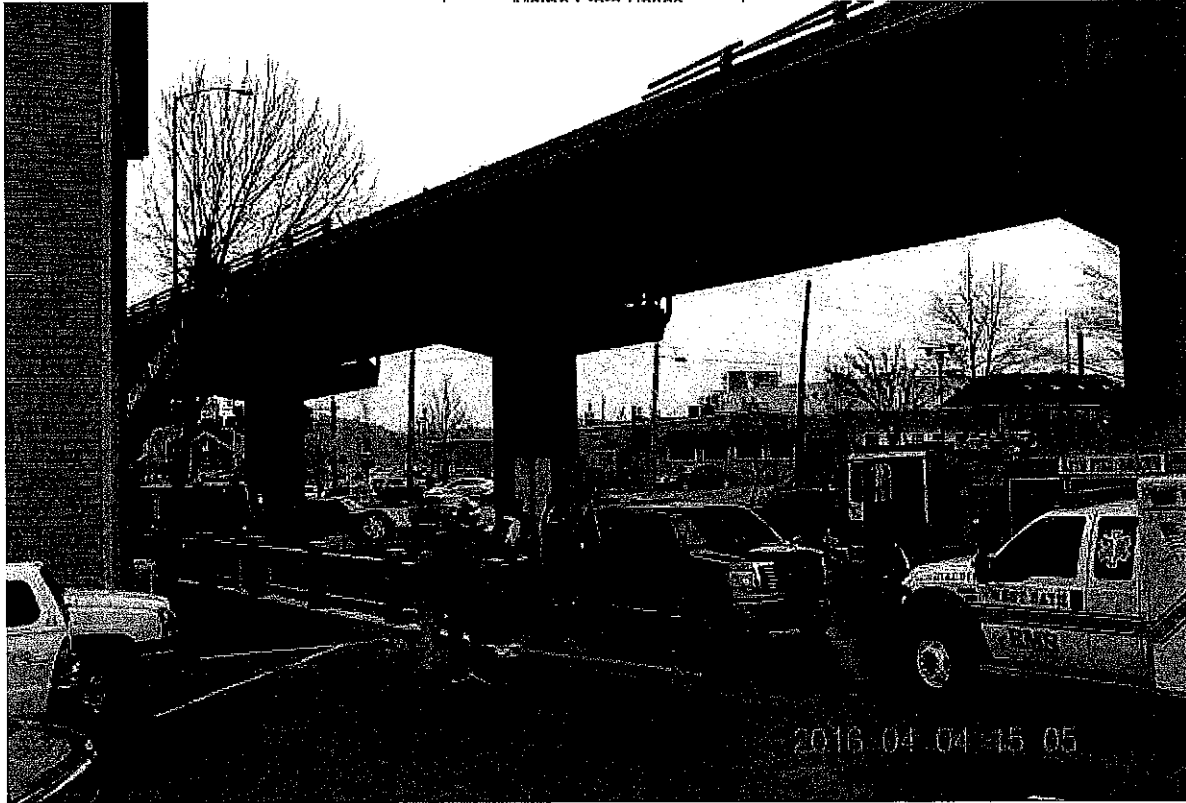
It appears, based upon the visual physical evidence, and witness and driver accounts, that Medina (Unit 1) was driving too fast for conditions (unexpected ice), which consisted of the viaduct freezing over before the bridge and road itself, due to weather conditions at the time. Medina lost control on the ice and crashed into and then over the guardrail. I have no evidence to support excessive speed, driver inattention, or intent to crash. It is reasonable to believe that their injuries would have been much more serious had they crashed onto the asphalt and not Ordway's pickup truck, which was able to absorb and support some of the energy in the crash.
