A report from the NIOSH Fire Fighter Fatality Investigation and Prevention Program

March 21, 2017

Career Female Fire Fighter Dies After Becoming Lost and Running Out of Air in a Residential Structure Fire—Pennsylvania

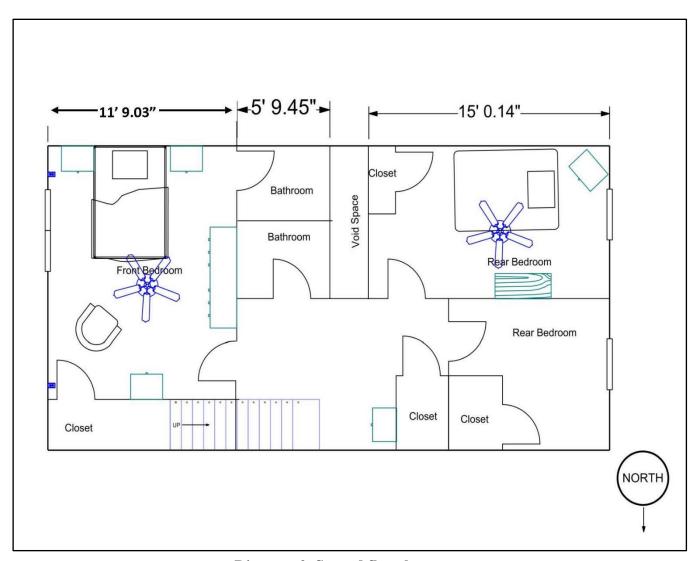
Diagram 2. Second floor layout. (Courtesy of the fire department.)

Diagram 2). The basement could be accessed either by an interior door leading to stairs off the right side of the kitchen or an exterior door at the rear (see Photo 2) of the house via an alley. The basement had a recreation room with half bath in the front half of the house, utility area on the left rear, and a garage on the right rear area (see Diagram 3). The garage was accessed by a standard aluminum garage door and had no interior access to the utility or recreation area and was formed by concrete block walls. The garage area was used for storage.
