**Assessments of streams and riparian plantings
within Carter Holt Harvey Forests
at
Mangakahia and neighbouring sites**

**- Bruce Alexander
October 2002**

An assessment of streams and riparian plantings within Carter Holt Harvey's Forest at Mangakahia and neighbouring sites.

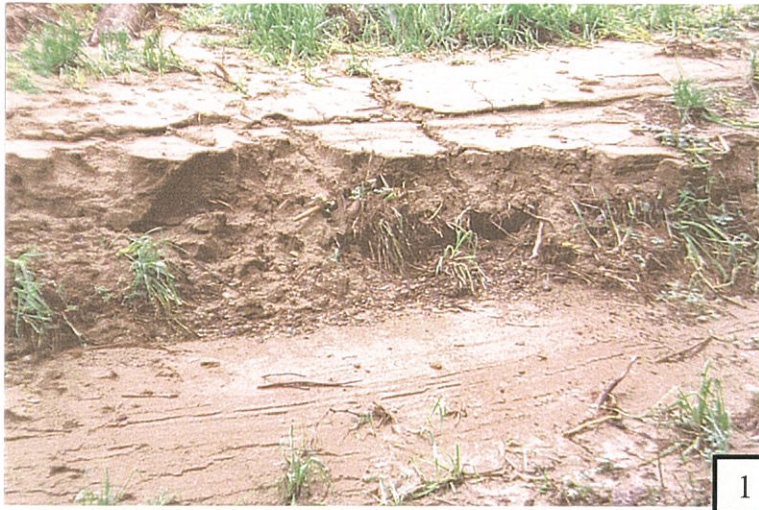
A considerable amount of soil has been released into the water. This photo shows silt build-up where Noall's 1 enters the Waitotekumerau river.

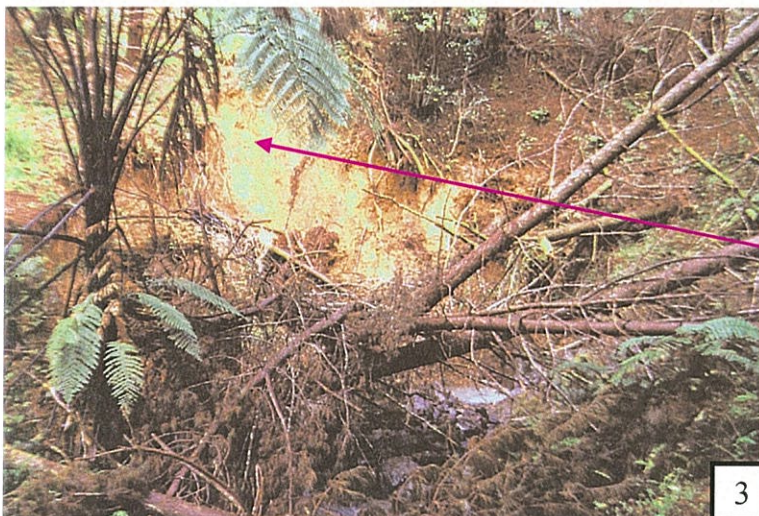
This demonstrates streambank erosion due to a blockage by pine trees.

Stream is being diverted and cutting away the bank.

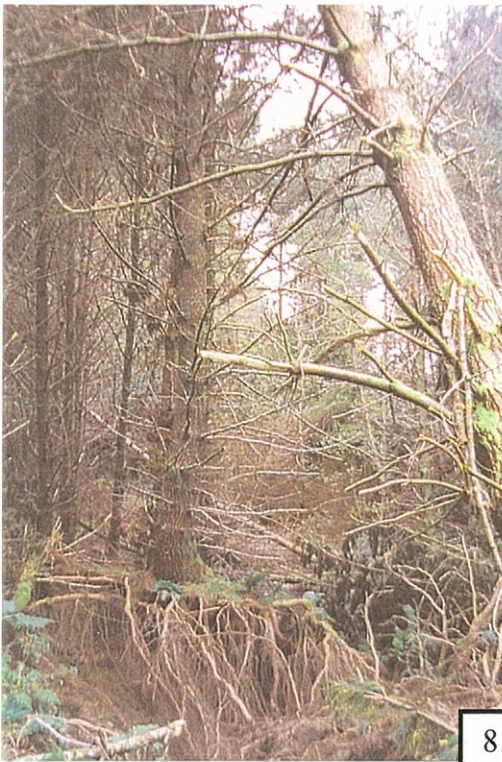
8 is an example of a domino effect ready to commence where the tree on the right hand side has four unstable trees in line to knock down.

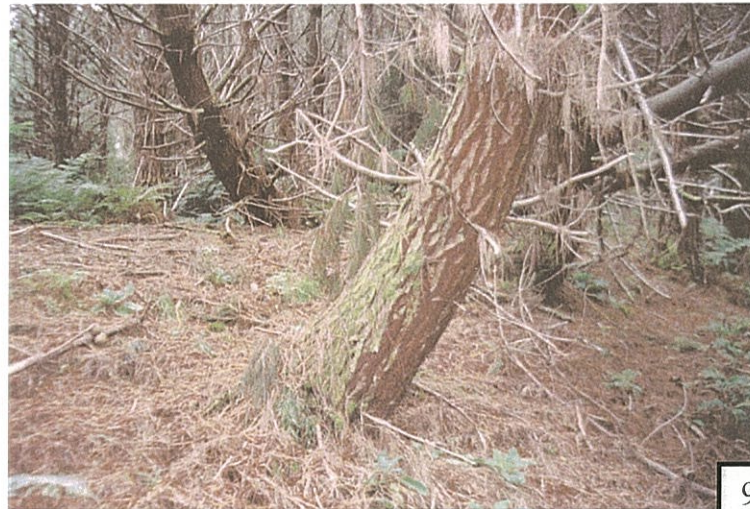
9

This buttsweep (9) indicates a less than favourable start for the trees. There are many examples of poor growth as one reaches the top of this area. There are three perennial streams at the top of N 1.

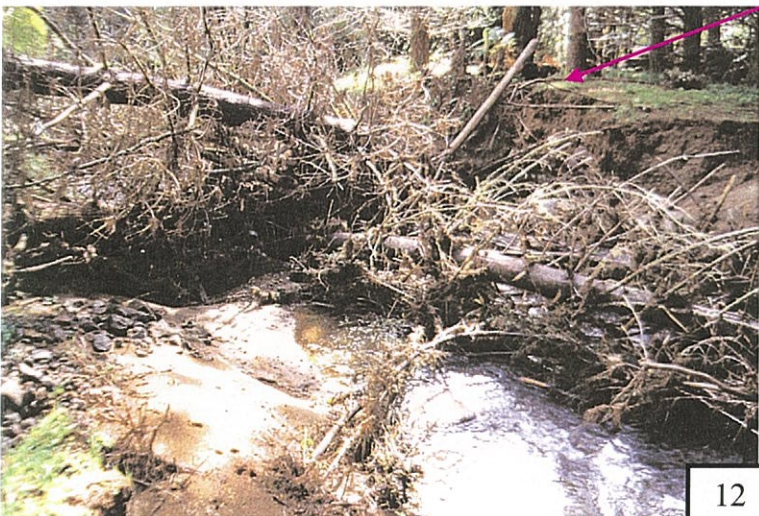
Severe erosion

Water depth here was between 2 to 2.5 metres deep. Twenty trees are due to topple due to the undermining of streambank. A large amount of soil has been washed downstream as can be seen by the buildup on the left of stream.

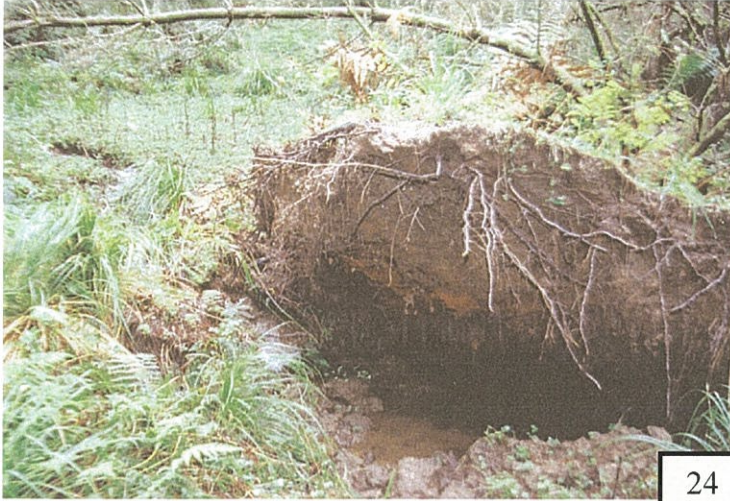
24

An uprooted tree on a wet hillside showing a stunted and diseased root system.

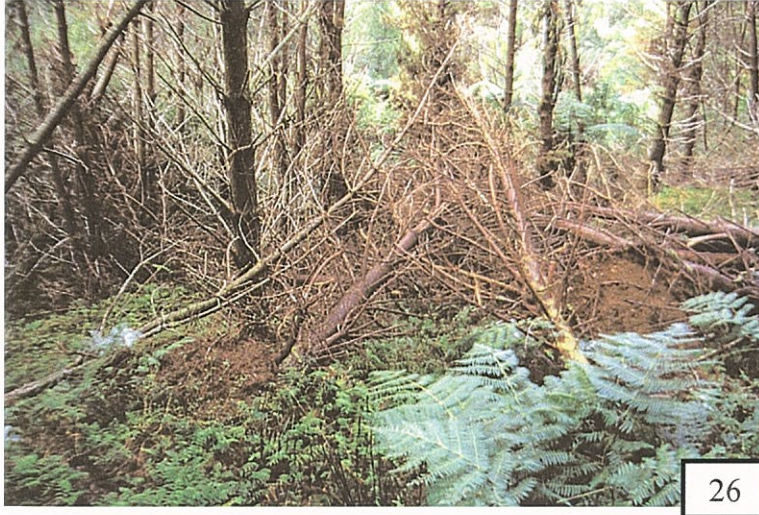
Also a small stream with a lot of windfall.

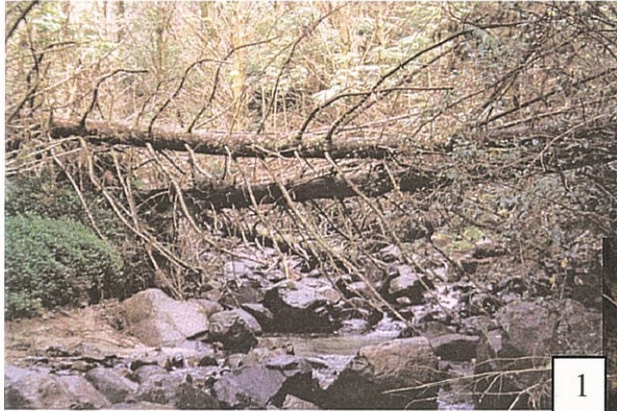
Left shows a perennial stream feeding into Carson's 1 and toppling exists for about 100m here in the soft ground.

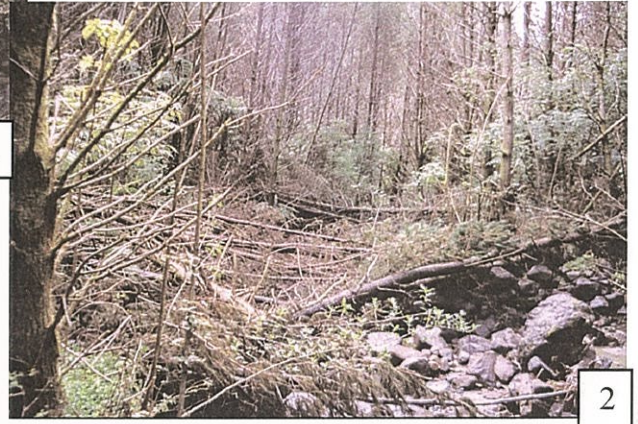
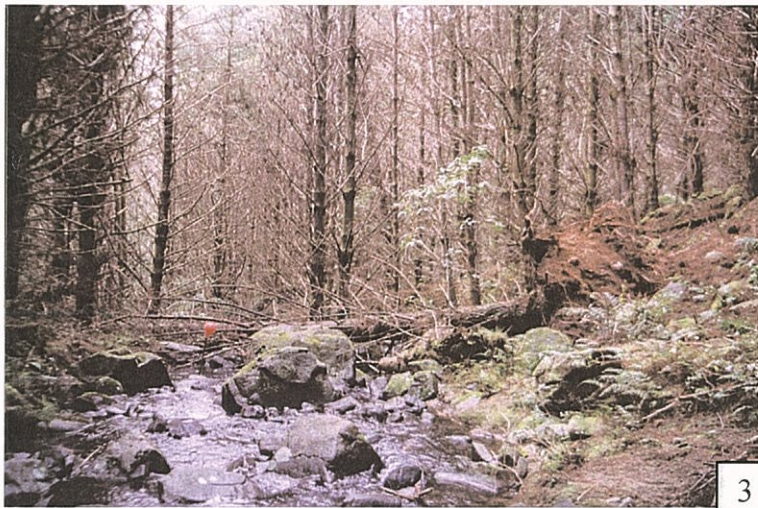
Flood height here would be about one to one and a half metres which is to the top of the red hat. This section above the gorge also has considerable toppling into the stream and comprises soft areas of hillside.

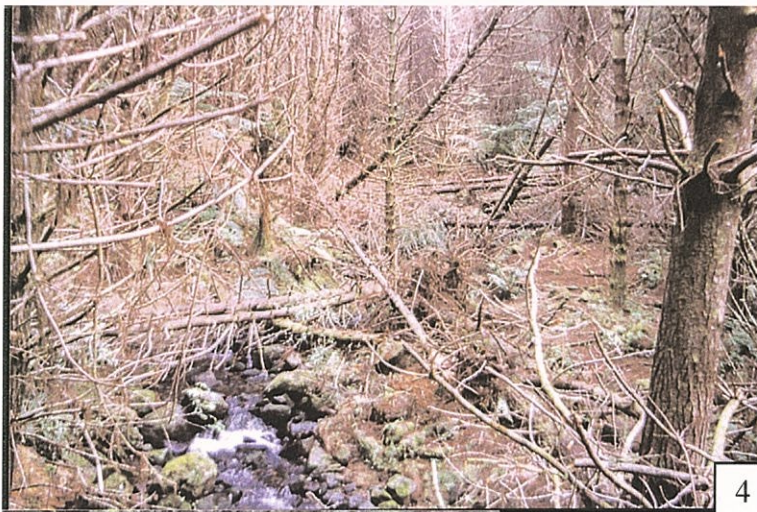
There are signs of a domino effect in several places.

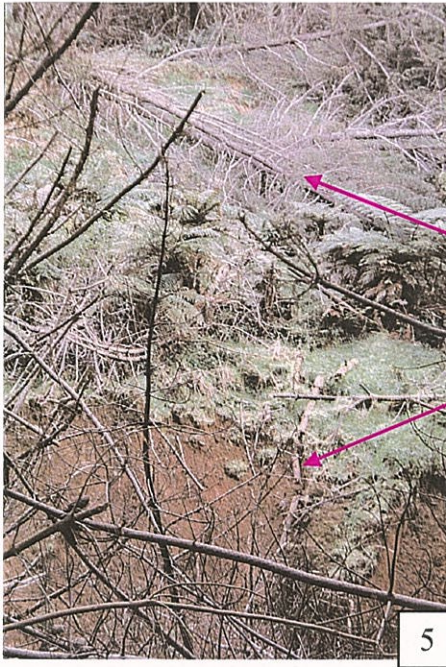
Old toppling up from stream

Recent streambank erosion

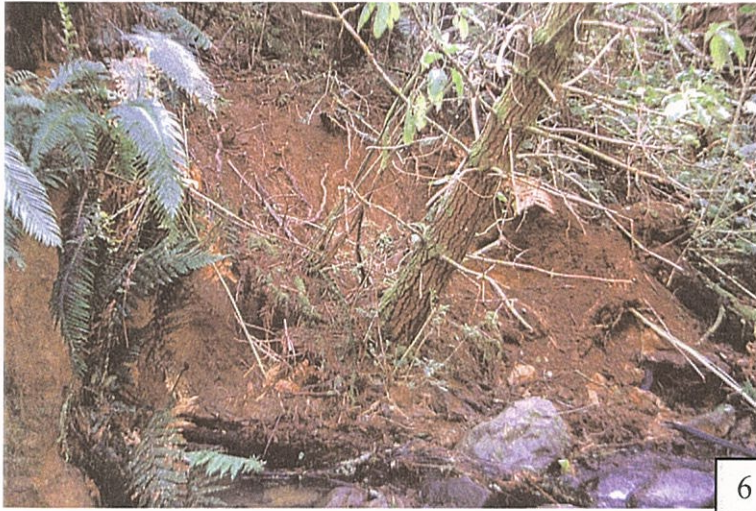
Large trees and many tonnes of soil have been deposited in the streambed.

From one vantage point over a distance of sixty metres, about forty trees have fallen over. About five to six hundred fallen and leaning trees would be accessible in Carson's 1 & 2.

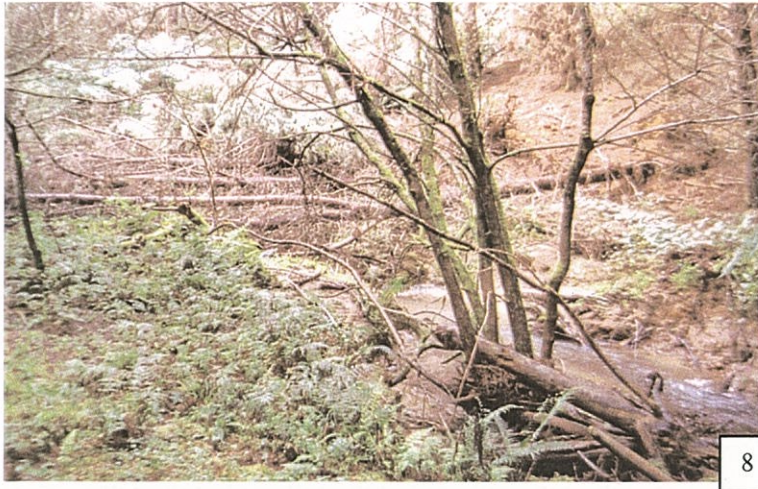
8

This section is about fifty metres from the security gate.

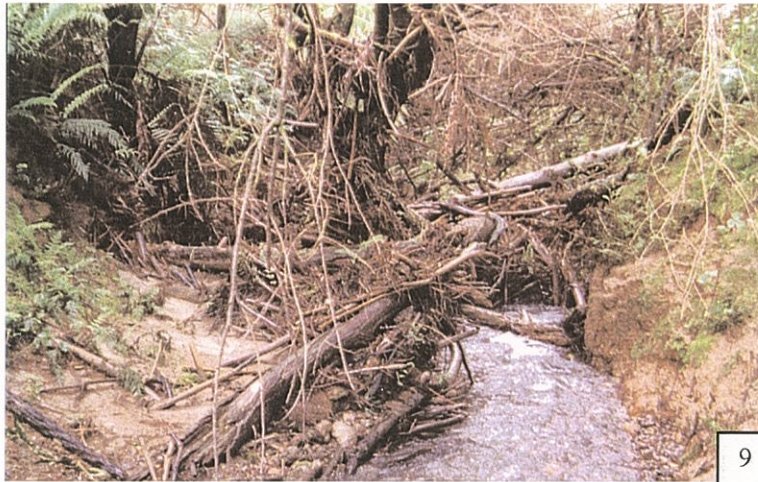
9

Continuing upstream about one hundred metres. A lot of toppling, almost a complete blockage and there are standing trees that will need removing as they are about to fall over.

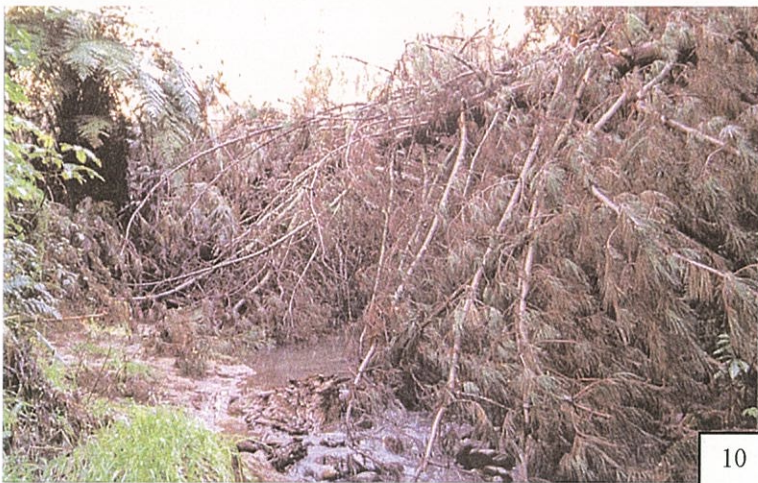
10

There are signs of trees that have been dead for some time breaking up and forming debris in the stream. The terrain is good for machinery to travel about six hundred metres upstream here.

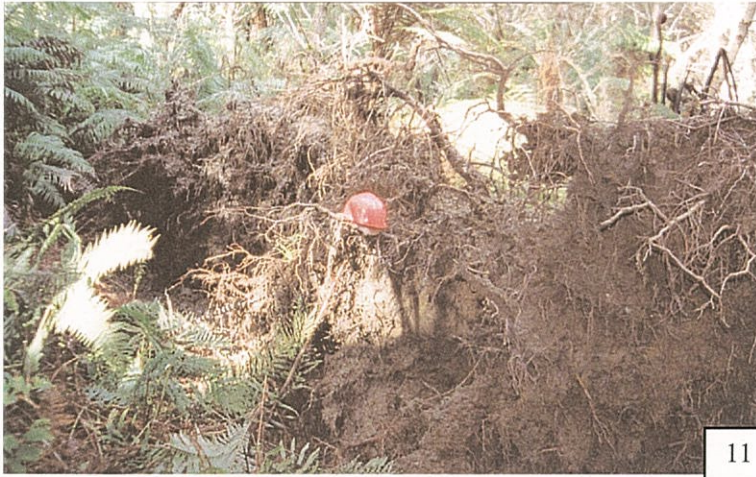
11

About one hundred trees over a distance of one hundred metres here have toppled and are affecting the streambed in one way or another. There is a lot of ground movement.

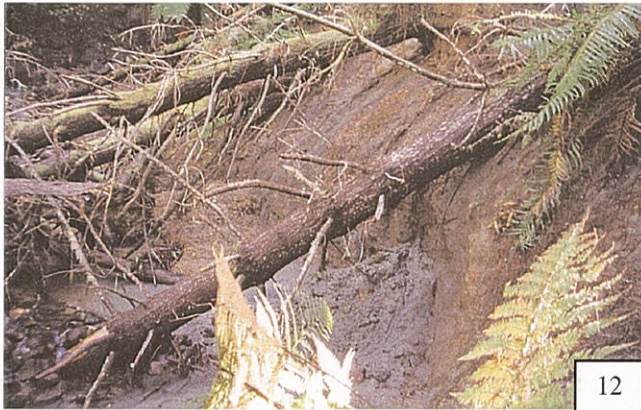
12

There is a lot of slumping (12) and signs of erosion with trees entering streams in earth flows.

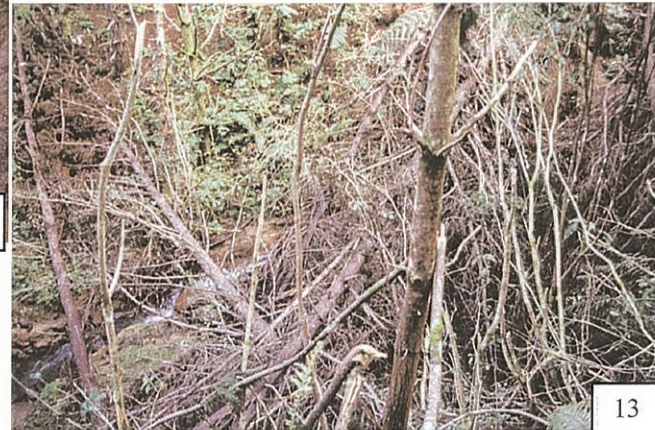
13

At the boundary with Department of conservation, land toppling is less because trees have not grown very large.

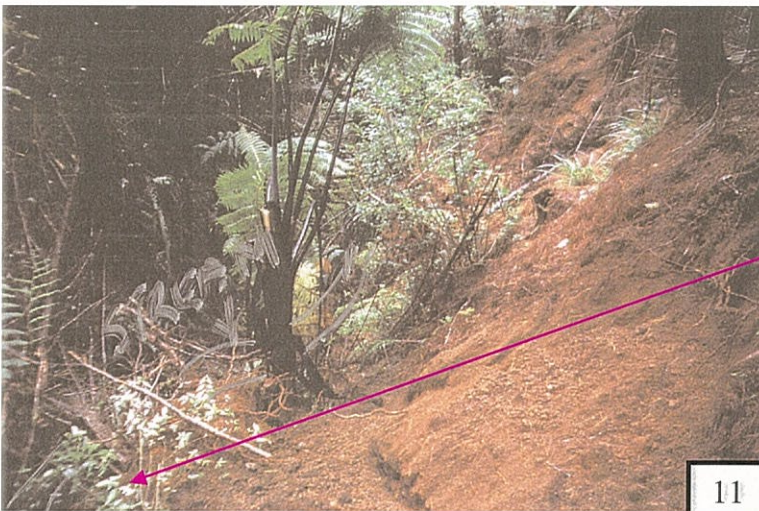
11

Takitu 3 - The amount of soil displacement into streams is considerable with this tree having slid its full length to end up in water.

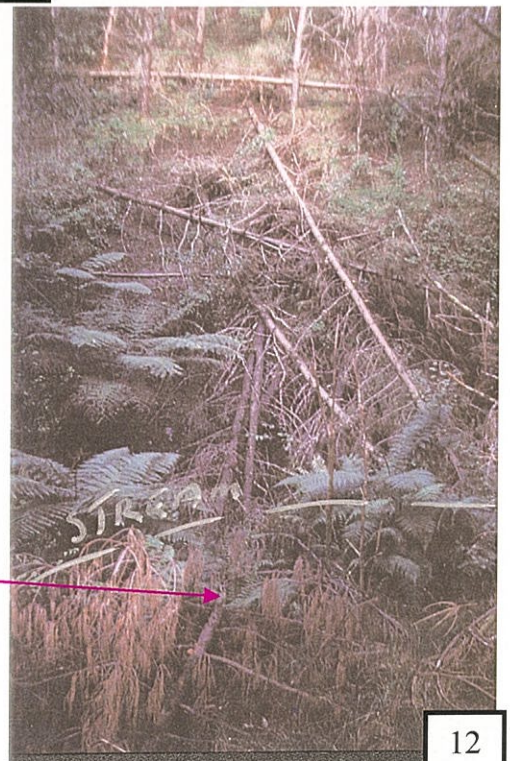
12

Takitu 3 - Roots could not anchor trees here and over eighty have fallen at this point.

There is a stream buried underneath.

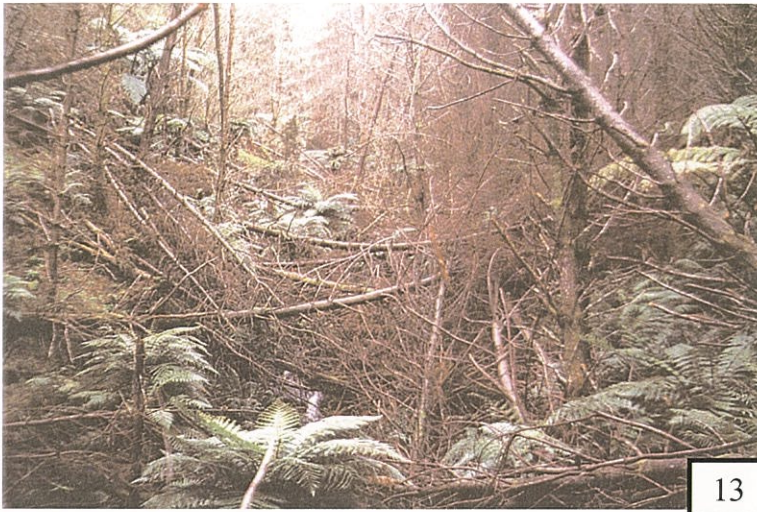
13

Takitu 4 - Areas up to one hundred metres from the stream edge are affected, there is more of the same through here with ricegrass present also.

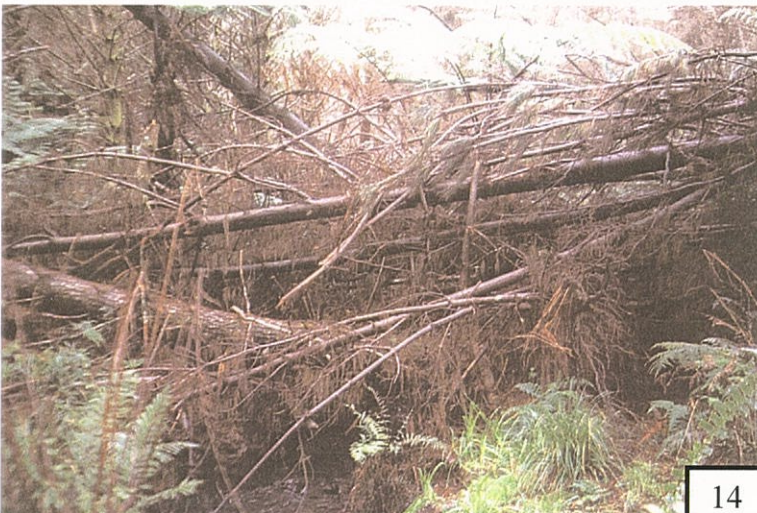
14

Takitu 4 – There is ricegrass as well as a stream under these trees.

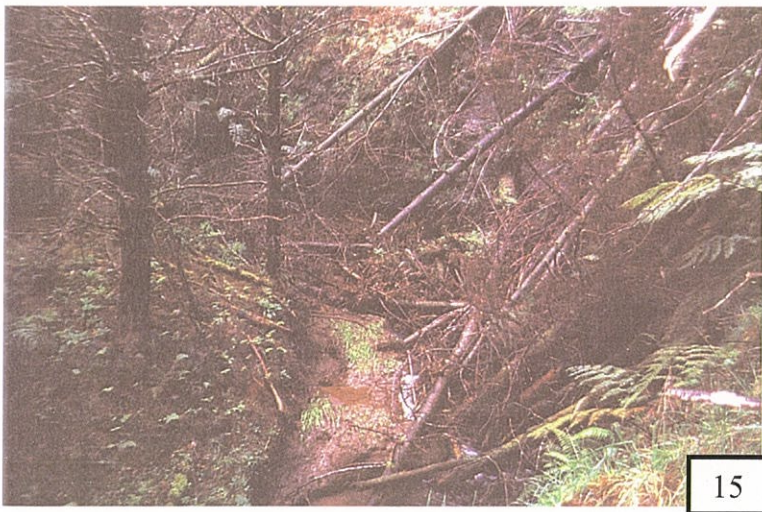
15

Takitu 5 - The steep faces and shallow soil have contributed to a high loss of trees that have slid downhill. The planting setback needed on sites like this is anybody's guess.

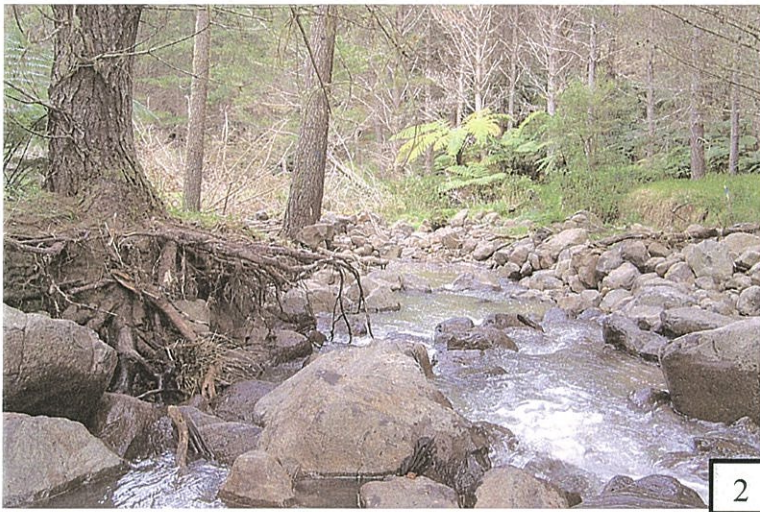
Water is diverted by blockages cutting new channels with more trees eventually toppling. About fifty are directly affected.

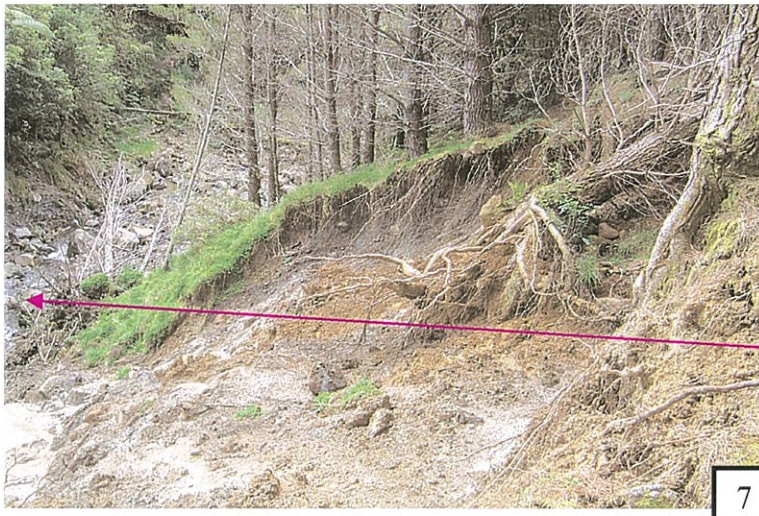
Some trees have moved as much as thirty and forty metres in slips with many tonnes of soil and debris being washed downstream.

Stream 10m to 12m wide

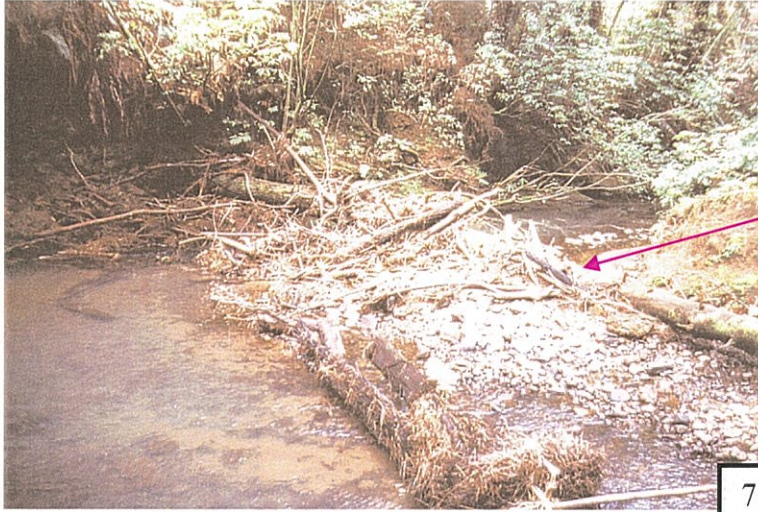
7

This tree has moved one hundred metres in the last six months.

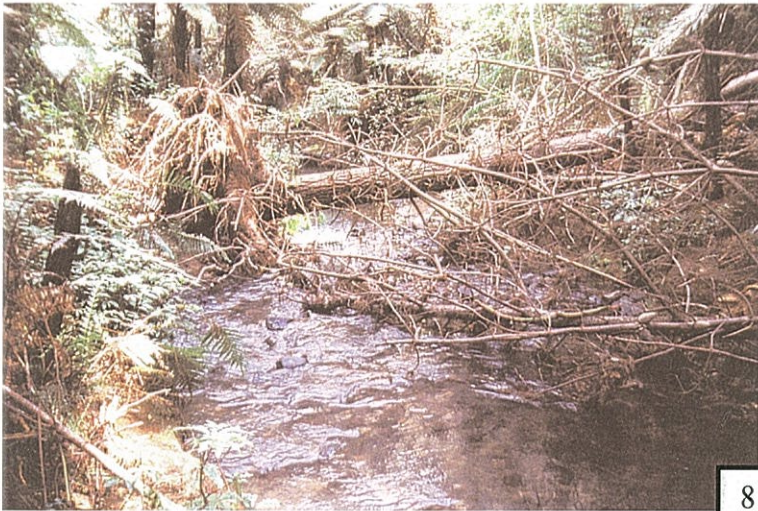
8

This area is easily accessed by machine above the waterfall from Dampier road. There is a dam to be cleared.

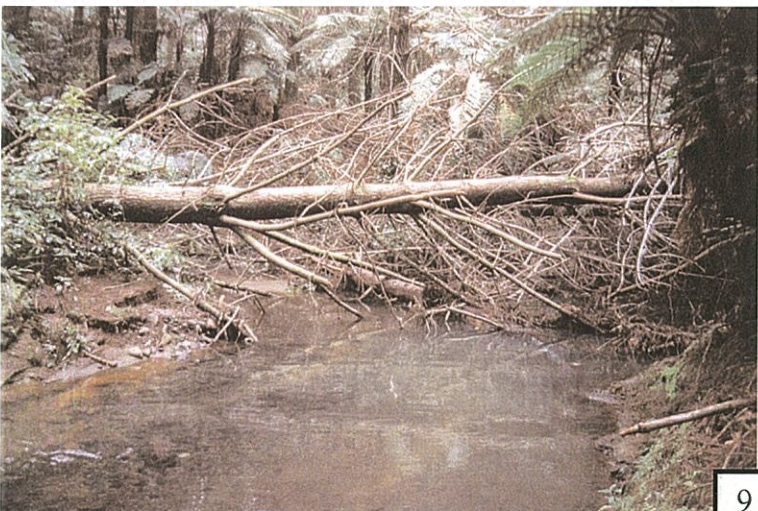
9

These build ups readily occur where streams are narrow. At flood time it would appear the water rises up to 3 metres deep in places.

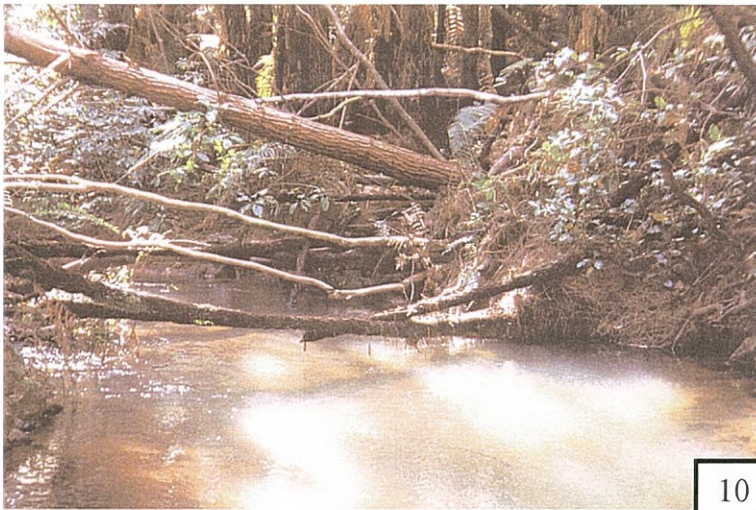
10

Halfway down between native forest and the junction with HaHa 1, water quality has gone from clear to murky.

When one encounters native vegetation among debris this often is the reason. The ground finally gave way under the weight of the pine tree.

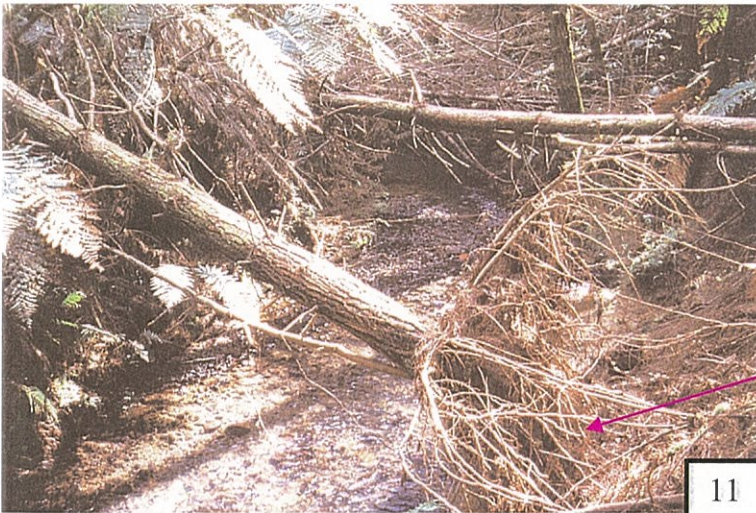
11

Further up stream.

Note that soil has been completely washed off the tree roots.

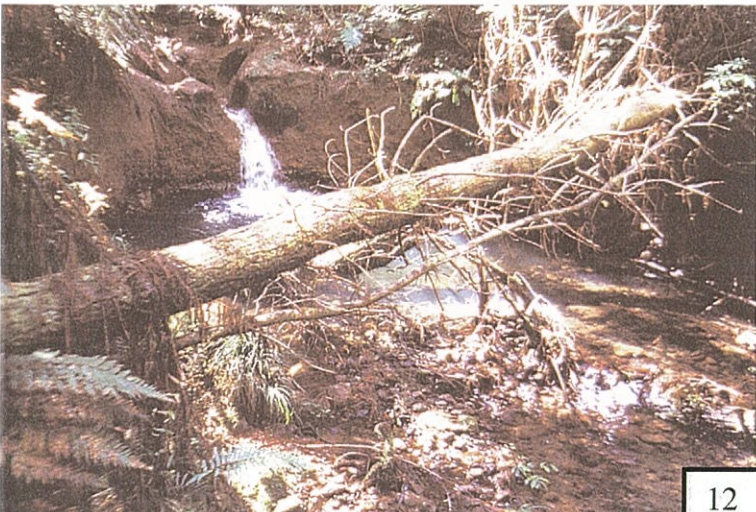
12

Just below the boundary with native bush erosion quickly commences. This is the result of water diversion in soft soil.

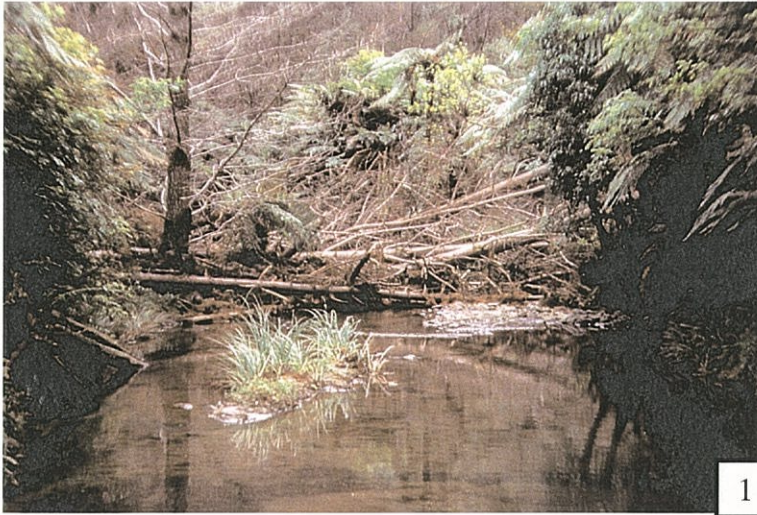
This blockage is not far from Wells road.
Machines can travel as far as:

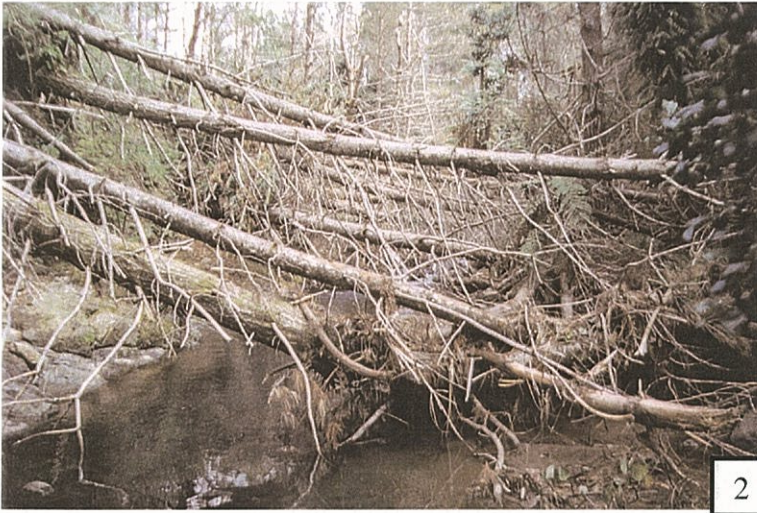
At least twelve toppled here.

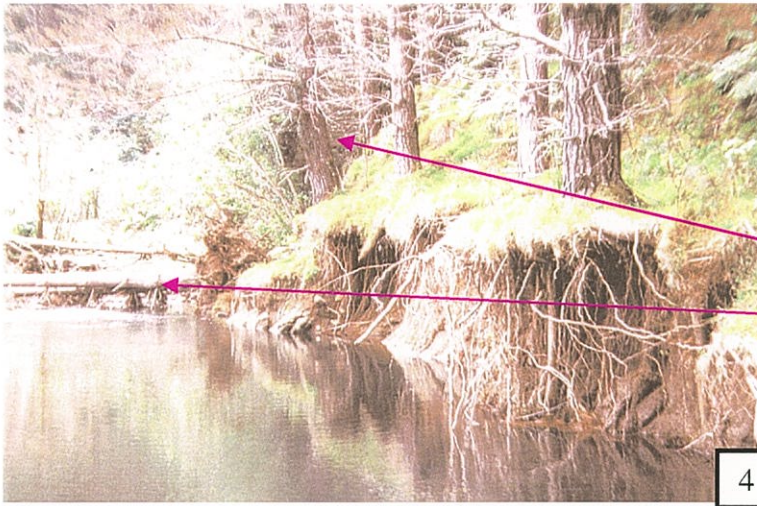
4

Silently waiting to enter the water – a familiar sight.

Starting to lean over

Already in the water

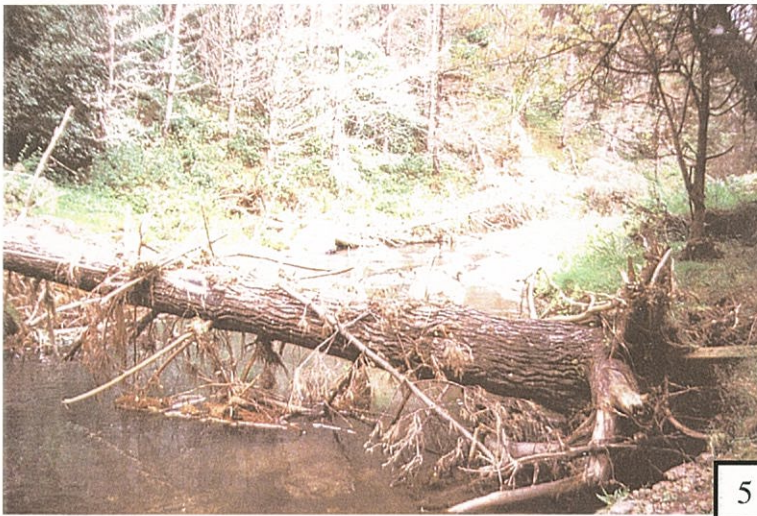
5

This log has already moved from where it fell.
Water rises to over two and a half metres.

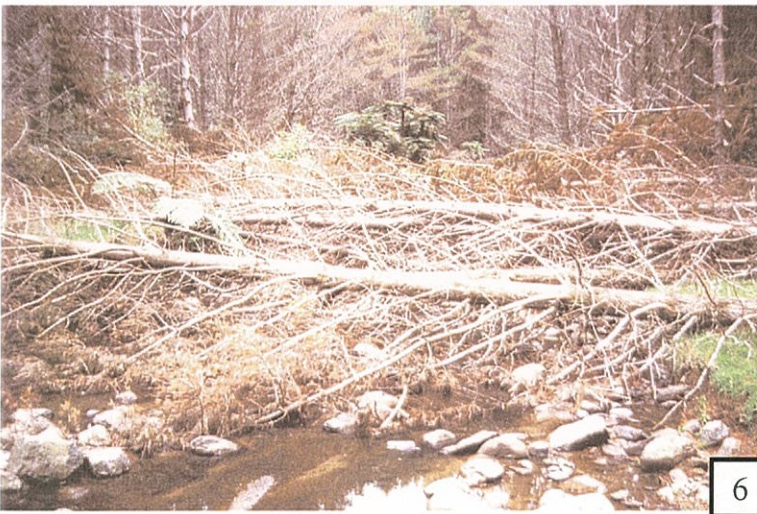
6

This blockage is about sixty metres long.
Access can be gained from Sierra road.
Much of this stream could be cleared.

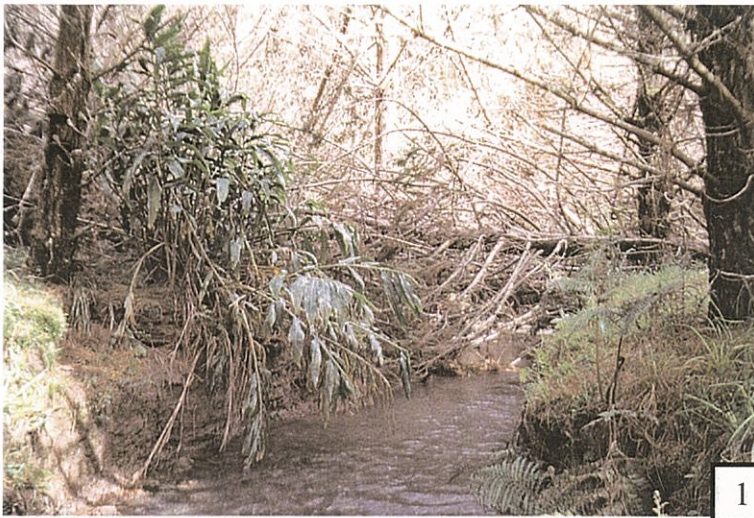
This stream is also subjected to excessive toppling and erosion. The plant to the left of photo is wild ginger.

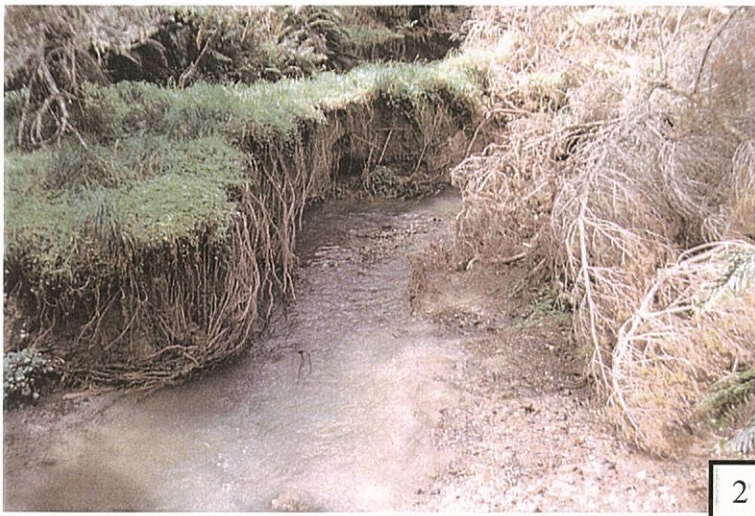
This blockage shows the typical pattern of erosion that follows. Deflected water eats into the opposing bank. Silt is a problem.

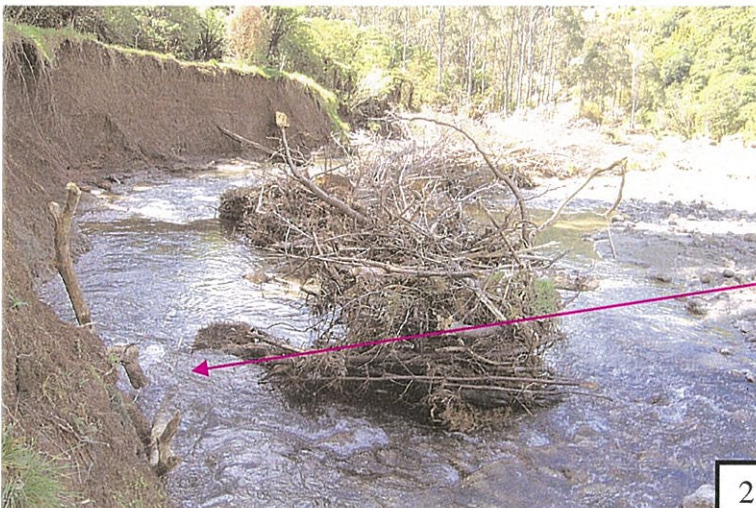
Up from Well's Flat continuous erosion is taking place depositing thousands of tonnes of soil in the water.

This debris has deflected water which has eaten a channell into the bank on its left.

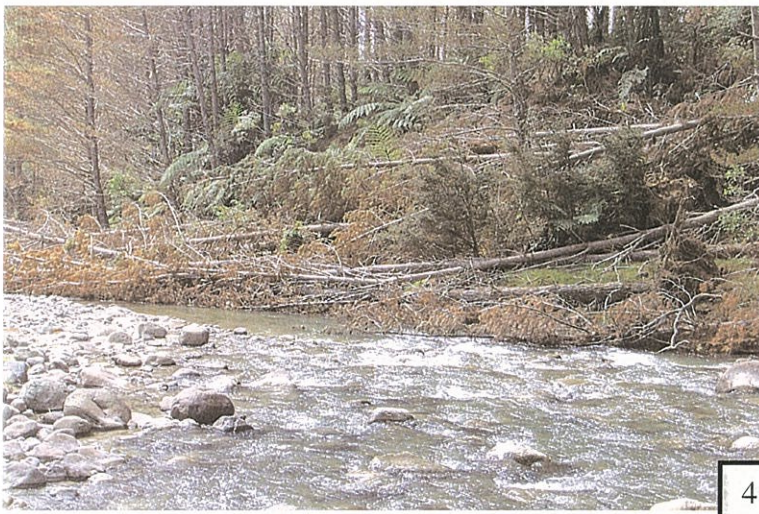
4

Access is gained from Cascade road

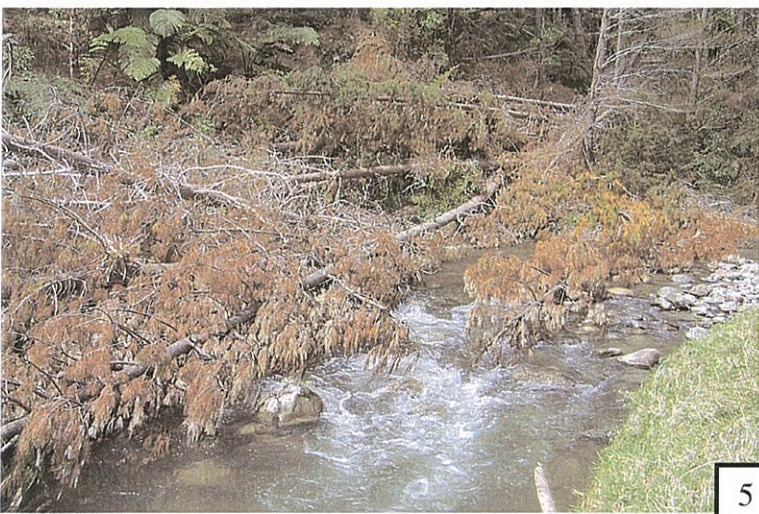
5

This has to be cleared.
Trees are forming a queue to join those downstream.

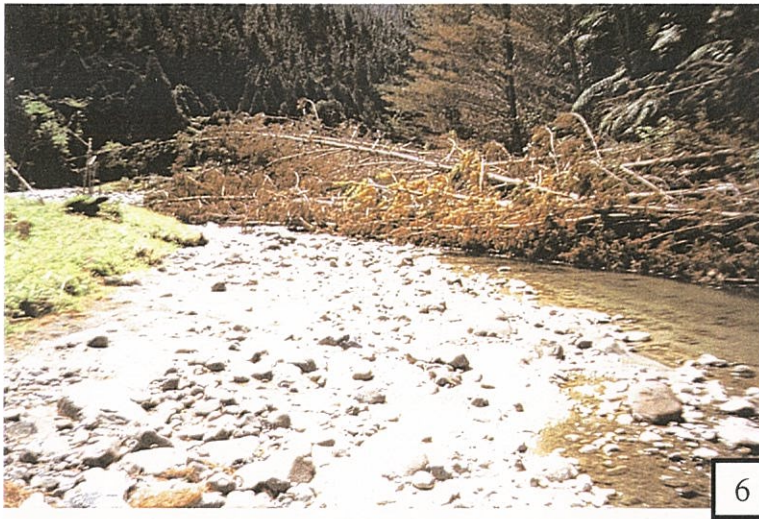
6

These are completely across the waterway.
Heavy silting is noticeable.

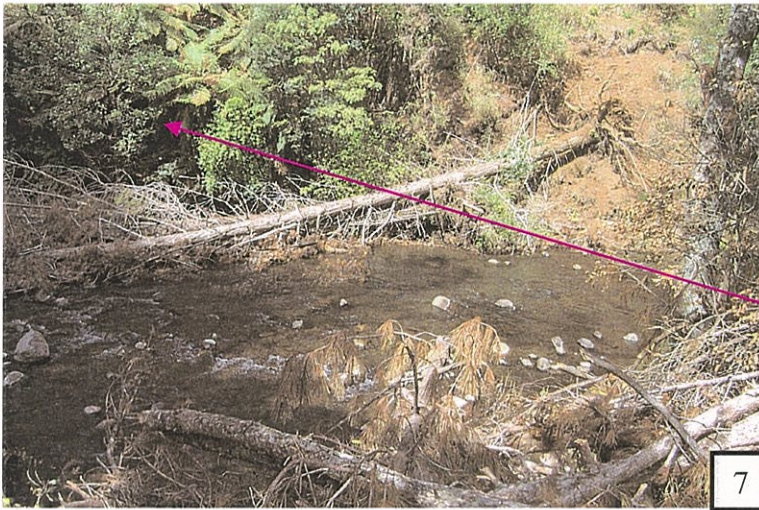
7

Here trees fall and snap their heads off on the opposite bank.

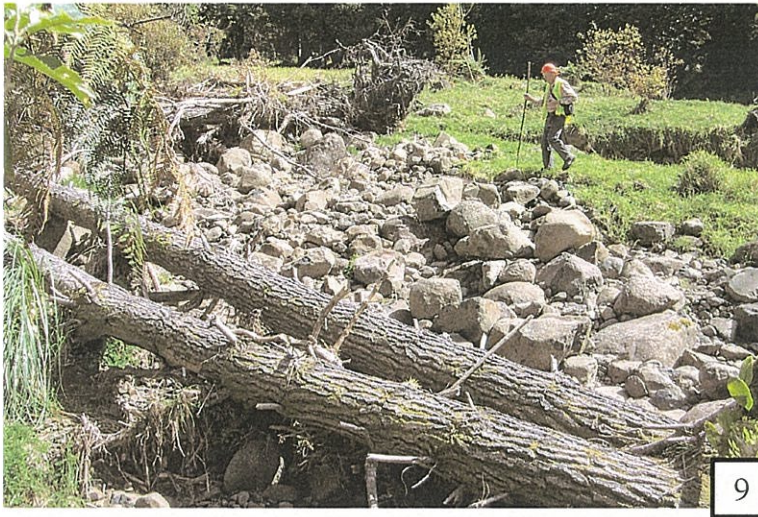
This island is a resting place for trees that are washed downstream.

They have enormous power when transported in swift flowing water.

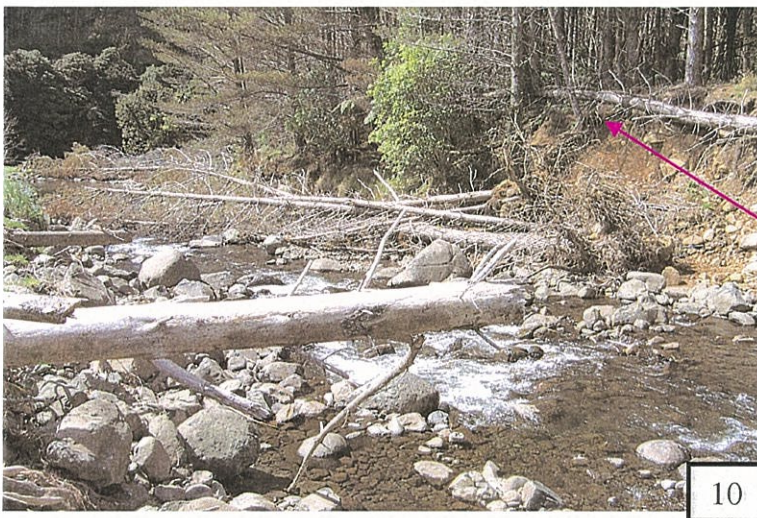
The log in the foreground has been down for several years.

Note pines planted too close to the river's edge.

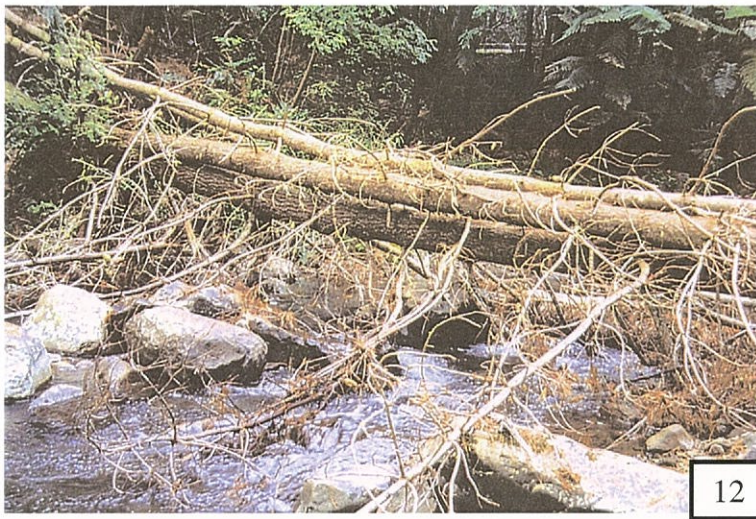
12

Upstream from Gibraltar road blockages continue

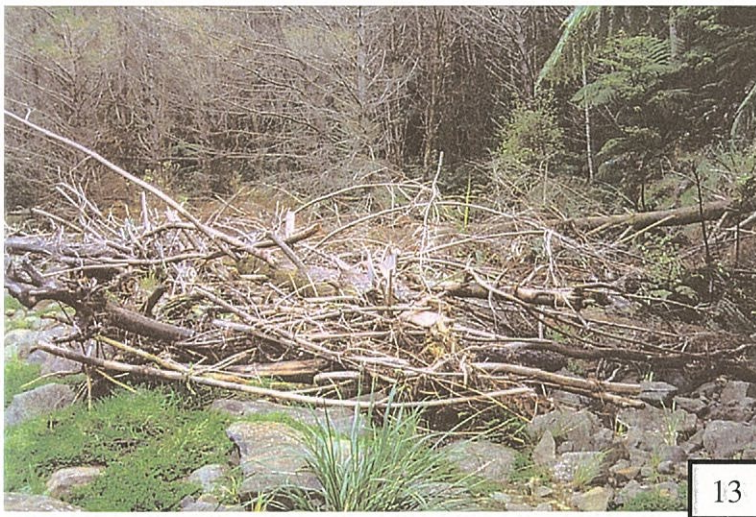
13

An older blockage that can be readily accessed.

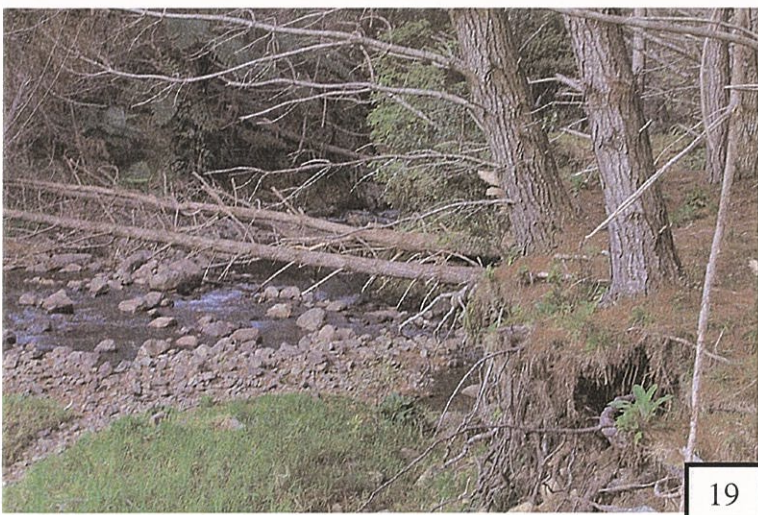
Ahomarama stream, also a tributary of the Opouteke. There is potential for ten trees to topple and dam the narrowed stream here.

Just upstream there is a pileup lying in the waterway that should be removed.

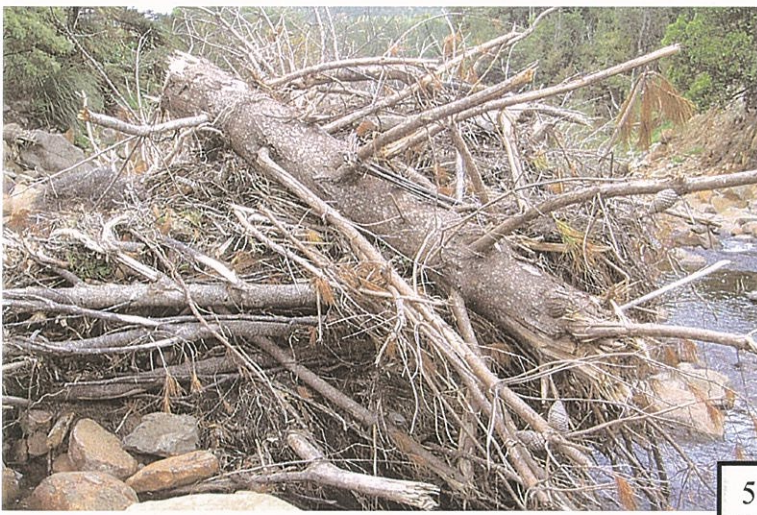
An illustration of how destructive water can be.

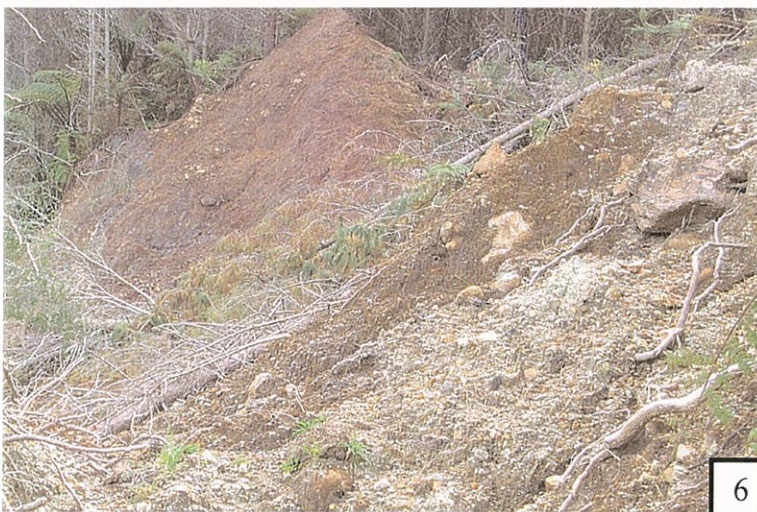
The soft wet nature of steep land such as here is conducive to toppling of tall trees. Erosion continues unabated and contributes to the reputed three hundred million tonnes of soil washed into the ocean each year from New Zealand.

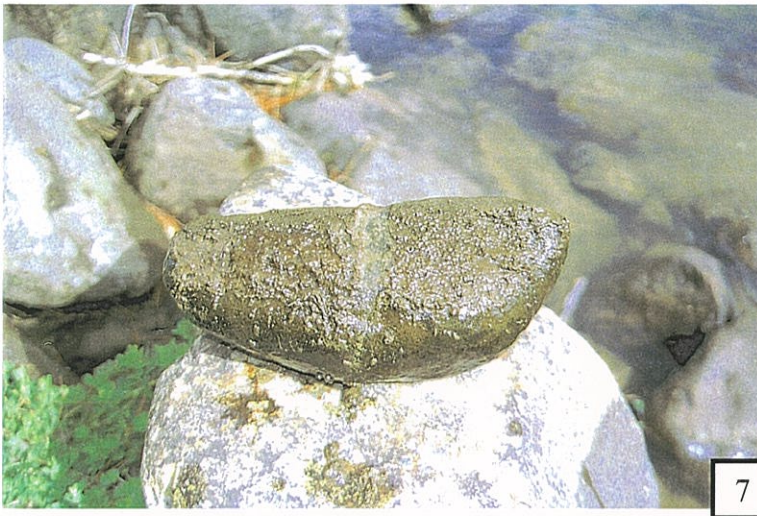
About one kilometre down a buildup of sediment becomes obvious.

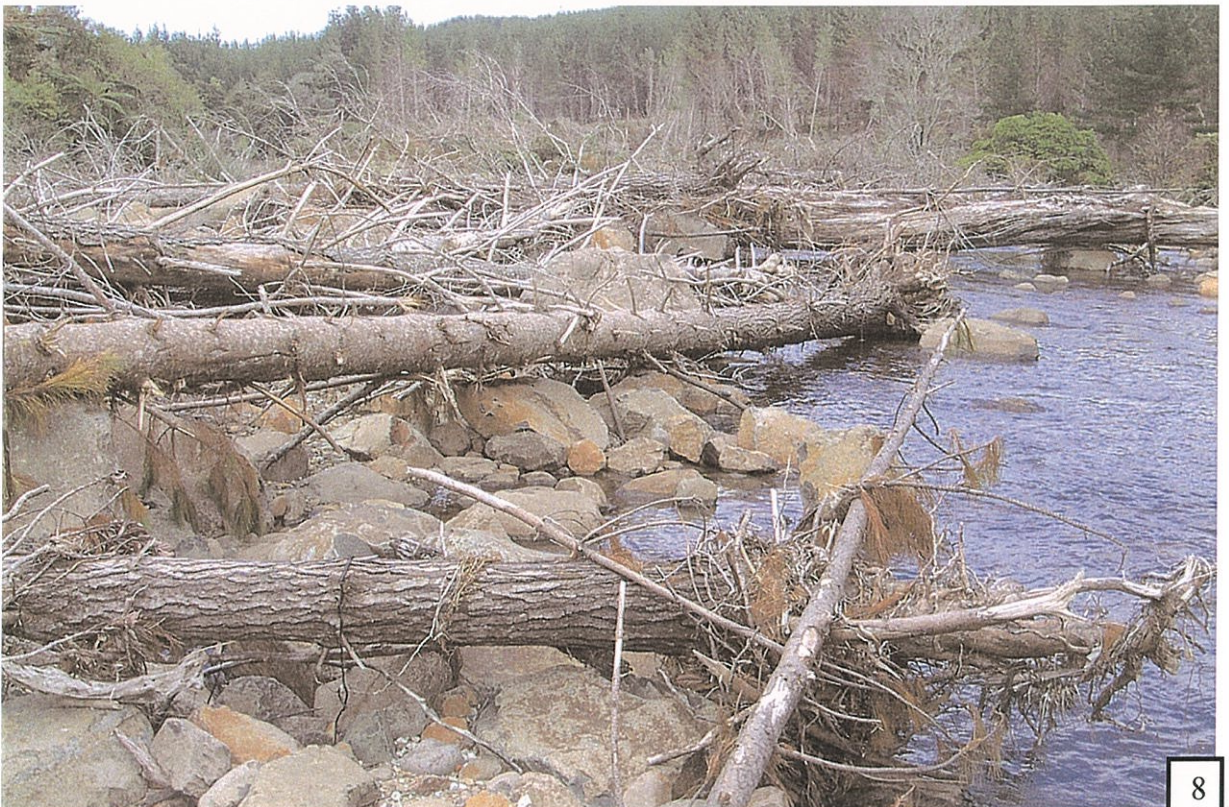
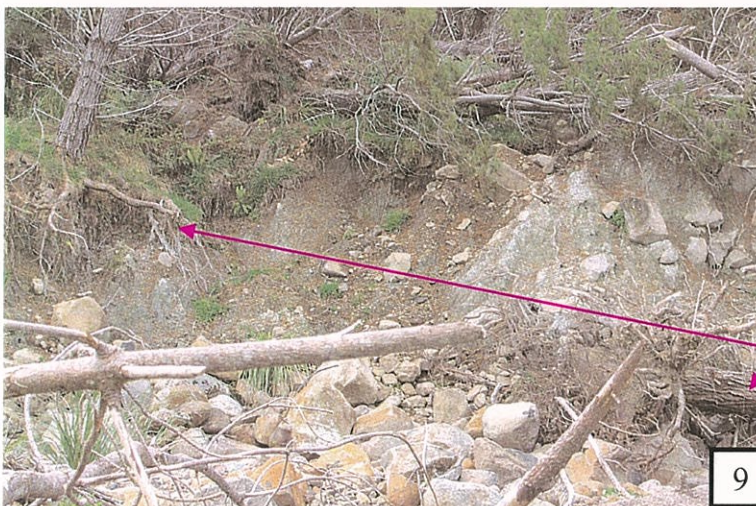
Problems are highlighted here in photo 8 above. To leave toppled trees in waterways is like playing Russian roulette.

Large setbacks when planting will prevent more of this.

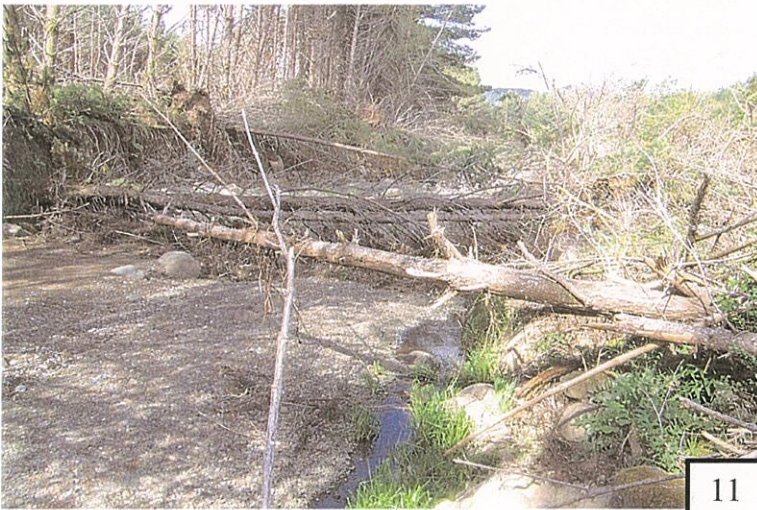
Erosion is prevalent where the toppling occurs on stream banks.

Photo 11 shows what was a continually flowing part of the main river until a recent diversion took place.
