**Assessments of streams and riparian plantings
within Carter Holt Harvey Forests
at
Mangakahia and neighbouring sites**

**- Bruce Alexander
October 2002**

An assessment of streams and riparian plantings within Carter Holt Harvey's Forest at Mangakahia and neighbouring sites.

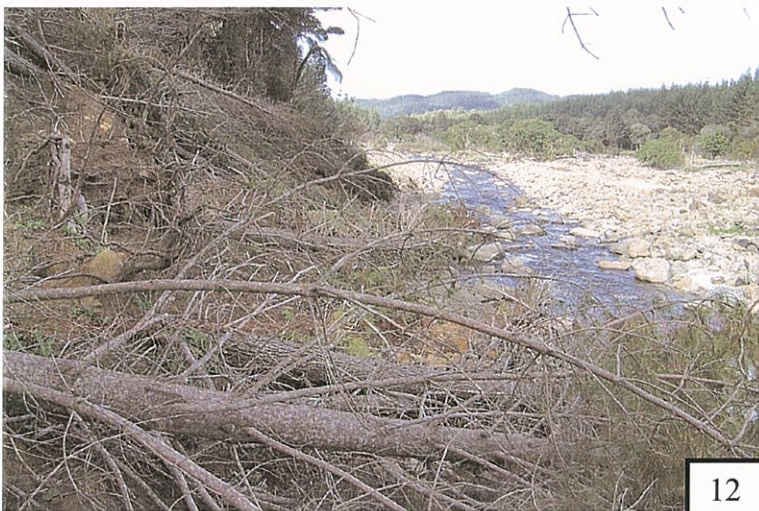
12

Once again, more toppling. As can be seen the river bed is very wide and is easily traversed.

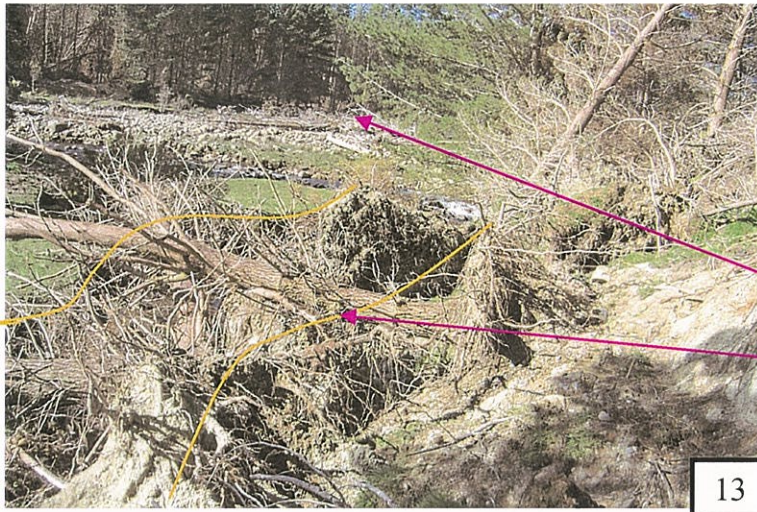
13

A collapse here smothers the outlet of a perennial stream where it joins the Mangakahia river.

Debris on main riverbed

Streambed is under here

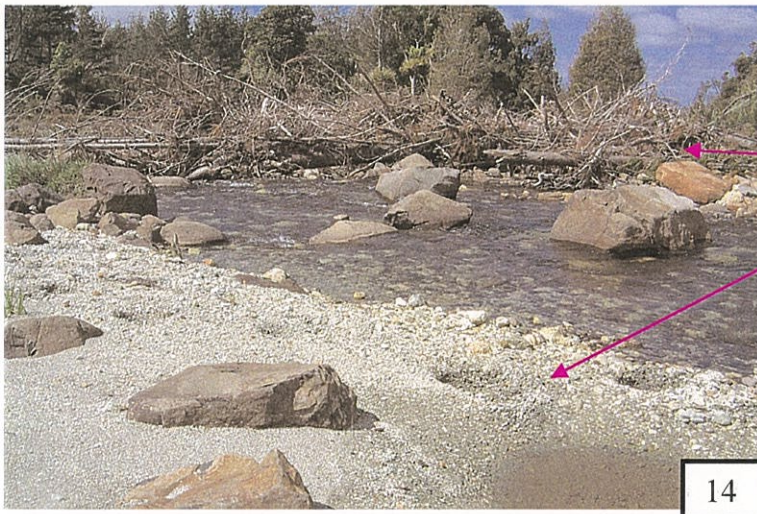
A mixture of old and new

There is a lot of soil mixed with this.
