December 2016 Quick Draw Express Lift (SC-008) Incident

Report of Investigation

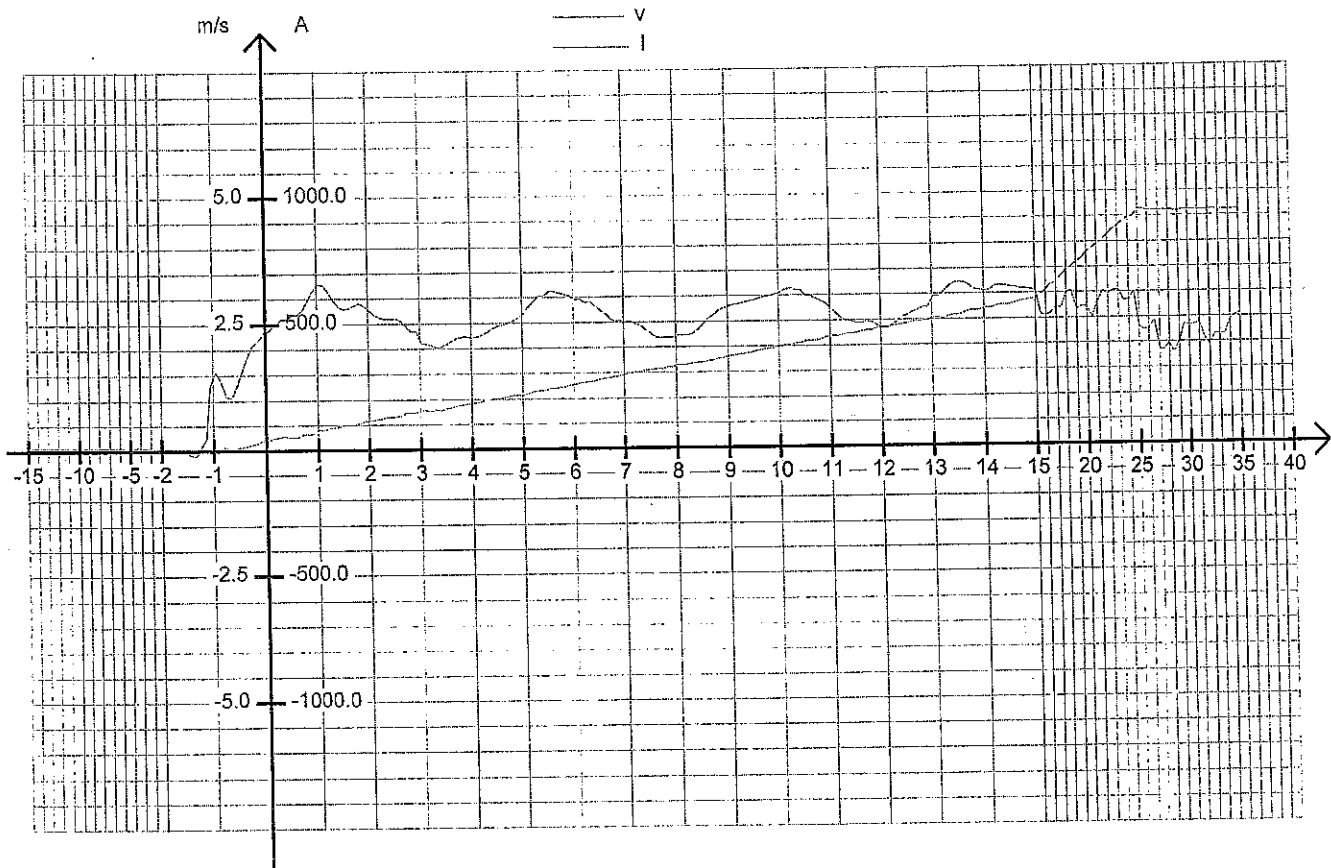
Record Nr.: 37, Registered on RUN at 09:27:52

Dynamic Values for Motor and Brake

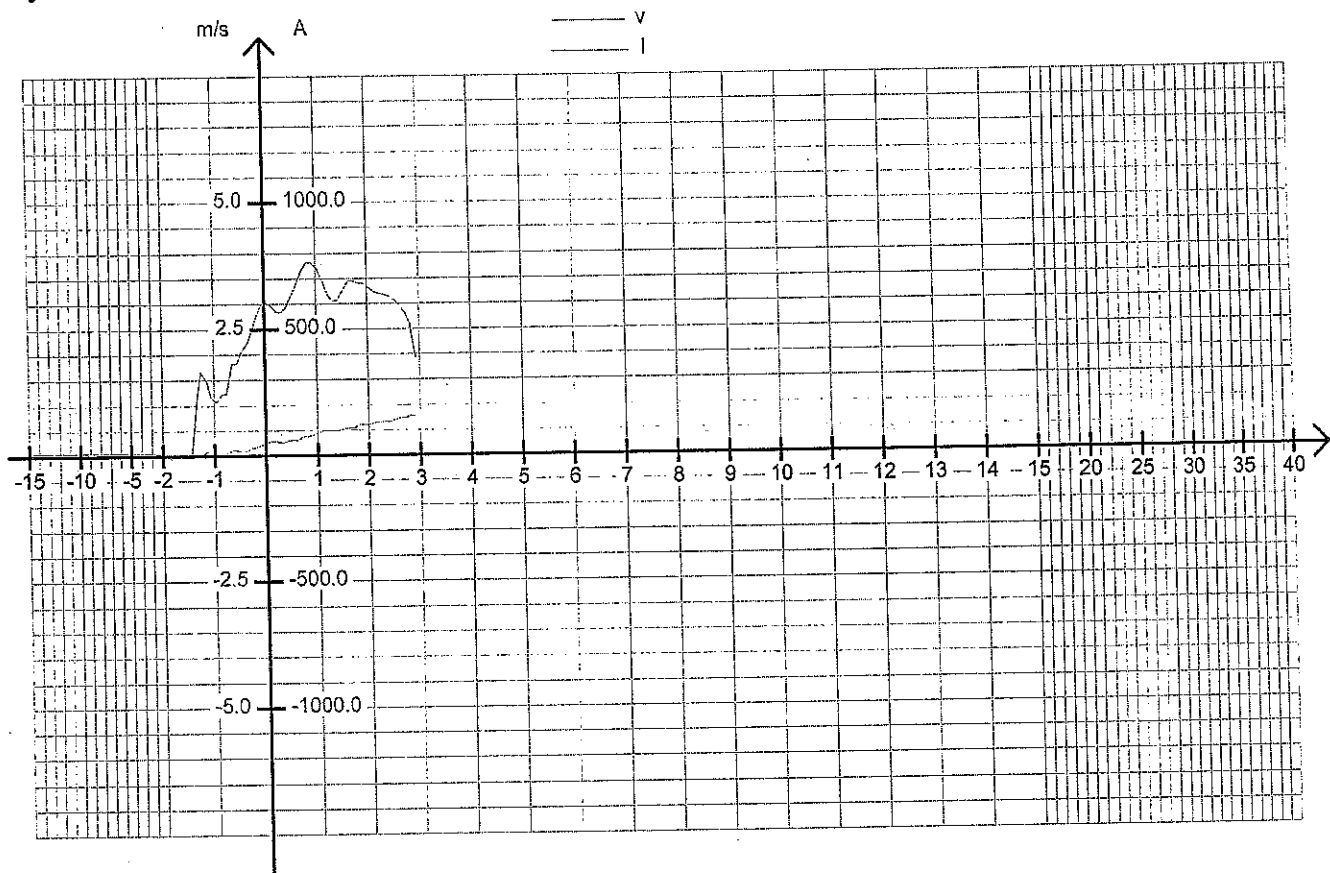
09:39:36,29 : RA 93.07 *ANTICOL S9

Dynamic Values for Motor and Brake

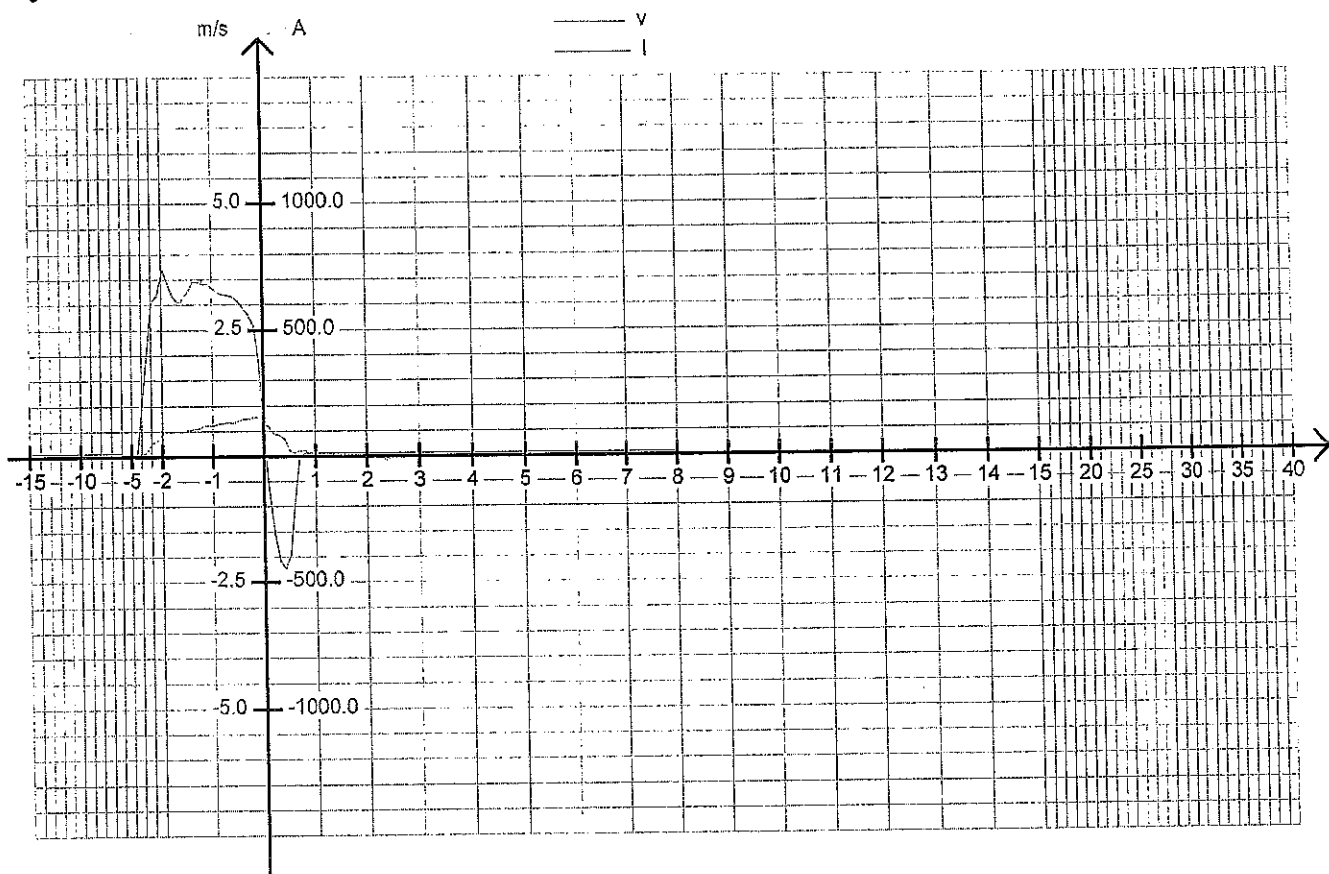
Record Nr.: 40, Registered on STOP at 09:39:36

before 09:39:21,40 : DA 91.29 *Stop ch. 1 from return
before 09:39:21,40 : DA 91.30 *Stop ch. 2 from return
09:39:36,40 : DA 91.29 *Stop ch. 1 from return
09:39:36,40 : DA 91.30 *Stop ch. 2 from return
09:39:36,40 : RA 93.07 *ANTICOL S9

Dynamic Values for Motor and Brake

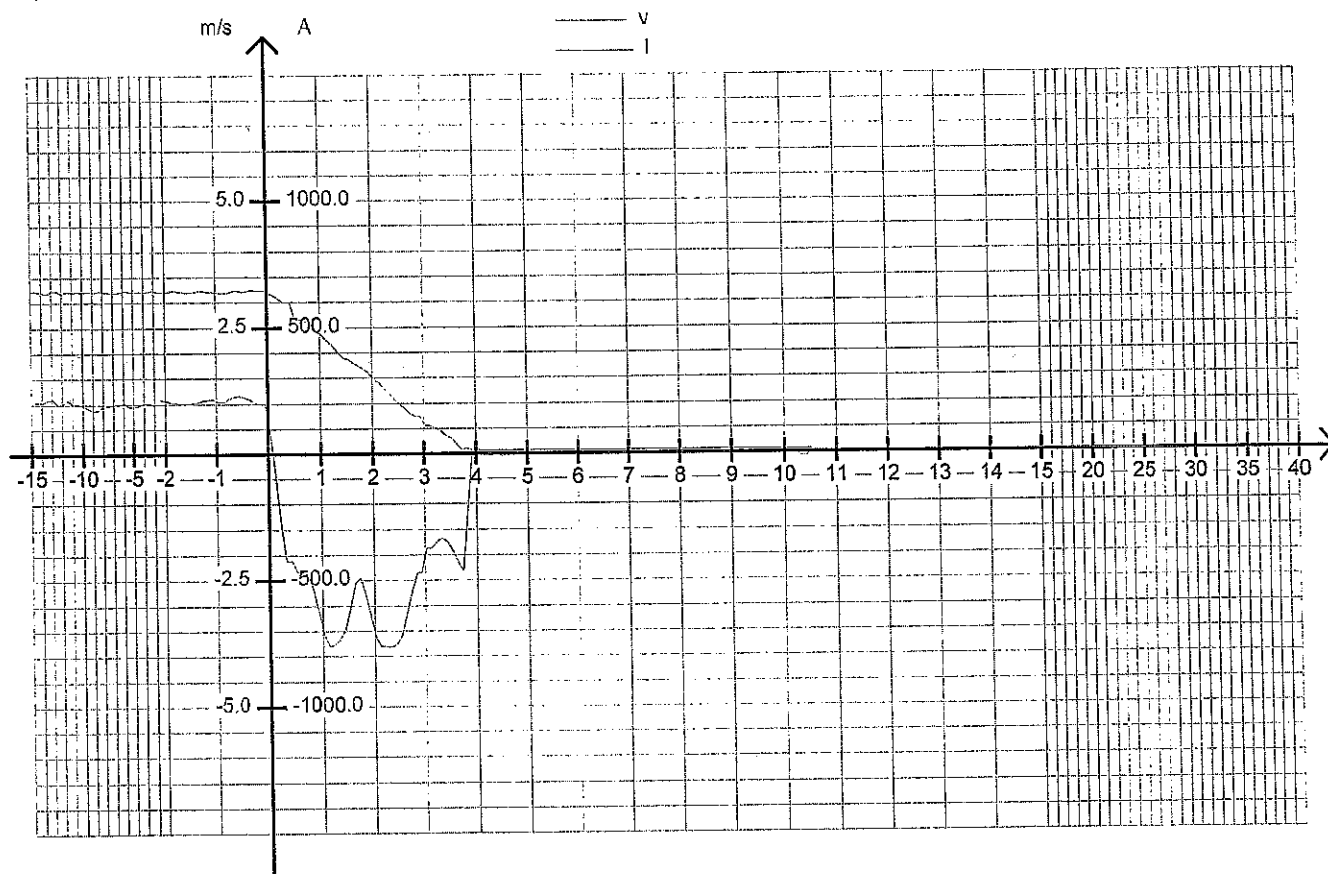
Record Nr.: 43, Registered on STOP at 10:23:20

10:23:20,90 : DA 90.20 **N-Stop Return
10:23:20,90 : DA 91.29 *Stop ch. 1 from return
10:23:20,90 : DA 91.30 *Stop ch. 2 from return
10:23:20,90 : RA 90.22 **N-Stop loading area
10:23:21,90 : DA 90.19 *N-Stop relay

Dynamic Values for Motor and Brake

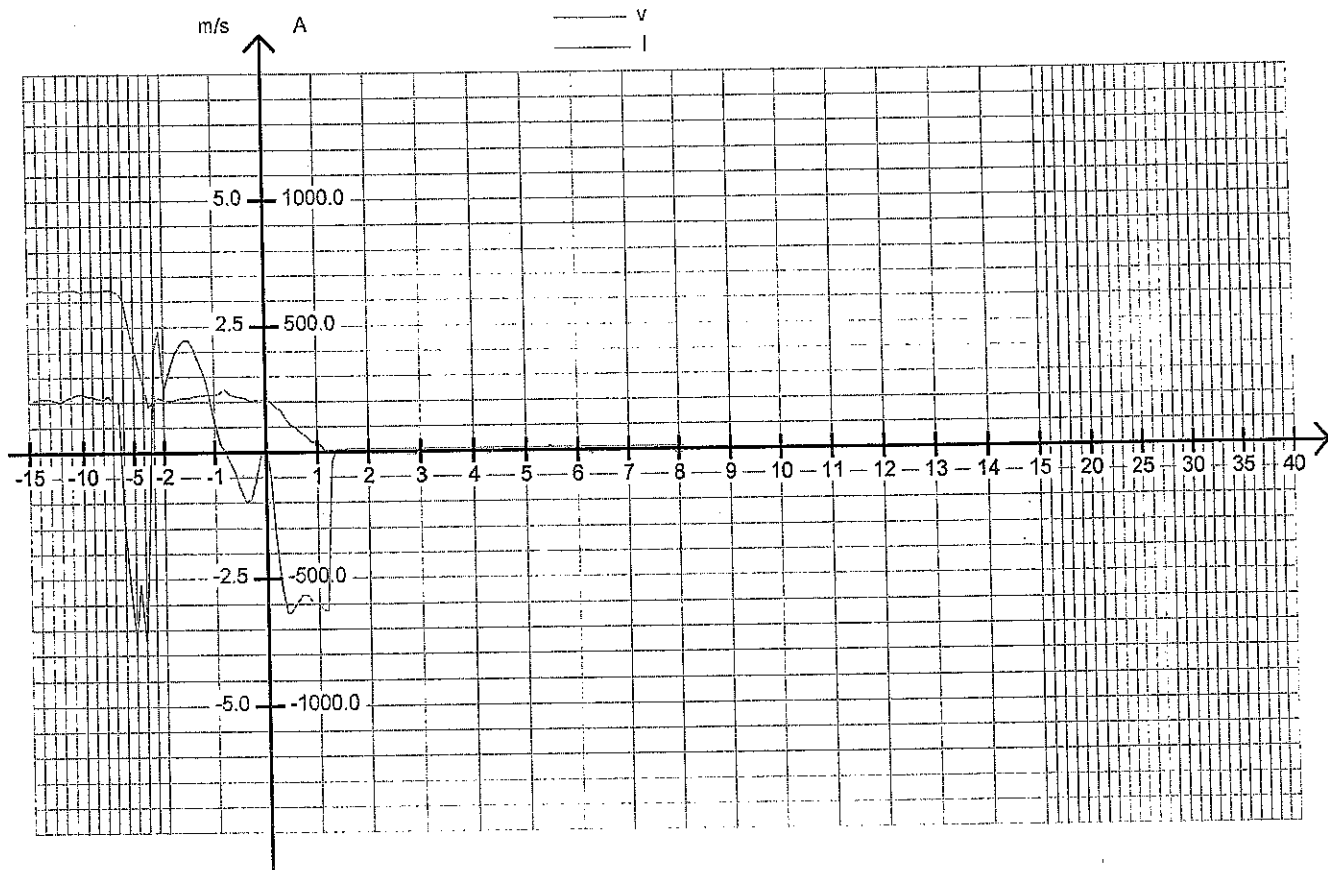
Record Nr.: 45, Registered on STOP at 10:35:22

10:35:22,59 : DA 90.23 **N-Stop downloading area

Dynamic Values for Motor and Brake
