MEMORIAL FIELD TENNIS BUBBLE

Post Installation Report

December 16, 2016

Arcadis of New York, Inc.

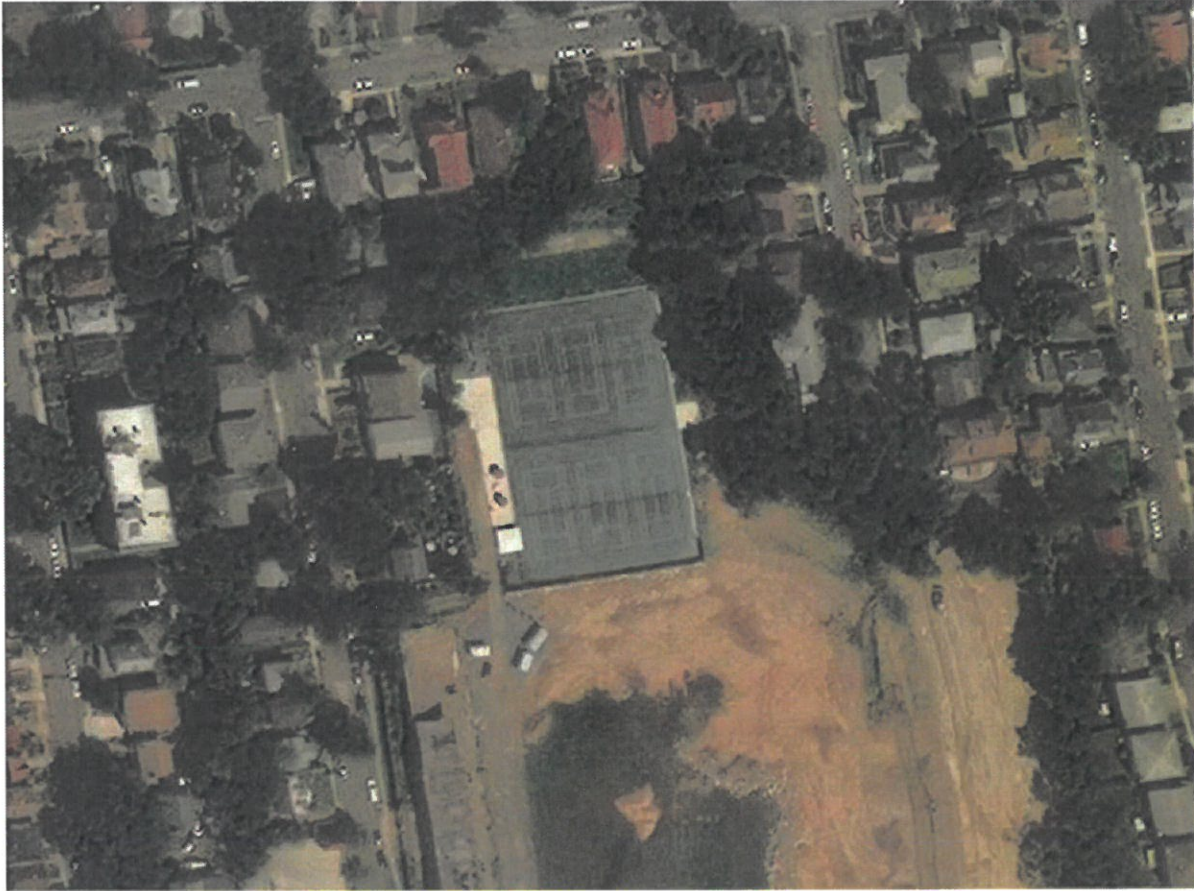
Figure 2. Zoomed in Aerial Site Photo

(tennis courts constructed and operating, partial first floor slab)

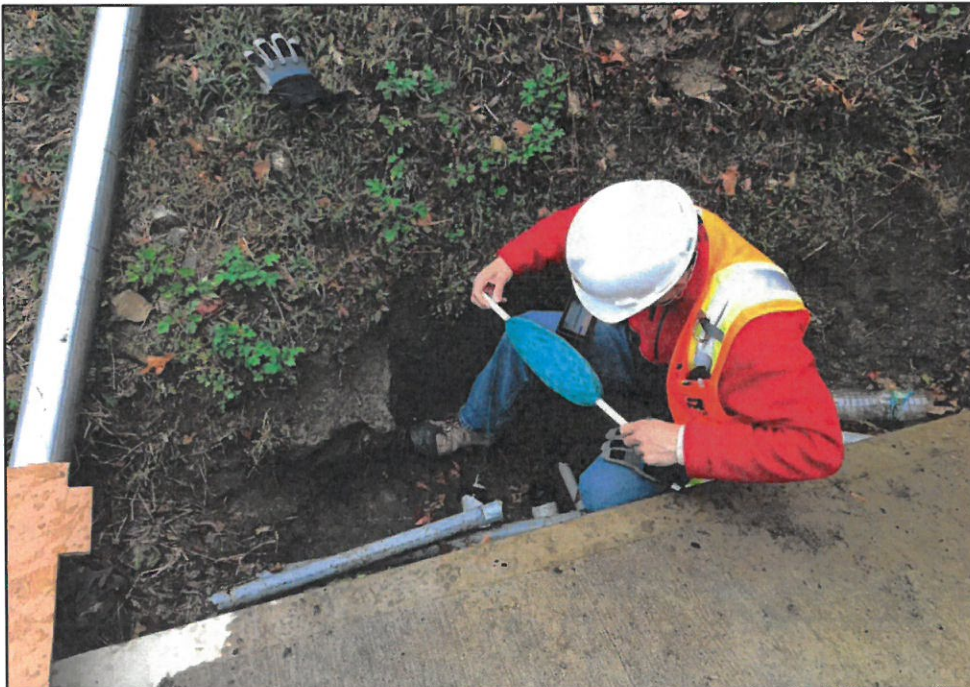
Photo: 20

Description:
Undocumented electrical
conduit. Field testing proved
them connected to building's
west side

Location:
Mechanical equipment pad,
north side
