INDEPENDENT FORENSIC TEAM REPORT OROVILLE DAM SPILLWAY INCIDENT

JANUARY 5, 2018

SUMMARY

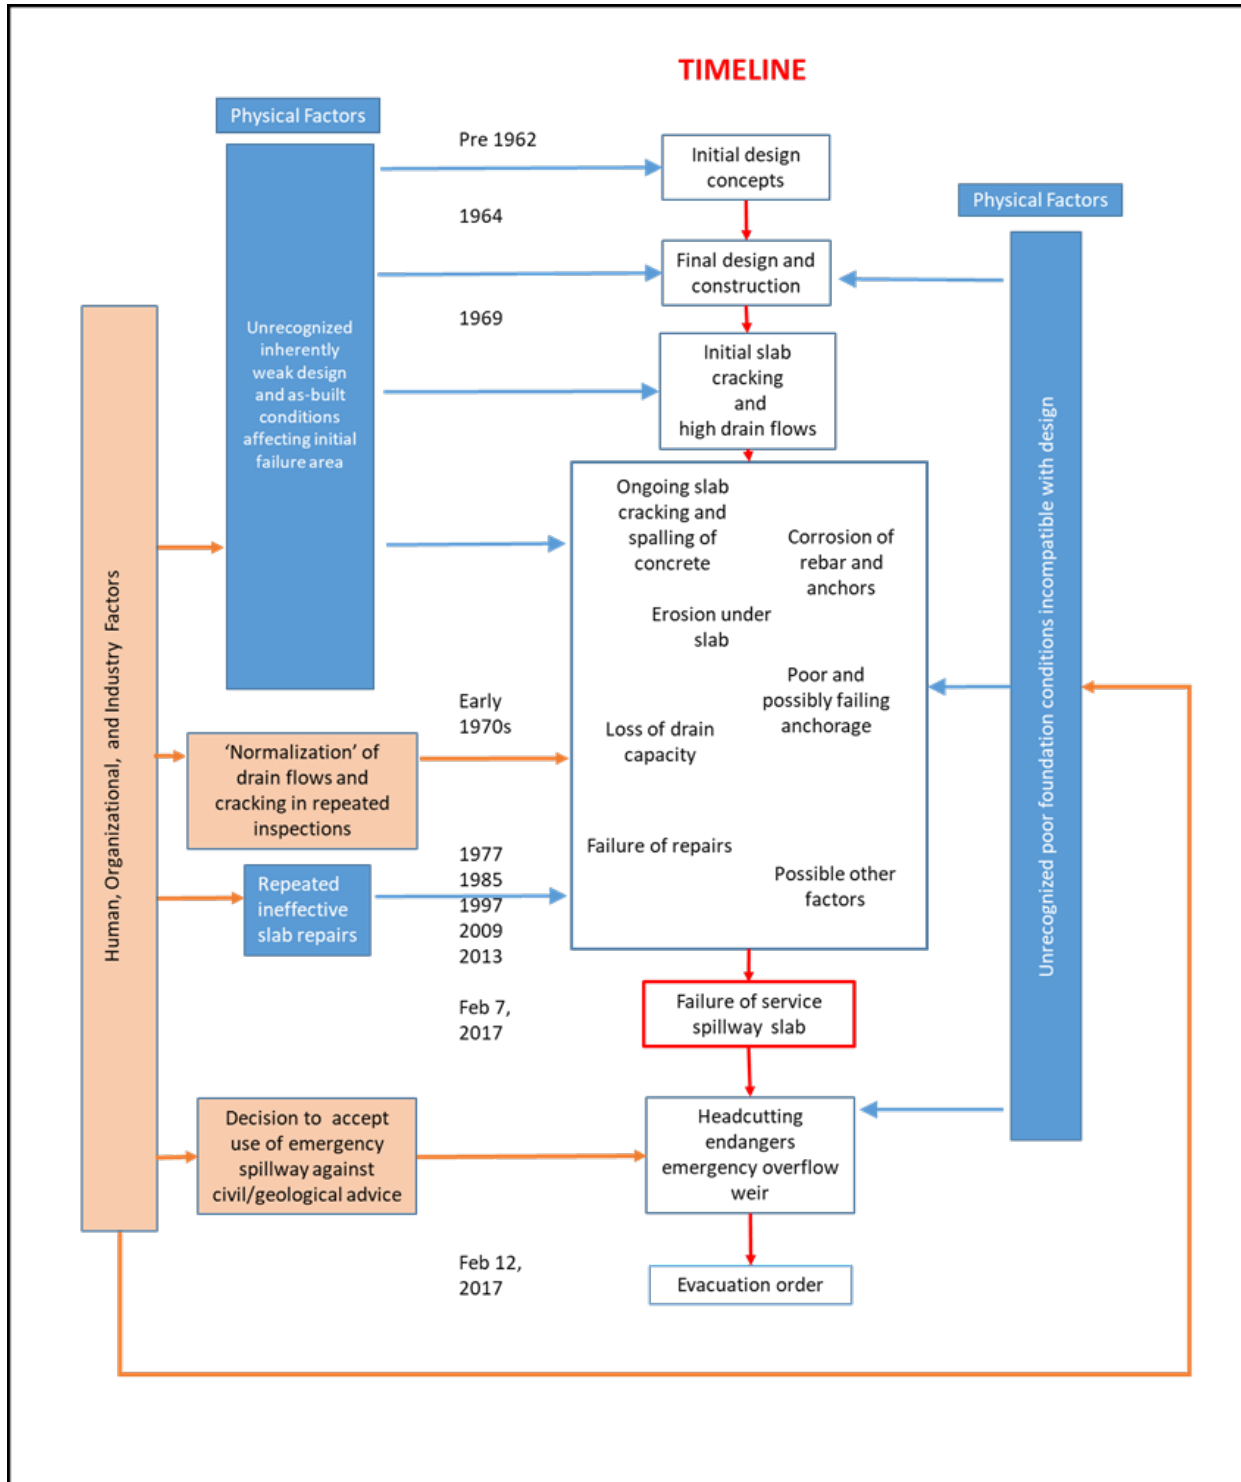
Figure S-1: Overview of interacting factors leading to the Oroville Dam spillway incident

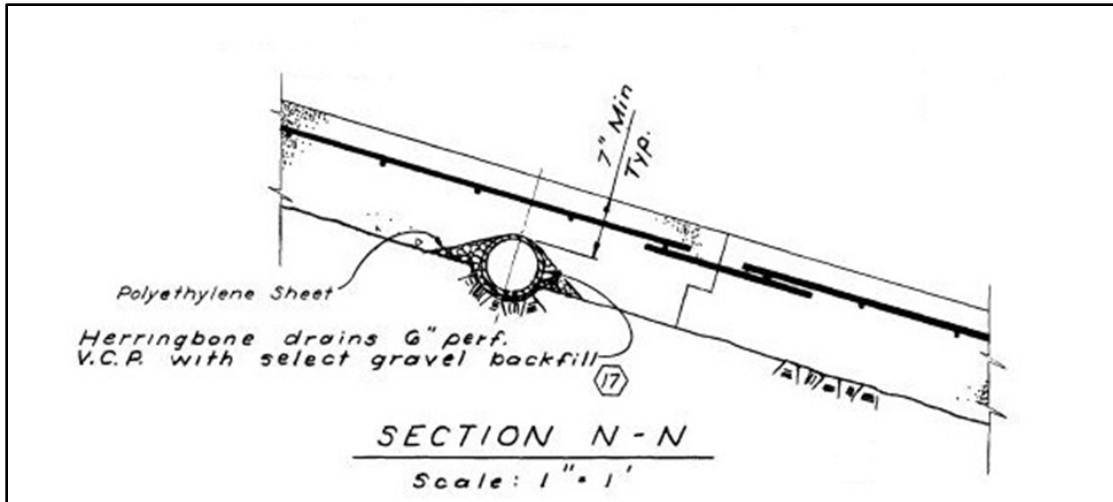
Figure 3-5: Herringbone drain VCP pipe protruding into slab section [5]

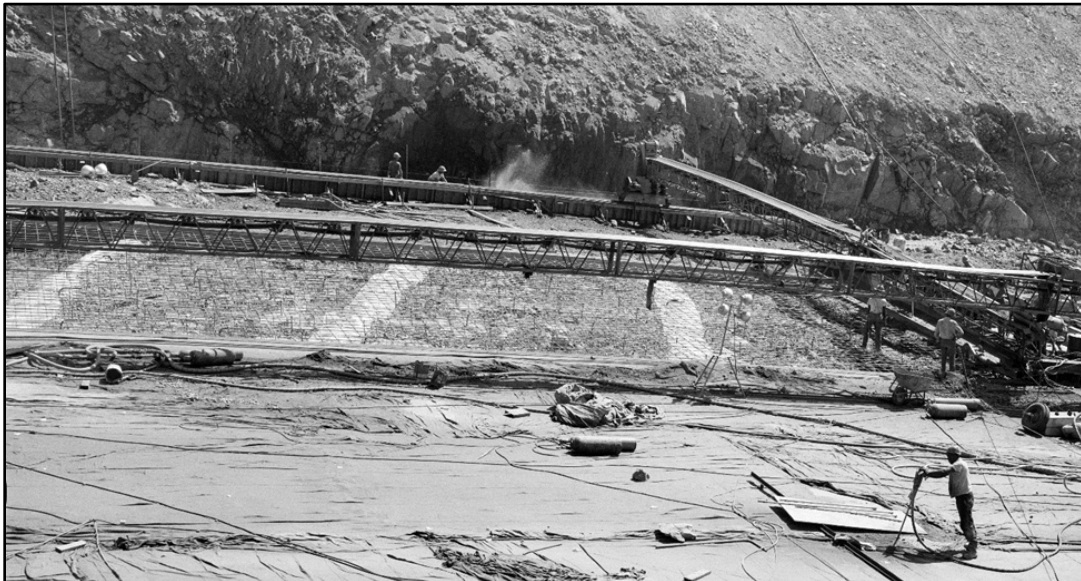
To connect the drains to the foundation when overexcavation occurred or was required, formed vertical gravel drains and gravel filled sonotubes were used, as discussed in Appendix A. To prevent contamination of the gravel during concrete placement for the chute slab sections, the drains were covered with plastic (polyethylene) sheets, as shown in Figures 3-5 and 3-6. Although some locations without plastic sheeting were found in the post-incident forensic investigations, the IFT believes that the sheeting was used at most locations.

Figure 3-6: Plastic sheets covering herringbone drains before concrete slab placement – Photo dated 09/30/66 (Photo OD_13202_09_30_1966) [8]

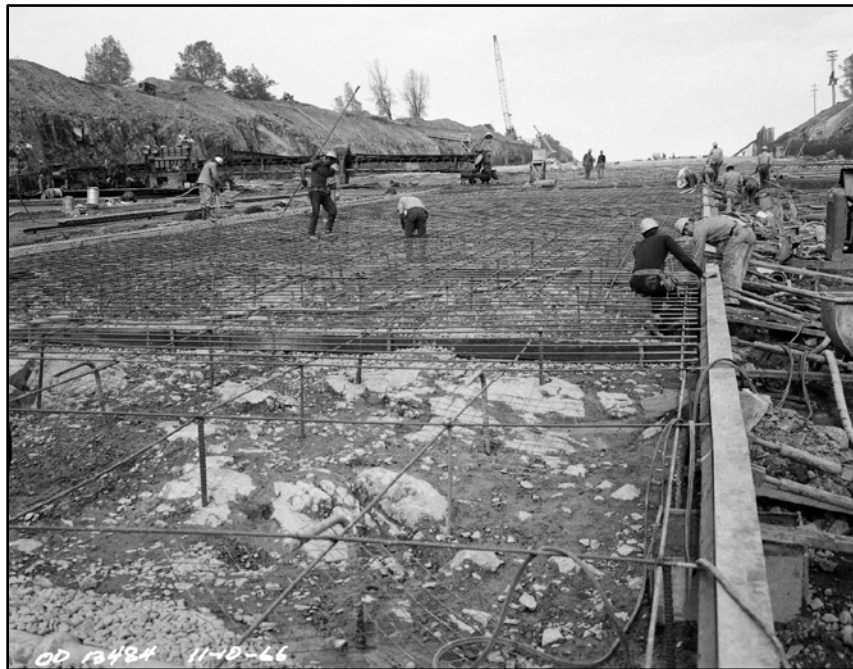
Based on the design drawings and specifications, as well as an interview, the design intent was for the chute slab to be founded directly on moderately weathered rock or better, which was to be pressure-washed to remove all mud, debris, and loose or unsound rock fragments. These specified foundation requirements would have resulted in a concrete slab that was well bonded to the foundation beneath, with anchors embedded into relatively competent material. However, the foundation requirements were substantially relaxed during construction. In some places, the prepared foundation appeared to have high points of reasonably sound rock surrounded by areas of what appears to be rock weathered to soil-like material, as shown in see Figure 3-10. These soil-like materials are described in the construction documentation as “compacted clayey fines.” In other locations, the prepared foundation appears to have been almost entirely rock that has weathered to soil-like material, as shown in see Figure 3-11.

Figure 3-10: Example of the clean-up effort for the spillway chute prior to placement.

Note what appears to be “compacted clayey fines” between the rock outcrops.

(Photo OD_13484_11_10_1966) [8]

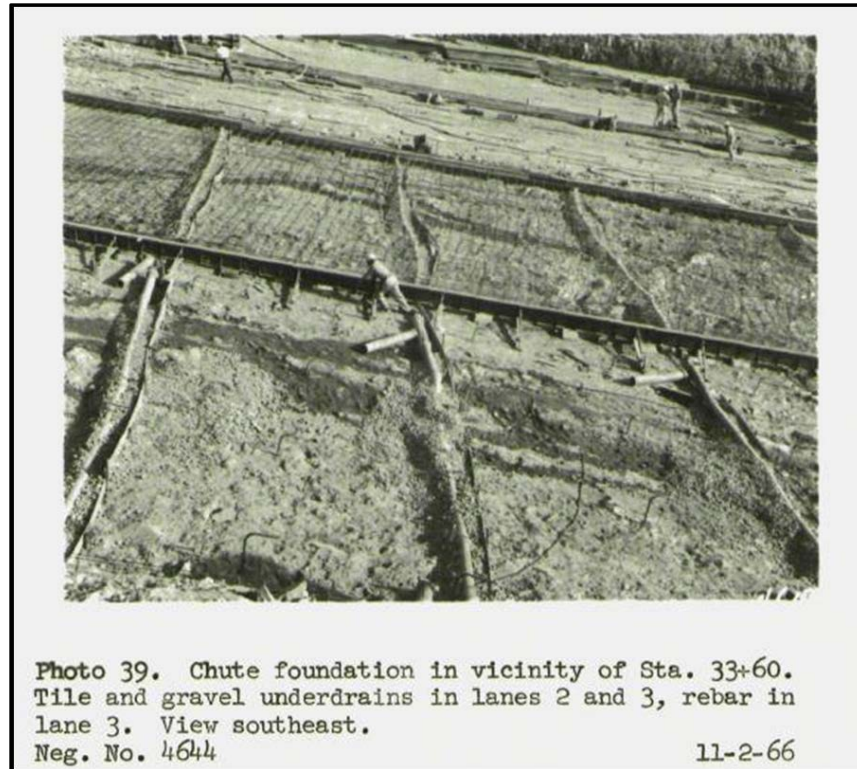
Figure 3-11: Lane 3 downstream from Sta. 33+00 being prepared for placement. [9]
Note what appears to be extensive areas of soil-like materials in the foundation.

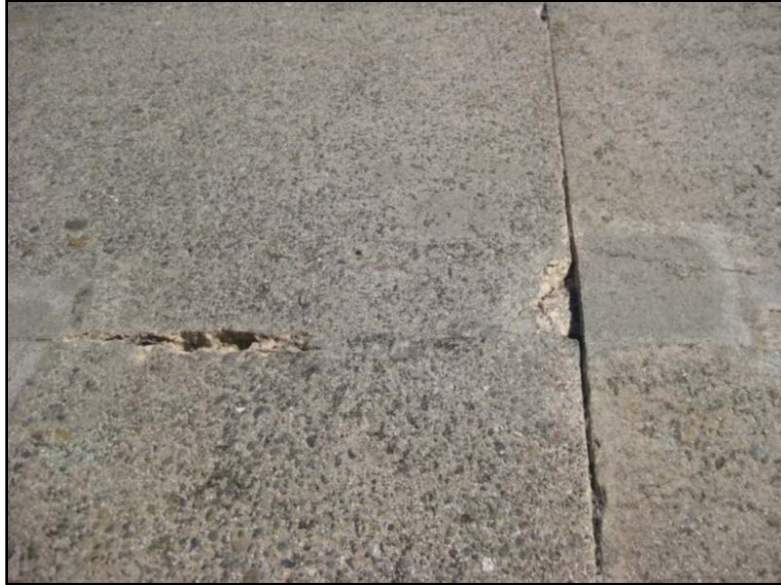
Spalling occurred almost entirely in delaminated concrete at joints and cracks and at patches from previous repairs, generally in the concrete above the level of the reinforcing steel and dowels (see Figures 3-14 and 3-15). Delamination led to spalling of the slabs near the joints and cracks. The spalling exposed reinforcing steel in the chute slabs and dowel bars at the joints to corrosion, leading to bar failure (see Figure 3-13) when subjected to tension during the winter contraction cycle. Depending on the magnitude and orientation of the spalls, vertical faces that create stagnation pressures⁷ could have been created.

Figure 3-13: Concrete spall before repair [11]

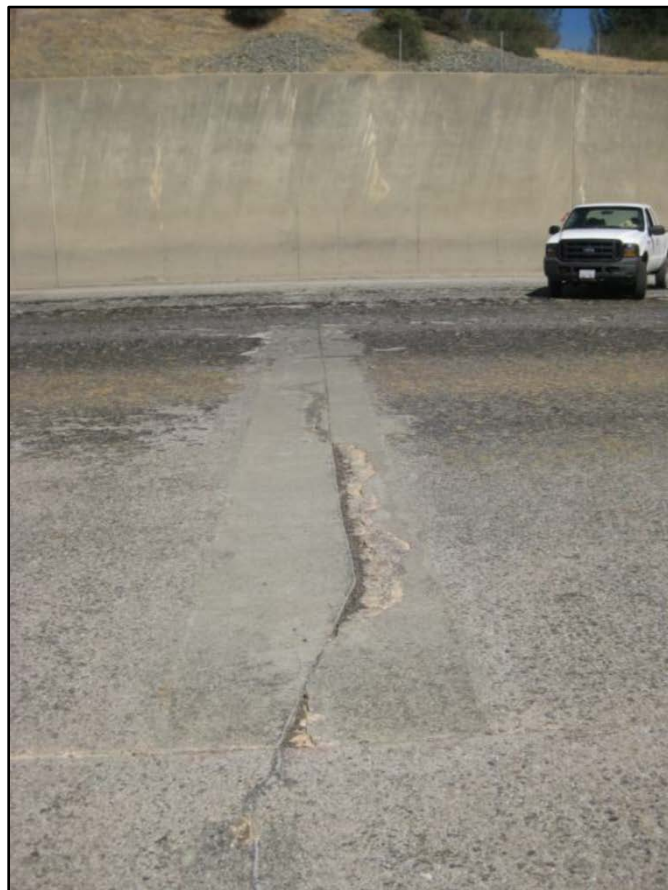
Based on reports of repair efforts and interviews with DWR personnel, the IFT understands that spalling both recurred in previously patched areas and occurred in areas that had not exhibited spalling before.

Figure 3-14: Spalling of previous patch [11]

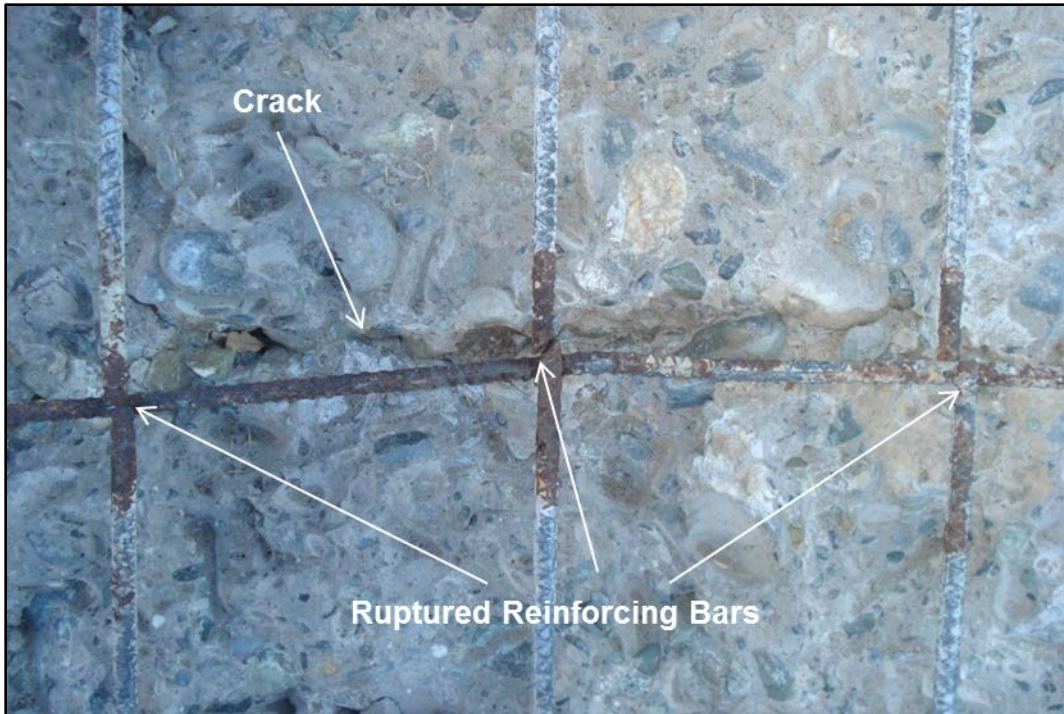
Figure 3-15: Corroded and ruptured steel reinforcing bars at a slab crack [11]

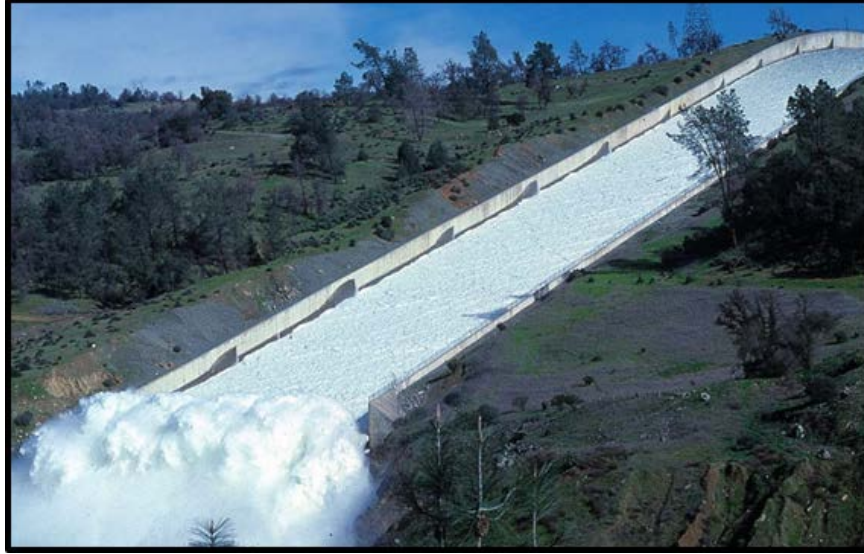
“The amount of drain water flowing from the pipe discharge openings along the spillway training walls seems extraordinarily large.” [12]

The IFT concurs. The amount of water that discharged from the drains when there was flow in service spillway is unprecedented in the IFT’s experience (see Figure 3-16).

Figure 3-16: Service spillway drain flows, February 3, 2006 (photo provided by DWR)

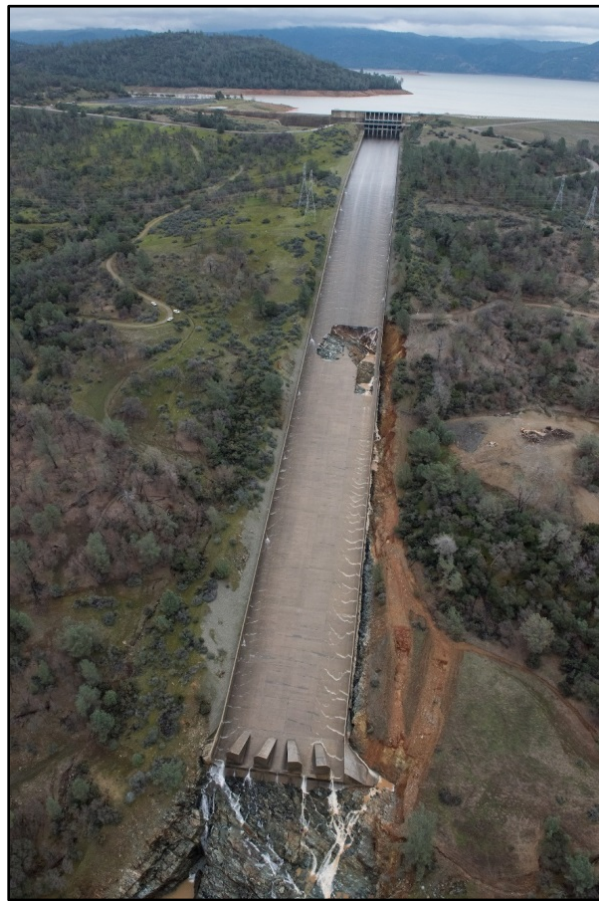
After the gates were closed, it was found that a significant section of the service spillway chute slab was missing, and a large erosion hole existed in the area where the slab sections were missing, as shown in Figure 3-19. This initial erosion hole at the service spillway was examined by a climb team on the morning of February 8, 2017.

Figure 3-19: Service spillway chute damage observed after gates were closed on February 7 (from DWR)

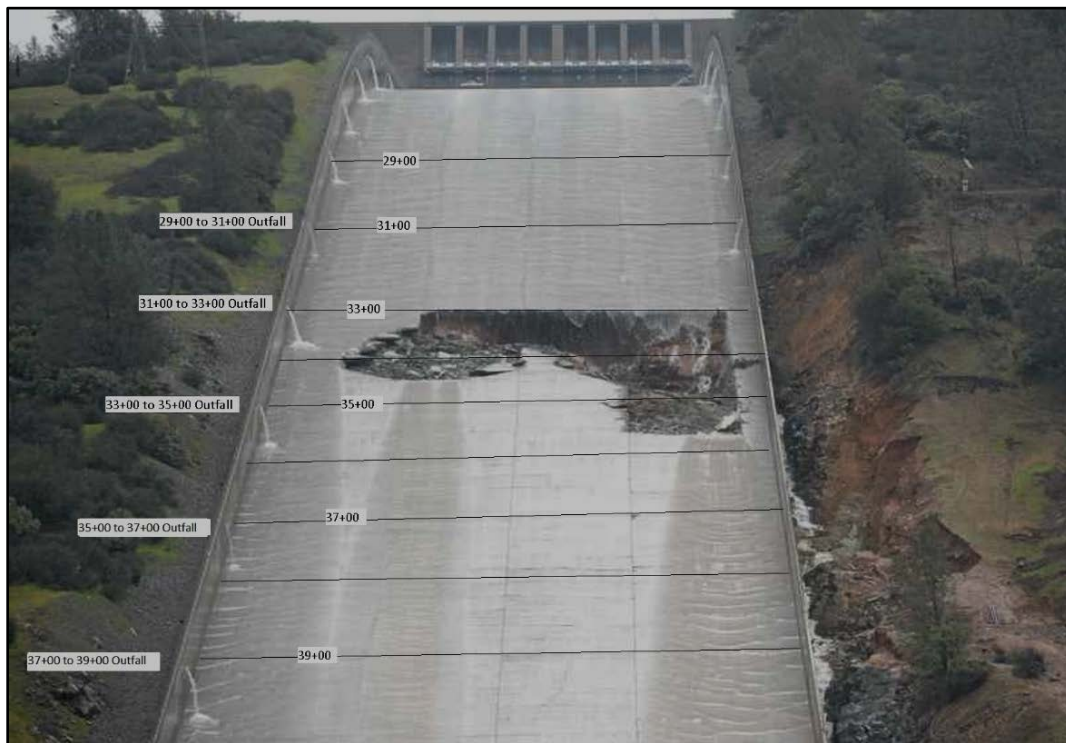
The IFT believes that the service spillway chute failure most likely initiated by the uplift and removal of a section of the chute slab in the vicinity of Sta. 33+50 at about 10:10 am on February 7, 2017. Once the initial section of the chute slab was removed, the underlying moderately to highly weathered rock and soil-like foundation material beneath the slab at this location was directly exposed to high velocity spillway flow. The high-velocity flow rapidly eroded the foundation materials at this location, removed additional chute slab sections in both upstream and downstream directions, and quickly created the erosion hole that was observed by 12:30 pm on February 7, as flows diminished following spillway gate closure (see Figure 4-1). These findings are based on eyewitness accounts, as well as photographic and videographic records.

Figure 4-1: Spillway chute damage observed after gates were closed (from DWR)

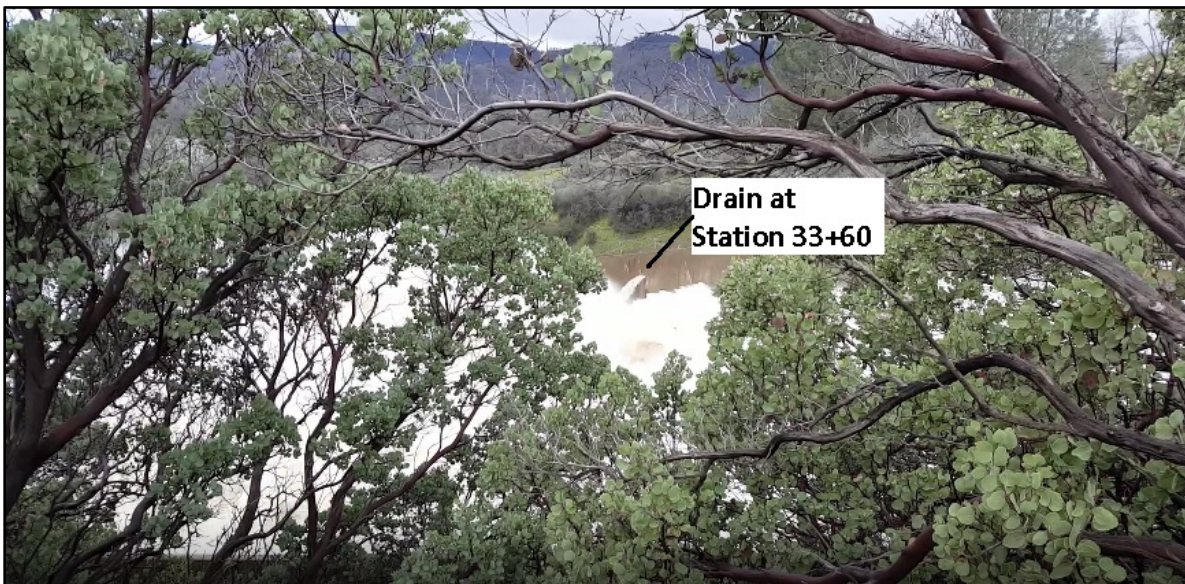
The DWR personnel arrived at the siren location at about 10:00 am on February 7. At about 10:10 am, they heard what they said sounded like an explosion or a loud bang, and they saw spray coming from the spillway chute. They turned to see a significant disturbance in the spillway flow. At 10:23 am one of them began to record video and take photographs of the disturbed flow in the chute, as shown in Figure 4-2. They stated that the flow disturbance subsequently moved upstream and toward them (toward the left side of the chute).

Figure 4-2: Flow in the chute at 10:23 am (from DWR)

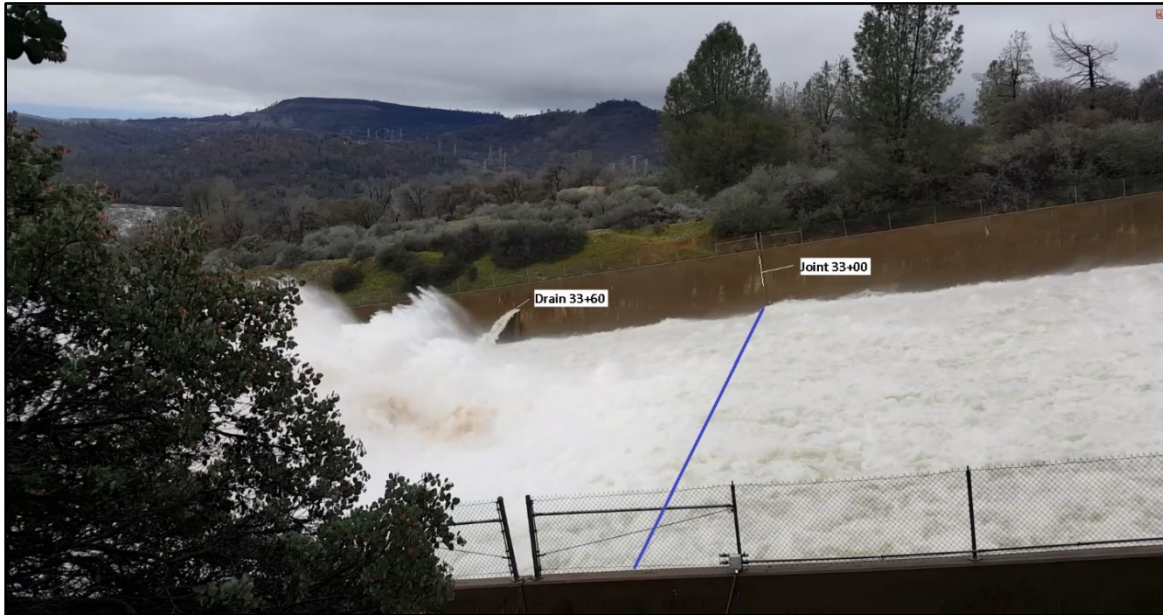
The IFT cannot rule out initiation of the chute failure farther downstream, but the photographic evidence does not seem to support this interpretation. If damage occurred farther downstream, the damage quickly moved upstream of Sta. 34+00, as shown by the image from 10:32 am, in Figure 4-3. Such rapid progression is conceivable, if the removal of chute slab sections downstream of

Station 34+50 resulted in upstream slab sections sliding downstream, due to lack of downstream buttressing and poor foundation conditions.

Figure 4-3: Flow in the chute at 10:32 am (from DWR)

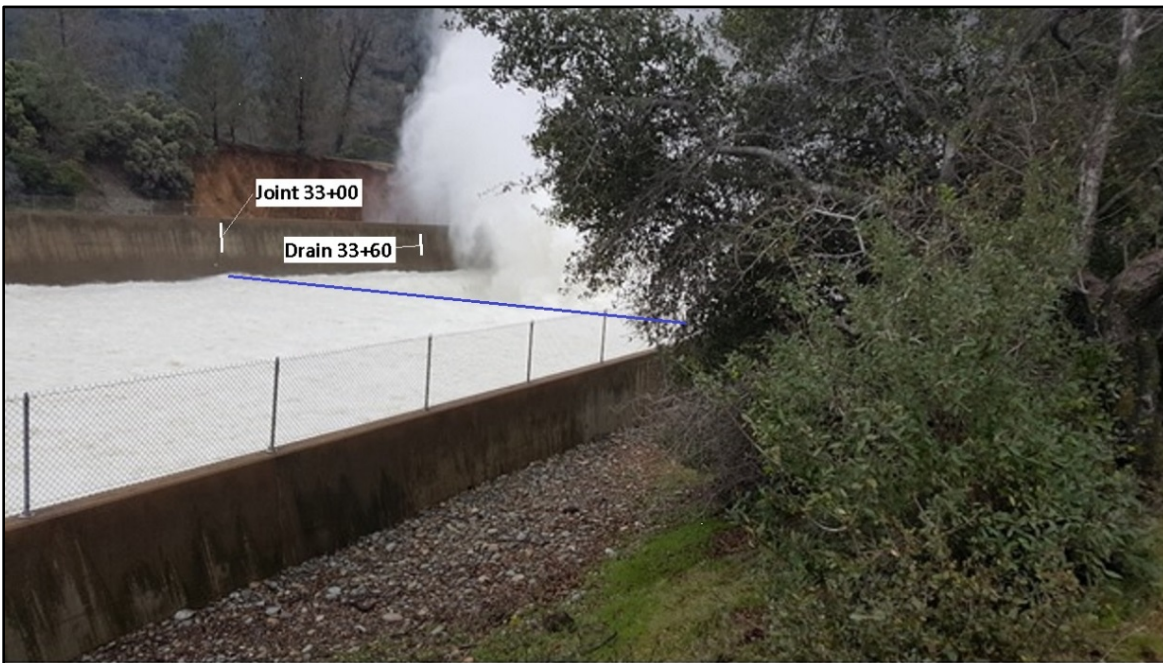
The photograph in Figure 4-4 shows that the damage had progressed upstream to Station 33+00 by the time this image was recorded (about 12:07 pm).

Figure 4-4: Flow in chute at 12:07 am (from DWR)

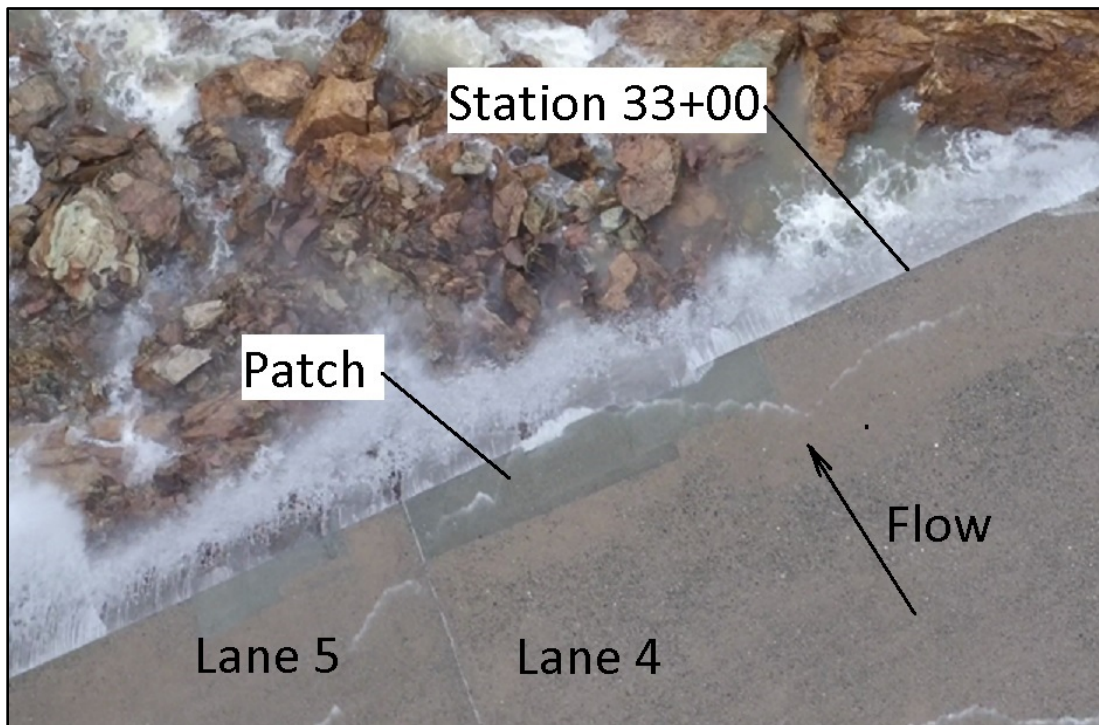
slab initiated at Sta. 33+00, in part because of a disturbance in the flow pattern on the spillway seen in a photograph reportedly taken on January 27, 2017 (see Appendix I for more discussion). However, the IFT has concluded that, although there may have been water injection along the Sta. 33+00 joint, this was almost certainly not the location of the initial failure. The slab section downstream of the joint at that location could not have lifted without shearing the concrete key in the upstream slab section, and this condition was not observed in the photos taken by a climb team or in drone videos taken on February 8, which were carefully reviewed by the IFT. The intact, overlapping key element upstream of Sta. 33+00 can be seen in a drone video image in Figure 4-5. In addition, the photographic evidence and eyewitness accounts suggest that the initial damage occurred downstream of Sta. 33+00, and subsequently progressed upstream. The conditions at the Sta. 33+00 are discussed further in Appendix I.

Figure 4-5: Joint at Sta. 33+00 on February 8 (from DWR)

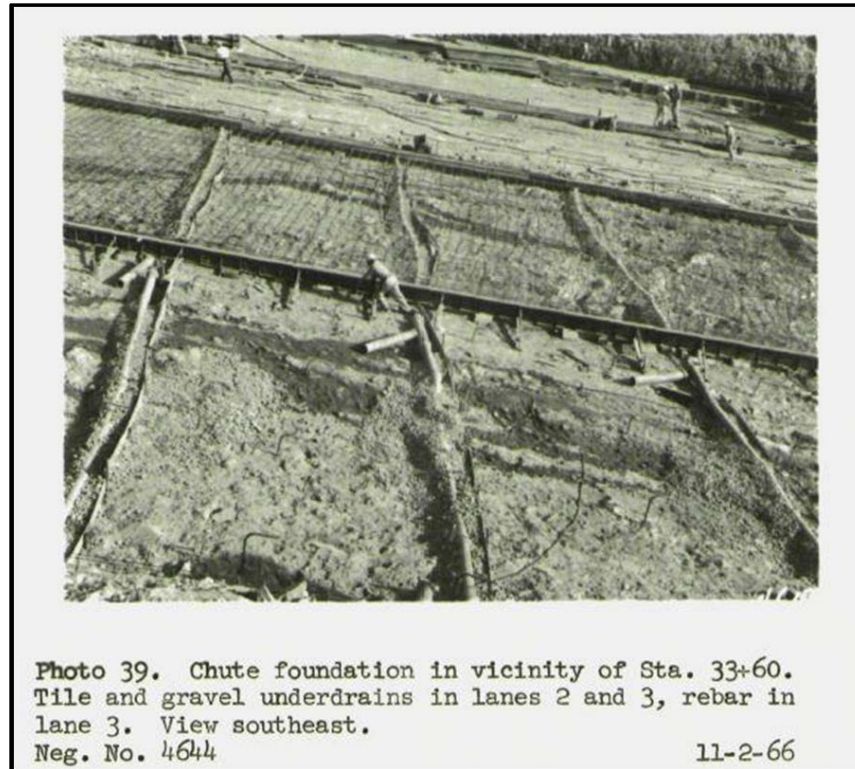
Expansion of relatively shallow void(s) under the slab: During construction, erodible materials were left in place in the foundation beneath the chute slab to varying extents and depths. Beneath the chute slab sections that were removed during post-incident forensic investigations, the erodible materials were found on top of and around areas of less erodible rock and are believed to be material left from incomplete cleaning and preparation of the rock foundation. In construction records, these materials were called “compacted clayey fines.” Only one void of limited extent was found beneath the remaining slabs in the post-incident forensic investigations, despite investigation locations being targeted in part at areas with “compacted clayey fines.” However, based on original geologic mapping of the chute foundation and limited available construction photos (see Figures 4-6 and 4-7), the IFT believes that erodible materials were much more

prevalent in the area of the chute slab failure. With the large amount of water that has been observed flowing through the underdrain system and the lack of filter compatibility between the drain system gravel and the erodible materials, it is conceivable that voids beneath the slab could have been created by piping (internal erosion) of the underlying materials by water flowing under the slab. As noted in Section 4.1.1, the IFT believes that any voids that would have formed would have been shallow (perhaps a few inches at most), rather than deep. With extended periods of underdrain flows, areas of voids could expand laterally beneath the chute. This would increase the size of areas of uplift pressure beneath the slab and also more readily transmit stagnation pressures over greater distances, resulting in an increase in the net uplift force on the slab. With the thickness of the chute slab and the anchors which would support the chute slab, voids beneath the slab would be difficult to detect.

Figure 4-7: Lane 3 downstream from Sta. 33+00 being prepared for placement. [9]
Note what appears to be extensive areas of soil-like materials in the foundation.

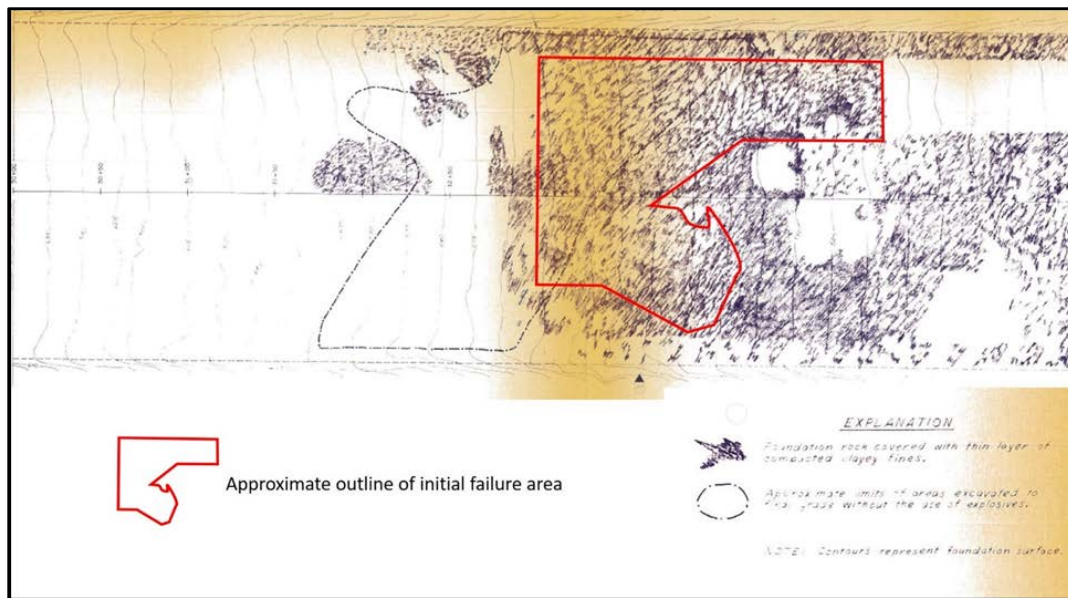
The foundation material beneath the chute slab in the area of the slab failure also plays a significant role in two of the four factors noted above. Based on the chute slab foundation geology maps and construction photographs (see Figures 4-6 through 4-8), as discussed in Sections 3.3.5 and Appendices A and C, the IFT believes that moderately to strongly weathered rock and soil-like

foundation conditions existed beneath the slab in the area of the initial chute failure. These conditions reduced effectiveness of slab anchorage, allowed for at least some underslab erosion, and certainly dictated the extent of the ensuing damage after the chute failure initiated. Areas immediately downstream from the initial damage area have much less weathered foundation rock conditions, where both bonding of the concrete slab and bonding of the anchor bars to the foundation rock offered significantly greater resistance to uplift, and some sections of these slabs remained in place when the gates were closed after the initial chute failure.

Figure 4-8: Extents of compacted clayey fines. Geologic mapping from Final Geologic Report [9]

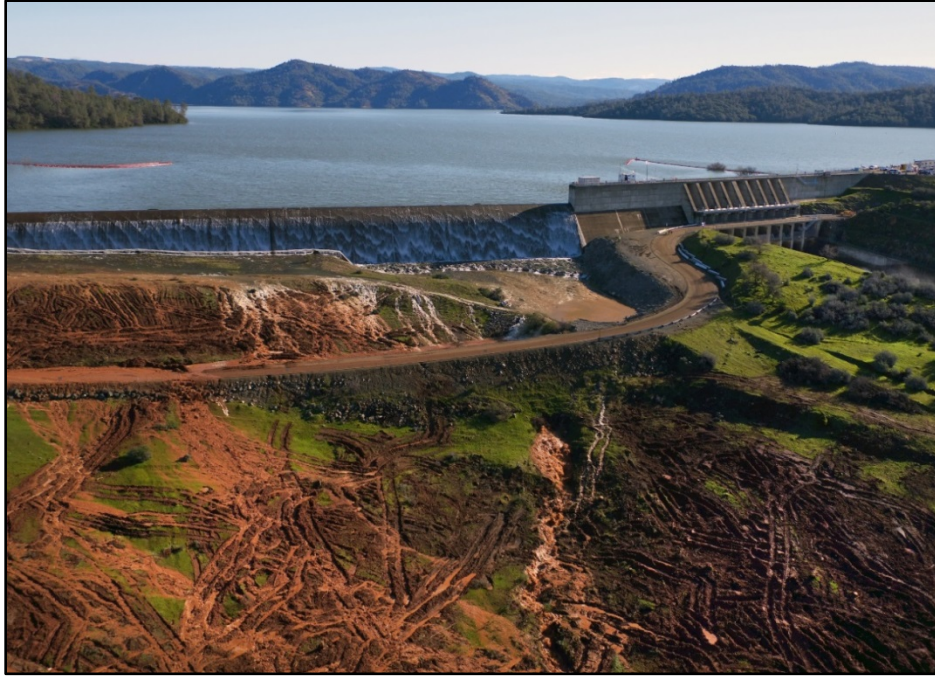
During the incident response, in preparation for using the emergency spillway, trees had been cleared from the natural hillside downstream of the spillway crest structure before flow over the crest structure occurred. As the emergency spillway discharge flowed over the natural ground downstream of the crest structure, erosion began to occur. Erosion of surficial soil deposits was expected, however erosion began to develop to greater depths than expected. By the afternoon of February 12, concentrated areas of erosion were observed to be rapidly progressing upstream toward the emergency spillway crest structure, resulting in issuance of the evacuation order at about 3:44 PM on February 12, according to Incident Command notes. Figures 4-9 through 4-11 show the emergency spillway during the incident.

Figure 4-9: Oroville Dam emergency spillway as overflow began on February 11 (from DWR)

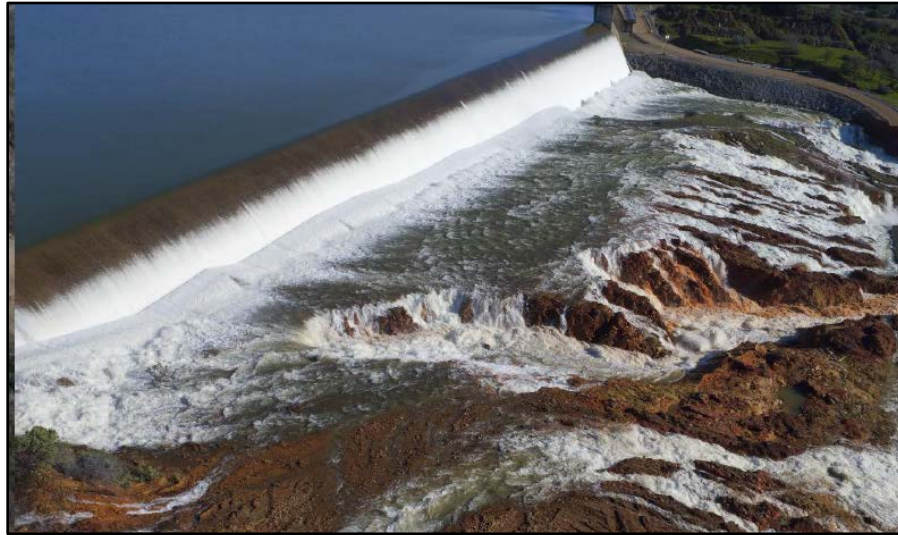
Figure 4-10: Emergency spillway headcutting on February 12 (from DWR)

The principal physical factor contributing to the damage at the emergency spillway was clearly the presence of significant depths of erodible soil and rock in features orientated to allowed rapid headcutting toward the crest control structure. The erodible materials appear to be associated with geologic features such as shear zones. Other factors that contributed to the damage at the emergency spillway include:

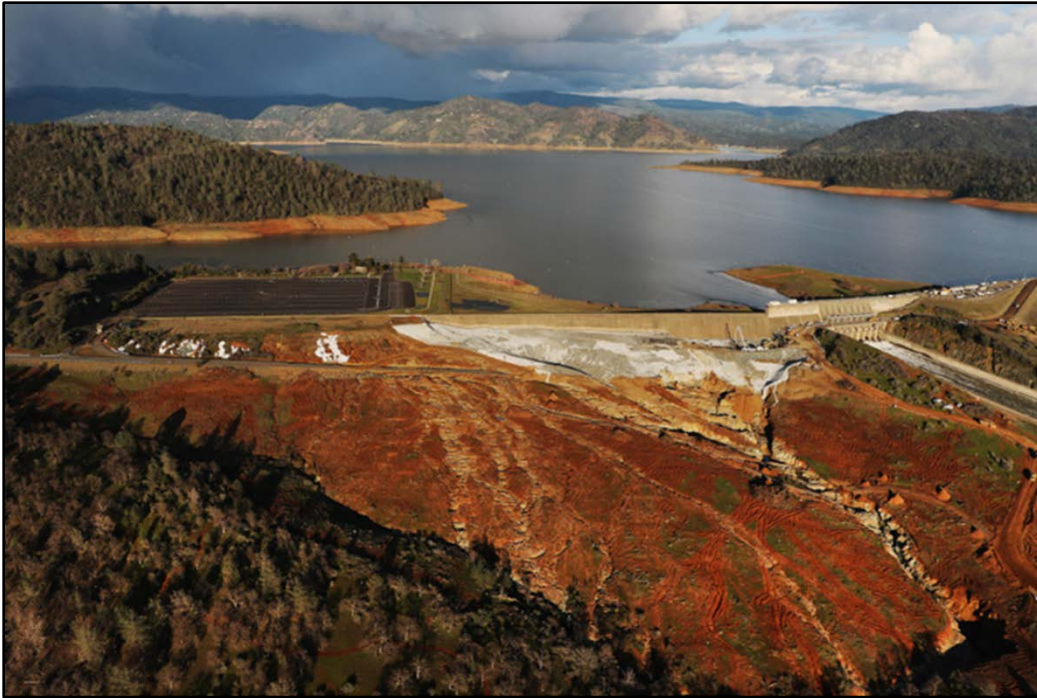
- Hillside topography that concentrated flows and increased erosive forces, facilitating headcut formation

- Insufficient energy dissipation at the base of the spillway ogee crest structure
- Absence of erosion protection downstream of the crest structures

Figure 4-11: Emergency spillway after the incident (from DWR)

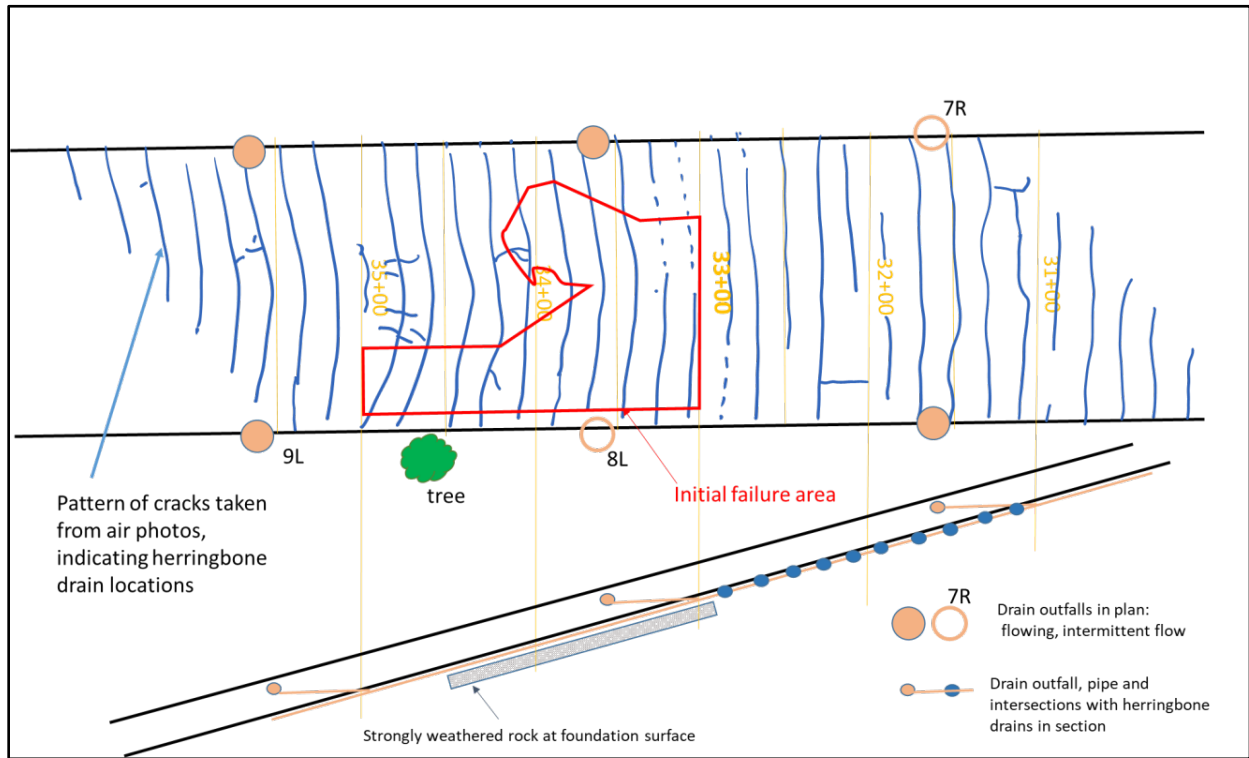
A report issued by others [20] suggested that roots from a single tree located on the left side of the spillway plugged Drain Outfall 8L (See Figure 4-12), which was observed to not be flowing just prior to the chute failure. The IFT believes that this is not plausible because of the physical arrangement of the drain system.

The particular tree in question was located very close to the left side of the spillway about 100 feet downstream from the initial chute failure area and Drain Outfall 8L. The layout of the drain system is illustrated in Figures 4-12 and 4-13. As illustrated in the figures, roots from this tree could not reasonably have blocked the collector pipe connected to Outfall 8L, which was the outfall observed to not be flowing. If roots from this tree blocked any outfall, it would have been Outfall 9L, which was observed to be flowing.

Figure 4-12: Schematics of service spillway chute near initial failure area

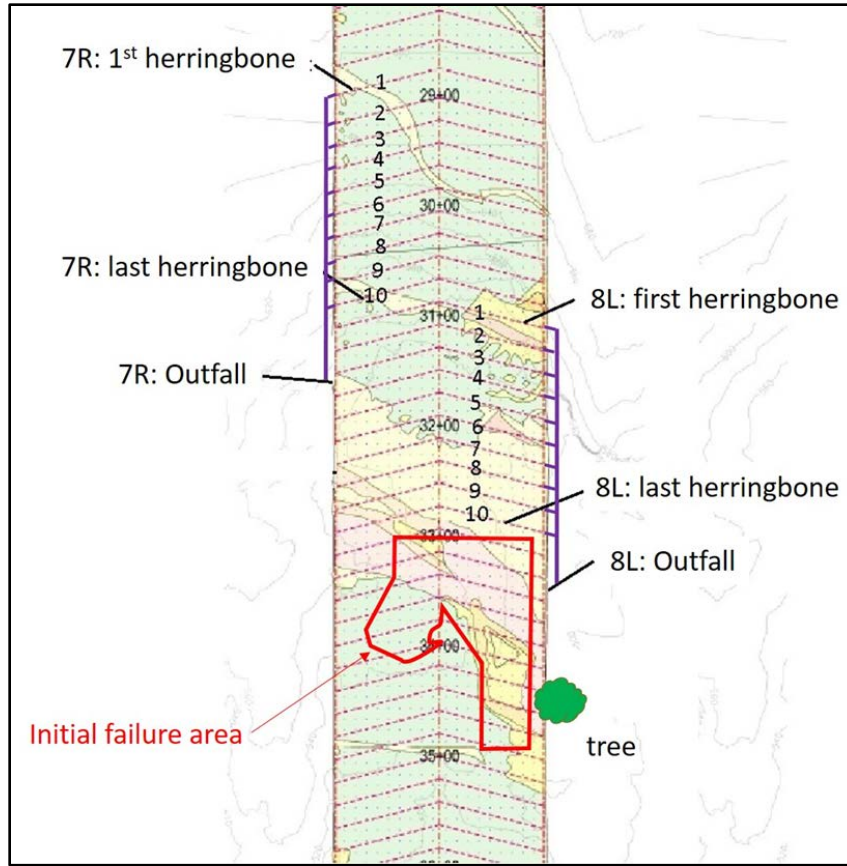
Figure 4-13: Idealized layout of spillway chute underdrains upstream of initial failure area (underlay of chute geology provided by DWR)

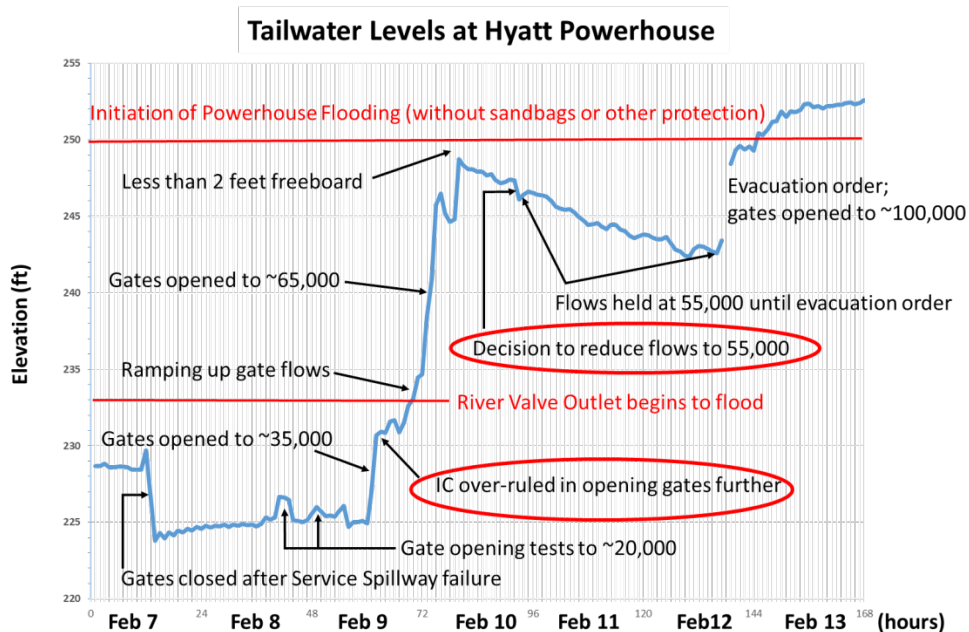
In reviewing data provided by DWR (see Figure 5-1), the IFT found that, at the times these decisions were being made, there was no immediate threat of powerhouse flooding. In fact, when service spillway flows were reduced at about 7:00 pm on February 10, the tailwater level was actually falling and the threat to the powerhouse was diminishing, even with the 65,000 cfs discharge. When the IFT asked a number of DWR personnel who were involved in the incident about the dropping tailwater level, they were surprised to hear this information. By their accounts, after the decision had been made to reduce discharge to 55,000 cfs, there was apparently little to no further discussion regarding whether service spillway discharges could be increased to reduce the risk of overtopping the emergency weir – this risk had been accepted. Further, the IFT learned that technical personnel had opined that the transmission tower was stable, and, due to better upstream rock quality, headcutting extending up to the service spillway headworks was no longer considered a major concern, based on their engineering judgment.

Figure 5-1: Tailwater levels during the Oroville Dam spillway incident

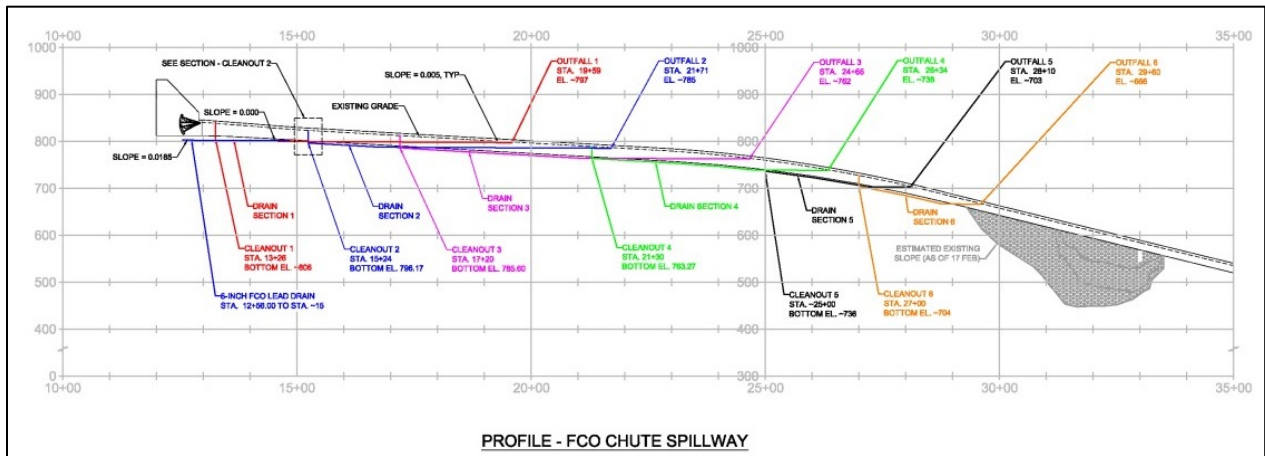
Figure A-7: Underdrain Schematic Drawing prepared by HDR [A-6]

Following the as-built design changes, the perforated lateral drains were to be placed within the bottom half of the spillway chute slab. After the drain size was increased to 6 inches, the minimum concrete cover over the drains was reduced to 7 inches above the pipe (Figure A-6). The perforated pipe was to be laid within an envelope of select gravel that was to be mounded over the top of the pipe. Perforations were to be oriented to face the foundation surface. Polyethylene sheeting was to

The herringbone drain design places the drains within the 15-inch concrete slab, such that there is only 7 inches of concrete cover above the drains (not including the bell at the connections), see Figure A-6. While this creates a problem in terms of concrete cracking above the drains, it also places the drains well above the foundation should overexcavation occur. Since the drains were intended to relieve pressure from groundwater in the foundation, it would seem that a better design would have been to place the drains on the foundation or in a foundation trench, as was being done at other dams at the time Oroville Dam was being designed (see Appendix E). There apparently was no consideration that the drains placed within the concrete slab would lead to concrete cracking and additional drainage requirements. Also, with polyethylene sheeting being placed over the top of the drain to prevent concrete contamination of the drains and gravel envelope, flow into the cracks occurring above the drains would be diverted away from the drain immediately below. Apparently, the designers, design reviewers, and staff making as-built changes to the drawings did not understand the concern related to water from the flow surface passing through cracks and joints into the foundation that other spillway designers at the time seemed to have addressed with alternative design details. Typical designs from that period included drains being associated with control joints placed above concrete keys, trenched into the foundation. The individual associated with the original design (interviewed by the IFT) recalled the design of this type of keys (which never made it into the bid specifications), but did not recall details related to placing drains beneath the chute slab.
