INDEPENDENT FORENSIC TEAM REPORT OROVILLE DAM SPILLWAY INCIDENT

JANUARY 5, 2018

SUMMARY

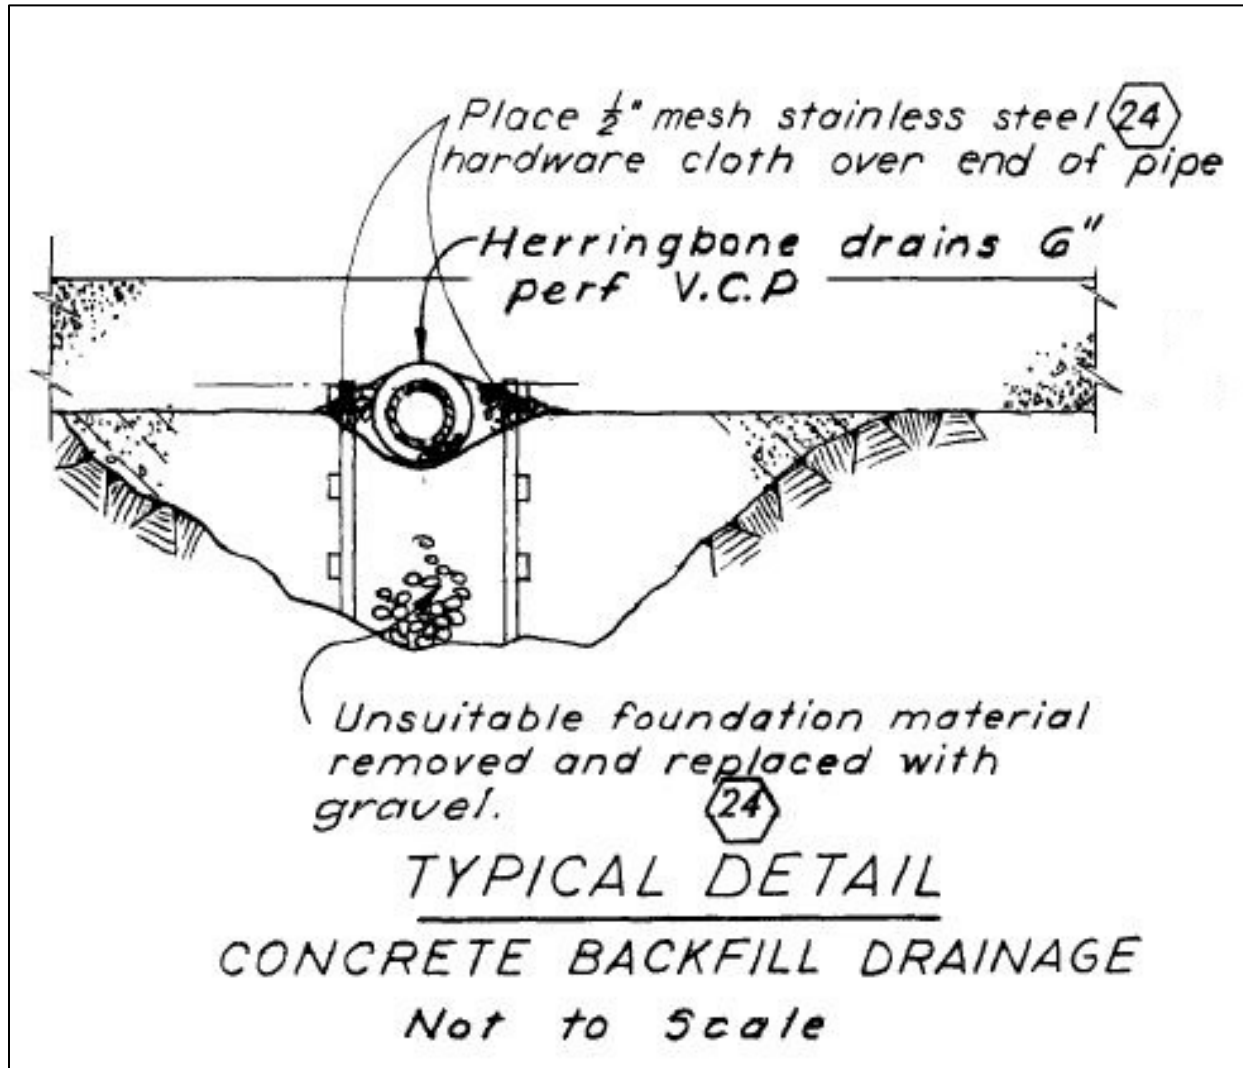
Figure A-8: Herringbone Treatment Where Overexcavation Occurs (from Drawing A-3B9-1)

be placed over the pipe and gravel envelope. Where foundation overexcavation was required, gravel contained by wooden formwork was to be placed between the foundation and the pipe (Figure A-8). Pipe laid within the limits of the concrete was to have caulked joints. The drains were to be field adjusted to have a 1 to 4 percent slope for drainage, as discussed above. However, from cracking patterns, it appears that the drains were placed uniformly and parallel to each other in a herringbone pattern. Construction photographs show that in areas of deep overexcavations, the drains were connected to the foundation through gravel columns that were constructed by placing gravel in sonotubes, see Figure A-9 (Photo 40 of the Final Geologic Report [A-5]), or in wooden formwork.

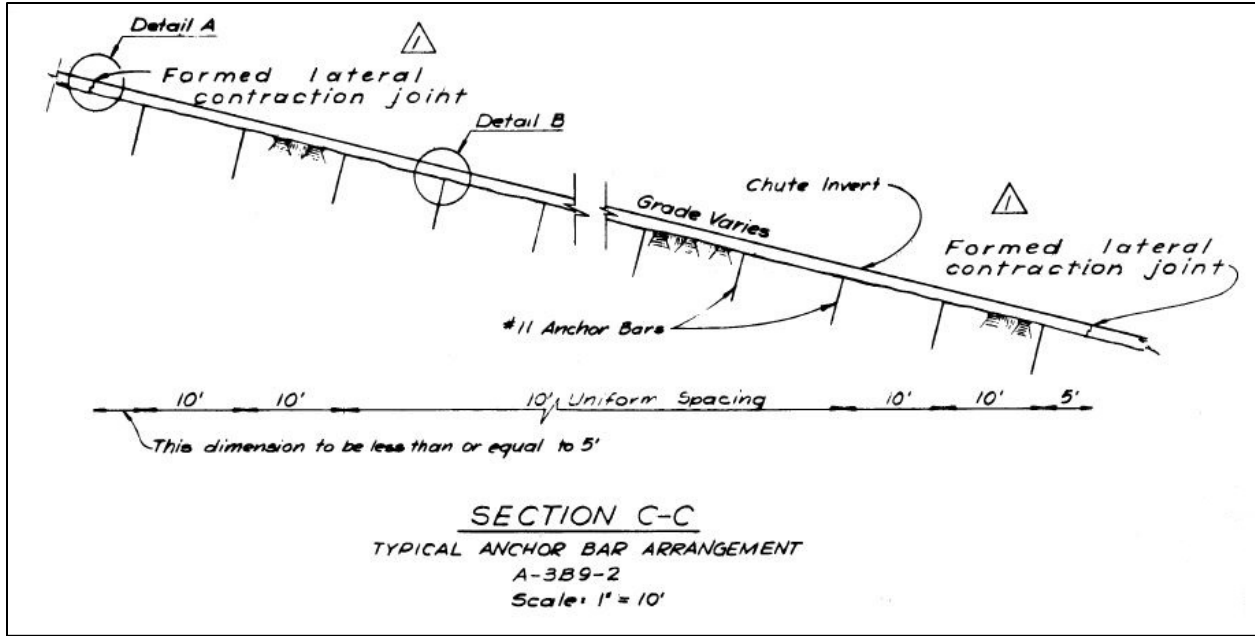
Figure A-10: Spillway Chute Anchor Bar Arrangement Showing Transverse Invert Contraction Joints (from Drawing A-3B9-4)

There has been considerable confusion about the types of joints used in the spillway chute slab. Expansion joints were shown in the bid specification drawings, and contraction joints were shown in the as-built drawings. Both types of joint have no bond or bonded reinforcement across the joint. The difference is that expansion joints have a compressible filler material in the joint that allows the joint to close under high temperature stress, while the contraction joint has a painted or sprayed on bond breaker to prevent bonding of adjacent concrete placements. The bid specifications and the as-built drawings were ambiguous and unclear about the location of these joints. The Plan and Profile views on as-built Drawing A-3B9-2 do not clearly state that the joints being shown are the expansion joints for the wall stem and base only, and do not apply to the chute slab. However, Section C-C, cut on the plan view of that drawing and shown on as-built Drawing A-3B9-4, shows that the chute invert has a contraction joint at the same location that the walls have expansion joints. It is not clear if the contraction joint detail shown in Section C-C for the joints at Sta. 33+00 and Sta. 37+00 are intended to be applied to all lateral chute slab joints, or to some of the lateral joints, but no other lateral joint details are provided for the spillway chute (Figure A-10). Part of this confusion may be due to the bid specifications drawings (Figure A-2) having expansion joints in the chute slab. There is no indication why the expansion joints were removed, but as discussed in Appendix E, expansion joints on high velocity flow surfaces were not considered good practice at the time (and still are not today).

The chute slab lateral (or transverse) contraction joint details include a 7½-inch deep key where the downstream edge of the upstream slab overlaps the upstream edge of the downstream slab. The detail includes a ½-inch offset that is lower on the downstream side, but transitions back to the normal chute slope within 6 inches of the joint. This detail was observed in the field during the IFT site visit at some locations, but it is difficult to tell how frequently it was used due to surface erosion of the concrete making a ½-inch offset difficult to observe at some of the lateral joints.

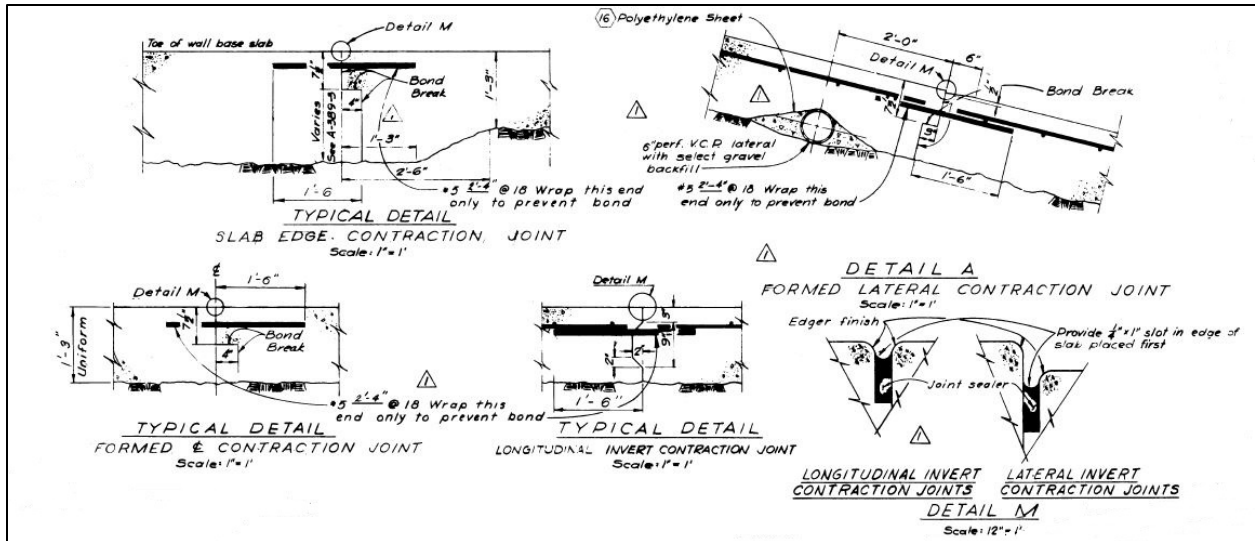
Figure A-11: Chute Slab Joint Details (from as-built Drawing A-3B9-4)

At some locations on the drawings, the lateral contraction joints were depicted without these offsets. Construction records and photographs indicate that much of the chute slab was constructed using slip-form methods. It is believed that the slip-forming used to construct the chute concrete allowed the contractor to place more than one 50-foot long concrete chute panel at a time. It is further believed that the contractor “cut” shallow grooves in the freshly placed concrete to initiate a crack at intermediate (50-foot) locations within the slip-form length, rather than stopping the slip-forming operation to construct a formed contraction joint (see Spillway Chute Construction Timeline in this Appendix). All contraction joints were to be treated with 1-inch deep by ¼-inch wide filler material, placed in a groove formed at the top of the joint. Corners of the joint were to be tooled to a round edge (see Figure A-11 for joint details).

No. 5 dowel bars at 18-inch spacing cross each of the chute slab contraction joints. These bars are embedded and bonded for a length of 18 inches on one side of the joint, and wrapped to prevent bond for 10 inches on the other side. These bars are shown to be placed just below the reinforcement mat at the top of the slab. With the dowels and rebar mat both being placed near the surface (as compared to dowels being placed at mid-height) there is an apparent plane of weakness created by the reinforcement near the joint, that could have increased the potential for delamination and spalling of the concrete near the joints.

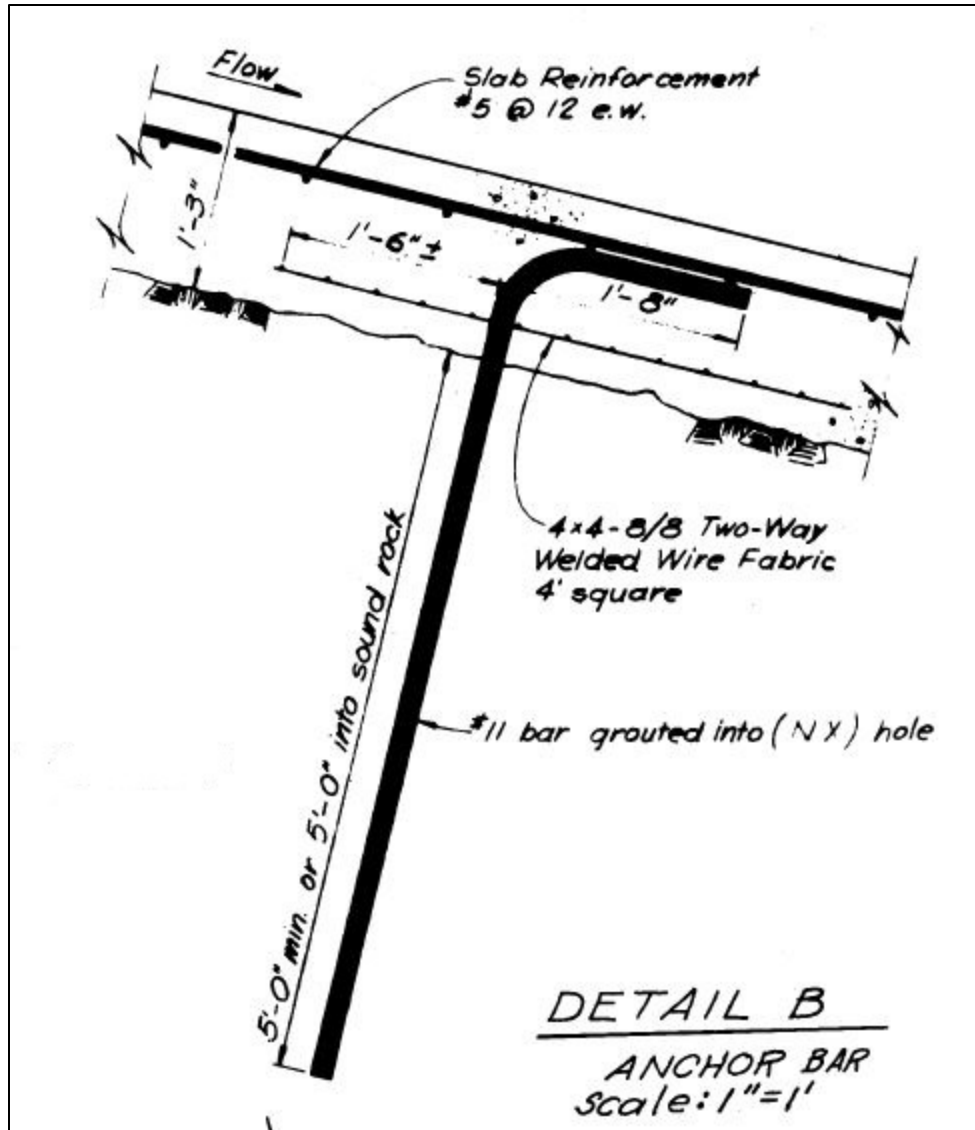
Figure A-12: Anchor Bar Detail (from Drawing A-3B9-4)

The service spillway chute slab design included No. 11 anchor bars spaced at 10 feet each way along the foundation surface (see Figures A-12 and -13). The anchor bars were intended to resist 5 feet of uplift [A-8]. The designed embedment lengths were likely insufficient to develop the full design tensile strength of these bars based on the assumed foundation conditions. The design embedment of the standard 90-degree hooks into the concrete slab is only 10¾ inches. The ACI-318 Code from that period would have required about a 21-inch embedment. While it is understandable that the designers would not have wanted to make the slab 10 inches thicker to accommodate the No. 11 hook embedment, a typical design might call for smaller bars more closely spaced to achieve the desired pull-out strength. For example, the designers could have used No. 8 bars spaced at 6 feet each way. However, even with No. 8 hooked bars, embedments could not fully develop the hook strength in the concrete, so it is possible that the anchors were oversized to provide sacrificial steel to accommodate possible corrosion. A 4-foot square piece of welded wire fabric was to be placed at the base of the concrete slab where the anchor bars were installed. Presumably this was to help prevent pull-out of the bar from the concrete.

The anchor bars were to be embedded 5 feet into the foundation in holes that were specified to be 1½ times the bar diameter, with the bars to be encased in cement grout. These bars were to be tested in the lowest quality rock. No strength requirements were provided in the specifications. Post construction documentation indicates they were to resist 5 feet of uplift.

There were no specification provisions for overexcavation with respect to anchor bar installation. Based on Figures A-12 and A-13, it is not clear whether the bars were lengthened to maintain 5-foot foundation embedment, the foundation embedment was reduced to keep the top of the anchor bar hook at its design location just below the rebar mat, or if the bars were all adjusted to maintain the specified embedments in both the slab and foundation while keeping the bar lengths constant. It is also not clear what rock would have been considered “sound rock” for the referenced 5-foot embedment into such rock. Two observations from the construction photos would tend to indicate that the required embedments in the foundation were either not always maintained, or that longer bars were sometimes used to compensate for overexcavation. Many photos show the tops of the bars just below the rebar mat as designed, even with a varying foundation surface (Figure A-13). Photos of the downstream area near the end of the chute show bars that appear to be longer and that have 180-degree hooks (see Figure A-9).

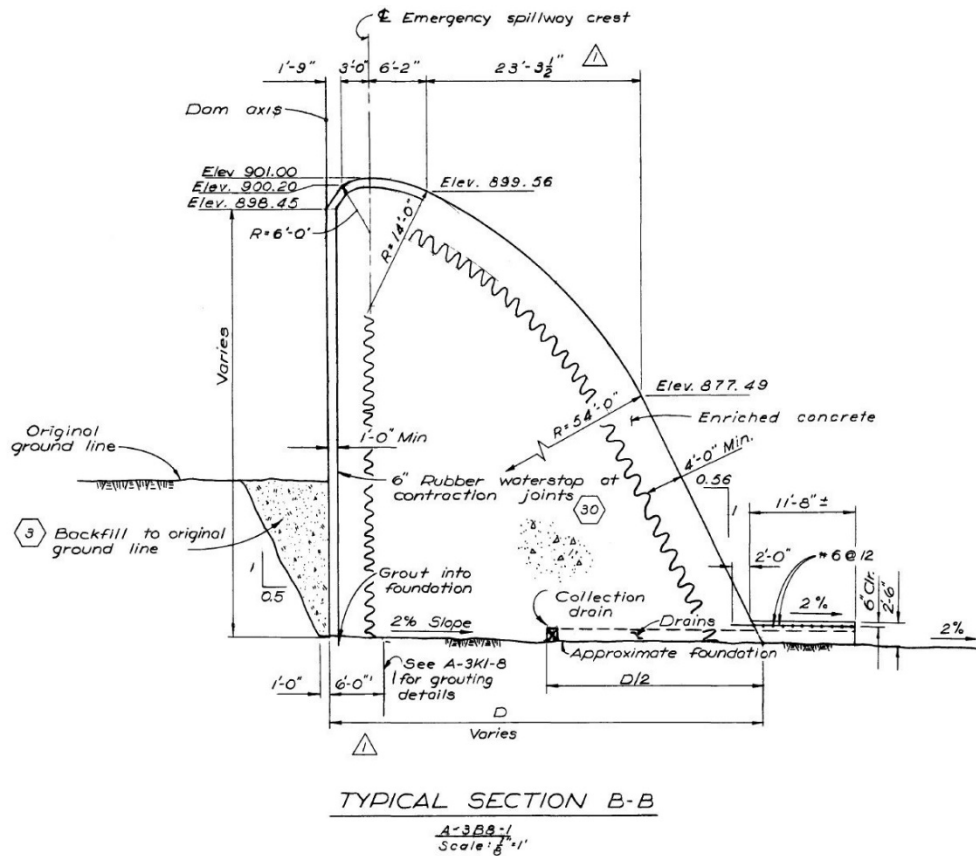
The overflow weir was designed with an 11.67-foot long downstream apron to protect against erosion as flows over the ogee weir reach the foundation elevation (see Figure a-14). While this apron will absorb some of the impact of direct flow onto the foundation, it does not protect against downstream erosion and headcutting. Spillways with this configuration have experienced significant erosion holes downstream of the apron, which could also undermine and fail the apron, if foundation conditions are unfavorable. Additionally, a large erosion hole could remove all passive resistance to sliding of the gravity structure, if any foundation features daylight into the erosion hole.

Figure A-14: Ogee section of the emergency spillway showing the downstream apron

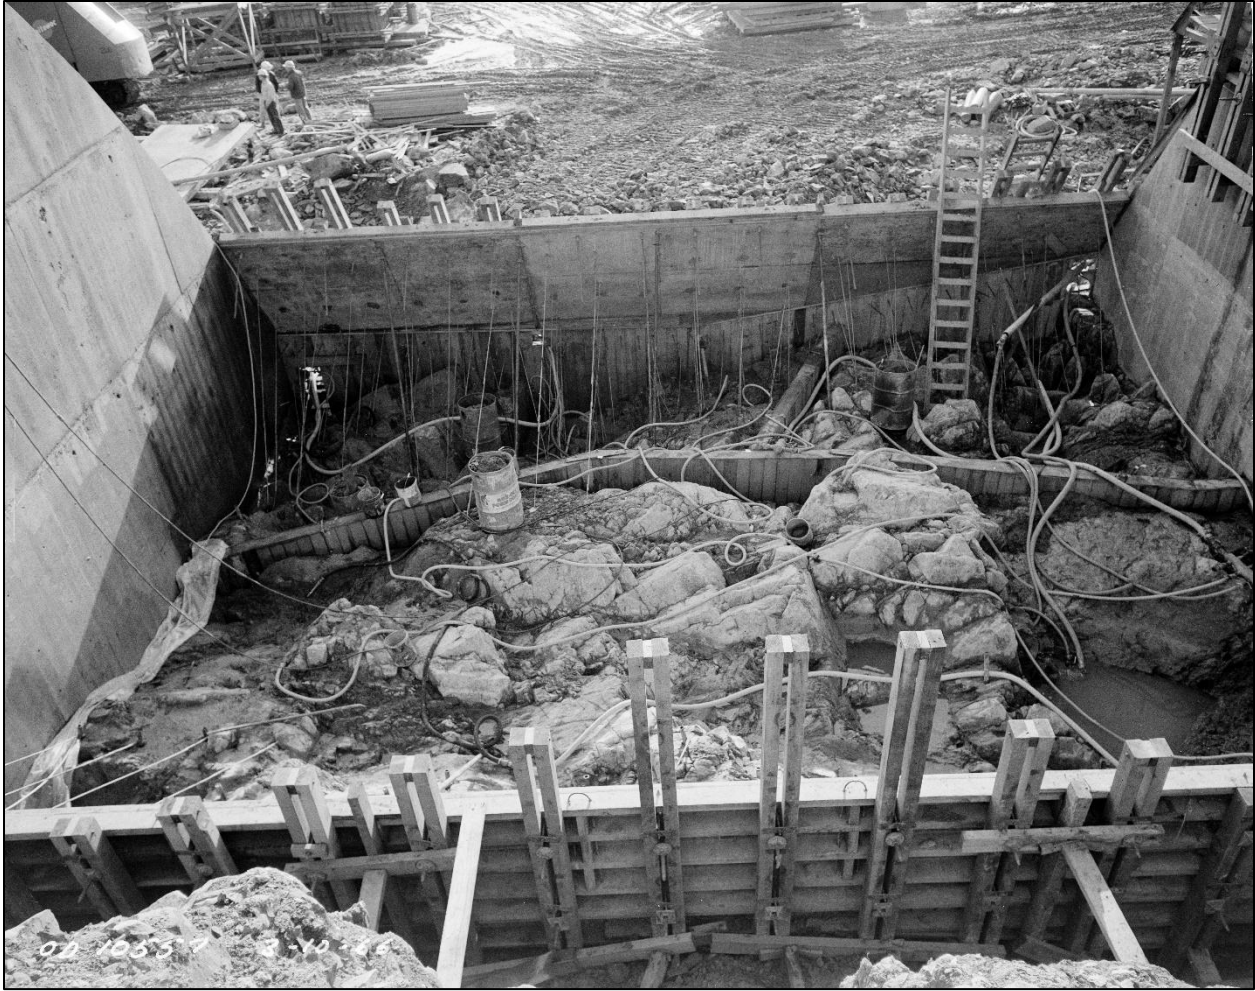
Figure A-15: Clean-up effort for the emergency spillway gravity crest structure just prior to placement. Note that all mud, debris, and loose or unsound rock fragments have been removed and the rock has been pressure washed. (Photo OD_10557_03_10_1966)

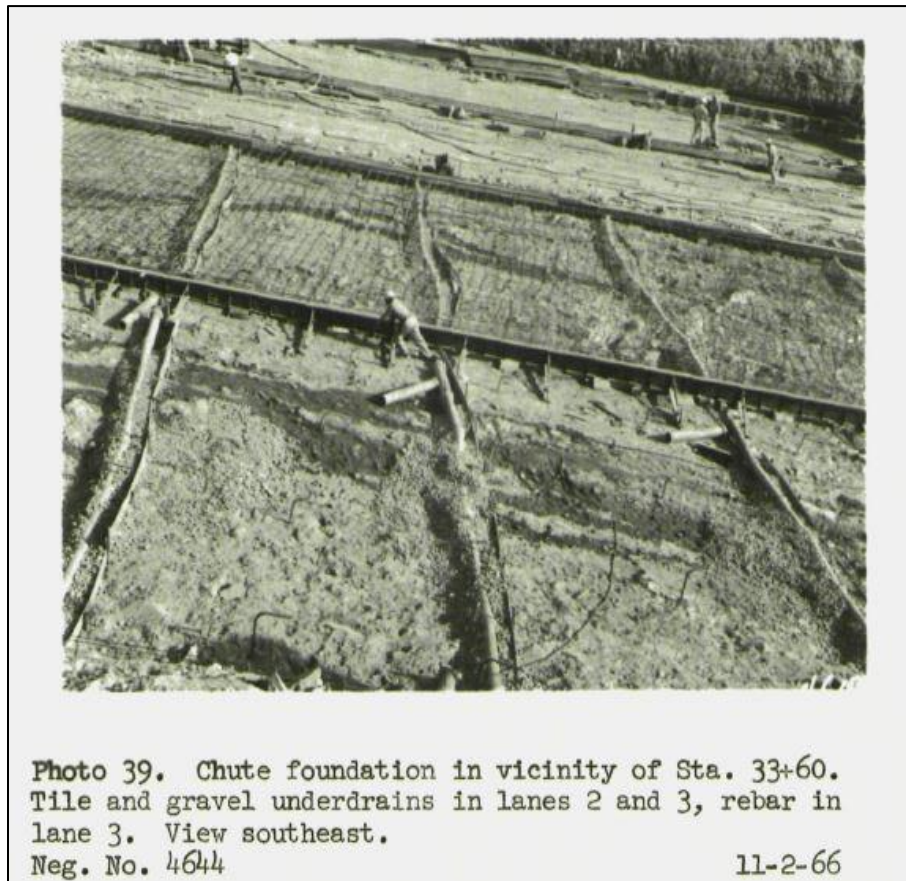
It is difficult to interpret the exposed foundation in Figures A-20 and A-22, with the way the rock is broken, as being the same material seen in Figure A-21. One might expect to see a blockier surface in Figure A-21 if the foundation was excavated as expected with heavy equipment to remove weaker weathered material, and then washed to expose the fresh rock. If anchor bars were embedded 5 feet into the excavated surface seen in Figure A-21, it is easy to imagine that some of the holes were partially drilled through weaker surface deposits that were left in place due to the relaxed cleanup effort.

Figure A-21: Lane 3 downstream from Sta. 33+00 being prepared for placement. Note that in both Lane 3 and Lane 2 (foreground) the gravel around the drain pipes was contained by wooden forms.

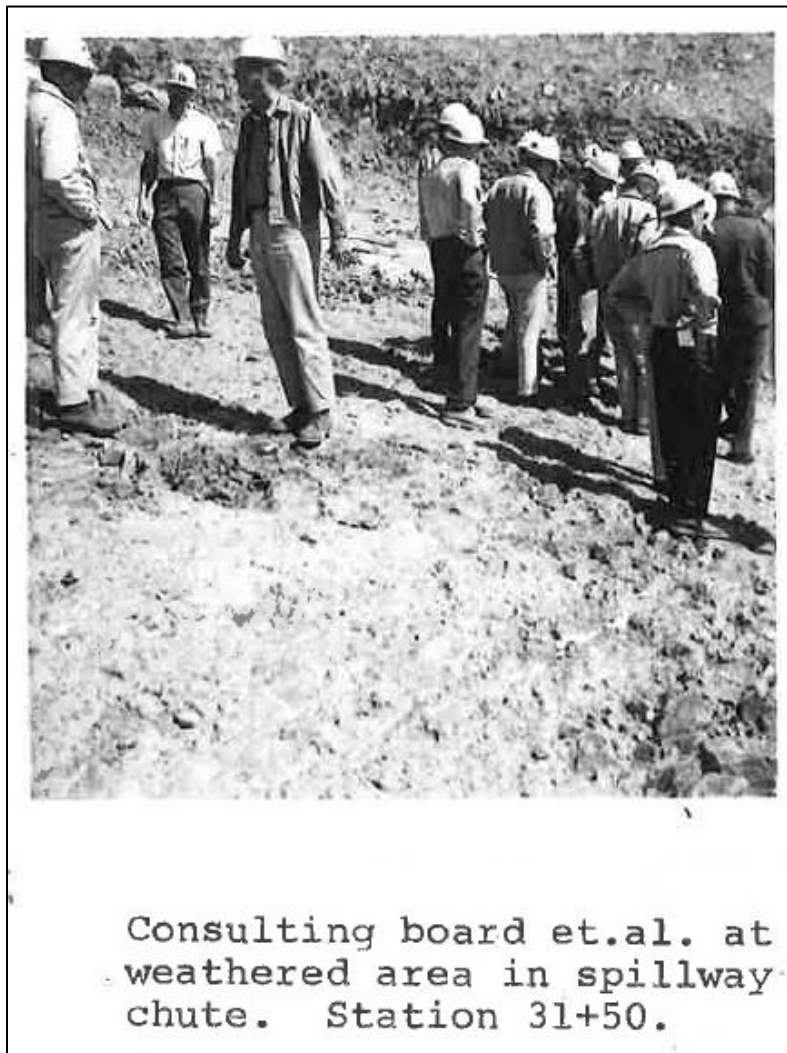
Figure A-31: Photo from the February 12, 1966 DSOD Inspection Report

04/19/1966 The IFT had access to the agenda prepared for the April 19-20, 1966 Consulting Board meeting. A photo showing the Consulting Board at spillway chute Sta. 31+50 was included with the DSOD reports (Figure 31). (No Consulting Board report of this visit could be found by DWR).

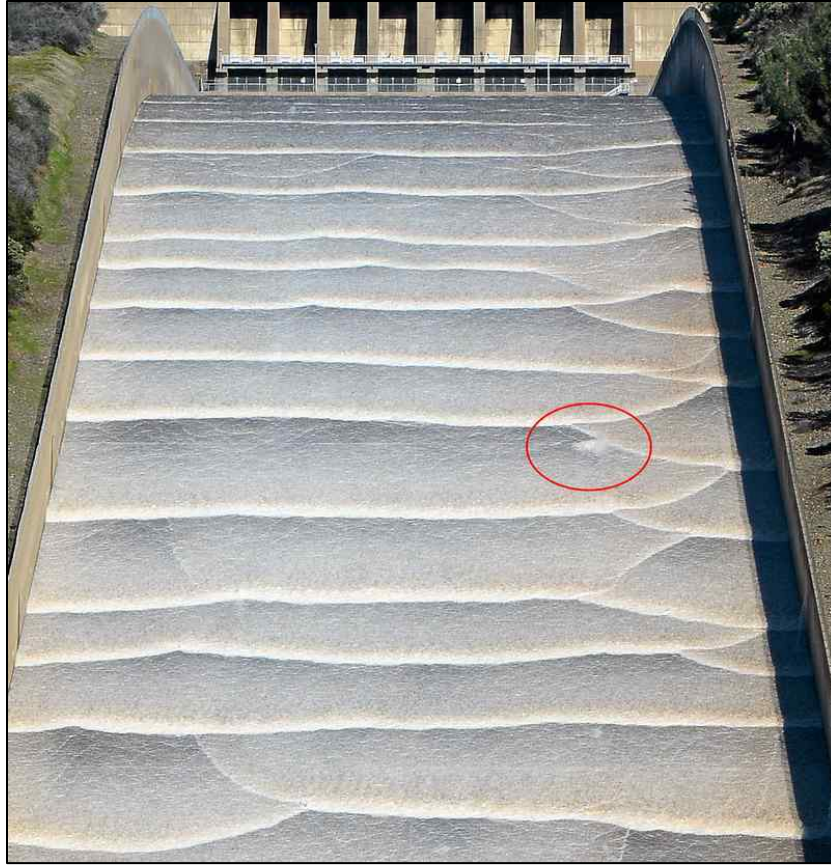
Depending upon the invert slope and velocity, an instability can develop on the water surface that create hydraulic bores. The bores are often called “roll waves.” The terminology is a bit confusing because some investigators also refer to surges as roll waves. In this document, roll waves refers to small bores that gradually increase in size until they form a large disturbance known as a surge. Surges are common for shallow flows, as shown in Figure B-2. However, they are not often seen

**Figure B-2: Slug Flow in Spillway Chute. The circled area shows a flow disturbance at Station 33+00 for very low discharge.
Reference [B-4]**

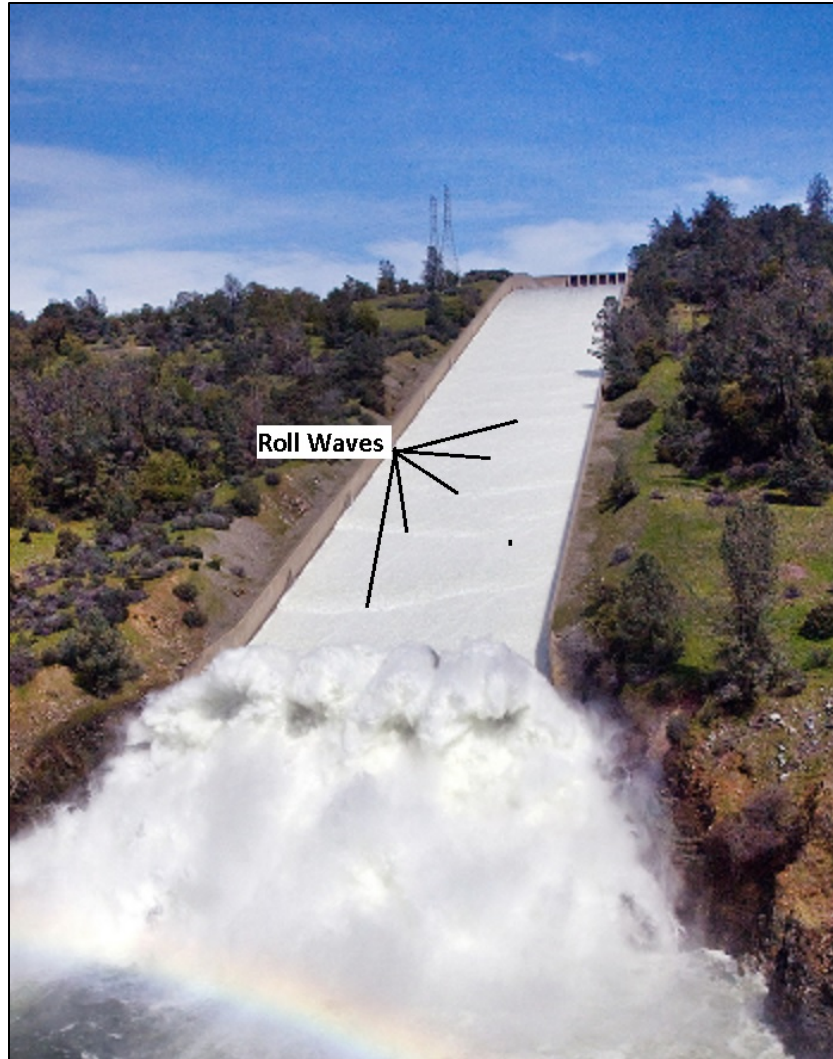
Roll waves with larger flows on the Oroville spillway chute are shown in Figure B-4. The distance between the waves is generally random. Each crest entrains air. The randomness of the waves will induce fluctuation pressures on the invert.

Bores or roll waves can be observed on the water surface of the flow for a discharge of about 19,000 cfs in Figure B-4.

**Figure B-4: Roll Waves for 19,000 cfs Discharge,
Reference [B-5]**

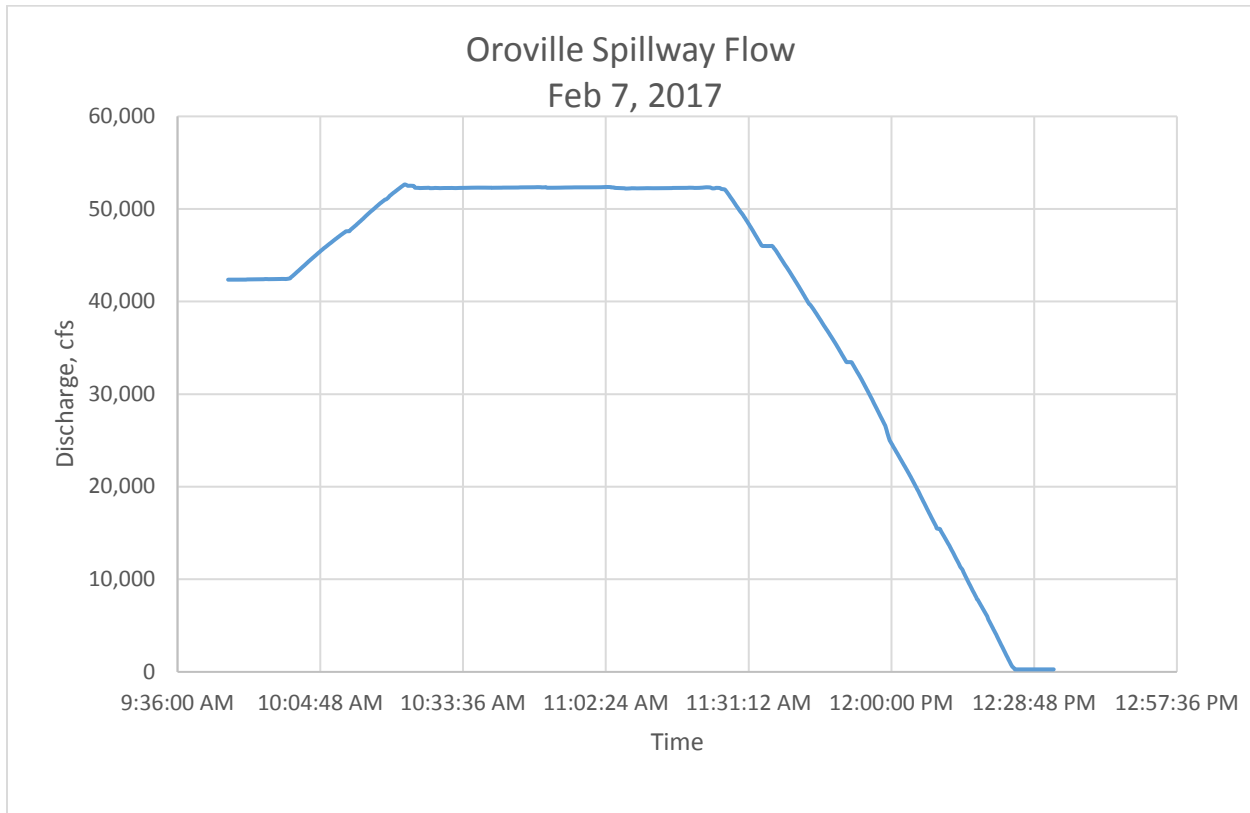
Figure B-7: Time History at Time of the Chute Failure

cavitation would not occur around Station 33+00. The flow was shut off around 11:30 AM and was essentially stopped around 12:20 PM.

Drone inspections of the sections of the chute remaining in place downstream of the chute failure area did not indicate evidence of cavitation damage. In addition, a careful onsite examination of the remaining lower chute sections by a member of the Independent Forensics Team (IFT) could not find any evidence of cavitation damage at supposed locations of damage. Therefore, we can conclude that cavitation was not a contributor to the failure that was observed on February 7th, 2017.

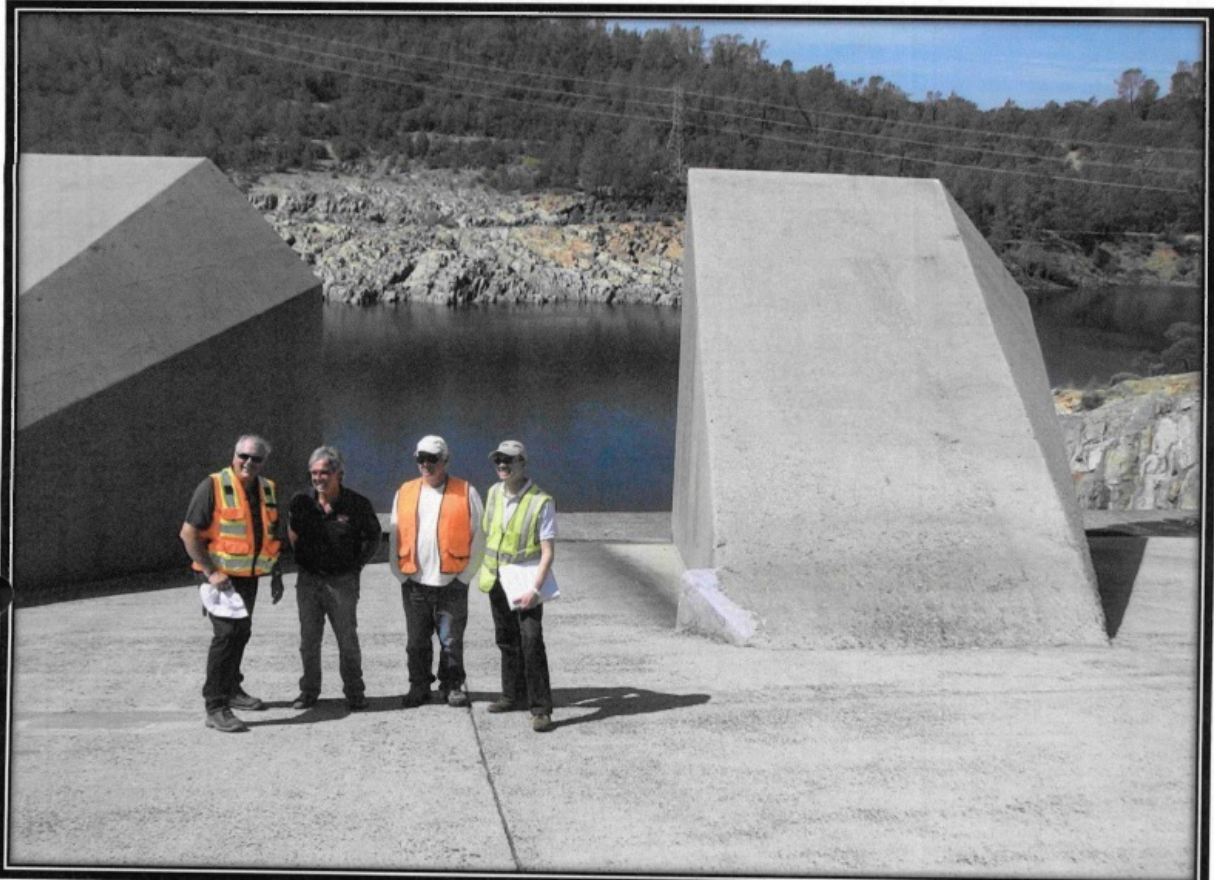
The only observable damage in any of the inspection reports was reported at the deflector blocks (chute blocks or dentates), by the DWR Board of Consultants, on November 18, 2015, as shown in Figure B-8. They are standing at the dentates for the chute. Note the concrete patch to the right of the Board members. Patching of the dentates is sometimes required after significant releases. The only problem with the conclusion of the Board of Experts is that the patch is not in a location where cavitation would occur. It is however, in a location that is susceptible to impact damage.

**Figure B-8: Observation of Cavitation Damage to Dentates,
Reference [B-7]**

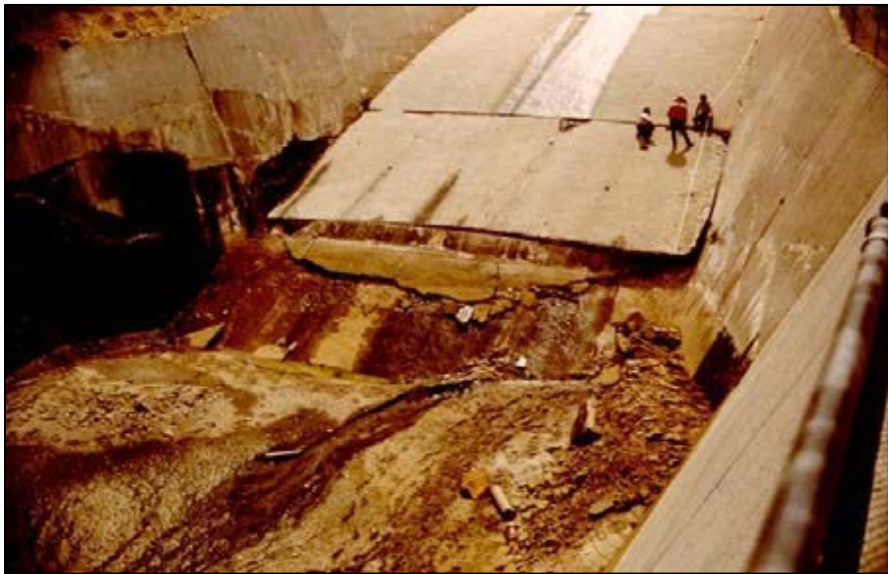
Uplift forces on slabs in hydraulic structures have been a topic of interest for safe and reliable operation for many years. Most of the research has focused on turbulent fluctuations under hydraulic jumps in stilling basins. However, in many instances, a chute slab has failed leading to catastrophic damage, as shown in Figure B-9.

**Figure B-9: Damage from Uplift of Chute Slab,
USBR Report DSO-07-07**

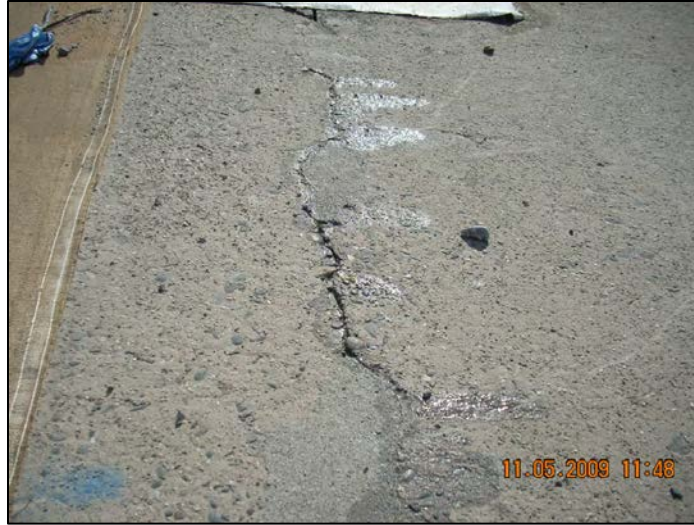
Some slabs have been designed with the drains located within the slabs, as is the case at for the Oroville Dam service spillway. This design feature produces structural weak spots in the slabs that can lead to cracks over the drains, as shown on Figure B-10. These cracks also allow the penetration of water into the foundation below the slab.

Figure B-10: Crack over Herringbone Drain at Oroville Dam Service Spillway, IFT Photo

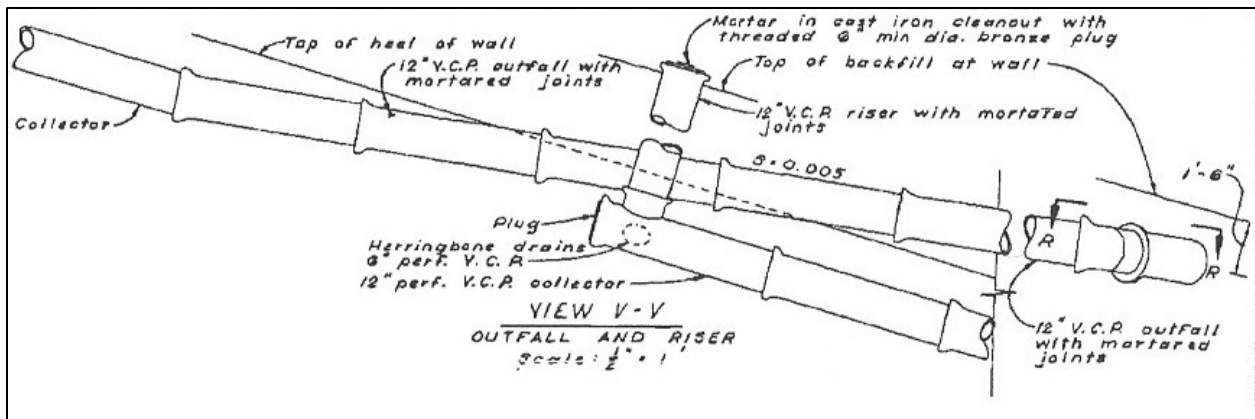
The collector drains exit into an outfall line as shown in Figure B-15. This line has a maximum capacity before it flows full that is determined by its diameter, friction factor, and invert slope. If the capacity of this outfall line is exceeded, the collector drains will begin to fill and discharge water into the backfill material behind the wall through perforations on the top of the collector pipes. For even higher inflow discharges, the flow in the herringbone drains will begin to fill and pressurize the area under the floor slabs on the chute.

Figure B-15: Collector Drain and Outfall, Reference [B-8]

For example, with a 1/4-inch gap in a 7-inch thick slab, the total leakage into the 66.8-foot long herringbone drain would be equal to 0.03 cfs/ft x 66.8 ft = 2 cfs. Since 10 herringbone drains flow into each collector pipe, the total flow into the collector pipe would be 20 cfs. The maximum capacity of the collector pipe before it becomes pressurized is 3.25 cfs. Thus, flows into even very small gaps can exceed the capacity of the collector pipes. This implies that unless the cracks are sealed, all the herringbone drains are probably full of water and that the drain envelopes are saturated.

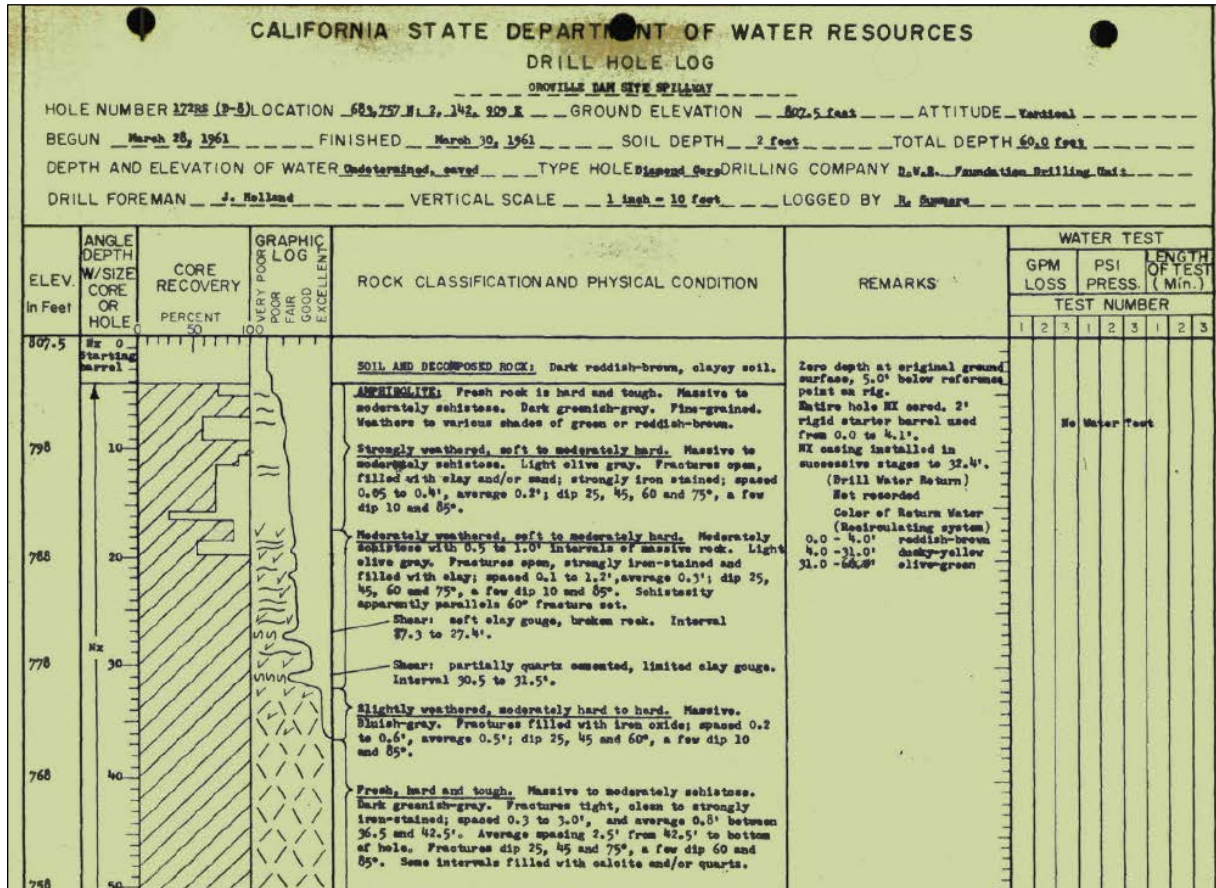
Figure C-6: Borehole 172RS, approximately 500 feet downstream of Emergency Spillway Weir

Although there is a general increase in rock quality with depth, there is great variability in the degree of weathering, jointing, rock strength etc., as would be expected. Rock quality (a product of all these different variables) is thus simply represented in a subjective graphic log.

In view of the high level of care and detail shown in the production of these borehole logs, it is difficult to believe that these authors did not consider these to be the conditions that they described as “subject to relatively accelerated erosion; where this is critical, the rock should be protected.” As the invert is generally shown to be lower, on or into the “sound rock,” there would be little or no rock requiring protection by a concrete lining. This could be the reason why the 1962 report shows the spillway excavation down into sound rock, and does not expressly address a concrete

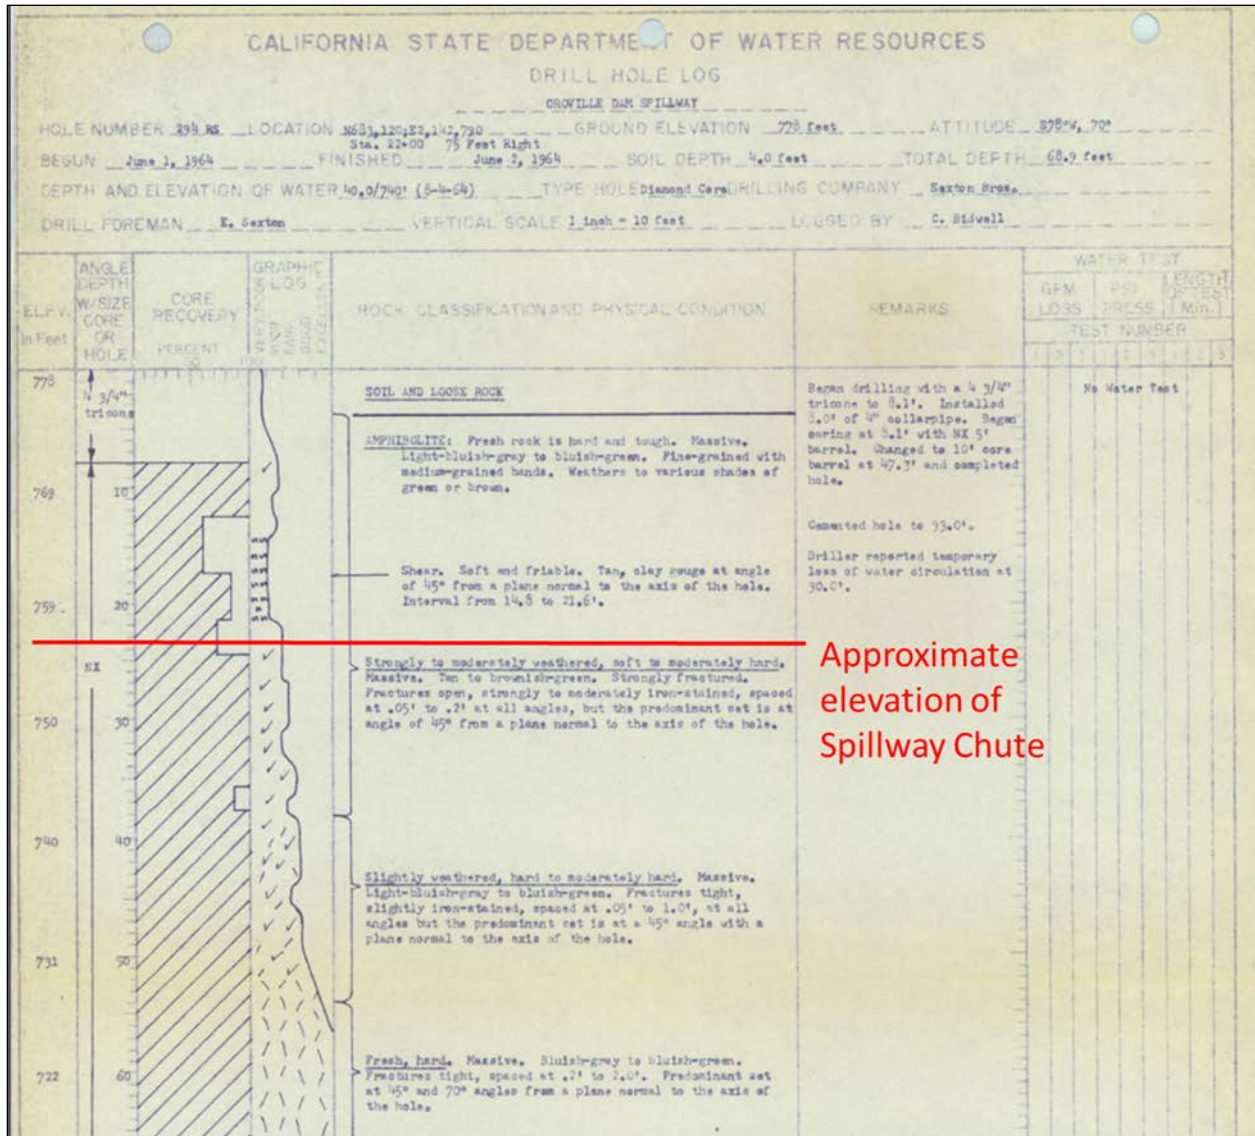
Figure C-9: Borehole 294RS, approximately Sta. 22+00 along Service Spillway, offset 75 feet

“Rippable material at and below invert grade should be anticipated in the chute between Stations 19+00 and 23+00.”

Although rippable conditions were called out in the report, apparently associated with strongly to moderately weathered rock of poor to fair quality (as per Figure C9), apparently no special treatment for such fully rippable foundations was considered, and the following general statement was given:

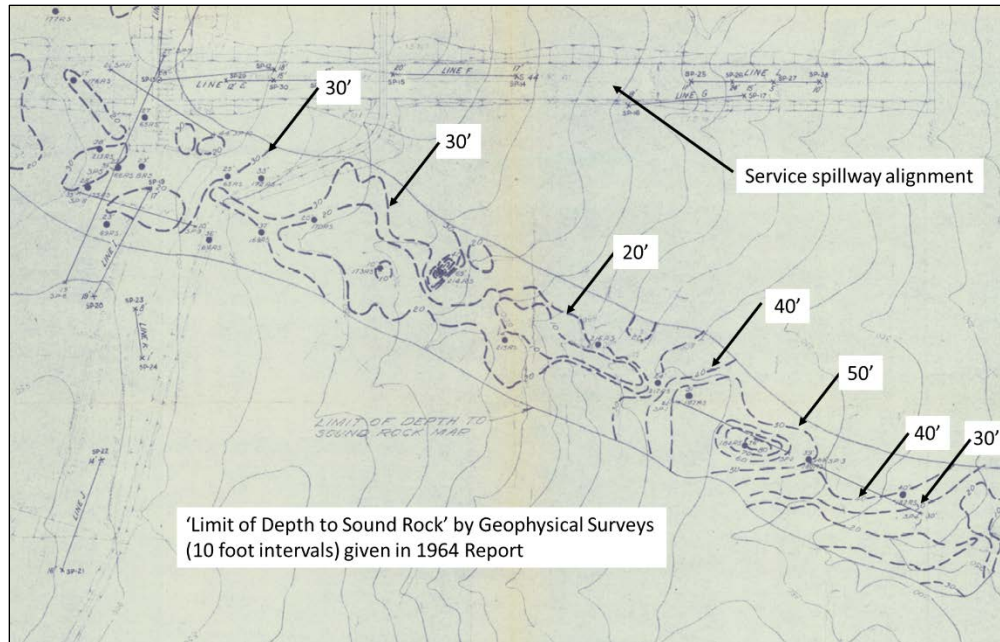
This summary shows large depths to sound rock, as defined for the purpose of riprap exploitation. The relevance to the current discussion is that the report indicates that there was no discernable difference in velocity from the surficial soil and decomposed rock layer until the “sound” rock layer was reached in most surveys, i.e. the measured velocities of the moderately to strongly weathered rock were not different enough from the measured velocities of the soil and decomposed rock to be interpreted as a separate layer. This would be yet another indication that significant depths of erodible material could be expected downstream from the emergency weir.

Figure C-10: Summary of 1961 Geophysical Results downstream from current emergency spillway weir

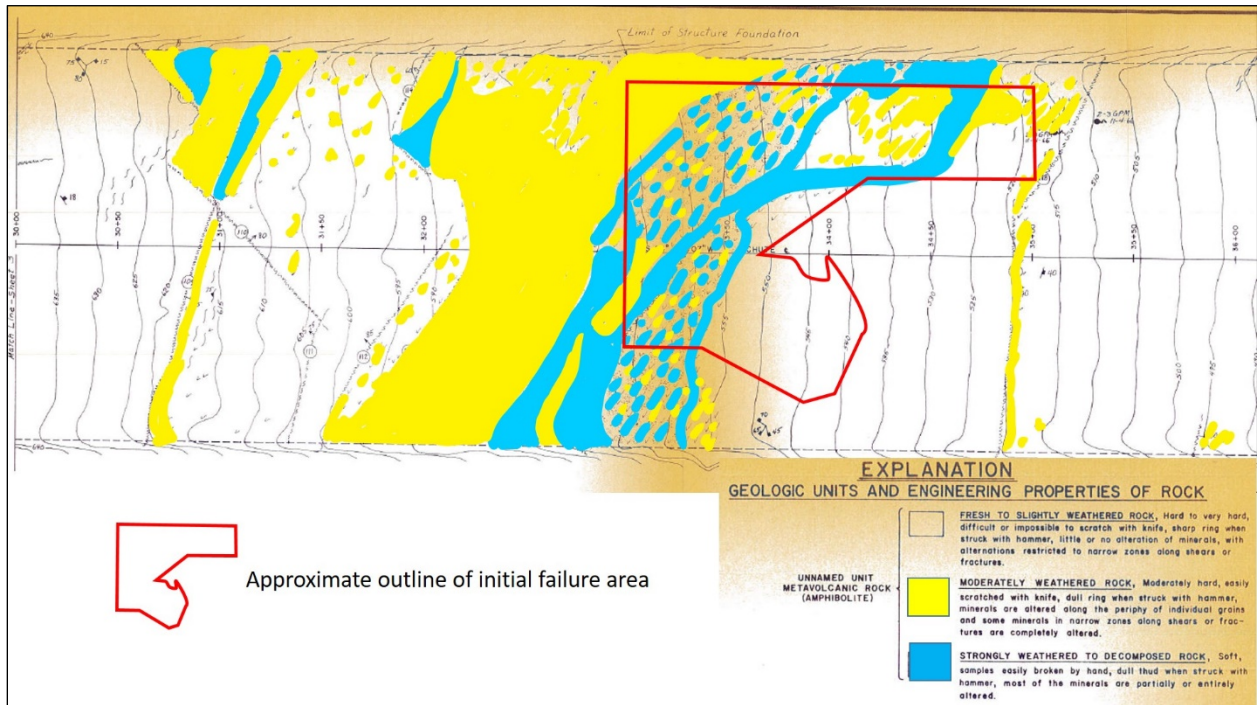
There is no moderately or strongly weathered rock noted in the foundation for the first 600 feet downstream from the headworks structure. The most upstream locations where such conditions were found are documented on the right side of the chute near Sta. 19+00 to 20+50, followed by an area on the left side at Sta. 27+00, with the largest areal extents from Sta. 31+00 to 38+00, in the area of the initial failure in February 2017. Figures C-11 and C-12 are excerpts from drawings in the Final Geologic Report showing the large extents of the moderately and strongly weathered rock, and the degree of compacted clayey fines left upon foundation cleanup in the vicinity of the initial spillway slab failure (colorized by the IFT). These aspects are discussed further in Appendix I.

Figure C-11: Extents of Moderately and Strongly Weathered Rock. Geologic mapping from Final Geologic Report [C-1]

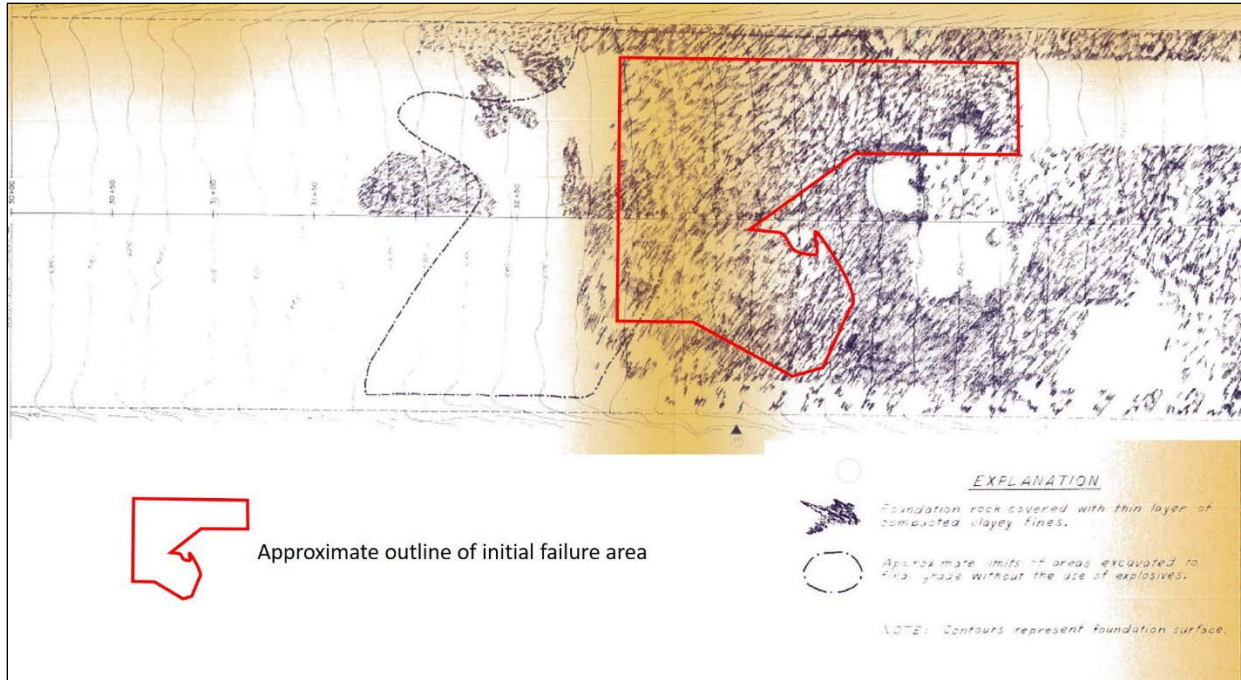
Figure C-12: Extents of Compacted Clayey Fines. Geologic mapping from Final Geologic Reportm [C-1]

layer of compacted clayey material on the rock beneath the drains (Photos 37 through 39, Plate 3). Removal of the compacted clayey material would not be necessary to satisfy foundation strength requirements for the chute lining. Also, removal of this material from 100 percent of the foundation would not be necessary to satisfy underdrain requirements. Therefore, the goal set by design engineers (removal of fines from 50 percent of the foundation) was a practical one, which would provide adequate relief of seepage pressures.”

The IFT could find no other reference to the decision (by the design engineers or others) to relax the specifications and allow 50% fines to remain in the foundation, nor was it ascertained over what unit base area this estimation would be made.
