INDEPENDENT FORENSIC TEAM REPORT OROVILLE DAM SPILLWAY INCIDENT

JANUARY 5, 2018

SUMMARY

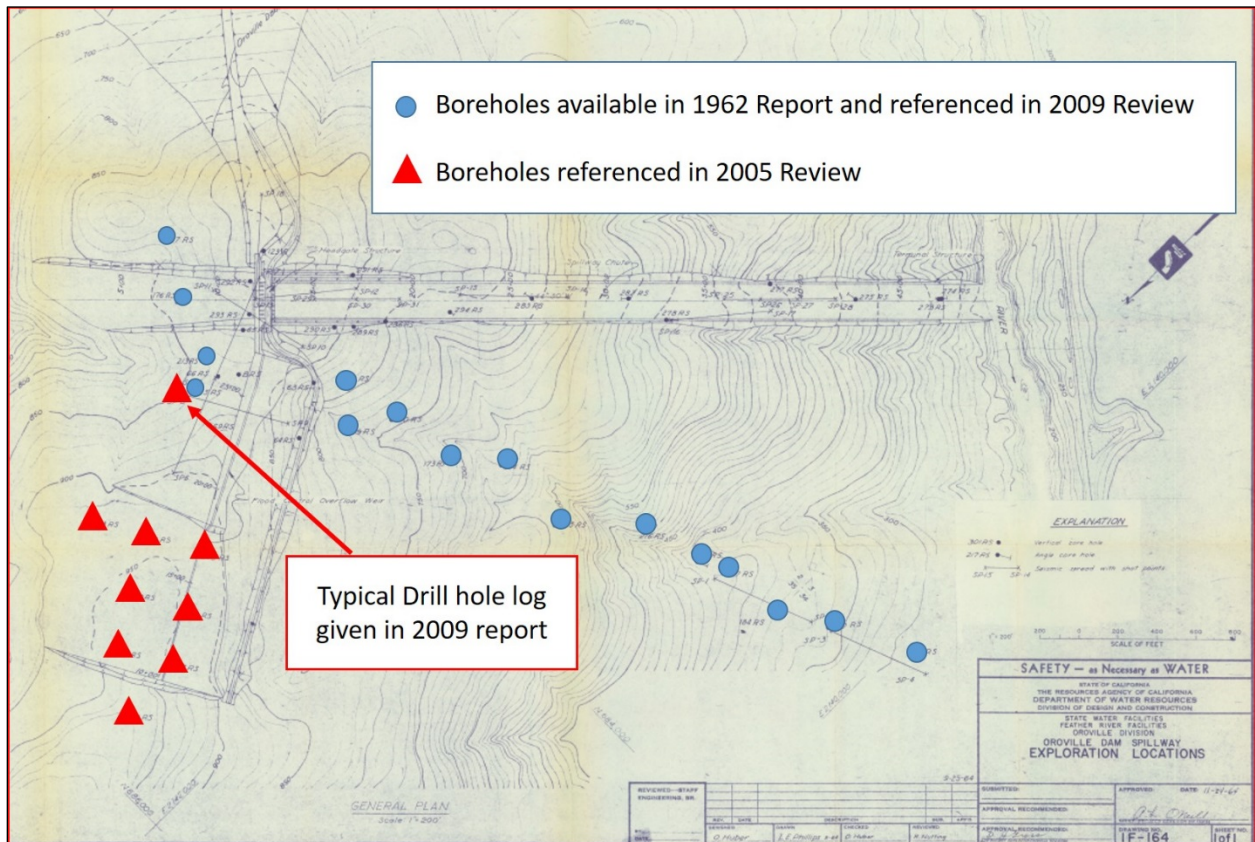
Thus, the detailed geological descriptions that would have given critical information on strength and jointing (which would have indicated the likelihood of erodibility) downstream from the emergency weir were not accessed. However, the nine borehole logs that were accessed provided ample evidence of poor to very poor rock conditions. Even if one assumed that moderately weathered rock was non-erodible, six of the nine logs show worse than moderately weathered rock conditions. Two logs show strongly weathered rock to depths of 12 feet and 17 feet, and all six logs indicate moderately to strongly weathered, moderately weathered to soft, poor to fair conditions to depths ranging from 22 Feet to 44 feet.

Figure C-13: Borehole Logs Available for Review

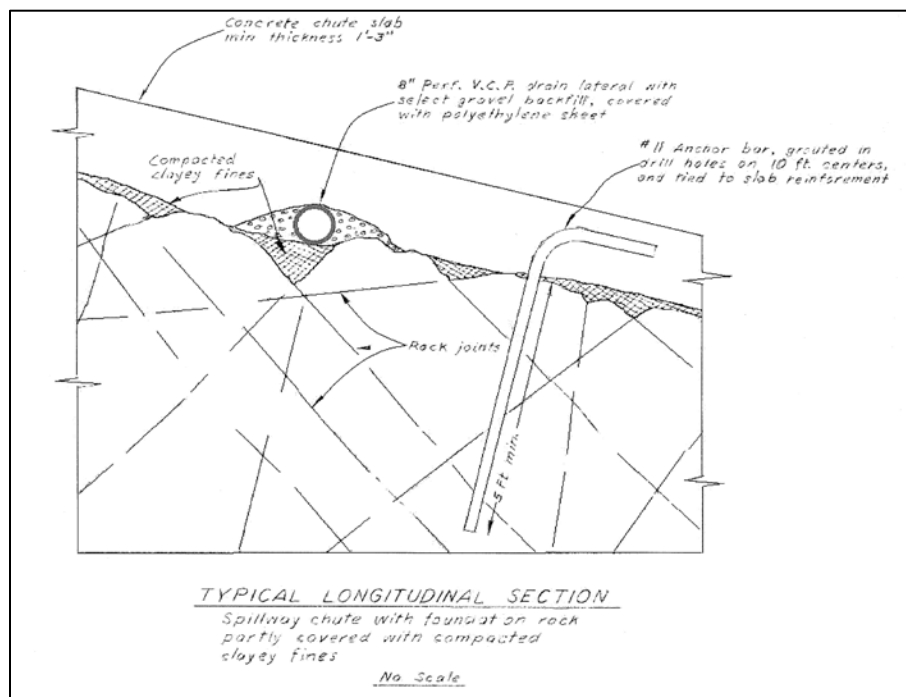
The construction geology report [D-4] includes foundation geological mapping sheets showing Geologic Units and Engineering Properties, including 124 specific shear zones tabulated along the chute. It also includes detailed drawings showing cleanup of the chute foundation, where the foundation rock was left partly covered with a layer of “compacted clayey fines” (Figure D-3). One objective of the IFT investigation program was to achieve a better understanding and definition of the phrase “compacted clayey fines.”

Figure D-3: Sketch from Construction Geology Report Showing “Compacted Clayey Fines”

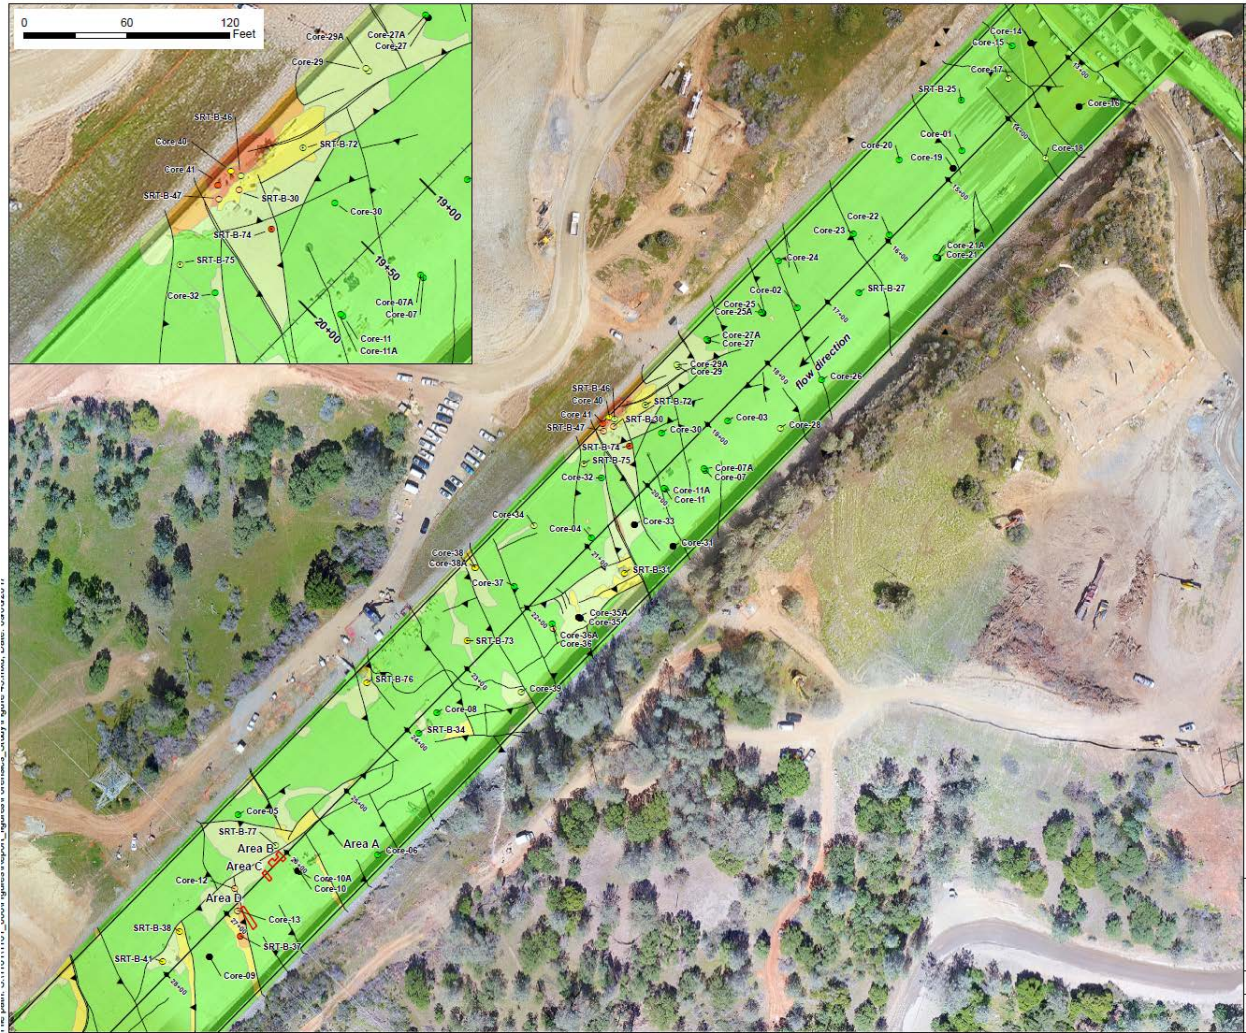
Since the February 2017 incident, DWR geologists have prepared new geologic drawings based on and depicting the original geologic mapping prepared during construction and presented in the Final Geologic Report [D-4]. An extract from the new DWR drawings is presented in Figure D-4. This clearly depicts the locations of some of the weathered conditions in the foundation described in the previous paragraph.

Figure D-4: Geologic Map of Foundation in Upper Chute Area

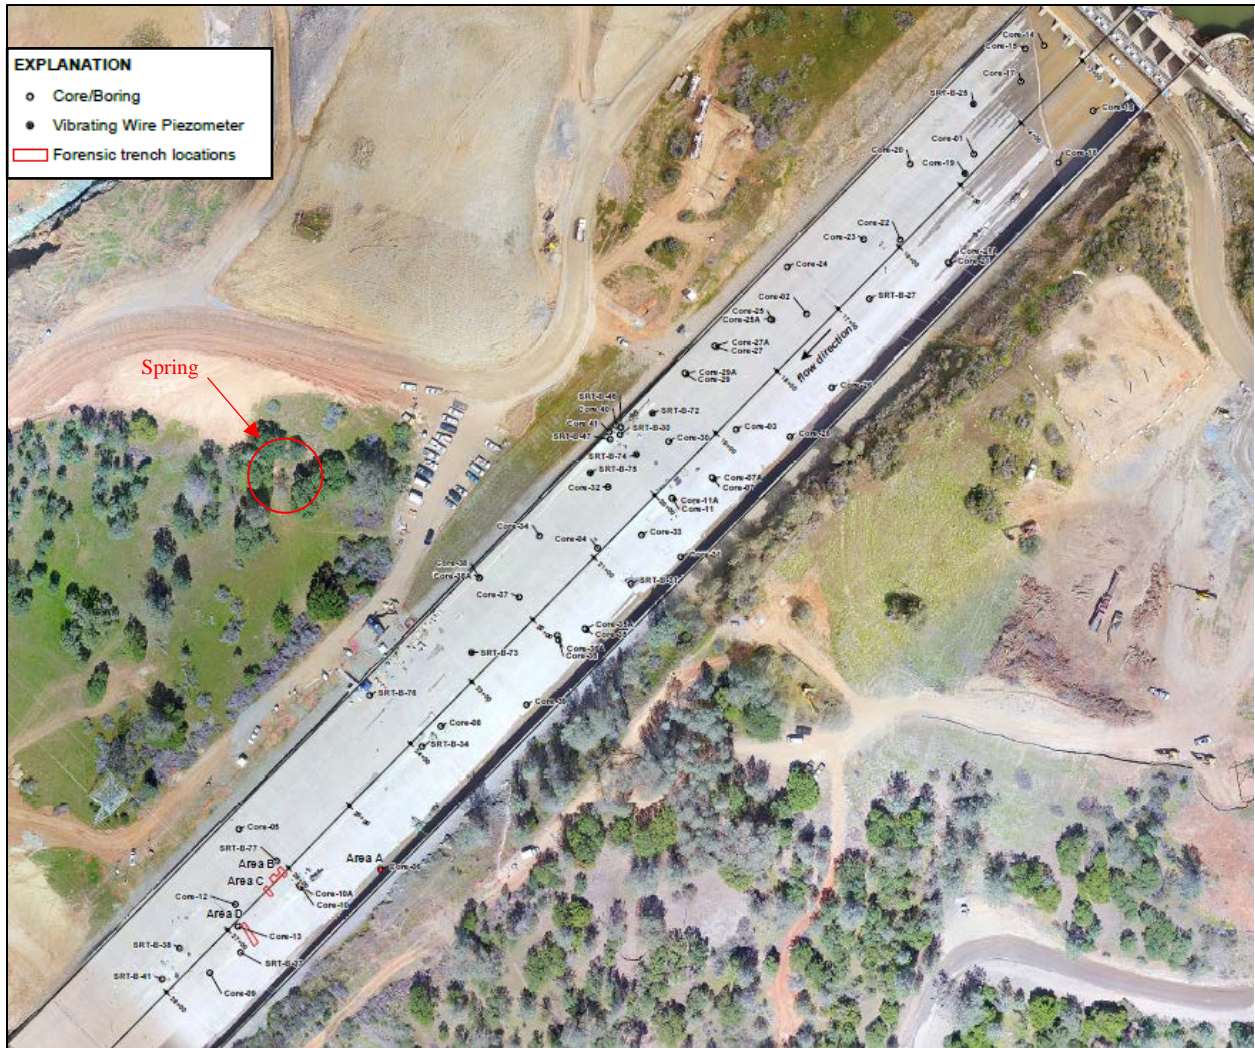
In only three core holes of the 56 locations evaluated in the upper chute area (Figure D-6) were conditions found to be more highly weathered rock than as documented during original spillway construction. Most of the core holes (39 of 68) were drilled to evaluate foundation rock weathering and to help validate or corroborate the historic geologic mapping conducted during construction [D-4]. In their recent program of investigations, DWR geologists compared results of mapping and sampling conducted as part of 2017 studies with mapping completed during original construction, focusing on characterizations of rock weathering. In general, the rock weathering characteristics observed as part of recent studies correlate well with the historic construction mapping. Similarly, foundation bedrock exposed in the forensic trenches was found to be generally consistent with the original construction geology foundation mapping conducted in those areas.

Figure D-6: Location of DWR Core Holes in Upper Chute Area

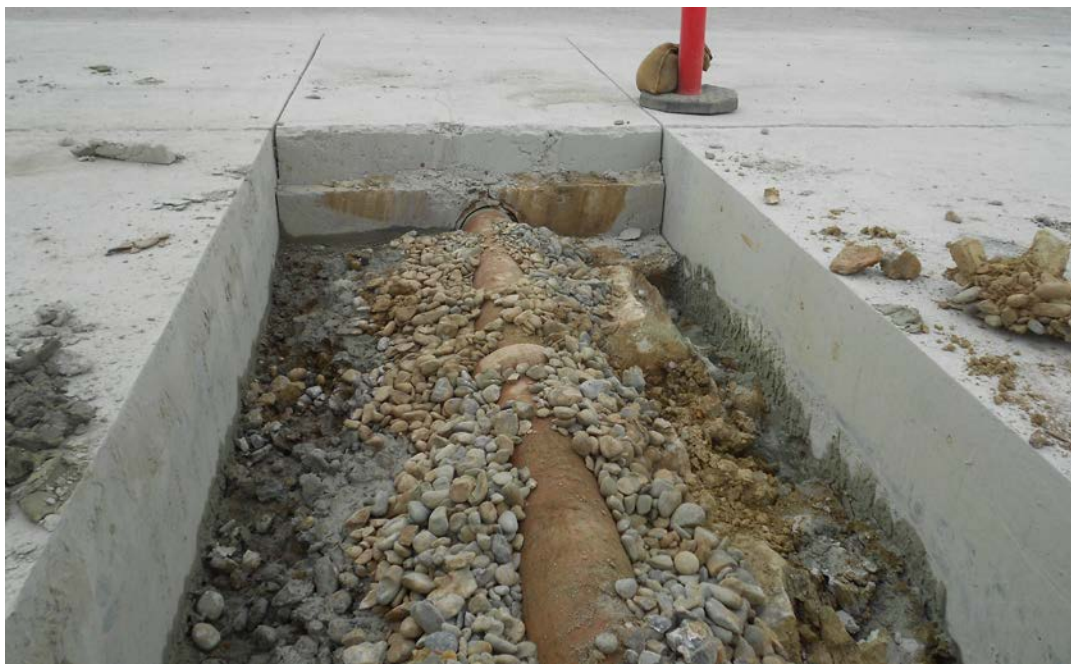
In Figure D-8, “compacted clayey fines” (tan-brown in color) can be seen immediately adjacent to and below a herringbone drain and gravel pack. The gray-colored fines seen in the photograph are from saw-cutting of concrete.

Figure D-8: Forensic Trench Area B (26B1, 26B2), Sta. 26+10

Washing of samples during gradation testing confirmed that much of the sand to gravel size fractions consisted of or included angular particles. It is concluded that the “compacted clayey fines” are largely materials left behind after incomplete foundation cleanup. The exact distribution of these soil-like deposits cannot be known with certainty but their presence and thickness obviously varied significantly over short distances.

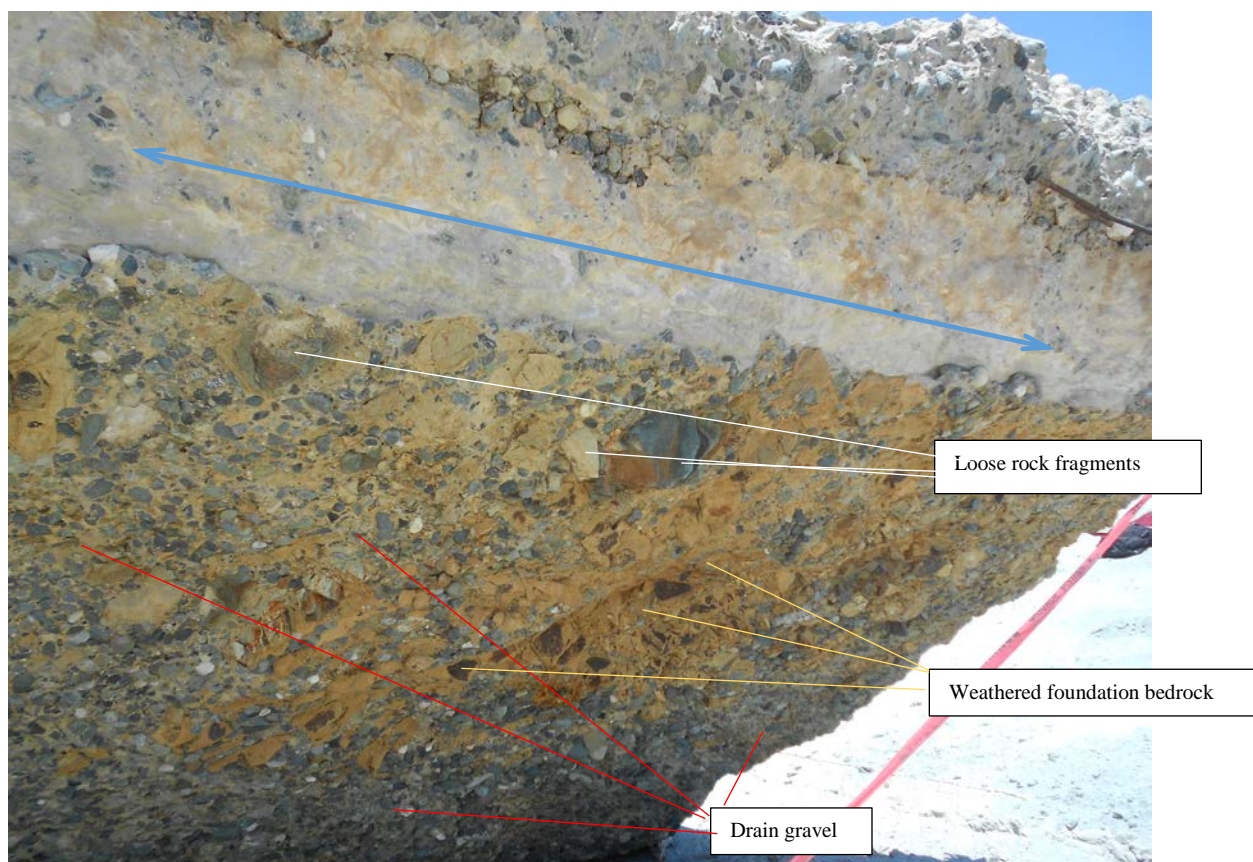
In the field, it was noted that these materials included sharp angular fragments of rock, ranging in size from barely visible to the naked eye up to 1-inch in dimension, suggesting that they are products from excavation of the bedrock foundation, which included blasting. Occasional rounded gravel clasts were observed and are assumed to have originated from spilled drain gravel material as seen in Figure D-8 (forensic trench Area B) and Figure D-9 (bottom of a loose up-rooted concrete block of concrete at the dentates). Figure D-9 shows a cast of a herringbone drain (blue arrows) and evidence of extensive spillage of gravel from drain construction. Also visible in the photograph are loose rock fragments and areas of weathered foundation bedrock adhering to the bottom of the concrete.

Figure D-9: Underside of Removed Chute Slab at Dentates

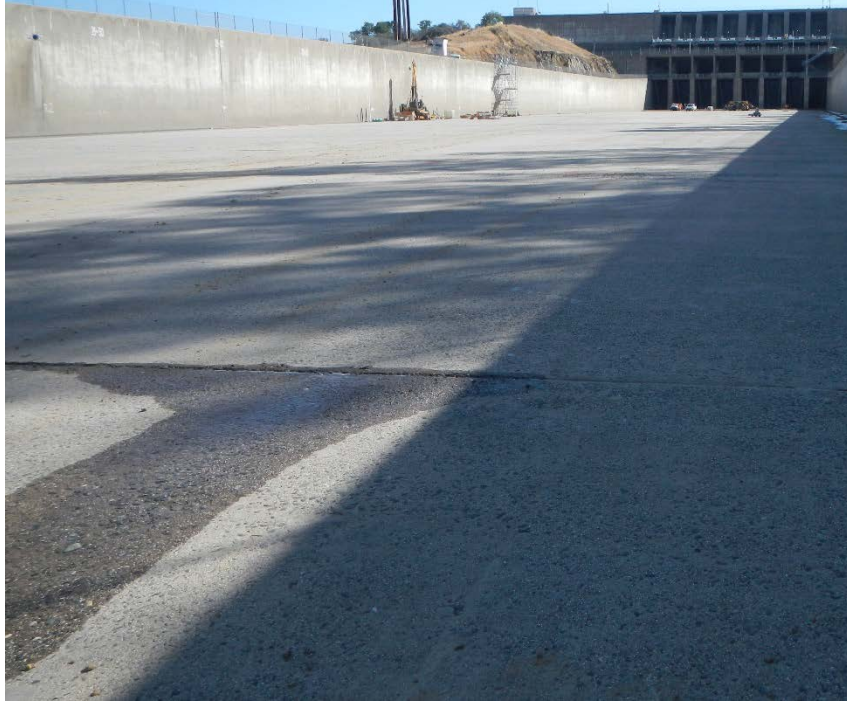
Evidence of water flow beneath chute slabs. Although pre-existing large voids at the concrete/foundation interface were not indisputably observed during the IFT investigations or studies by DWR [D-3], evidence was seen of water flowing under the chute slabs. During the forensic observations, an observation was made of water discharging from a contraction joint at Sta. 23+00 in the upper chute area. This is shown in Figure D-10, where water can be seen welling out of the joint and flowing down the chute surface.

Figure D-10: Water Discharging from Lateral Contraction Joint at Sta 23+00

The origin of the water shown in Figure D-10 is not known but is thought most likely to be from leakage through the gate seals which had been channeled (with sandbags) over to the left side of the chute. Some of this water flowed into cracks and joints in the chute slabs where it could then be intercepted by the underdrain system. In this case, it is thought that the water had migrated along the concrete-foundation interface and then had re-emerged at the surface along a joint once it achieved sufficient head and downstream flow was occluded. Another possibility is that this could be artesian groundwater (or reservoir water). These interpretations are considered less likely since similar conditions were not observed in any of the core holes drilled in the area in 2017. However, they cannot be discounted at this time and until a comprehensive groundwater evaluation is conducted (which is outside the scope of the IFT investigations).

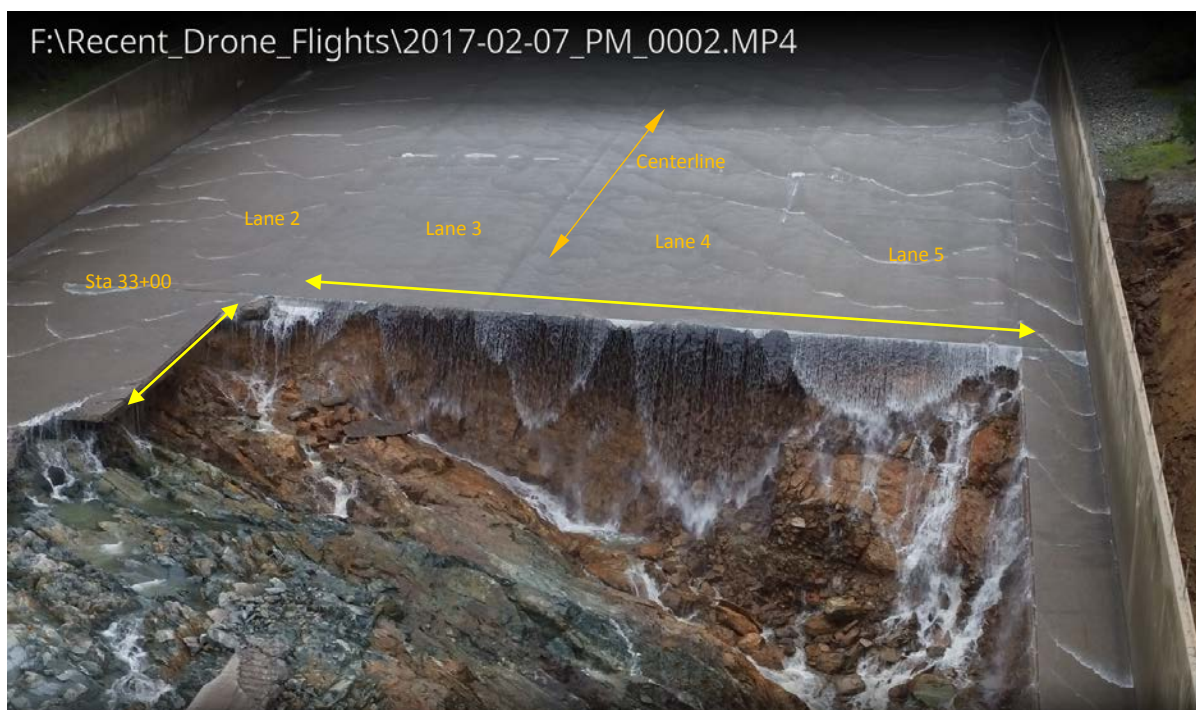
Sta. 31+50 to Sta. 34+50. This area includes the location of the initial spillway chute failure on February 7, 2017, shown in Figure D-11 below. Yellow arrows shown on this photograph indicate sections along which estimates were made of chute slab concrete thickness. Weathered rock is

evident by brown discoloration in contrast to relatively unweathered and fresher rock which is green-gray to blue-gray in color. At the time of the forensic investigation, virtually all concrete slab sections had been removed from this area. However, from detailed examination of enlarged photographs and drone footage of the initial chute damage, it was possible to estimate approximate concrete thickness along the exposed edge at Sta. 33+00. The exercise was somewhat impaired because water was still flowing over the edges, and there was a general absence of objects that could be used for scale. Features used to assist in scaling included spacing of dowels in joints (typically consistently spaced at 18 inches), spacing of steel reinforcement (usually consistently at 12 inches each way), and details of contraction joint keys. In spite of these constraints, concrete thickness estimates were made at various locations along sections indicated by yellow arrows on Figure D-11.

Figure D-11: Image from Drone Flight Showing Location of Initial Chute Failure Downstream from Sta. 33+00

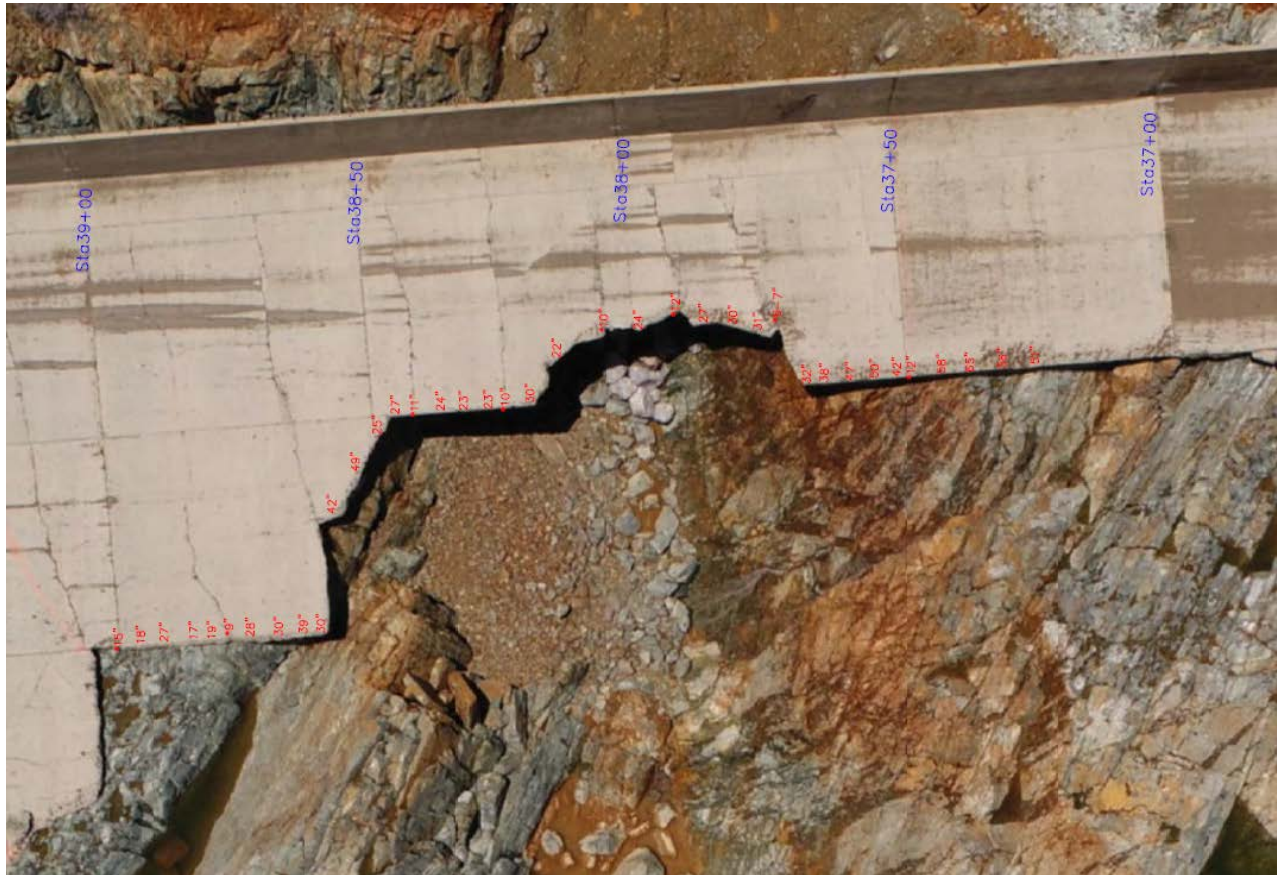
The edge of the Lane 2 panel was well exposed at the chute centerline between Sta. 38+50 (+/-) and Sta. 39+00. The thickness of the concrete in this area ranged from 18 inches (1.5 ft.) to 39 inches (3.25 ft.). The concrete cover over a herringbone drain was 9 inches (observed minimum cover at herringbone drains indicated by * symbol in front of the numeral on Figure D-13).

Figure D-13: Plan of Erosional Feature Between Sta. 37+00 and Sta. 39+00 Showing Observed Concrete Thickness Values (in inches)

The thickness of concrete remaining on each side of the erosional feature was observed to be significantly greater than it was in the central part. On the upstream part, from Sta. 37+25 to Sta. 37+60, the concrete was from 48 inches (4.0 ft.) to 65 inches (5.4 ft.) thick. In the central area, between Sta. 37+60 and Sta. 38+50, the concrete thickness values ranged from 22 inches (1.8 ft.) to 38 inches (3.1 ft.). Downstream of Sta. 38+50, the thickness values increased up to 49 inches (4.1 ft.).

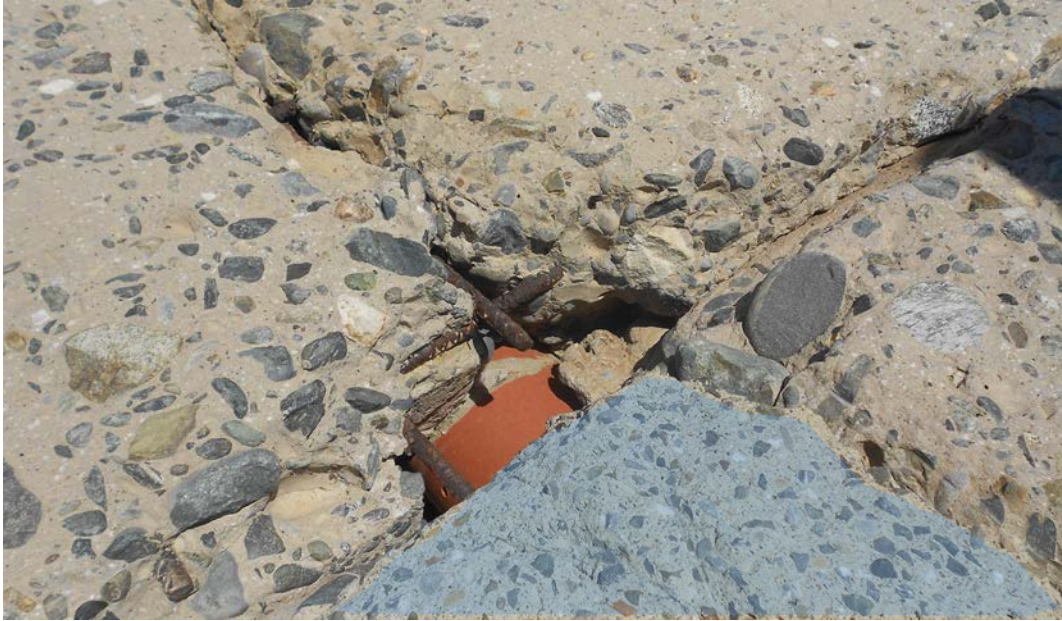
- Large aggregate, combined with the 7-inch cover over drains and the reinforcement mat above the drains with 3-inch cover, probably resulted in issues at these locations during concrete placement and screeding at herringbone drains that required increased effort to consolidate the concrete, especially near the chute centerline. The effects of this were observed at several locations particularly in central areas of the chute, see Figure D-14. At some locations, it appeared that troweling, possibly excessive, was done in order to provide a smooth concrete placement in this difficult area above drains.

Figure D-14: Example of area of congested large-size aggregate over herringbone drain and reinforcement. Location at Sta. 42+00 and centerline. Area of repair patch concrete shaded (note smaller aggregate).

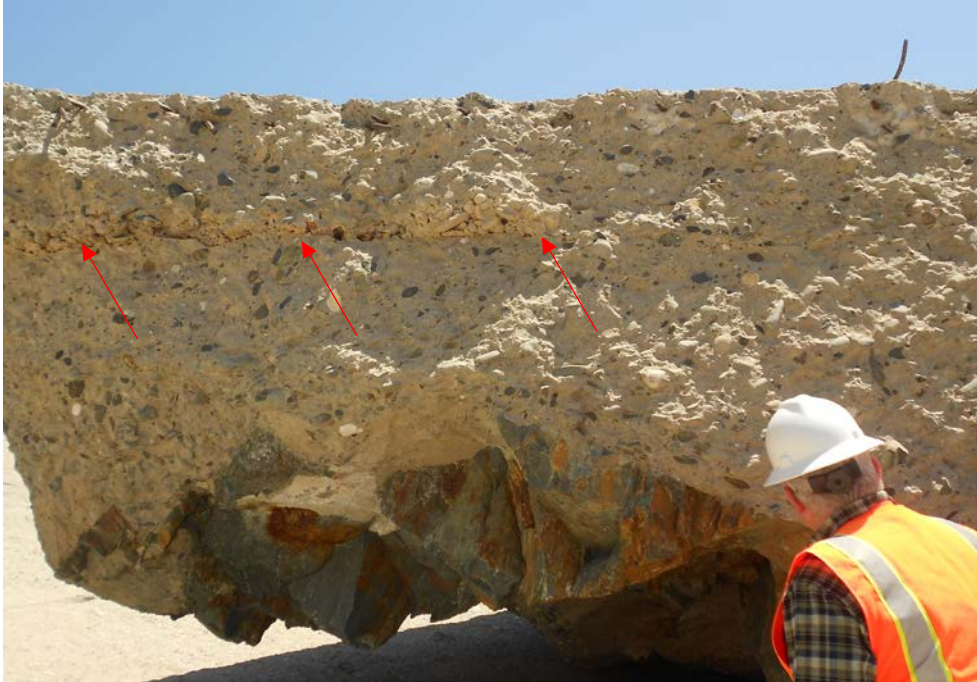
- As concrete was being placed, larger aggregate could have damaged the vitrified clay pipe (VCP) herringbone tile drains.
- Large size aggregate made it difficult to form and place concrete at joint keys between slabs with probable segregation.
- Evidence of segregation was observed at several locations where large aggregates seem to have accumulated toward the bottom of lifts and finer aggregates in the upper areas. The larger aggregate could have presented difficulties in concrete placement through the single layer of reinforcement in the upper part of the slabs.
- Cold joints and poor contacts between multiple concrete placements are evident in many of the thicker concrete sections, see Figure D-15.

Figure D-15: Example of poorly prepared joint (red arrows) between two concrete placements in loose block lodged at dentates; joint was associated with open honeycombing, about 2 feet below top of slab; maximum slab thickness was ~6.2 feet. Note base of concrete bonded to relatively fresh rock, which became detached when the slab was lifted from foundation.

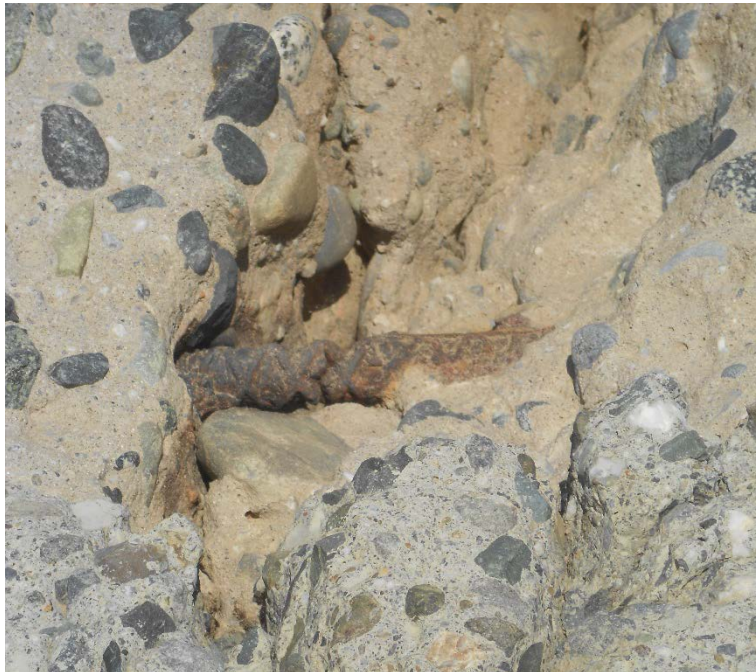
Condition and Deterioration of Concrete Reinforcement over Time. Reinforcement corrosion had been reported at some locations in previous inspection and repair documentation, as discussed in Appendix G. During the forensic investigations several examples of corrosion and failed bars were witnessed in cracks overlying herringbone drains, Figure D-16. In places, the bars appeared to have failed in tension from temperature loading (contraction). Corrosion at the cracks probably weakened the bars, making it easier for them to fail. The frequency of herringbone drains (approximately every 20 or 25 feet along the chute) means that what little benefit the single layer of reinforcement provided was seriously compromised. Severe corrosion was only observed at locations where flowing oxygenated water had come into direct contact with the steel, such as at cracks in the concrete, and not within intact concrete as has been indicated in some media reports.

Figure D-16: Example of failed reinforcement steel with corrosion at a crack above a herringbone drain. The reinforcement is completely severed.

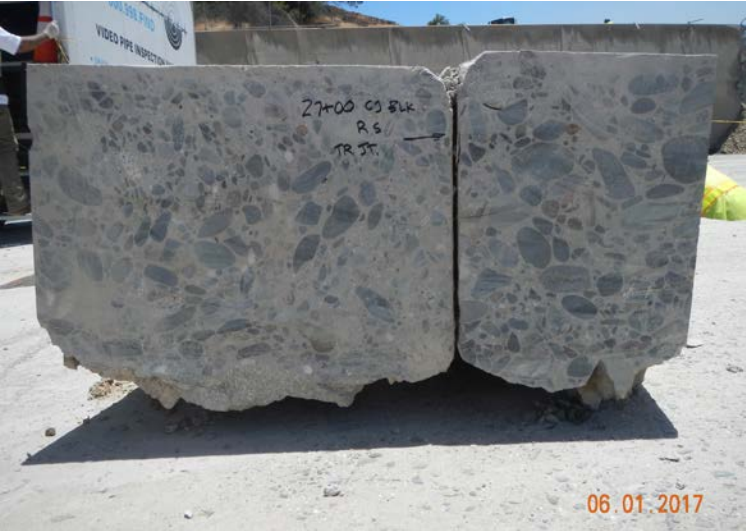
Most formed lateral contraction joints were constructed with keys and dowels, as shown on Figure D-17, although several variations in the geometry of the keys were observed during forensic investigations and demolition. Some lateral contraction joints showed no evidence that keys had been installed during construction, e.g. Sta. 27+00 and Sta. 39+00, Figures D-20 and D-21.

Figure D-20: Lateral Contraction Joint at Sta. 27+00; Joint Key Absent

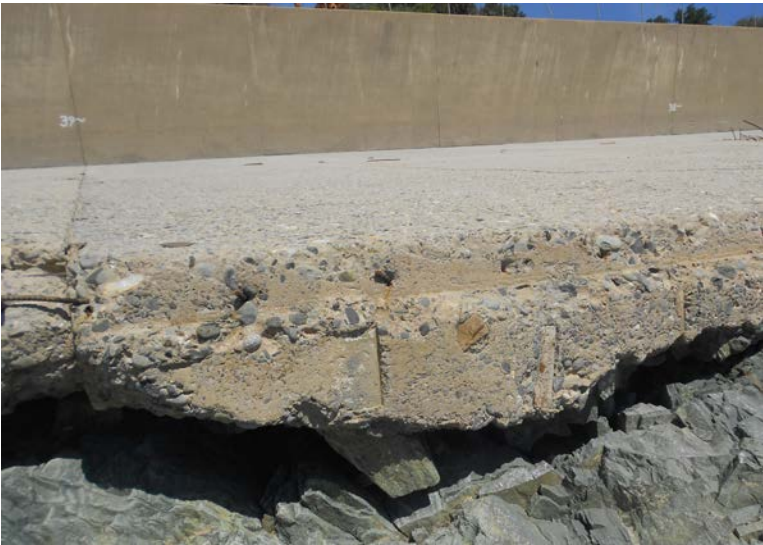
Figure D-21: Lateral Contraction Joint at Sta. 39+00 on Left Side of Photograph with Missing Joint Key

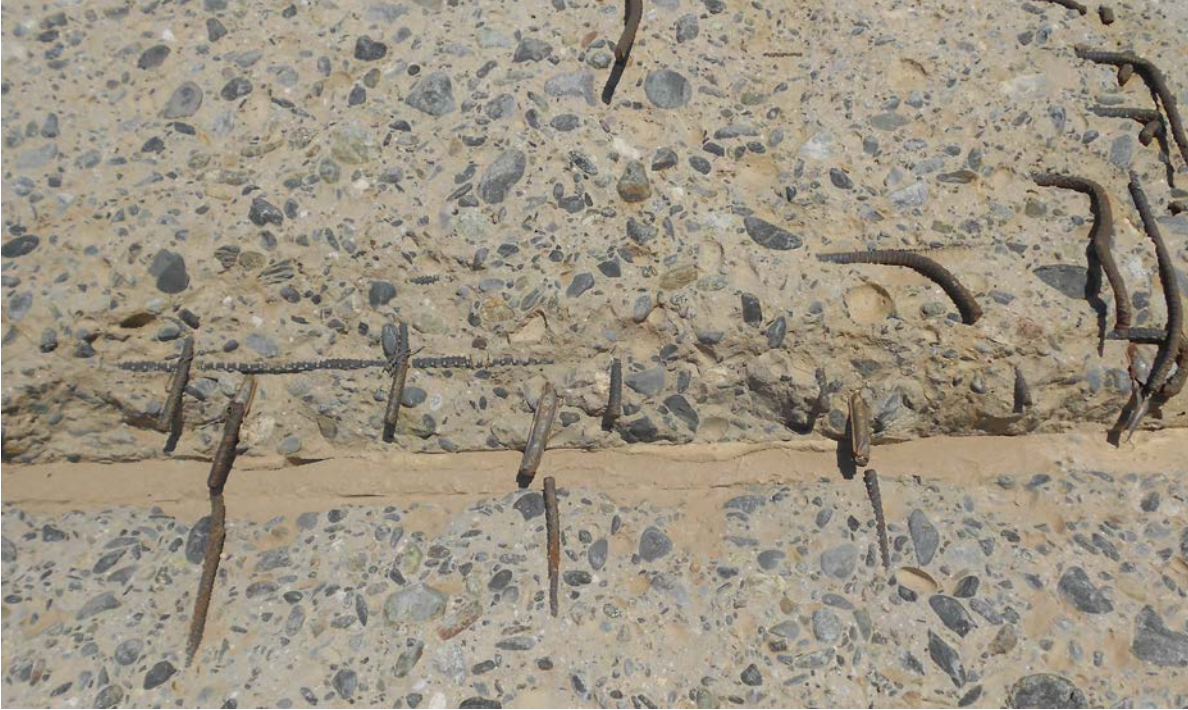
Figure D-23: Lateral Formed Contraction Joint at Sta. 43+00

Dowels at contraction joints were also observed to be quite severely corroded in places. This was generally at locations where the dowel sleeves had become damaged or where the dowels themselves had become damaged or exposed during concrete repairs. Corrosion was likely more severe because these dowels were not bonded to the concrete, and therefore more vulnerable. The original grease packing in the dowel sleeves had disappeared a long time ago. During the forensic field investigations, evidence was also seen where concrete reinforcement at herringbone cracks and dowels at contraction joints had been saw-cut during earlier repair programs but had not been replaced or spliced, see Figure D-23.

Reports have been noted of injection of grout into some joints during historical repair programs on the service spillway chute, as discussed in Appendix G. However, no evidence of cementitious grout materials was seen in any contraction joints during the forensic investigations, except in one possible instance at Sta. 43+00, where probable grout filling was noted in this lateral joint on the left side of the spillway. This is shown on Figure D1-23, which is an area of the lower chute that was highly eroded by spillway flows following February 2017 incident. Grout infill can be seen from an earlier repair program. In addition, dowels across the joint can be seen to have been saw-cut but not replaced or spliced during these repairs.

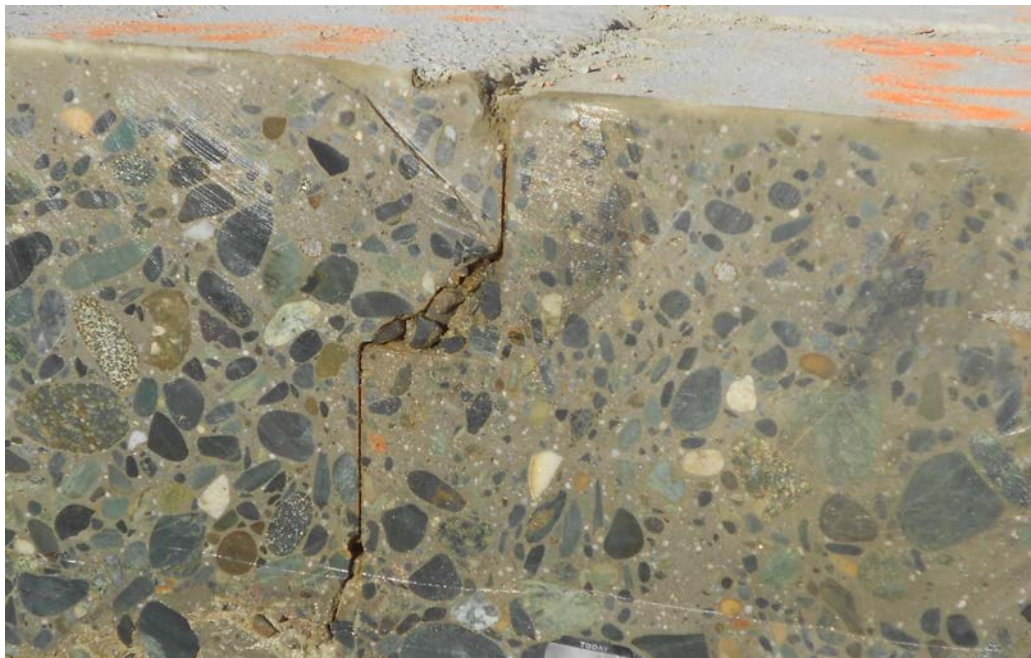
- Stress failures at shear keys. During the forensic investigations, numerous observations were made of diagonal cracks cutting across the shear keys as illustrated in Figures D-24 and D1-23. This is a consistent and pervasive condition that could be properly seen only in the forensic trenches and at edges of concrete exposed by demolition or erosion. It would have been difficult (or even impossible) to detect such cracks during visual inspections at the surface of the chute. The condition appears to have mostly affected the right-angle (rectilinear) shear key configuration – as indicated on Figures D-24 and D-25. It is estimated that 80% to 90% of the joints with this configuration that were observed exhibited cracking of this nature to various degrees. Cracking was observed mostly above the horizontal section of the joint than below it, and in only one case cracking was seen both above and below the horizontal section. Cracking occurrence on the longitudinal joints appeared to be slightly less common than on the lateral joints. Although it is not known when the process would have begun, it is assumed that the condition developed progressively due to loadings exceeding the strengths of the keys. The result would have been reduced capacity of the shear keys and reduced ability to resist uplift forces applied to the slabs. In addition, it is possible that the hydraulic conductivity of some joints could

have increased as a result of the cracking and shortened the seepage path between the top and bottom of the slab.

Figure D-24: Typical Cracking at Shear Key

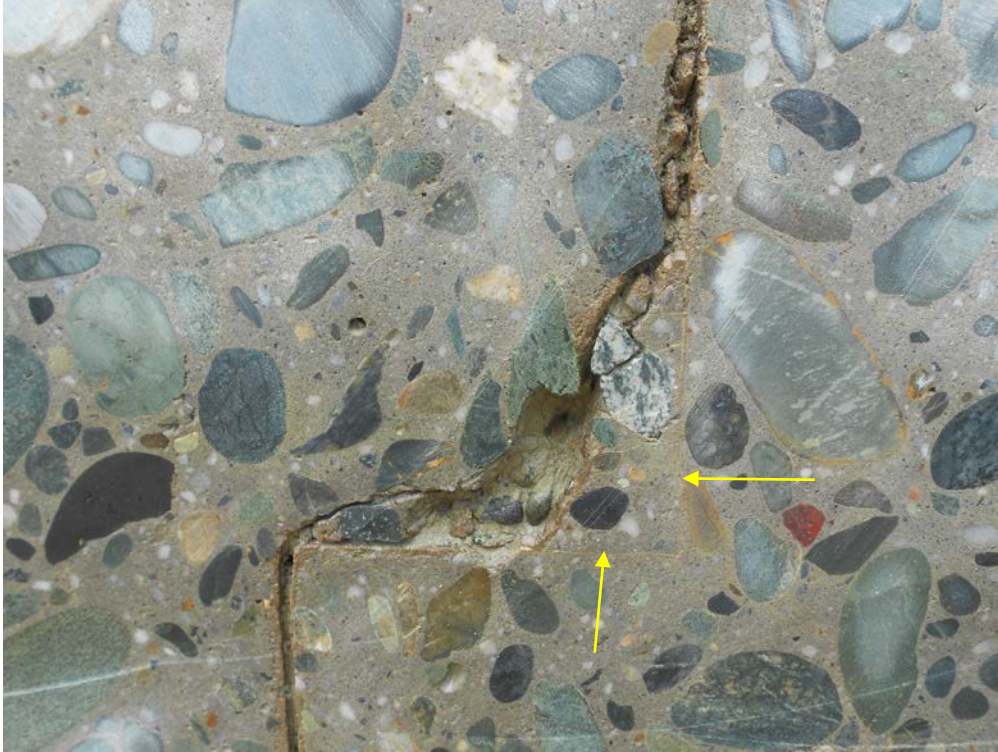
- Bond at shear keys. According to the as-built drawings [D4], a bond breaker should have been applied on the concrete surfaces within the shear keys. It appears that, if the bond breaker had been applied, it was not effective in parts of many keys, in particular some parts of the horizontal and upper vertical portions of the key, as shown in Figures D-24 and D-25 (see yellow arrows). These portions appeared to have bonded (e.g. during low-flow/no-flow periods, by deposition of hydroxides and carbonates exuding from the concrete). Such cementation could also have contributed to the cracking described in the previous paragraph.

Figure D-25: Shear Key with Tight Bond (Arrows) and Typical Cracking

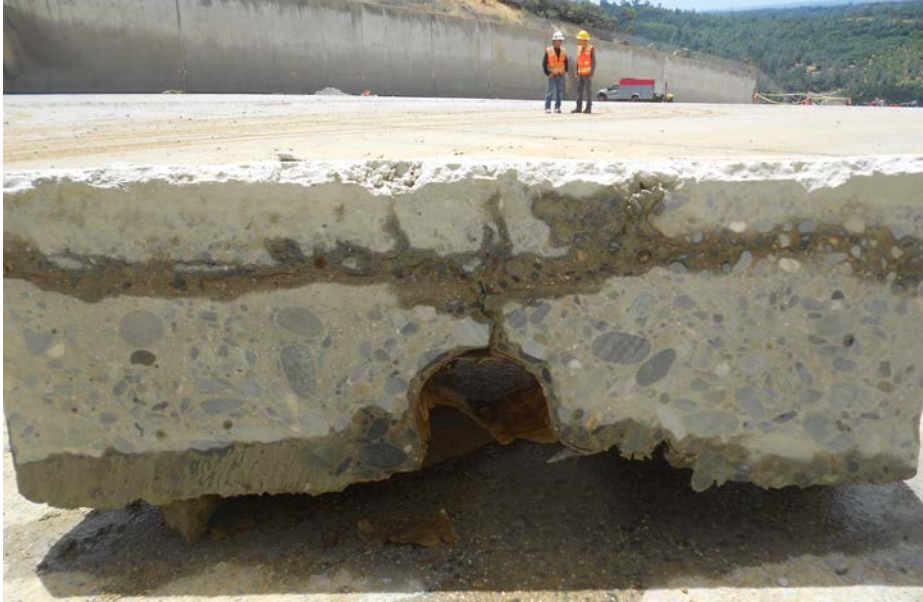
- **Delamination.** A common feature observed during the forensic investigations was the presence of delamination of the chute concrete. This feature consists of development of a horizontal crack ranging in depth from 3 to 6 inches, just above or at the steel reinforcement and dowel line. Typically, it was observed to extend away from a contraction joint or a crack located above a herringbone drain for a distance ranging from a few inches up to 2 feet. Figure D-26 shows an example of delamination extending from a crack over a herringbone drain encountered in forensic trench 26F1 at Sta. 26+37. Figure D-27 illustrates an example of delamination extending from a centerline contraction joint at Sta. 27+11. To the left of the contraction joint, a delamination is present at the base of a patch (at a depth of about 8 inches) and another delamination is running through the patch at the reinforcing steel level (at a depth of about 3 inches). Another delamination is starting to the right of the centerline joint extending horizontally about 6 inches at a depth of about 3 inches, just above reinforcing steel.

Figure D-26: Delamination Extending from Crack over Herringbone Drain Encountered in Forensic Trench 26F1 at Sta. 26+37

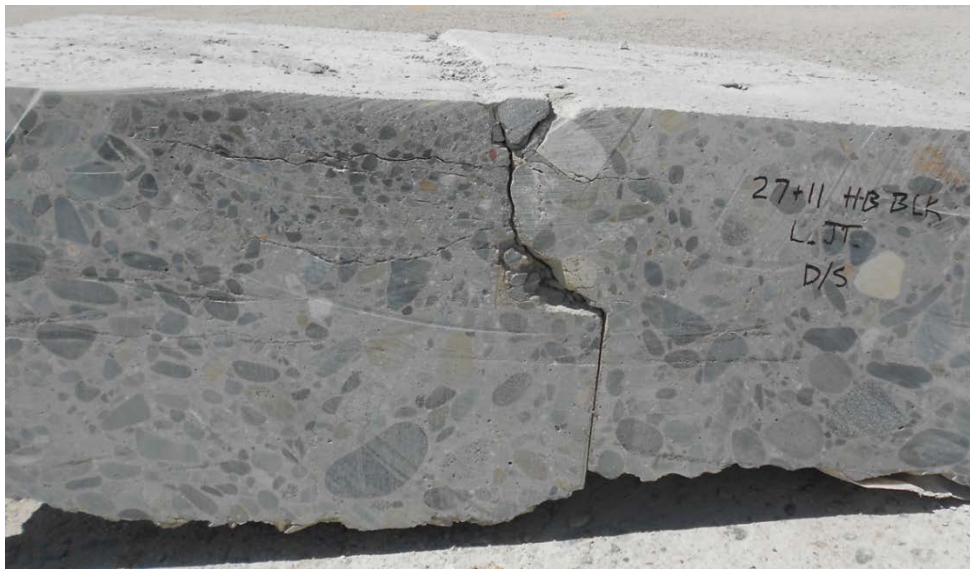
Based on the forensic investigation and reports from historic repairs, delamination cracks were seen to have developed mostly on the downstream side of lateral contraction joints or herringbone cracks, though some instances were also observed on the upstream side (estimated approximately 75% on downstream side and 25% on upstream side). Evidence of delamination was also observed extending laterally away from longitudinal contraction joints, in particular the centerline joint which has a similar configuration as the typical formed lateral joints.

Figure D-27: Delamination Extending from Centerline Contraction Joint at Sta. 27+11

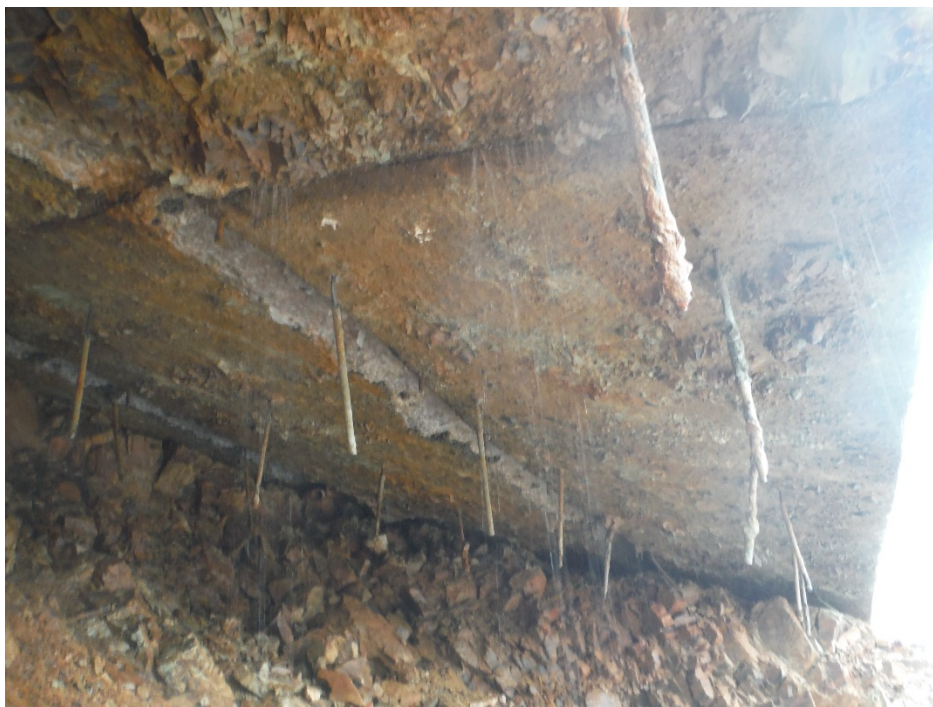
Figure D-29: Undercut Area of Chute Slab at Sta. 33+00 (left side) with Exposure of Anchor Bars

It is evident that at many installation locations these actions were not properly followed. As a result, anchor bars could be seen that were not properly encapsulated in grout, probably as a result of not properly fulfilling points 2, 3, or 4 listed above, or any combination of them. In the area shown in Figure D-29 (Sta. 33+00), photographic and video records show that most of the visible anchors were apparently well-encased in grout, though there are some possible indications of corrosion near the foundation-rock interface. In the area illustrated in Figure D-30 (approximately Sta. 37+00 to Sta. 38+00), consistent grout encapsulation was not as evident from photographs, drone imagery, and field observations. The anchors in the closest row seem to be reasonably well-encapsulated and, even where the grout has been chipped/knocked off (during erosion following the spillway chute failure), the underlying steel looks fresh and apparently uncorroded (e.g. anchor on extreme left of image and anchor second from right). In contrast, the next row of anchors behind are in poor condition with poor encapsulation, and exhibit moderate to severe corrosion.

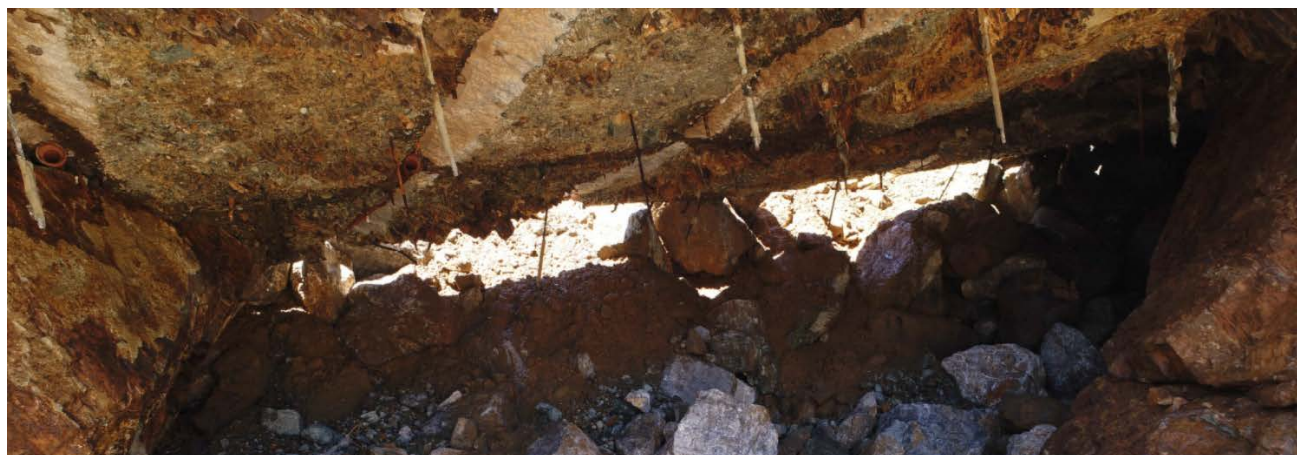
Figure D-30: Undercut Area of Chute Slab at Approximate Sta. 37+00 (left) to Sta. 38+00 (right)

Similarly in Figure D-30, which is a photograph of the area beneath scenes in Figures D-12 and D-13, anchors can also be seen with uniform spacing and lengths, even though the foundation in the area was mapped as moderately weathered to strongly weathered and decomposed and included a major shear [D-4]. In this photograph, the sloping surfaces that can be seen cutting into the slabs was produced by the plastic-wrapped gravel envelope surrounding the herringbone drains.

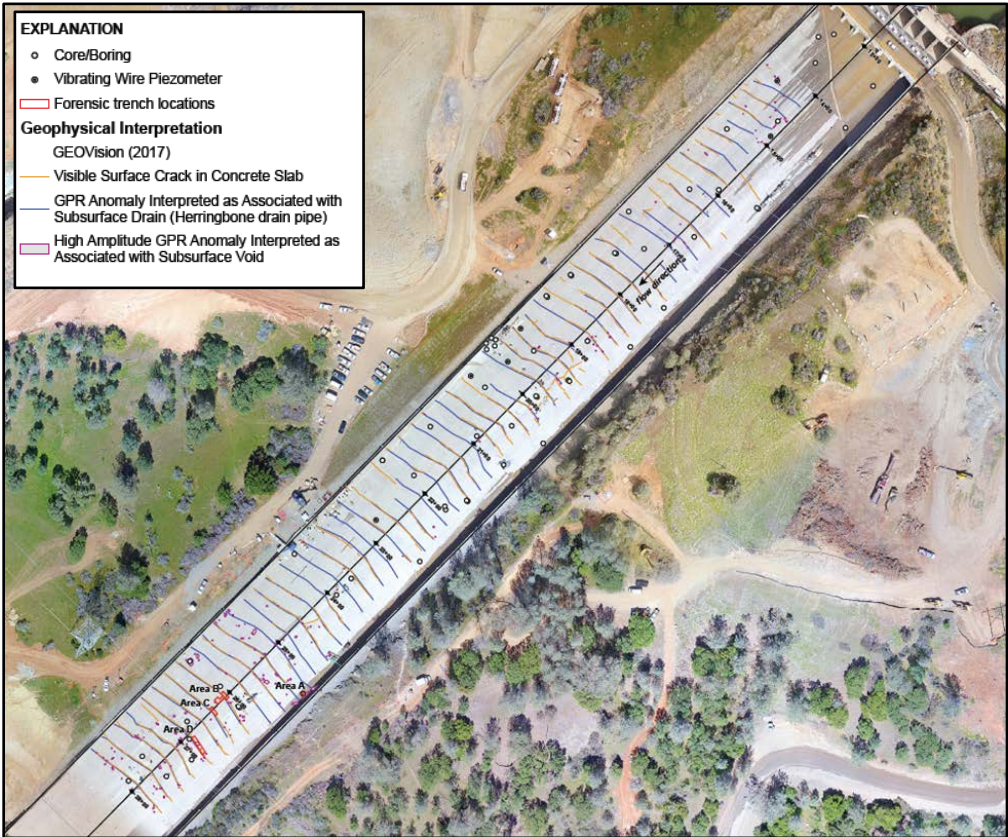
Crack Mapping. From DWR reports, photographs, and satellite imagery prior to the February 2017 incident, it was evident to the IFT that nearly every herringbone drain under the service spillway chute was associated with a crack in the concrete immediately above a drain. Following sealing repairs in 2009, the visibility of the cracks was so conspicuous that they could even be seen on Google Earth satellite imagery [D-13]. The initial phase of the 2017 geophysical surveys included systematic mapping of crack traces on the concrete surface of the upper area of the spillway chute. This crack mapping was performed by DWR Project Geology using high-resolution, geo-referenced drone photography, Figure D-31. A similar survey of the damaged lower chute section was not performed, although high-resolution drone imagery was obtained and reviewed by the IFT. Results of the crack mapping are presented in the DWR Geology Report [D-3].

Figure D-31: Crack Mapping in Upper Chute Area
