INDEPENDENT FORENSIC TEAM REPORT OROVILLE DAM SPILLWAY INCIDENT

JANUARY 5, 2018

SUMMARY

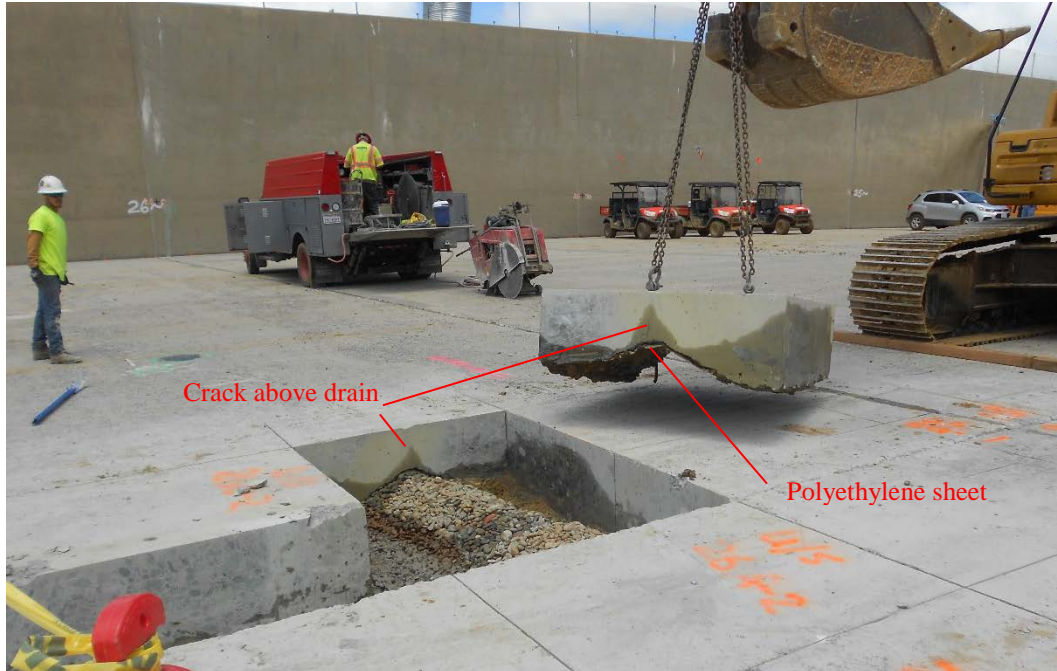
Photograph in Figure D-34 shows typical removal of a saw-cut slab from above a herringbone drain in the upper chute area at Sta. 26+12 and centerline. This illustrates the typical gravel pack at an underdrain, the polyethylene sheet (adhering to base of concrete), and a crack above the drain.

Figure D-34: Removal of Saw-cut Slab from Above Herringbone Drain in Upper Chute Area

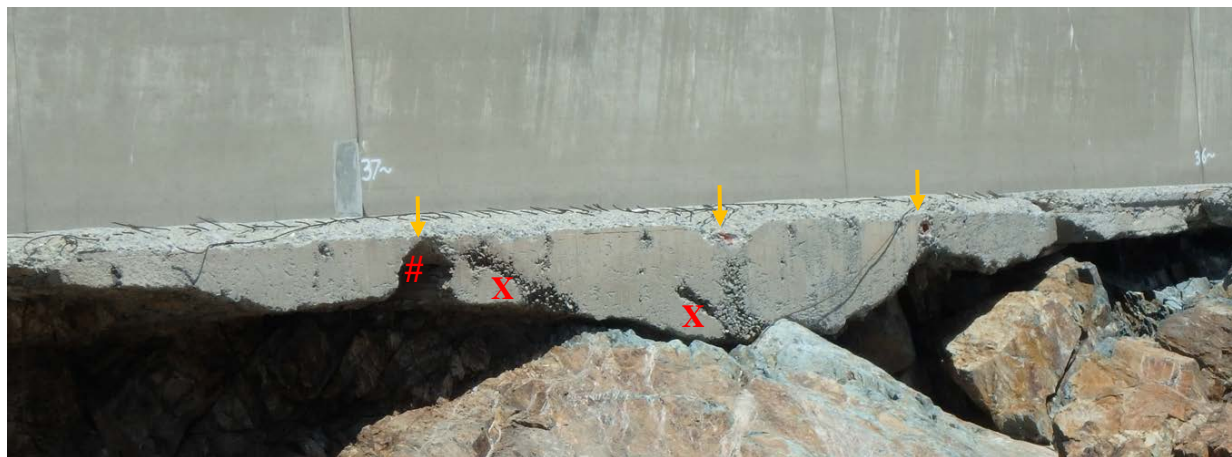
Figure D-36: Typical Drain Construction Defects (explanation in text)

Both the types of concrete backfill drainage detail were observed at numerous locations during the forensic investigations and demolition. It was noted by the IFT that these details were probably difficult to construct, and several deviations or defects were observed during forensic investigations, including:

- Collapsed gravel formwork or sonotube, resulting in a locally ineffective drain and/or uncontrolled hydraulic pathways through concrete or over the foundation. Figure D-36 illustrates drain construction defects at a longitudinal contraction joint, between lanes 2 and 3, at approx. Sta. 37+00 – Sta. 37+70 in the lower chute area. Underdrain locations are shown by yellow arrows, collapsed formwork and gravel spillage are shown by X symbols, and a suspect installation is marked by # symbol where gravel formwork was apparently 3-4 feet in width.
- Noted absence at several locations, over distances of 10 to 20 ft., of gravel formwork or sonotubes needed to connect drains to the foundation through thick concrete backfill.
- Frequent spillage of gravel from formwork or sonotubes.

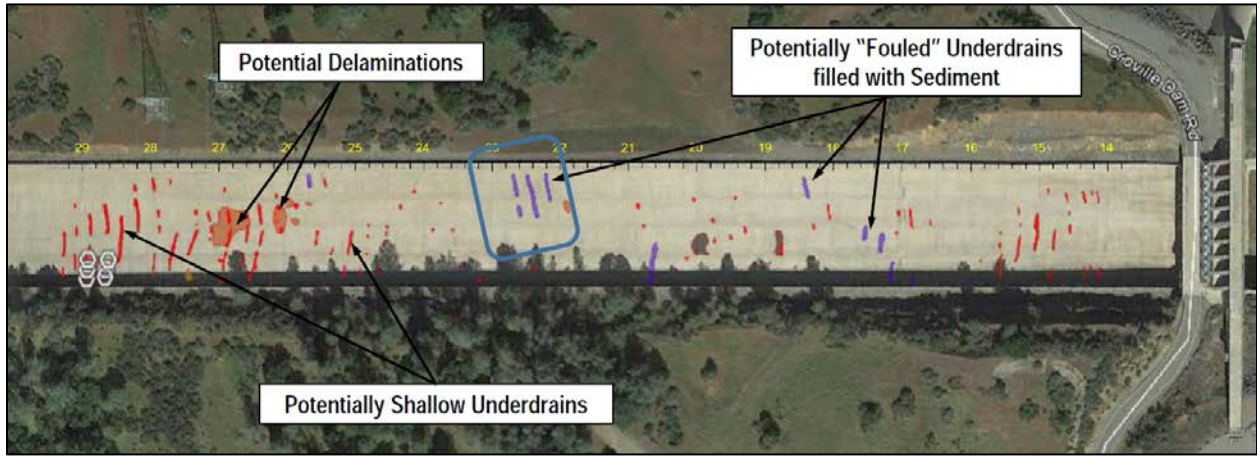
Figure D-37: Location of Potentially Blocked Underdrains and Potentially Shallow Underdrains

Soil Infilling (Settled Deposits), Debris, Encrustation and Scale: The only area where significant deposits were found resulting in total blockage was in one herringbone drain in the upper chute area, see Figures D-37 and D-38 [both from reference D-14]. This was discovered during a follow-up video inspection to investigate potentially “fouled” underdrains that could have been filled with sediment and originally identified in a Caltrans GPR survey [D-14]. A 15-ft-long section of a herringbone drain at Sta. 22+50 was found to be completely filled with a lean clay deposit. This infill was sampled and analyzed but its origin has not yet been determined, though it could

conceivably have originated from erosion of highly weathered foundation or from re-working of the known deposits of construction debris left on the foundation (“compacted clayey fines”).

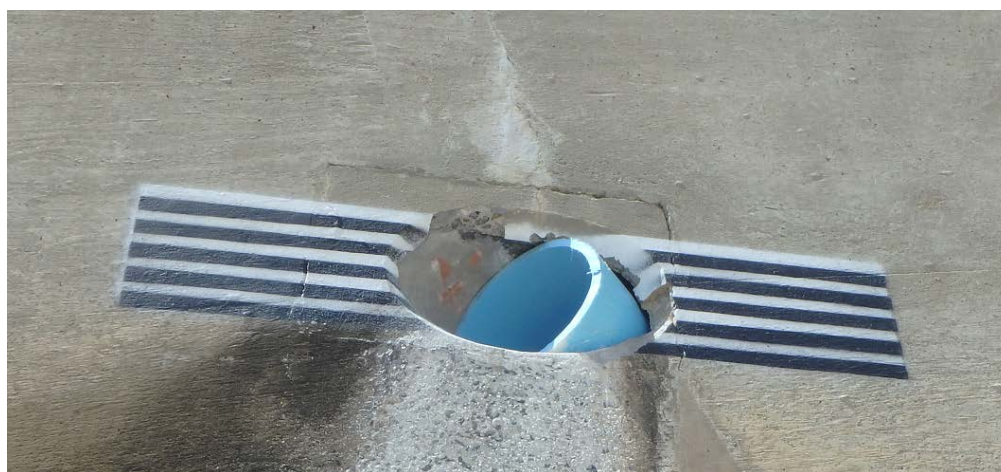
Figure D-39: Collector Pipe Outfall

The flows from the outfall pipes was observed for six outfalls on the left side of the chute and five on the right. The flow rates were determined by observing the flow depths from a scale that was painted on the chute walls, Figure D-39. The scale on the side of the wall is excellent, but it was drawn relative to the outside diameter of the outfall conduit and not to the inside diameter. Therefore, the measurements do not represent the flow depth in the outfall pipe. The outfall of the collector drain are made from HDPE pipe and not VCP pipe as specified in the design drawings. The dimensions of the HDPE pipe were not called out in the report nor the date when the VCP pipe was replaced.

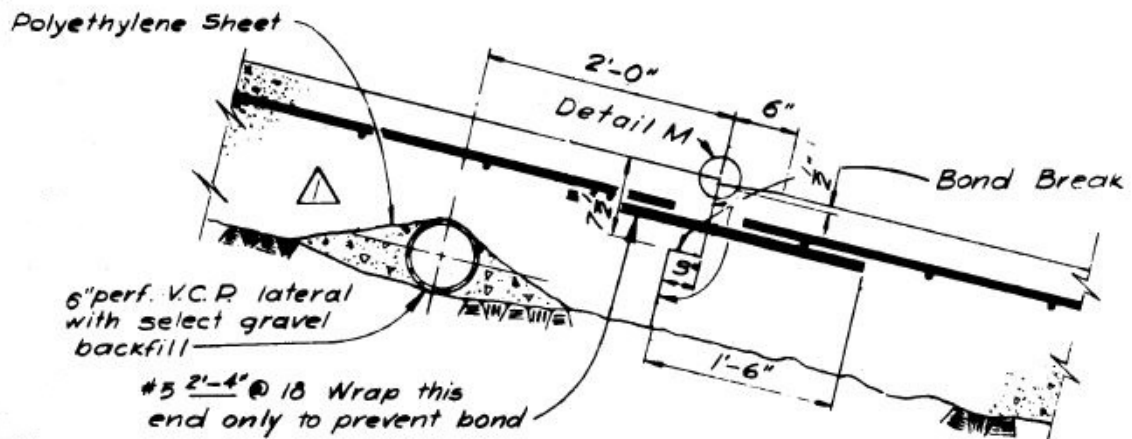
Figure E-2: Oroville Dam Spillway – Transverse Joint Detail

Keys are used at joints to prevent differential movement between individual slab panels. Keyed joints were provided in 83% of the spillways surveyed for this study. Reclamation and others typically provided a key that is integrated with a cutoff design, as shown in Figure E-1 from the Best Practices document [E-3]. This “key” prevents upward movement of the downstream slab panel relative to the upstream panel. Keys at transverse joints for the Oroville Dam service spillway chute provide an offset at a depth of 7.5 inches that prevents the downstream slab from moving upward (Figure E2). This key is not as robust as the key in Figure E-1 because it is not the full depth of the slab. Differential movements could more easily cause spalling of the upstream slab panel above the key for the Oroville detail.

Compounding the drainage issue was the plastic sheeting placed over the drains, which would cause water leaking into the cracks above the drains to flow around the drains, rather than into the drains (see Figures E-2 and E-4). Clearly flow into the drains was expected to come from the foundation below, not the chute flow surface above. While it is understandable that the placement of concrete over unfiltered gravel drainage material could cause contamination, or plugging, of the gravel with concrete, the solution to place plastic over the drains also served to isolate the drains from leakage flows passing through the chute slab into the foundation. Many other spillways from that period used burlap to filter the concrete during placement. Burlap would still allow flow from open joints or cracks to enter the drainage system. At Oroville, the ability of flow entering the foundation through open cracks above the drains to enter the herringbone drains is restricted by the plastic membrane. Since there are no drains at the joints, unless a herringbone drain happens to cross the joint, water flowing into the open joints must travel along the foundation contact to

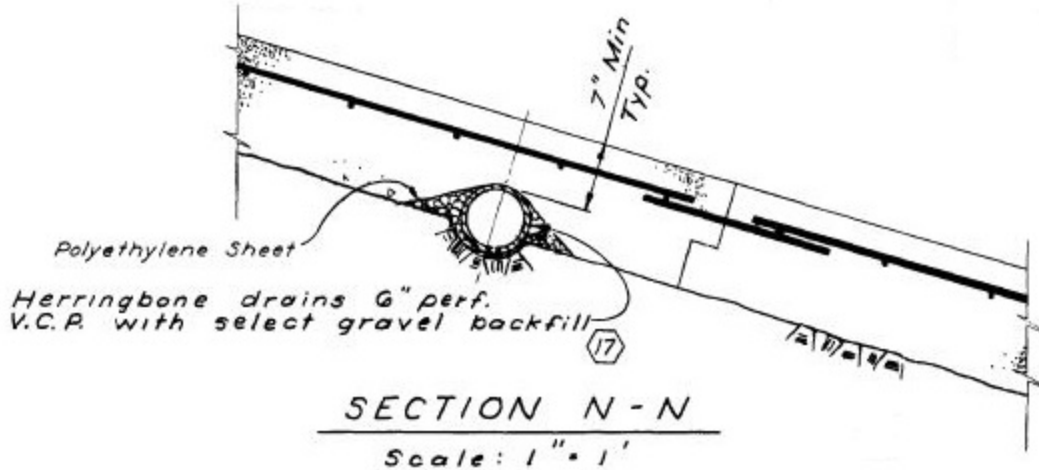
Figure E-3: Oroville Dam Service Spillway Slab and Drain Detail

During the period when Oroville spillway was designed, the potential flowing water in the chute to produce uplift beneath the chute slab through hydraulic jacking was not well understood. The design of offset joints (as discussed above) was based on the concern that flowing water could enter the foundation, increasing uplift. However, the potential for high uplift and foundation inflows caused by stagnation pressures at joints and cracks was not quantified. Nevertheless, the Oroville Dam spillway chute drainage system was originally designed to remove ground water, and the entire piping system was increased in size after the contract was awarded to increase capacity. The survey of spillways for this study showed that 95% of the spillways had a drainage system for the foundation. However, only 9% had drains that were placed within the bottom of the slab, as was done at Oroville (Figure E-2). Of the spillways with drains within the chute slab, the drain pipes were a smaller percentage of the total slab thickness, than was the case for the Oroville Dam service spillway chute. For example, the one DSOD spillway with drains placed in the slab had a 6-inch half round pipe in a 21-inch thick slab (approximately 3 inches projecting into the slab, or 12.5% of the slab thickness) More than 50% of the 15-inch slab thickness was reduced at the drain locations for Oroville (see Figure E-3). This reduction in thickness lead to cracking over the drains. In most cases, when drains are placed within the slab there is enough room for a bottom layer of reinforcement to be placed above the drains. There was not enough room for this to be done at Oroville.

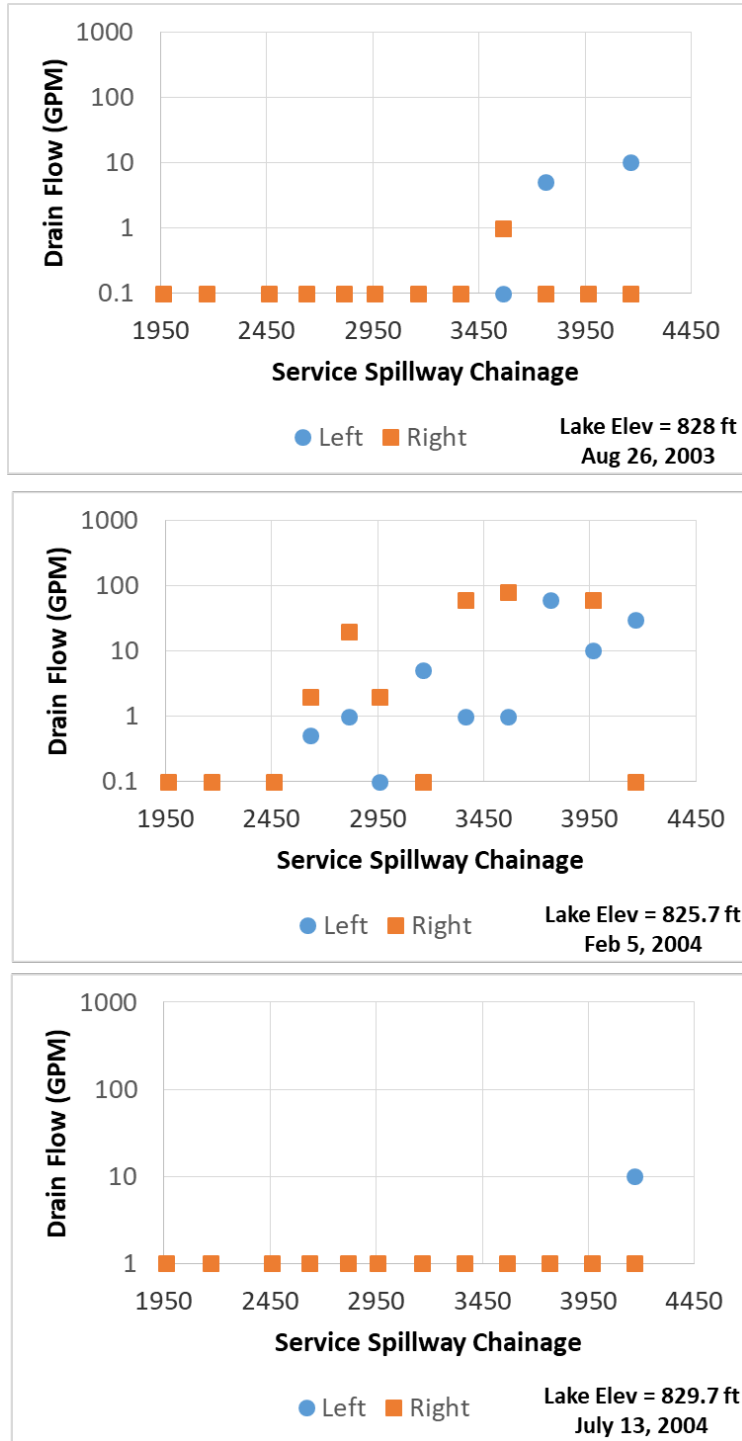
Figure F1-3: Plot 2 of 2003 DWR Unreferenced Data

Figure F1-3 shows the major effect of seasonal factors that could include thermal opening/closing of cracks, rainfall and runoff, etc. A series of three plots are shown over a period of a year, while at about the same reservoir elevation of 825 ft.: summer flows are negligible from all outfalls, while in winter, 18 of the outfalls are flowing, seven of these between 10 and 100 GPM each.

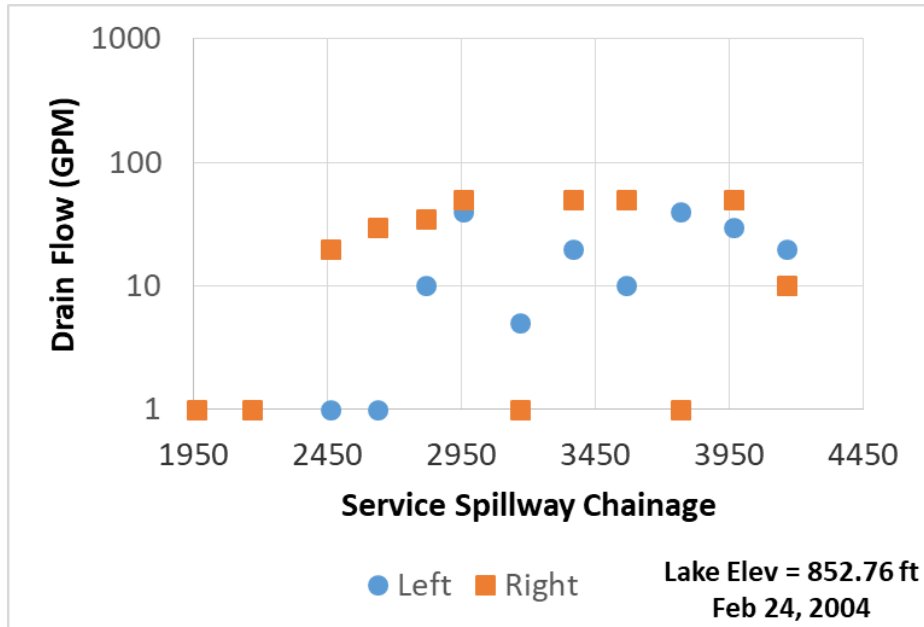
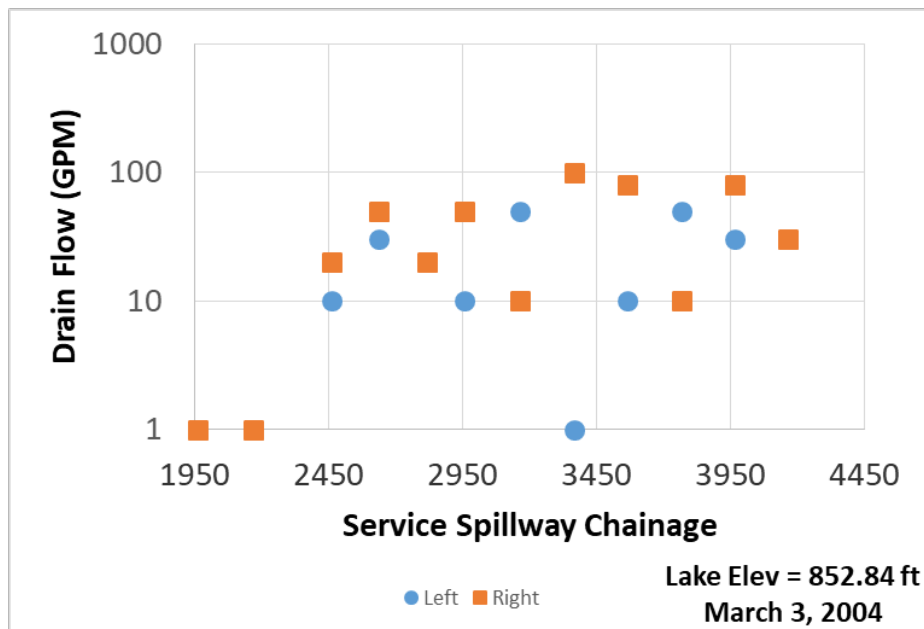
Figure F1-4: Plot 3 of 2003 DWR Unreferenced Data

Figure F1-4 illustrates the variable nature of the flows by comparing two plots separated in time by one week at the end of February 2003, with essentially no change in reservoir elevation. In this short timeframe the changes in flow are significant, and include:

- Outfalls 3L and 4L and 7R and 10R, start flowing up to > 10 GPM from being originally dry, while at the same time:
- Outfall 8L goes dry after originally flowing up to 100 GPM.

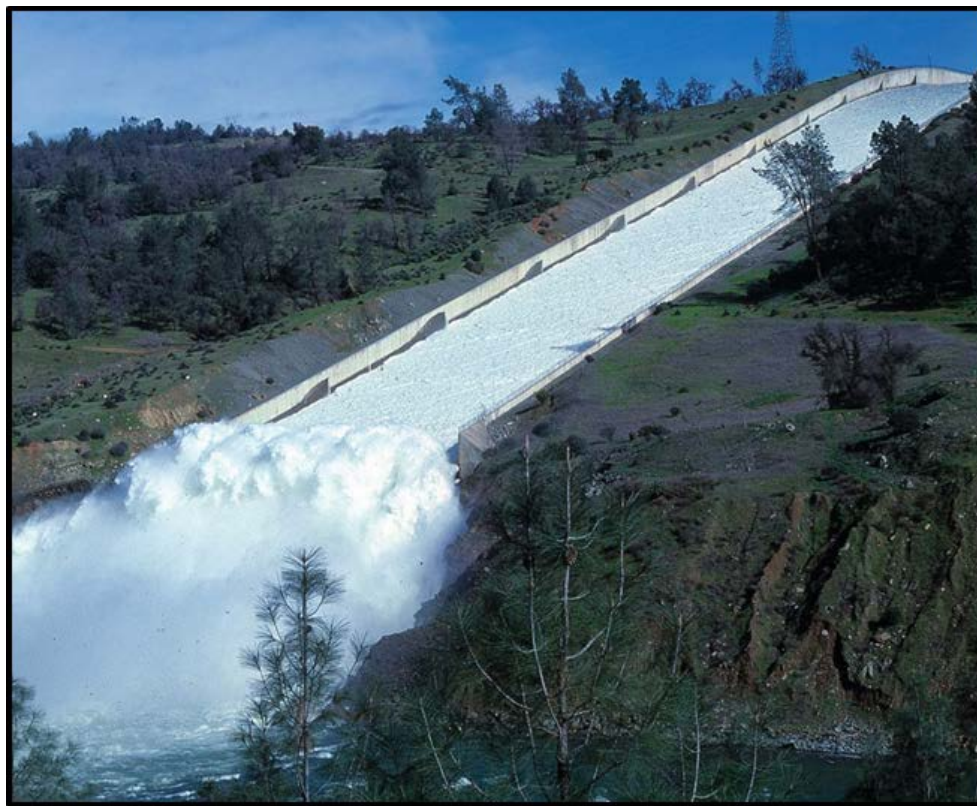
Figure F1-5: February 3, 2006 (Photo provided by DWR): Spillway in use - all right side drains apparently flowing well. No photos available for left side.

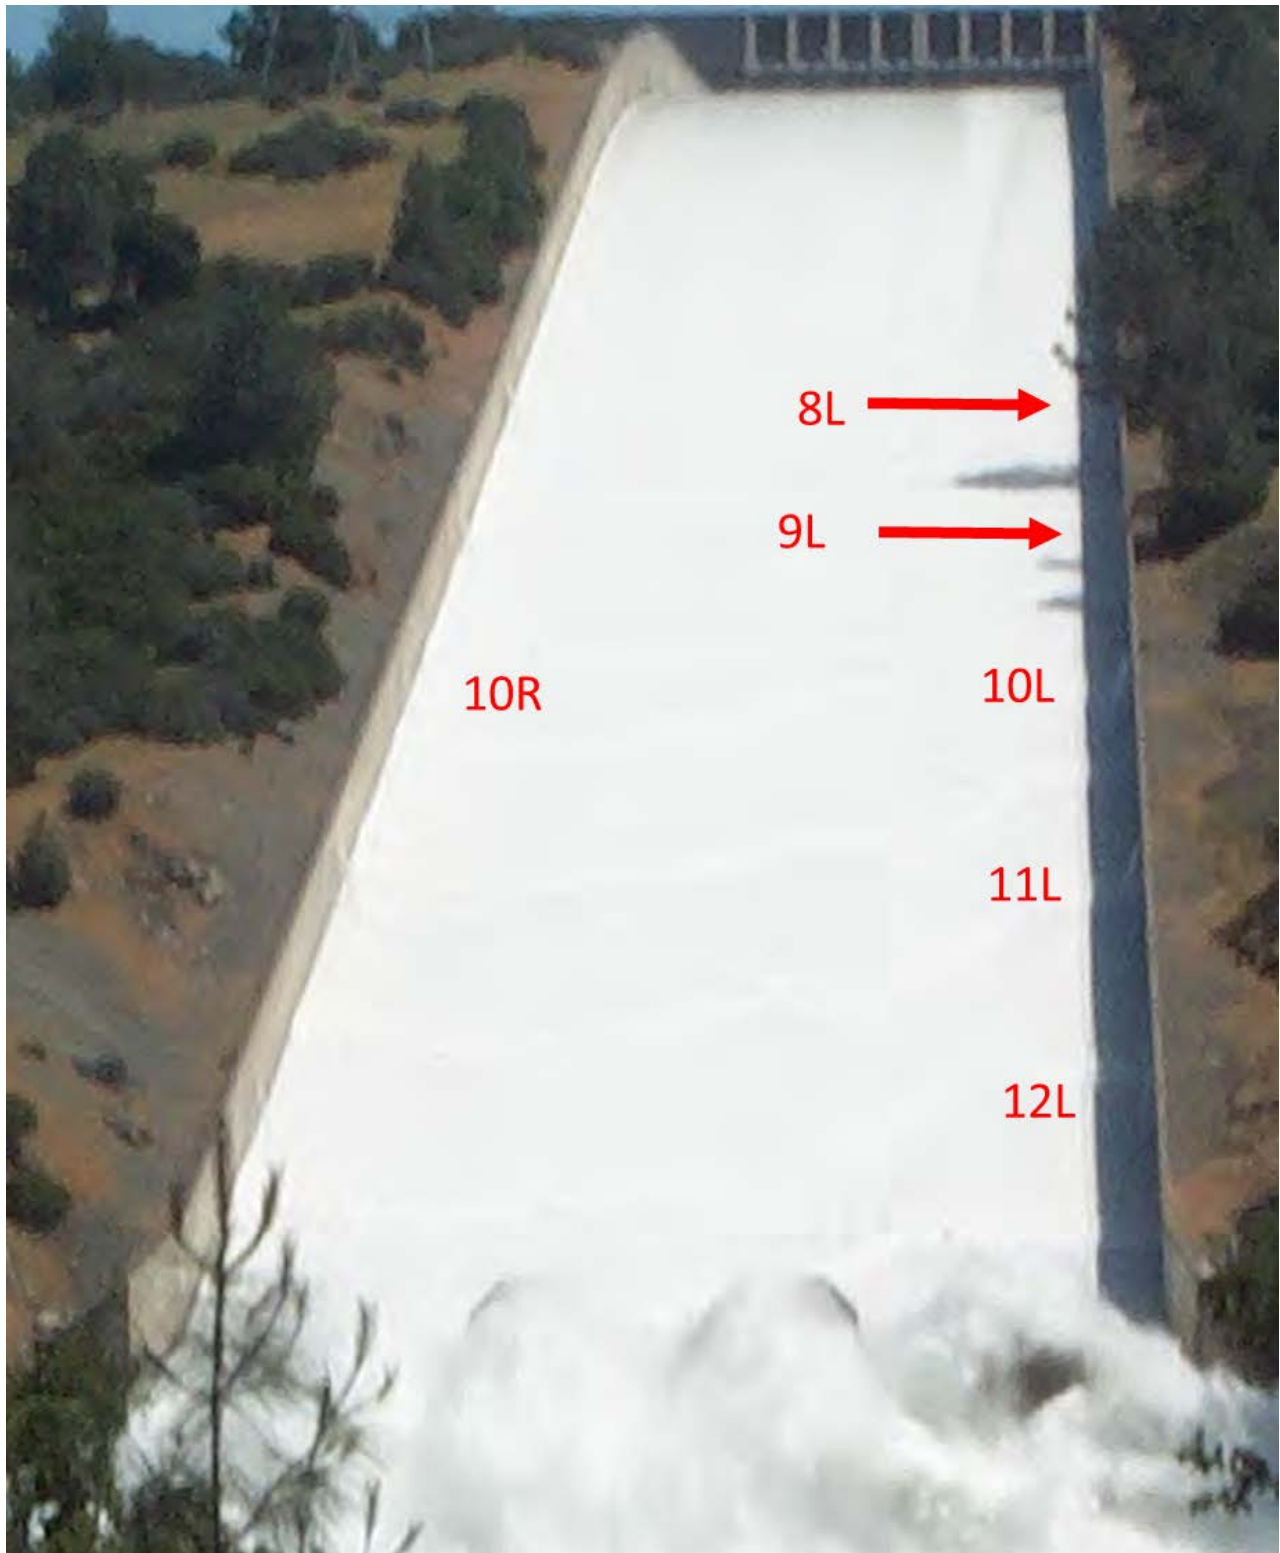
Figure F1-6: May 17, 2006 - Spillway in use (photo provided by DWR): obscured view, but possibly little to no flow in outfalls 9L and 8L and possibly 10R.

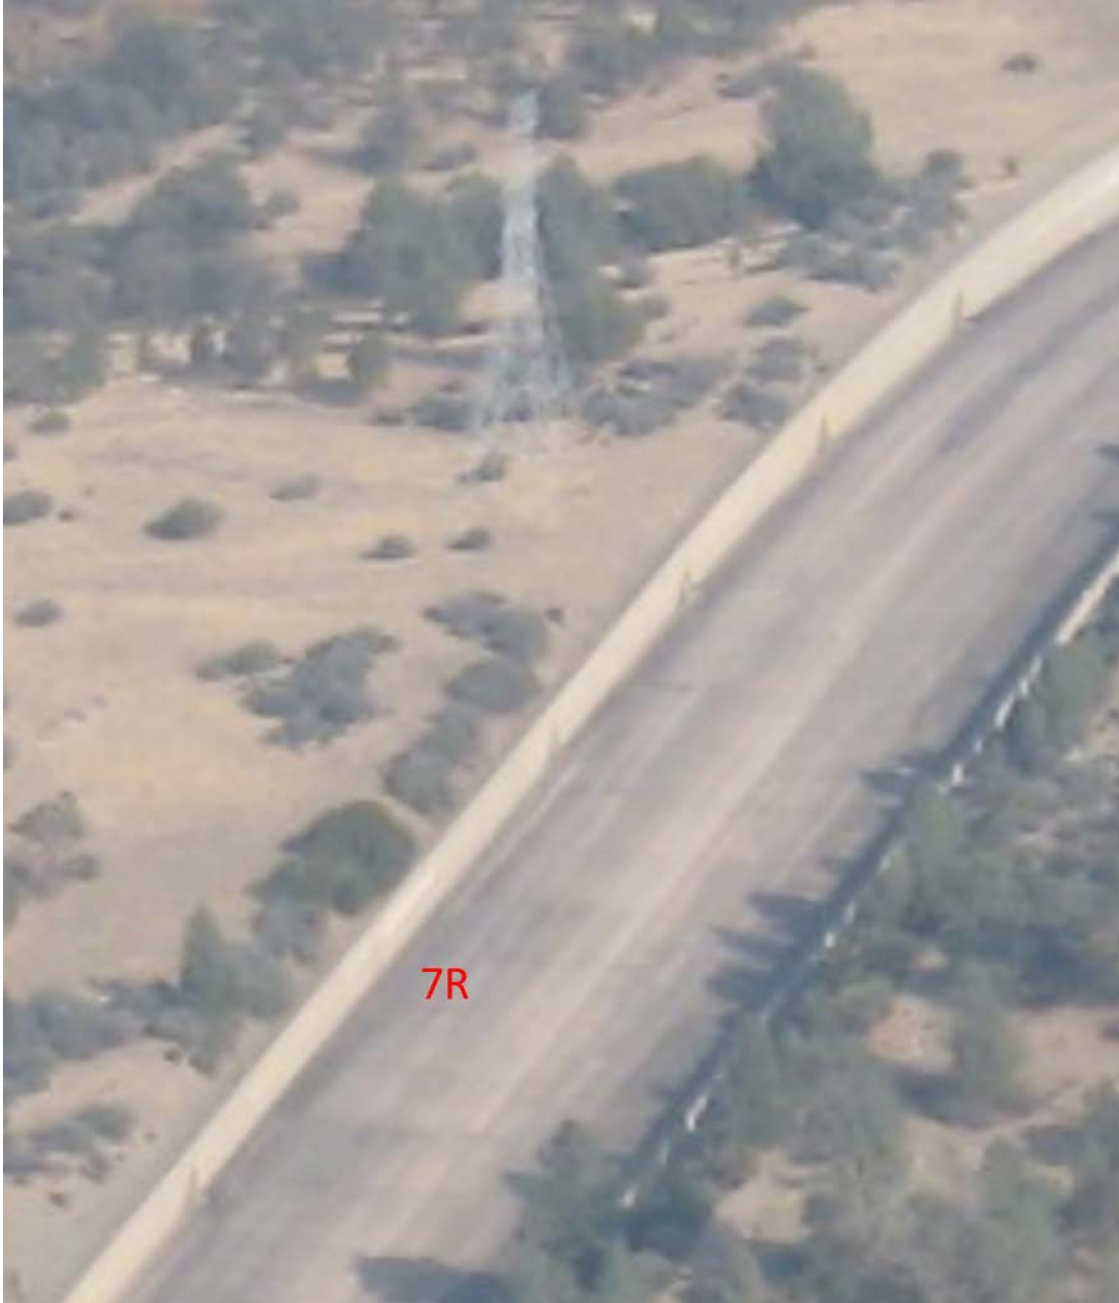
Figure F1-7: November 9, 2007 ^{F1-15} – Spillway not in use: Outfall 7R is not flowing. However, Outfall 6R is strongly flowing, in contrast to notes during 1969 first use, where the total of both left and right outfalls at Location 6 was only 0-10 GPM total flow

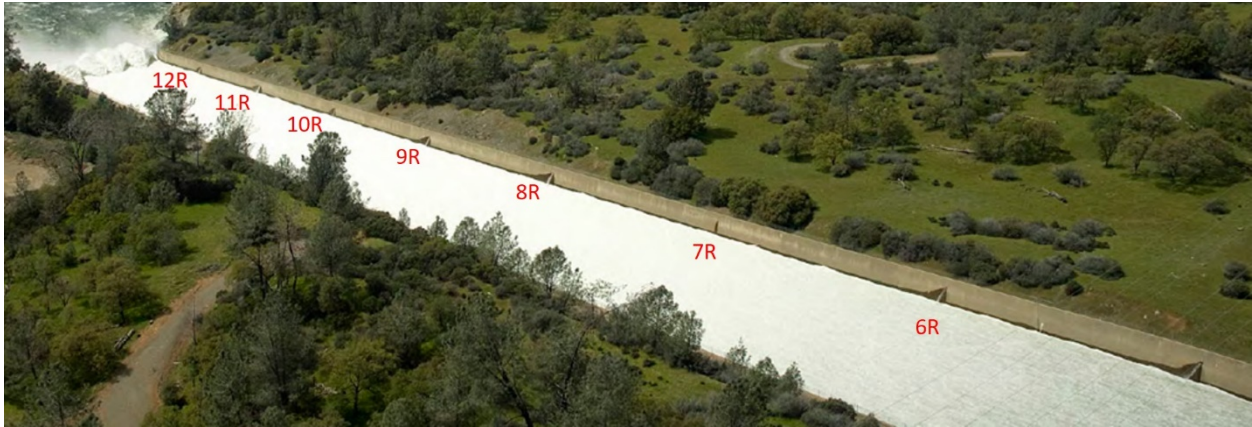
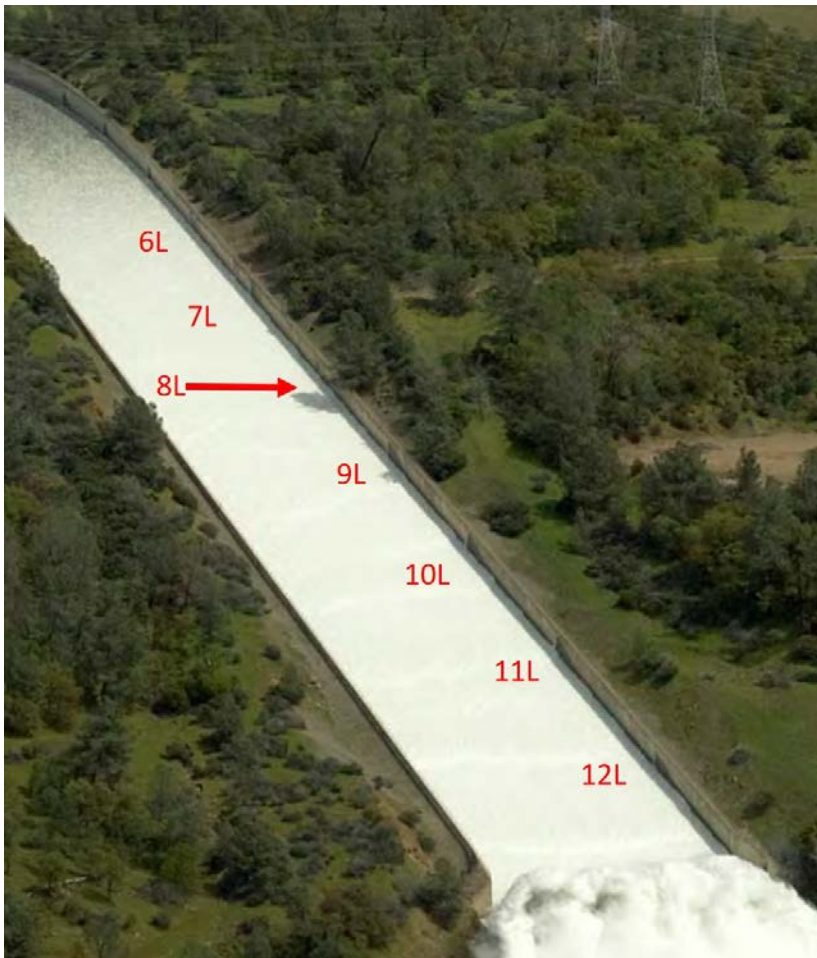
9L flowing
8L apparently not flowing

Figures F1-8 and F1-9: April 2011, Spillway in operation (photos provided by DWR): Outfall 7R is only seeping compared to other outfalls.

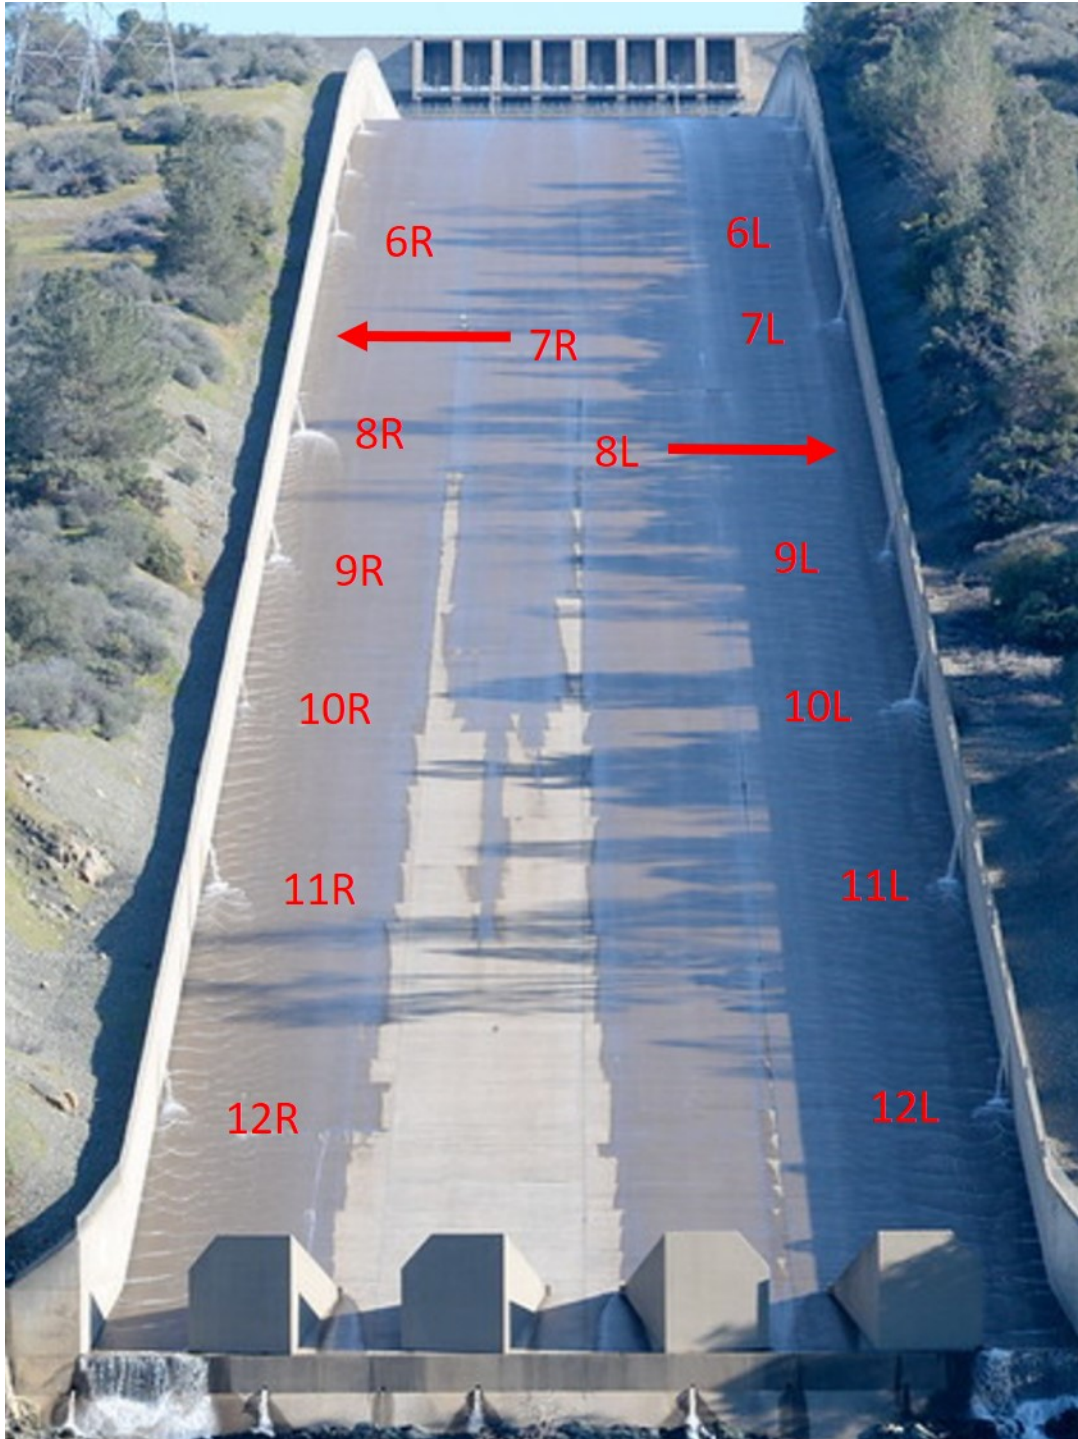
Figure F1-10: January 27, 2017^{F1-16} – Spillway not in use: Outfalls 7R and 8L are not flowing.

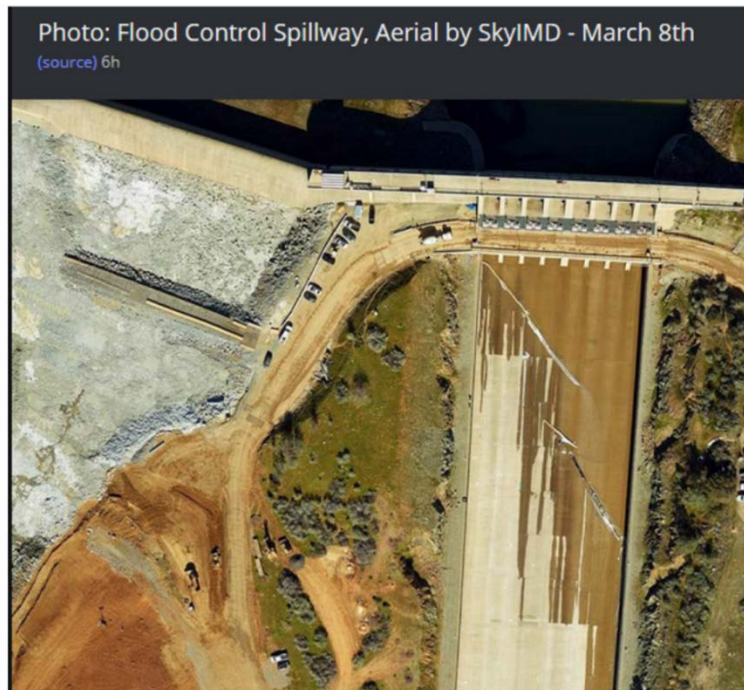
Figure F1-11: Aerial View of Service Spillway following the Incident

One of the most significant post incident observations was that, with gates closed but leaking, the drains were flowing, but the drain flow stopped on the right side once the leakage from the gates along the spillway chute was diverted from that side by sand bags. This indicates that the source of the drain flow in this instance was water flow into the spillway slab joints and cracks. The photo below [F1-18], taken in this time period, also clearly shows spillway flow from leakage terminating at the construction joints, again indicating their open nature.

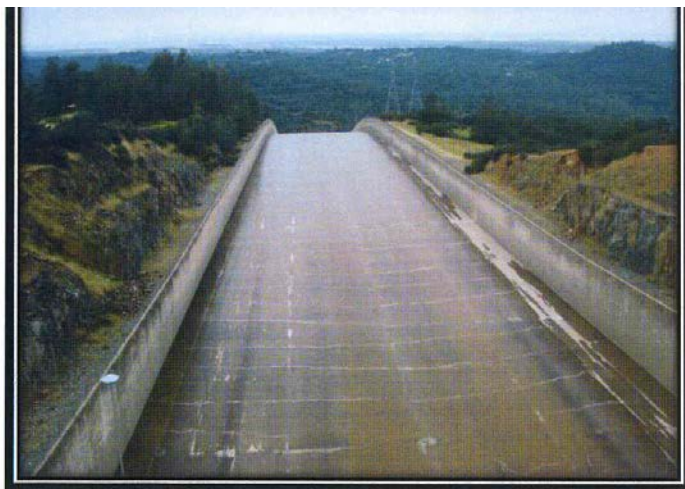
And a photograph from the 2010 annual FERC inspection report [F1-20] illustrates the crack pattern, as shown below:

12. The concrete along the spillway chute has been repaired. The repaired herringbone crack pattern is said to reflect the underlying drain system. ”

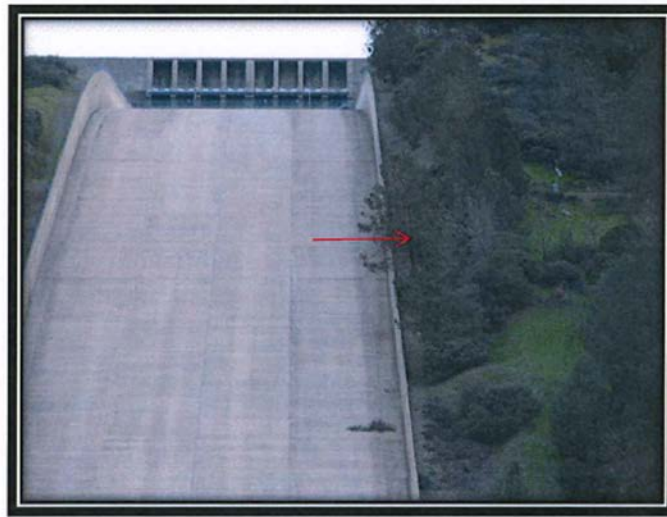
9. This view looking upstream along the FCO discharge chute shows one tree (arrow) that needs to be removed following a significant effort to remove brush along the outside of the wall. „

The tree noted is in the general area of the initial chute slab failure, adjacent to an outfall (8R) seen not to be flowing. As there has been much public speculation in regard to this particular tree, the IFT spent considerable time investigating the possibility of drain blockage at this particular location, and this is discussed in the following section. Refer to Appendix D for a general discussion regarding invasive tree roots.

brush along the outside edge of the left chute wall. A lone tree, photograph 9, should also be removed.

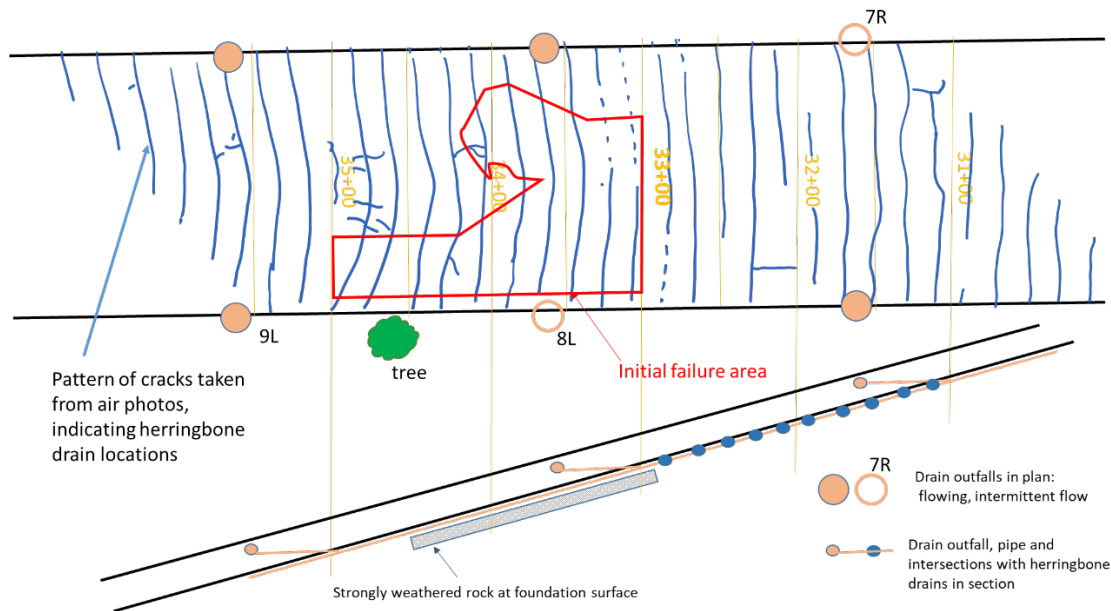
Figure F1-12: Schematics of Spillway Chute near Initial Failure Area

The particular tree in question was closest to the left side of the spillway at about station 34+50. The IFT considered whether roots from this particular tree, only about 100 ft. or so from the initial failure area, could have been a contributing factor. The IFT believes that this hypothesis is unlikely, due to the layout of the drain system as illustrated in Figures F1-12 and F1-13:

As shown in the plan views, the tree was located close to the left spillway wall, between Outfalls 8L and 9L, so that blockage by roots from this tree would affect Outfall 9L. Each outfall connects to the herringbone drains upstream of the outfall location, as shown in the profile view and lower plan view. The most downstream drain for each outfall is located about 60 to 70 ft. upstream from the outfall, and the most upstream drain is located about 260 ft. upstream of the outfall. Had roots from this particular tree entered the drainage system, they could have blocked the herringbone drains in the vicinity of the initial failure. However, the outfall for this section is at about station 35+65 (Location 9L), which in 2011 and 2017 photos is flowing freely. As such, roots from this particular tree could not have been significantly blocking the 9L outfall.

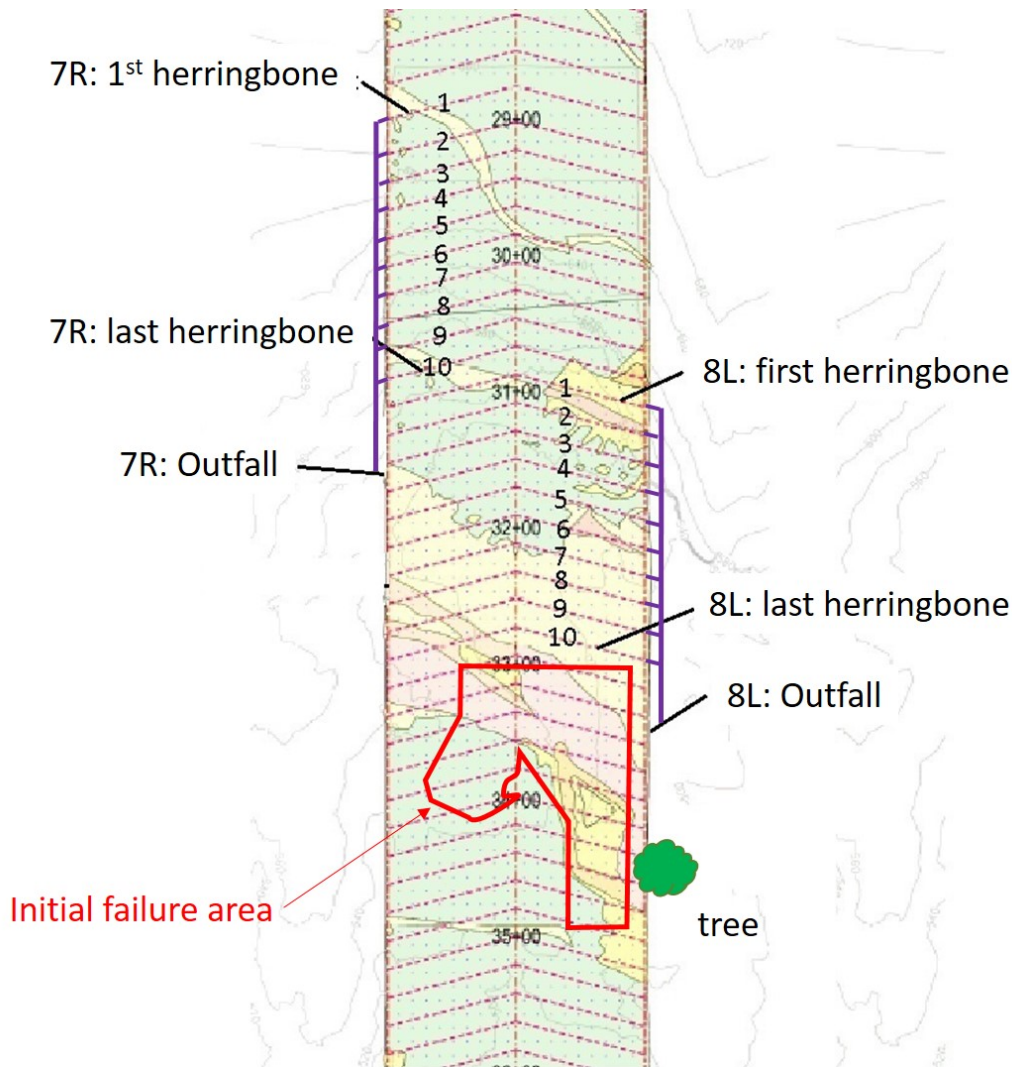
Outfall drain 8L, immediately adjacent to the initial failure area, has been observed not to flow, and thus was possibly blocked. This outfall collects flows from drains under the chute from about Station 31+00 to 33+00, upstream from the initial failure area as shown in the sketches. Blockage of 8L is a possible contributor to the failure under certain assumptions. If the slab was thick enough in this area (upstream from Sta. 33+00) that the drains were well above the foundation, and water leaking into the foundation could pass through a thick gravel layer placed beneath the drains where the foundation was overexcavated. This water could make its way to the downstream drainage set that is in the area of the initial damage. If this happened, the downstream drain set (9L), might not have had sufficient capacity to handle the combined drainage flow and caused flows to back up under the slab.

Another possibility possible explanation for no drain flow is that the water from the chute entered the foundation, and bypassed the herringbone drains by flowing under the slab through piping internal erosion channels downstream to the next drain set.

Figure F1-13: Idealized Layout of Spillway Chute Underdrains upstream of Initial Failure Area (underlay of chute geology provided by DWR)

However, it is also possible that either this drain was not connected to the outfall pipe prior to the damage, and flow from the herringbone drains discharged into the gravel outside the wall, or there was actually no inflow to the herringbone drains in that drain set because the repairs had not failed there, and no flow was entering the foundation.

Thus the lack of flow in the outfall pipe does not necessarily indicate that pressure was building under the chute slab in the zone immediately upstream from the initial failure. There is no further evidence to support either view.

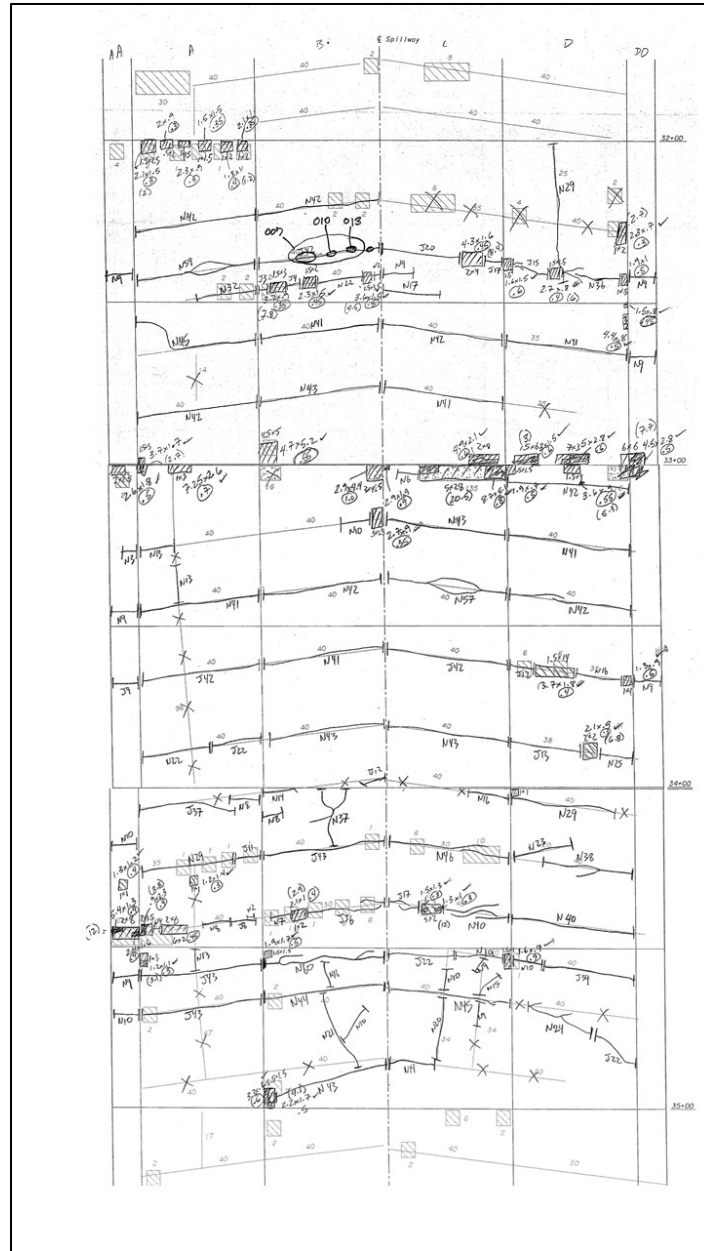
The 2009 repairs were well documented. Specifications No. 09-14 were prepared for these repairs. Documentation also included Field Notes consisting of drawing mark-ups (Figure G-1), a Final Construction Report [G-5], and numerous photographs of the work. The specifications drawings showed areas that were to be repaired by the contractor. The field note mark-ups show the areas that were actually repaired. Most of the construction photos were not captioned, so it is difficult to determine the location of the work shown in the photos. The repair work was completed by a private contractor under contract to DWR.

Figure G-1: Repairs made in 2009 (from Field Notes)

The repair effort for cracks ranged from minor crack repair (1/4-inch wide or less) to major crack repair. Where spalls and/or delaminations (labeled as “voids” on the drawings) were adjacent to cracks, the repairs were more extensive. Minor repairs called for the cracks to be completely filled with a low-viscosity epoxy. The epoxy used was a Sikadur 55 SLV formulation that is specifically intended to penetrate and seal cracks, driven by gravity only. While it worked well, most cracks required three to four applications to completely fill the volume of the crack, with a few localized spots requiring six to seven applications. Major crack repair included preparing the cracks by sawcutting or routing to a neat rectangular cross-section with minimum dimensions of 3/8” wide x 1/2” deep. The contractor used hand-held grinders to cut a rectangular groove at the top of these

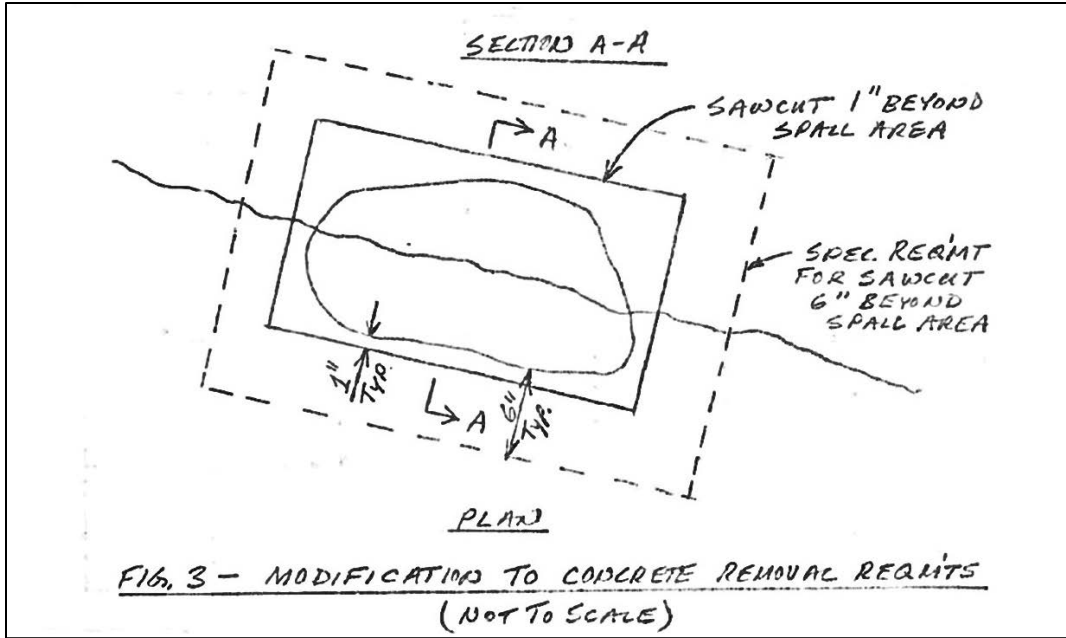
Some of the repairs as described above were the result of modifications made to the repair methods during the construction. These included a reduction to the area of concrete to be removed around a spalled area above the drains, a 1-1/2-inch sawcut above the crack in the new concrete, and splicing of broken rebar over the drains (see Figures G-2, G-3, and G-4). The modification to reduce the area removed around a spall (Figure G-2) was made to minimize the potential to damage the VCP pipe below as the concrete was being chipped out. This process seemed to inadvertently fracture the pipe when large concrete aggregates were present, and it was believed that by reducing the area of concrete to be excavated, the damage to the pipe would also be reduced. However, this change may have resulted in some cracked or delaminated concrete not being fully removed.

Figure G-2: Revision to 2009 Repairs to Reduce the Area of Concrete Removal Around Spalls
