INDEPENDENT FORENSIC TEAM REPORT OROVILLE DAM SPILLWAY INCIDENT

JANUARY 5, 2018

SUMMARY

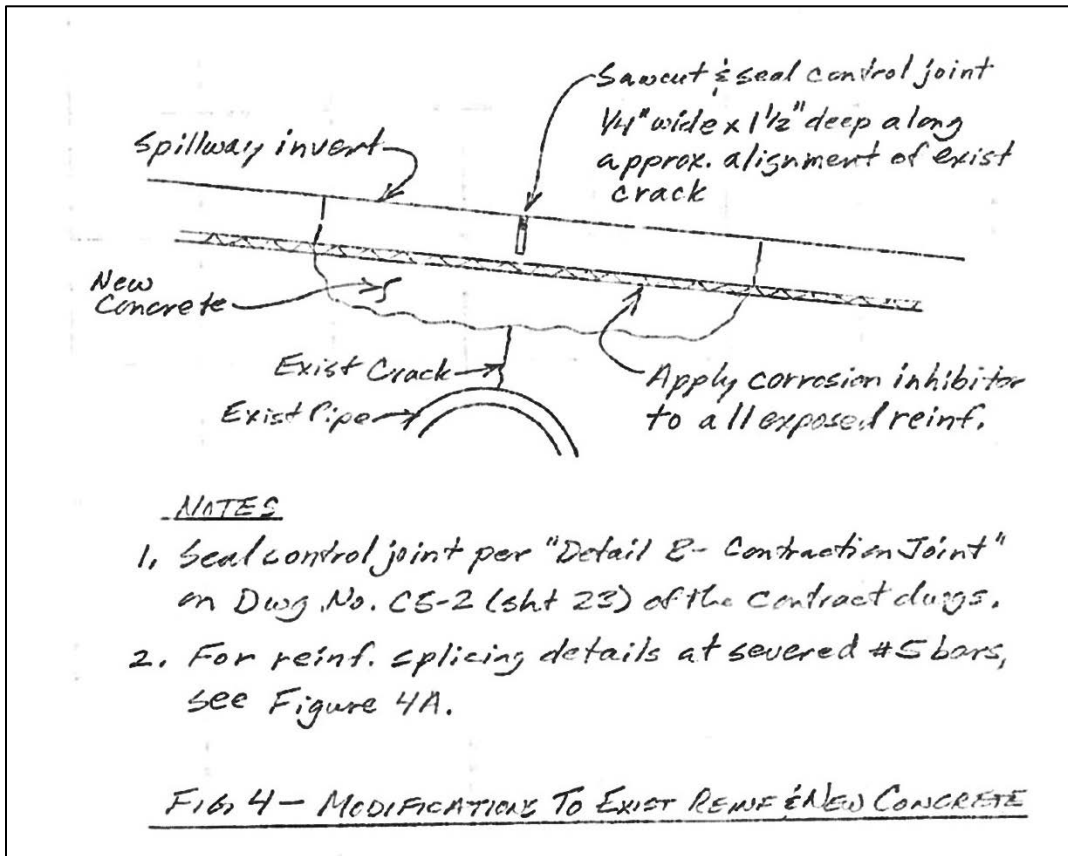
Sawcuts above the cracks in the new concrete (Figure G-3) were done because the DOE staff believed that the cracks had become "expansion joints." The IFT believes that the cracks had opened as a result of concrete contraction, and the location above the herringbone drains corresponds to the reduced concrete thickness (from a minimum of 15 inches to 7 inches) above the drains. If the cracks below the new concrete were still open, a partial 1-1/2-inch sawcut above the crack in the new concrete would not prevent transfer of load as the concrete expanded in the summer heat. The thin section of new concrete between the sawcut and the cracked original concrete below the repair would be subjected to high compressive stresses, which could cause delamination of the repair. Rebar passing through the repair, whether spliced, or original intact bars, would go into compression during high temperature periods, possibly buckling the bars and contributing to the potential for concrete delamination and spalling. In the IFT's opinion, these repairs were merely temporary and cosmetic, and would not be capable of resisting the temperature stresses that caused the damage in the first place. The way in which they were done may have even potentially resulted in larger damaged areas in the future.

Figure G-3: Revision to 2009 Repairs to Provide Sawcuts Above Cracks Over Drains

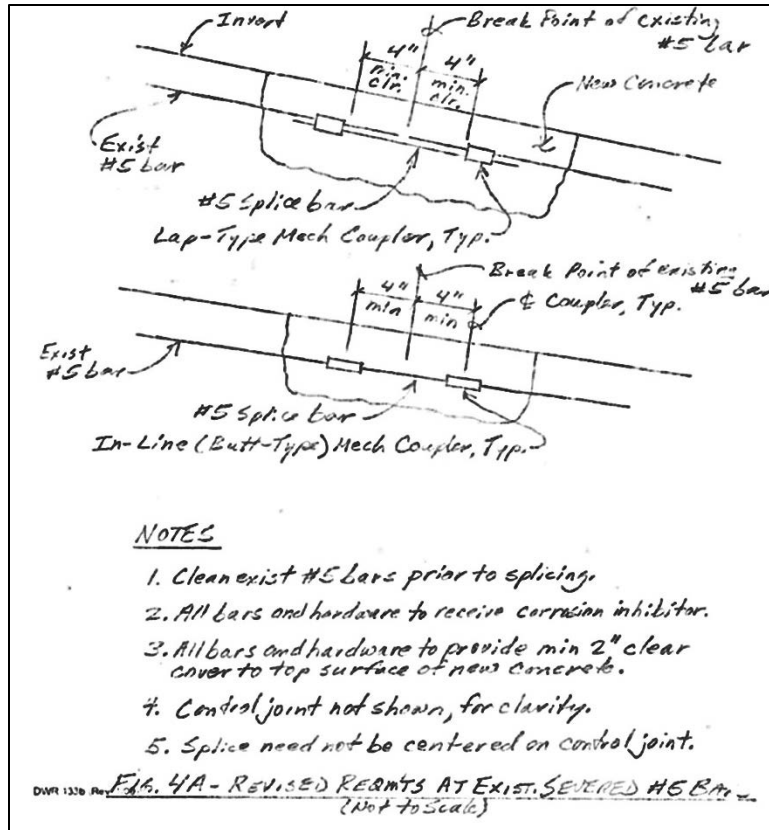
Figure G-4: Revision to 2009 Repairs to Splice Broken Rebar Over Drains

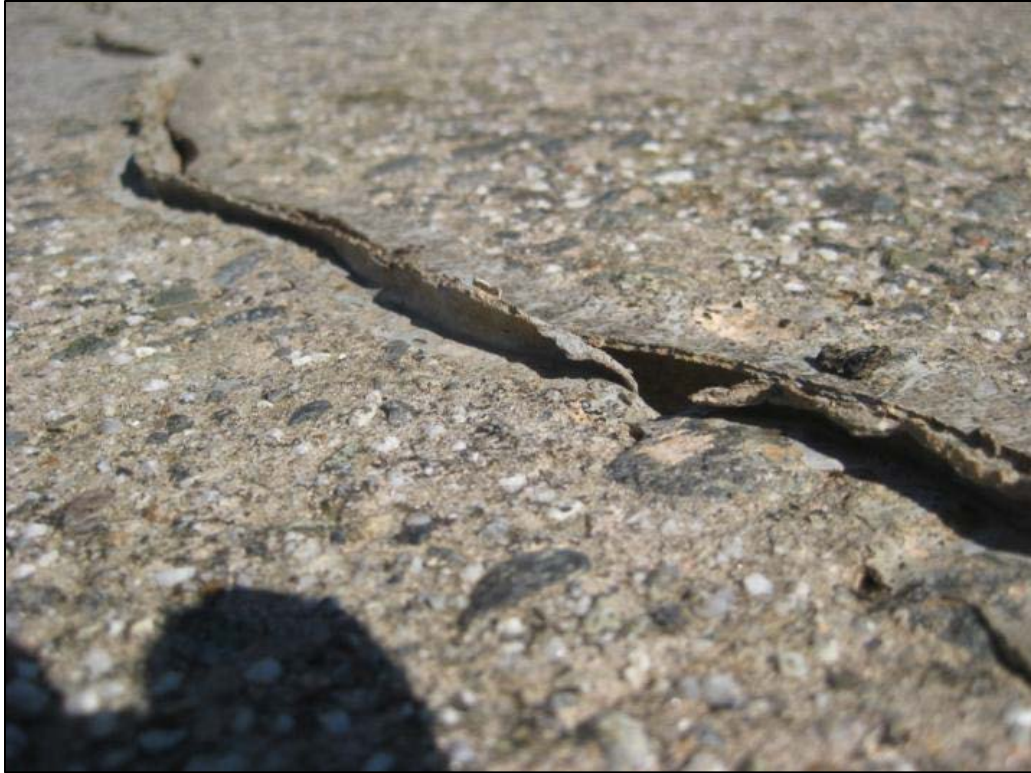
1. "The spillway repairs are holding up well although areas are beginning to degrade and fail with use.
2. The spalling and cracking of the concrete panels continues to occur.
3. The polyurethane sealant is performing much better than grout sealing. Most of the grouted cracks had washed out."

Figure G-5: Sealant Failure Over Herringbone Crack

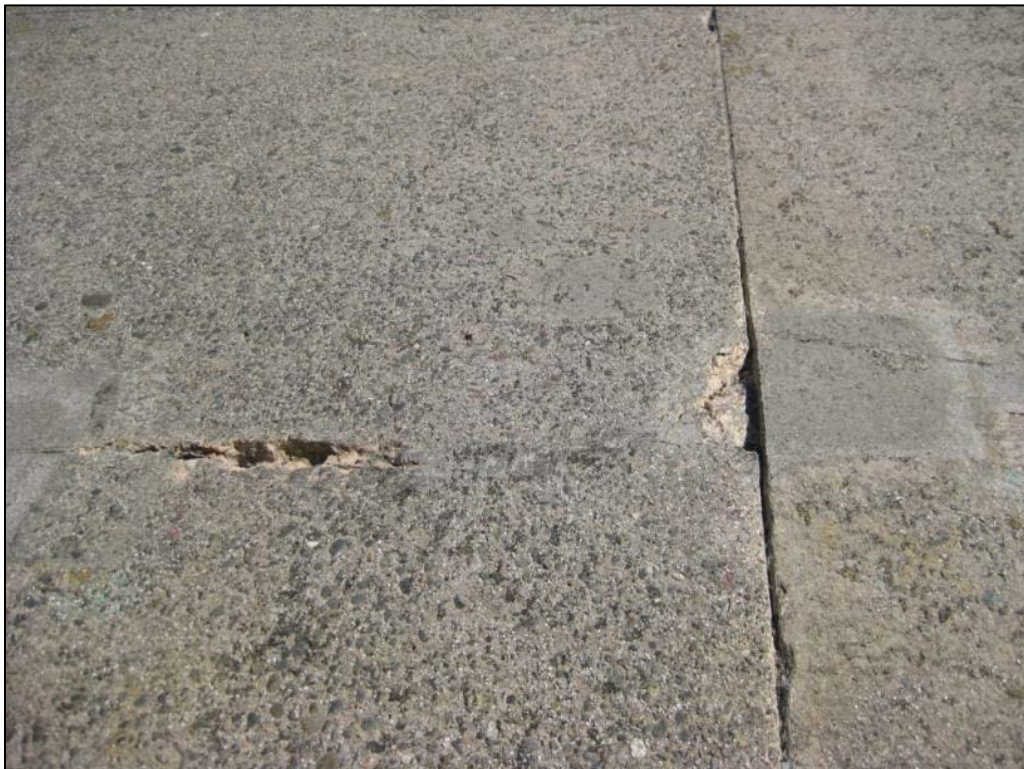
Figure G-6: New Concrete Deterioration

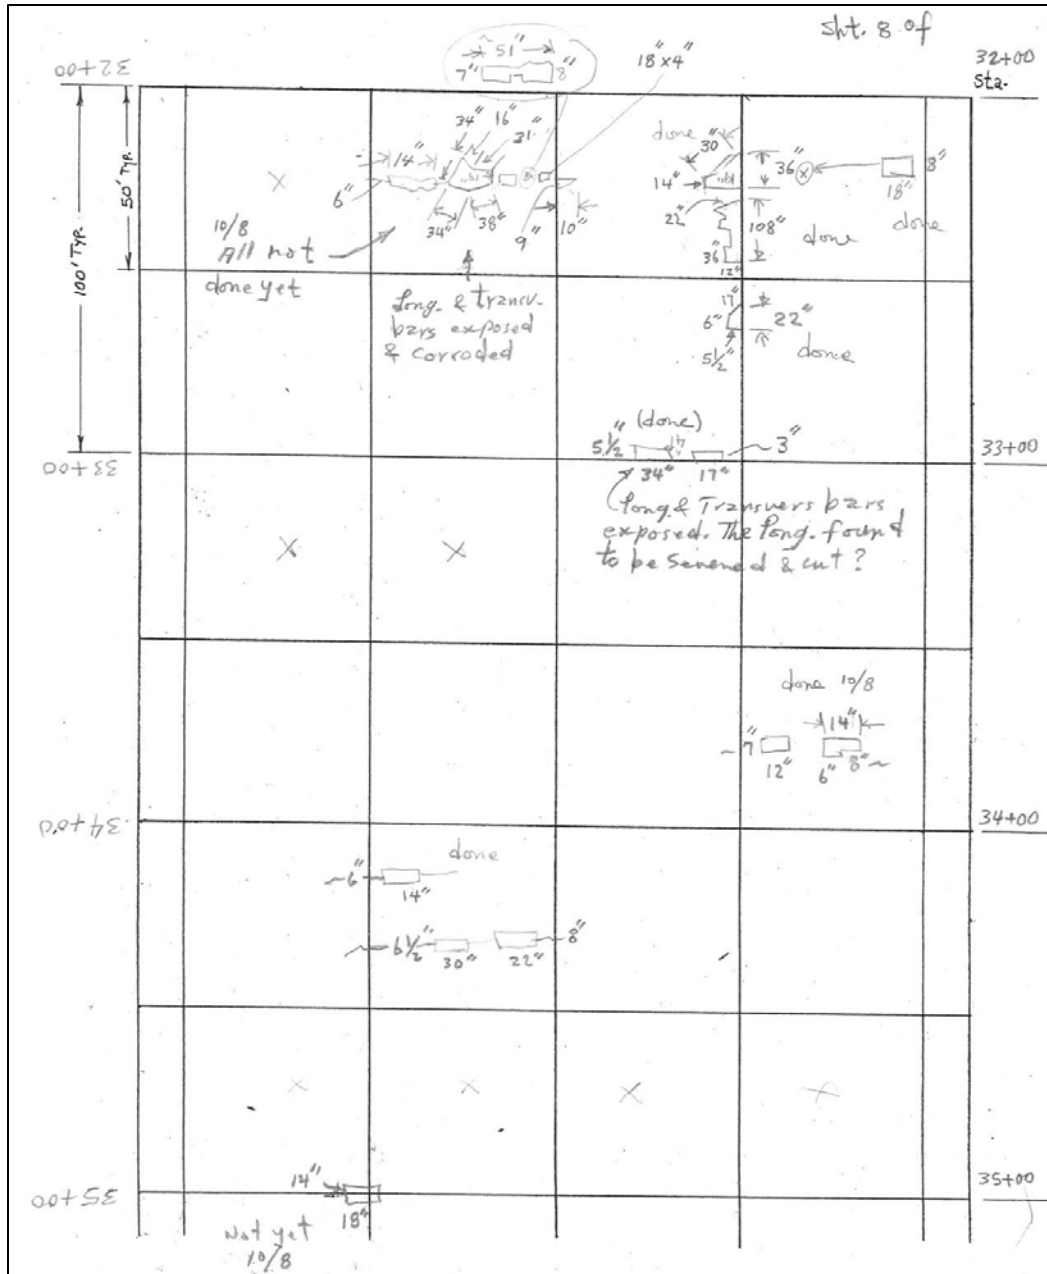
The memo recommended that repairs be made by OFD civil maintenance, followed by reinspection. Repair methods generally followed the methods specified for the 2009 repairs. The 2013 repairs are shown in Field Notes (Figure G-8).

Figure G-8: 2013 Repair Field Notes, Sta. 32+00 to 35+00

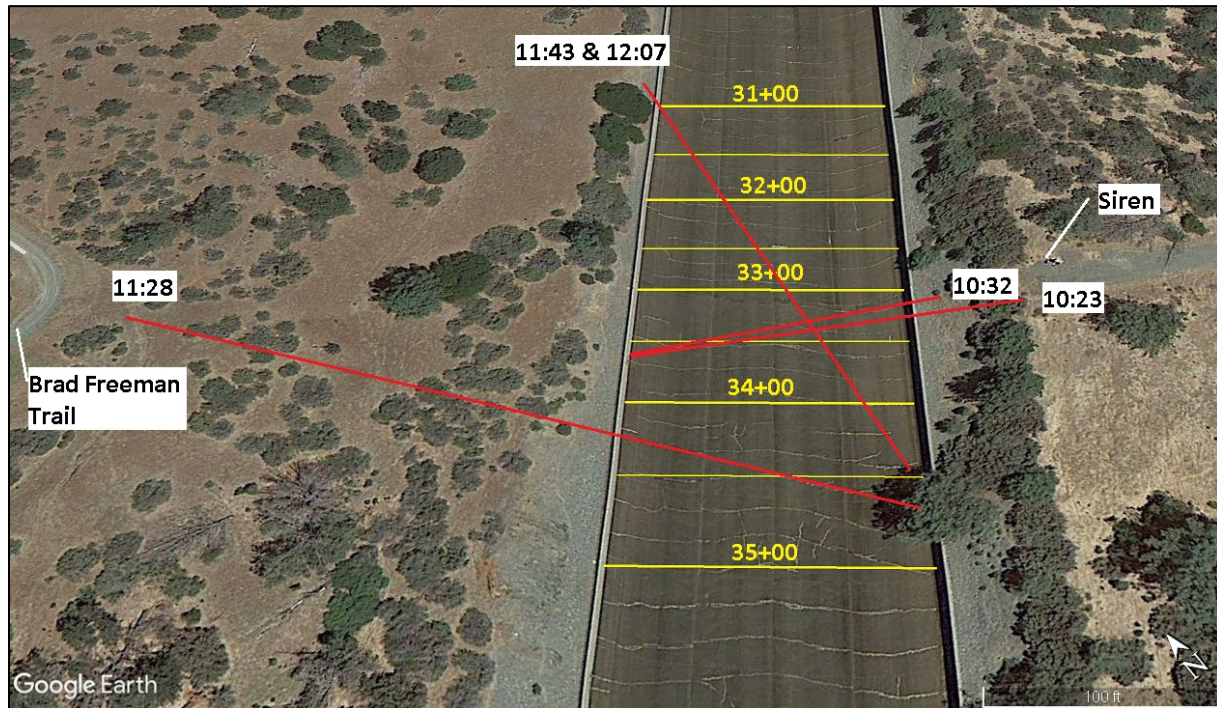
taken by these eyewitnesses to help understand how and why the chute failed. Figure I-2 [I-1] was modified to show spillway stationing and approximate locations of these individuals (text boxes with time of photo). Figures I-3 through I-9 show the damage at successive times.

Figure I-2: Location of Photos in Figures I-3 to I-9 Based on Time of Photo [I-1]

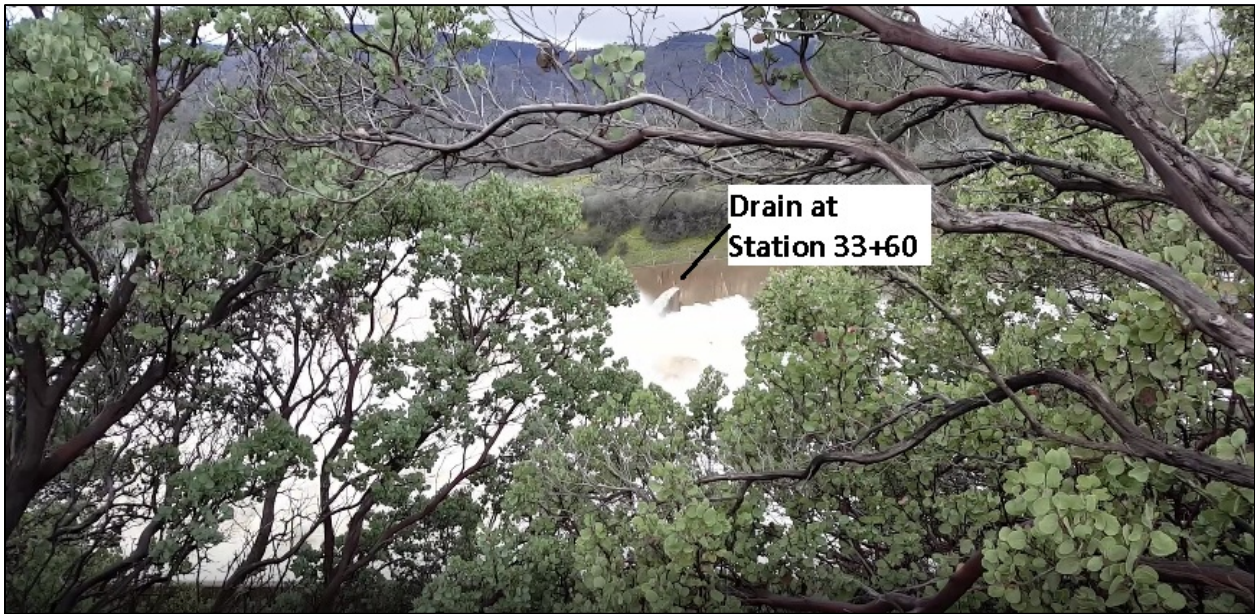
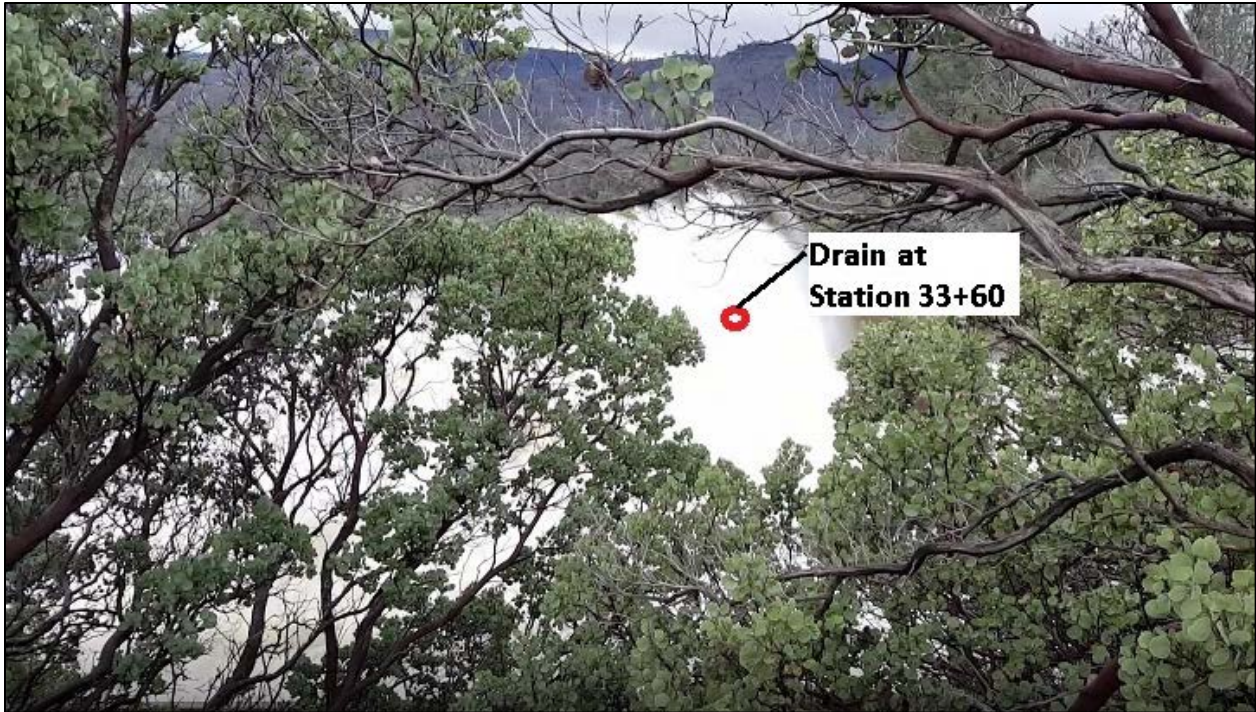
On February 7th, at approximately 10:10 am, DWR maintenance staff workers, who were servicing the siren on the left side of the spillway, next to the spillway chute, heard what they said sounded like an explosion or a loud bang, and saw spray coming from the spillway chute. One of the workers began to take photos and videos [I-2]. The first video was made at 10:23 from the location noted on Figure I-2, and two still frames from that video are shown on Figures I-3 and I-4. They reported that the damage appeared to start near the center of the chute and then move toward them (the left wall.) As they watched, the area of spray also moved upstream. A photo taken at 10:32 am shows that the damage is occurring downstream of Station 33+00, Figure I-5.

Figure I-3: Flow in Chute at 10:23 am [I-2]

Figure I-4: Flow in Chute at 10:23 am, a Few Seconds Later [I-2]

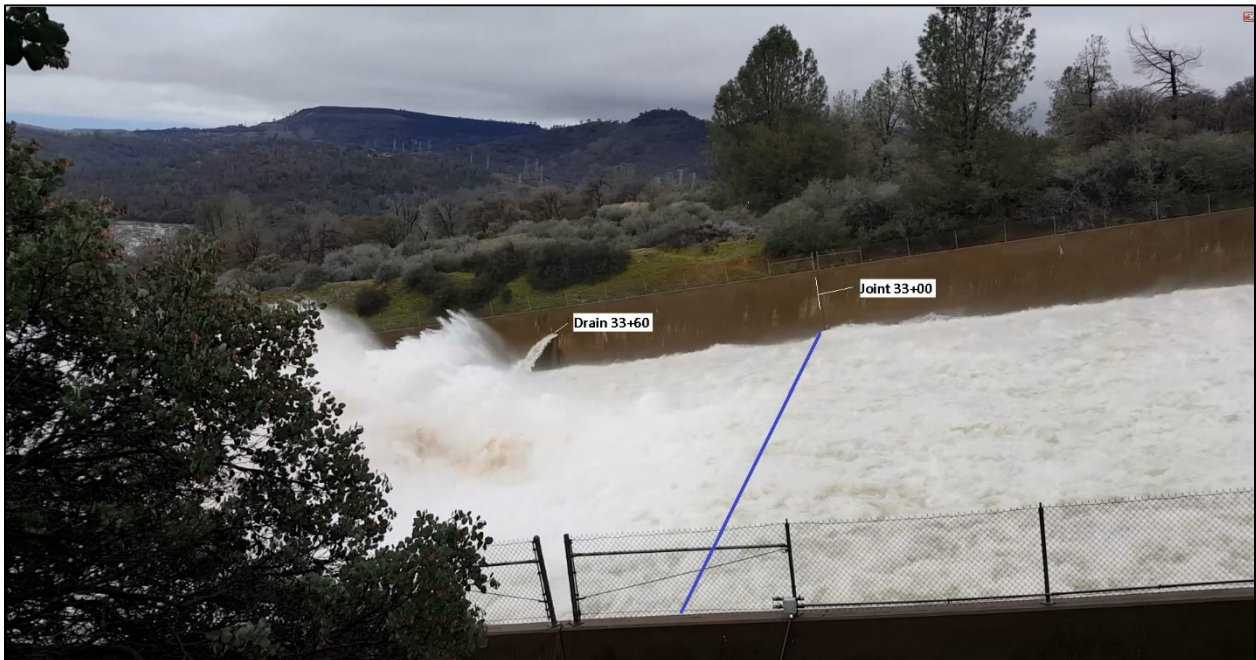
Figure I-5: Flow in Chute at 10:32 [I-2]

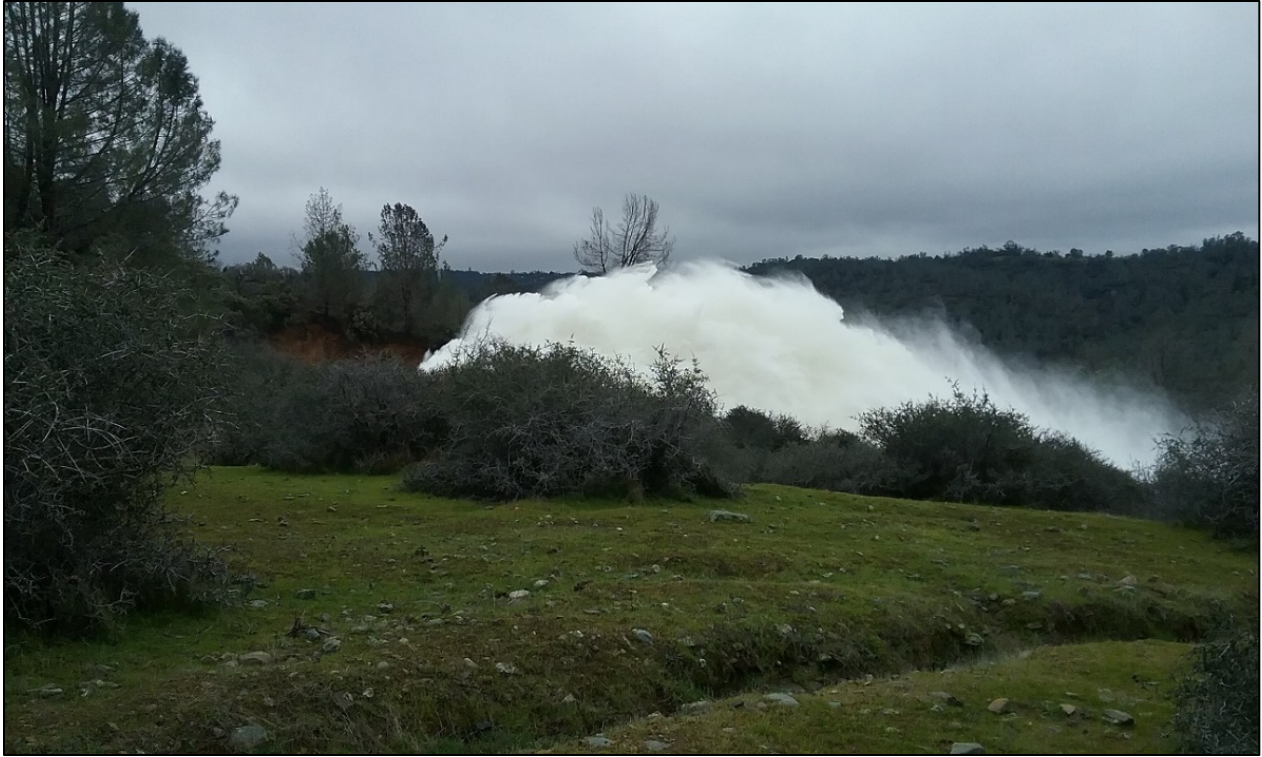
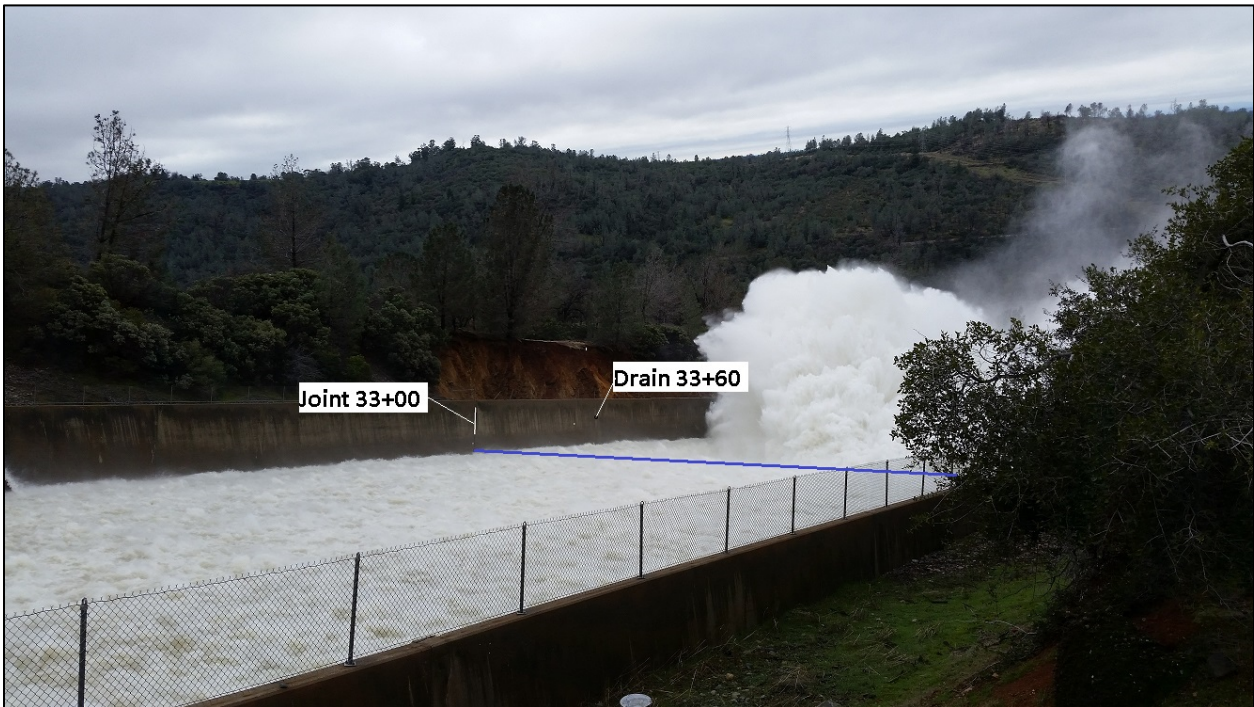
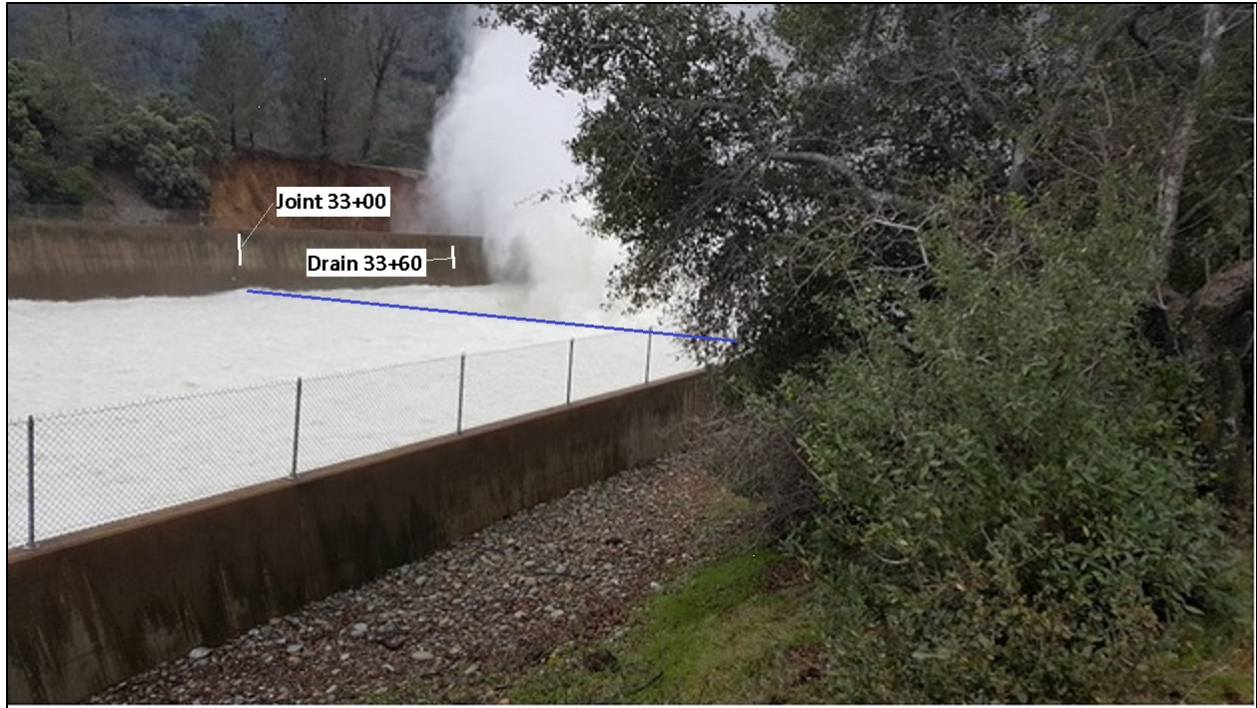
Figure I-6: Flow in Chute at 11:28 [I-3]

Figure I-7: Flow at 11:43 [I-2]

Figure I-8: Flow in Chute at 12:07 [I-2]

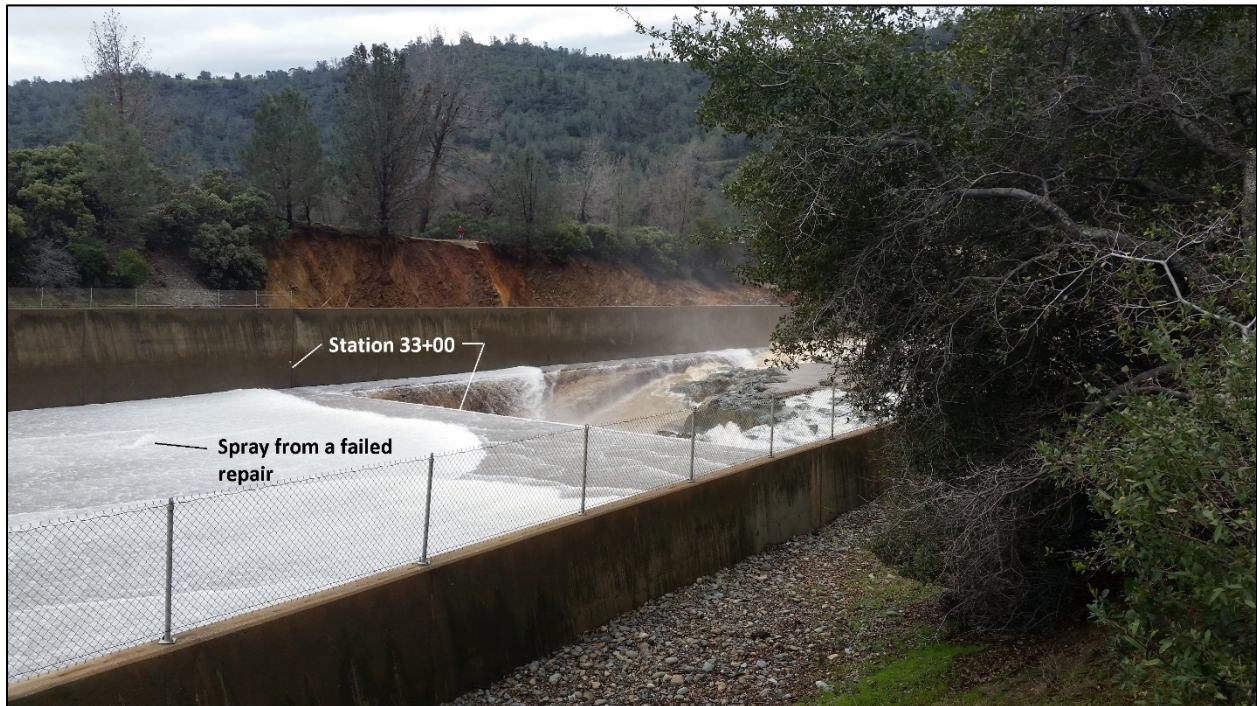
The shut down of spillway flow began at a about 11:25 am and the gates were fully closed by about 1:00 pm. Figure I-9 [I-2] shows flow on the spillway chute at 12:26 pm, when it appears that the gates are nearly closed. Note that spray from a failed repair or spall can be seen upstream of Station 33+00. This indicates that previous repairs had probably failed within the chute. This occurrence is discussed further below.

Figure I-9: Flow in Chute at 12:26 [I-2]

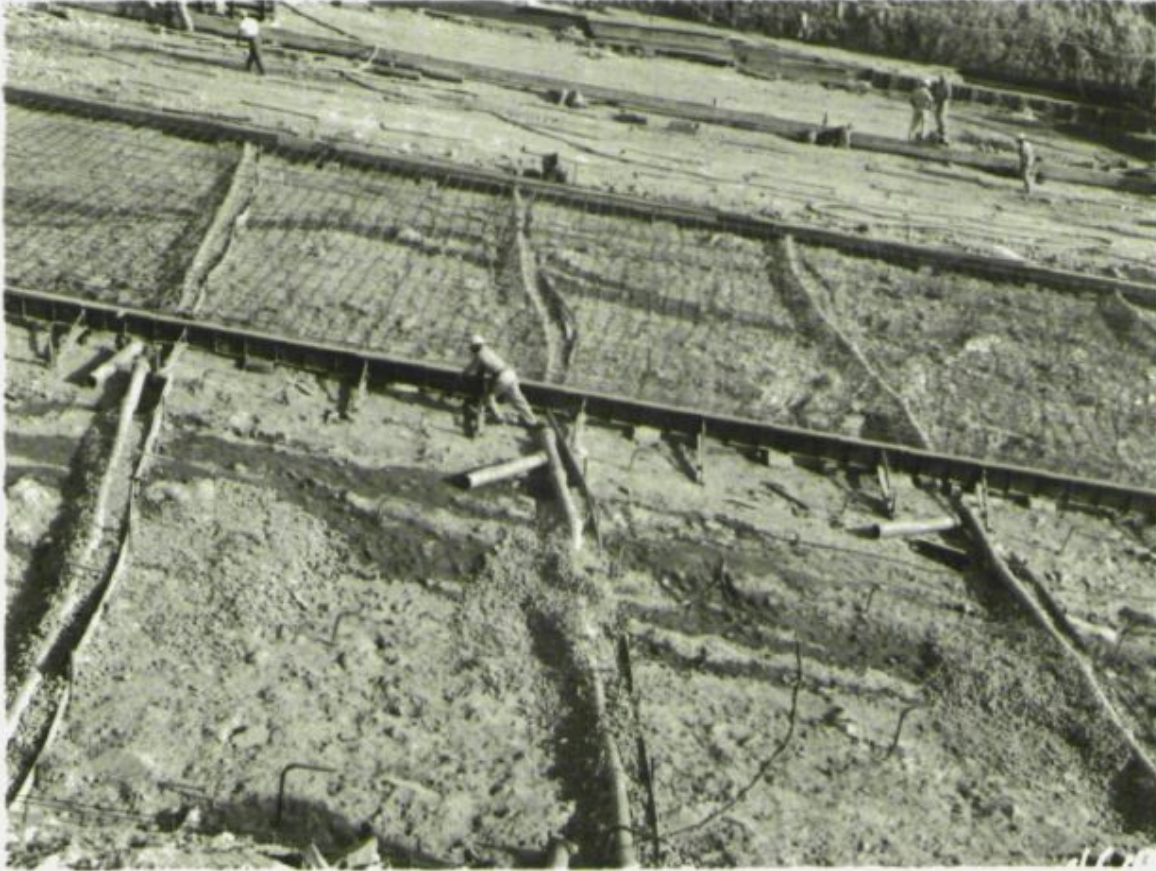
From construction photos and reports (Appendix A), it appears that much of the foundation in the vicinity of the initial failure was covered by soil-like materials. The weathering profile and presence of shear zones likely contributed to this. To obtain an adequate foundation downstream of Station 33+00, the IFT believes that significant local overexcavation may have been necessary, but construction records do not indicate that this was requested of the contractor during construction. The post-damage photos in this appendix and elsewhere in this document show that rock below the foundation contact significantly improves at the downstream end of the failed area, where shallow scour depths can be seen. However, cleanup of the foundation had been an ongoing concern by the time the contractor reached this area (work moved from upstream to downstream), and in an effort to limit claims DWR staff seemed to not be directing the contractor to overexcavate the foundation, but rather clean it up the best they could when they reached the design grade without going deeper. By comparing Figure I-11 to Figure I-20, it appears that a good clean rock foundation could have easily been achieved downstream of Station 33+50 with little more effort (based on shallow scour depths to good rock), but apparently the effort to limit overexcavation and backfill concrete also resulted in a relaxation in the specified cleanup effort in areas like this where it could have provided significant benefit.

From the original geologic data, it could have been anticipated that local overexcavation would be necessary to achieve the specified foundation conditions. The depth of erodible foundation material immediately downstream from Station 33+00 is significant, and as discussed in Appendices A and C, the specified quantities for overexcavation and backfill concrete may not have been sufficient to cover all of the areas requiring overexcavation. However, this is one area that the IFT believes should have been overexcavated.

Photo 39. Chute foundation in vicinity of Sta. 33+60. Tile and gravel underdrains in lanes 2 and 3, rebar in lane 3. View southeast.
Neg. No. 4644 11-2-66

Figure I-11: Foundation in the Vicinity of the Failure [I-4]

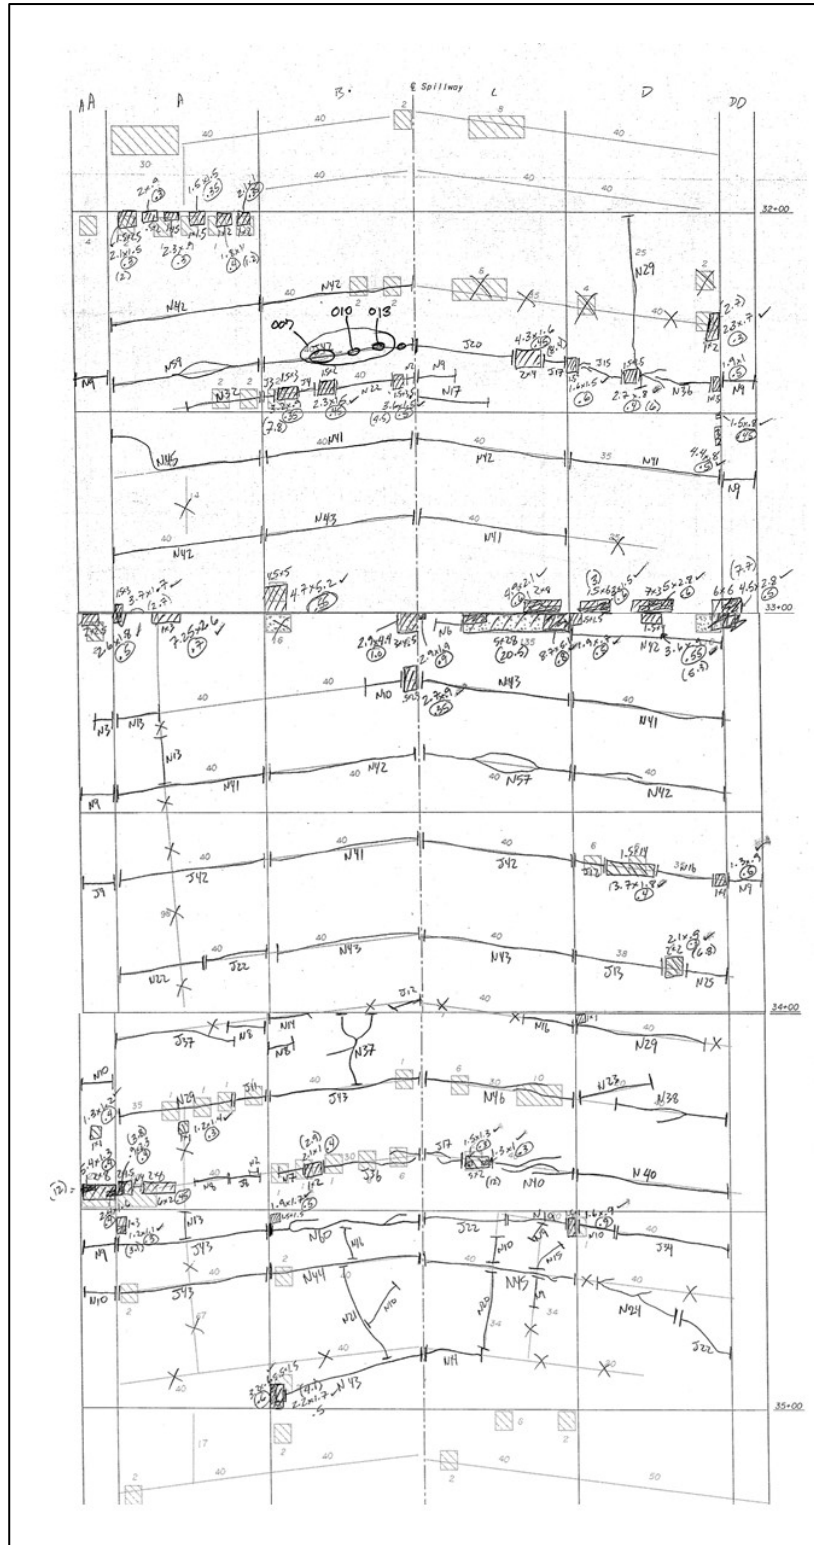
Figure I-12: 2009 Repairs [I-5], Sta. 32+00 to 34+00 from Field Notes

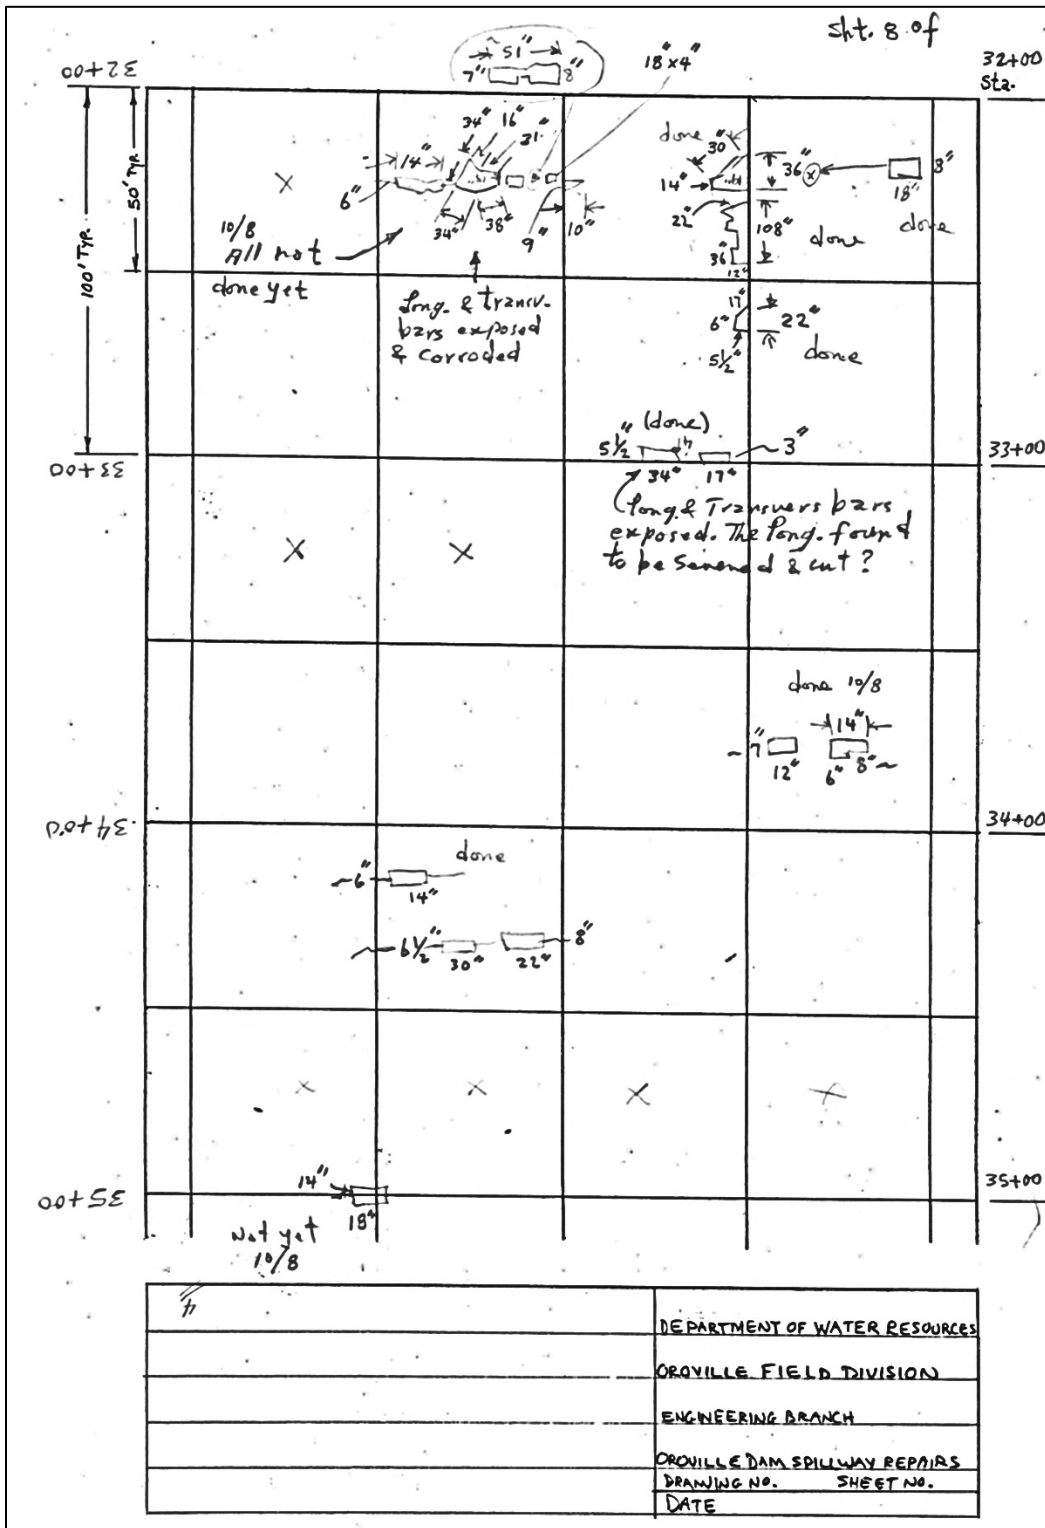
Further repairs were made in 2013, as shown in Figure I-13. These repairs seem to included repairs to areas with previous repairs that had failed and new areas of damage. Repair methods were similar to the 2009 repairs [I-5], although it is believed that non-shrink grout was not used in 2013. The 2013 repairs in the failed area between Station 33+00 and 34+00 were again, mostly sealing of cracks, with few new patches. While it is assumed that there were few visible spalls between Station 33+00 and 34+00 in 2013, it is not known if there were delaminations developing in that area that were undetected at the time. A possible explanation for fewer patches in this area could be that the chute slab was partially founded on a better foundation downstream from this area, as is evident from the post-failure photos showing shallow scour depths and intact slab sections further downstream. As discussed above, the weaker foundation between Station 33+00 and 34+00

may have allowed the slab to move more freely, causing stress concentrations upstream and downstream.

Figure I-13: 2013 Spillway Repairs from DWR Staff Field Notes from Sta. 32+00 to 35+00

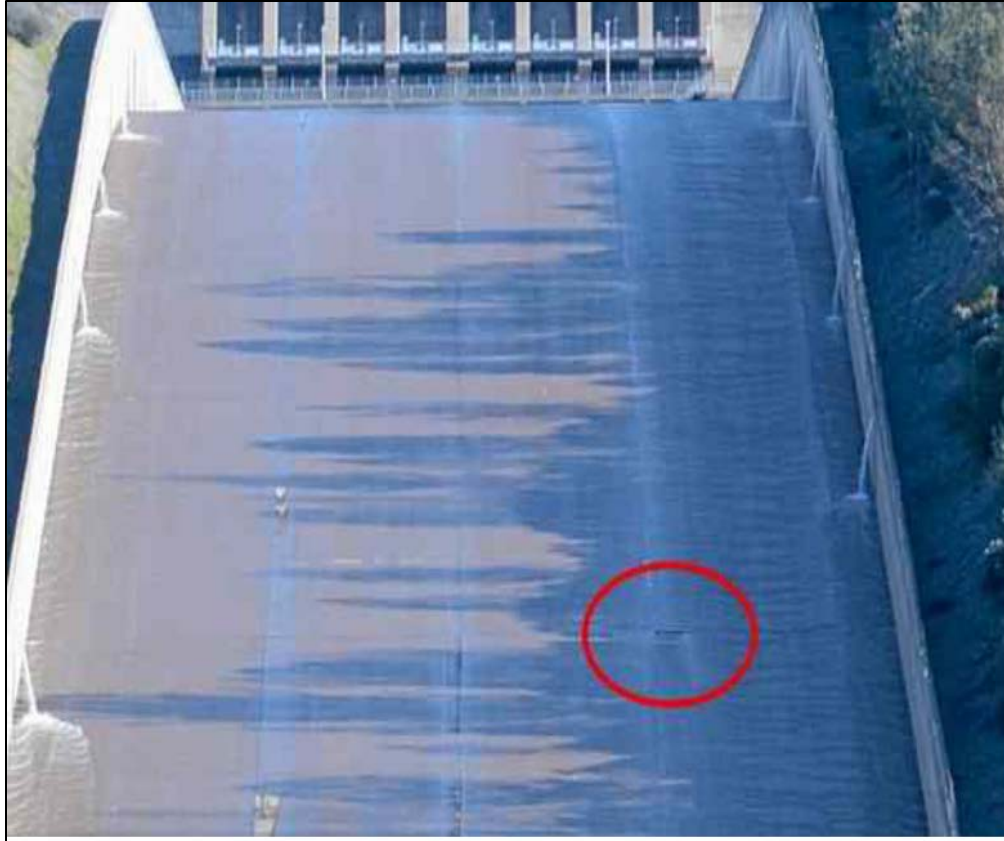
On January 27th, 2017 (Figure I-16), the area of the flow disturbance seems to be caused by the same repair failure or spall in Lane 5 at Station 33+00 as shown in Figure I-15. Note that patches in Lane 4 can also be seen, but appear to be intact. If this is a spall or failed patch in Lane 5, and it is upstream from the joint, it could create a stagnation point with a vertical offset into the flow at the joint, where water could flow into the joint. However, if the spall is downstream, the offset would be several inches downstream from the joint, and the path to the foundation would not likely be through the contraction joint at Station 33+00, but could instead be through a crack over the herringbone drain that is located a short distance downstream from the joint.

Figure I-16: Spall in Lane 5 Jan 27, 2017 [I-6]

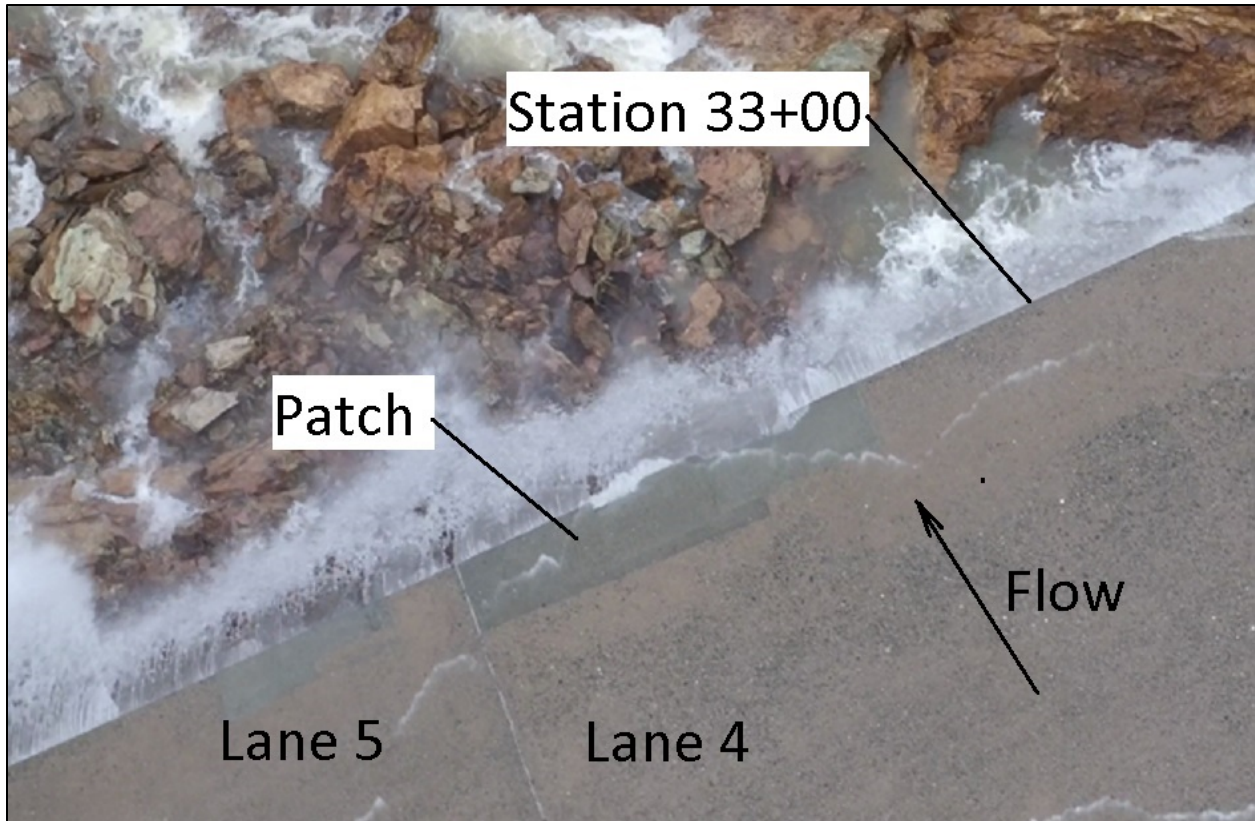
Figure I-17 is a still shot captured from drone video taken on February 8, 2017 after the initial damage occurred. Note that the patch upstream from the joint in Lane 5 is not damaged. This photo is evidence that the upstream patch did not fail before the chute failed. This leaves two other possible explanations for the flow disturbance as seen in Figures I-15 and I-16. The first is that a failed older patch or new spall occurred downstream from the joint. The second is that the flow disturbance is caused by joint filler material that has been partially removed from the joint. There is no clear indication from past repair reports that a repair was ever made at this location downstream from the joint, but it is possible that repairs were made that were not documented in available information. The IFT could not obtain a clearer copy of the Figure I-16 image to help identify the cause of the disturbance.

Figure I-17: Patches Upstream from Sta. 33+00 [I-2]

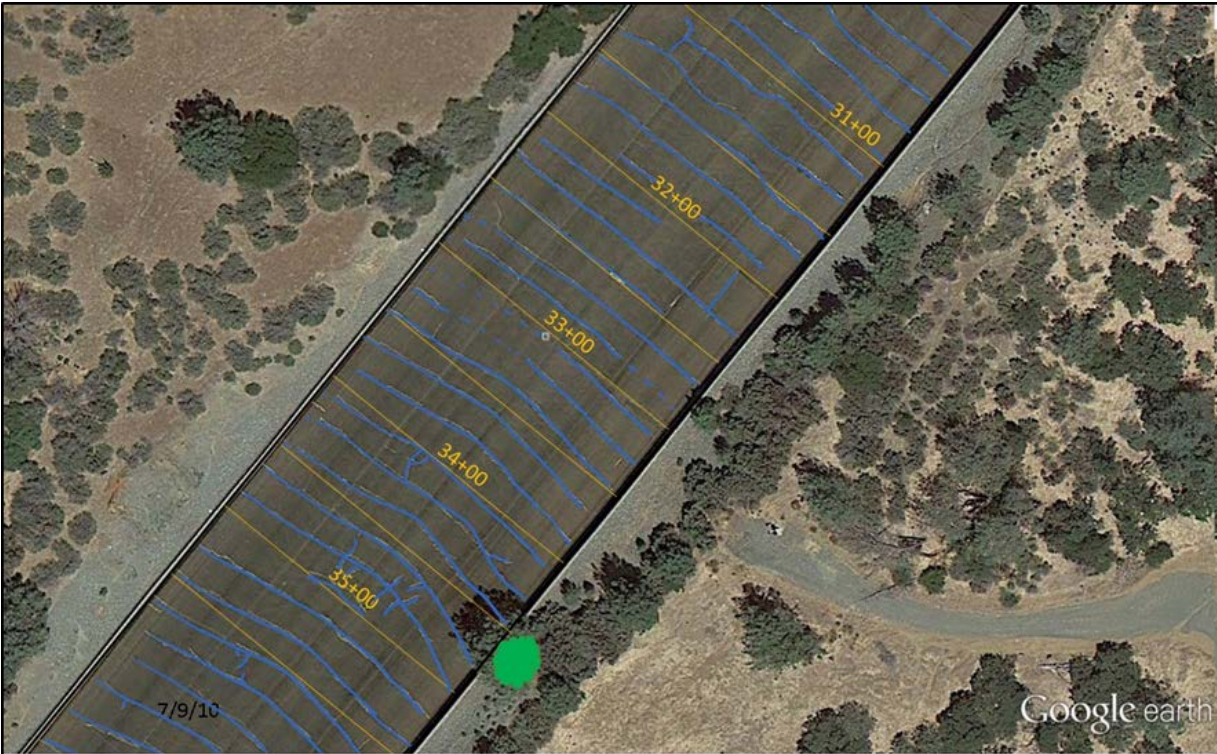
The cracks over the herringbone drains are clearly visible from a satellite photo taken on July 9, 2010, Figure I-18. As can be seen in Figure I-18, a herringbone drain crack is located a short distance downstream of the joint at Station 33+00 in Lane 5. The feature in Lane 5 (Figure I-16) could be a failed section of slab over the drain where the concrete is thinner. Cracks that form over the herringbone drains have been known to cause a rupture of the rebar. This could be a failed section of concrete bounded by the contraction joint at Sta. 33+00 upstream and the crack over the drain downstream. Since dowels were cut at this contraction joint when repairs were made in 1997 (see Appendix G), a section of concrete bounded by the joint upstream and a drain crack with failed rebar on the downstream side may only be held in place by rebar that is parallel to the lateral joint. It cannot be determined if the concrete has been removed at the time of the photograph, it may still be hanging on by a single rebar passing through the loose concrete. However, with no clear photos made available to the IFT, actual conditions at this location prior to failure remain unknown.

Figure I-18: Herringbone Drains Visible from a Satellite Photo (highlighted in blue) [I-1]

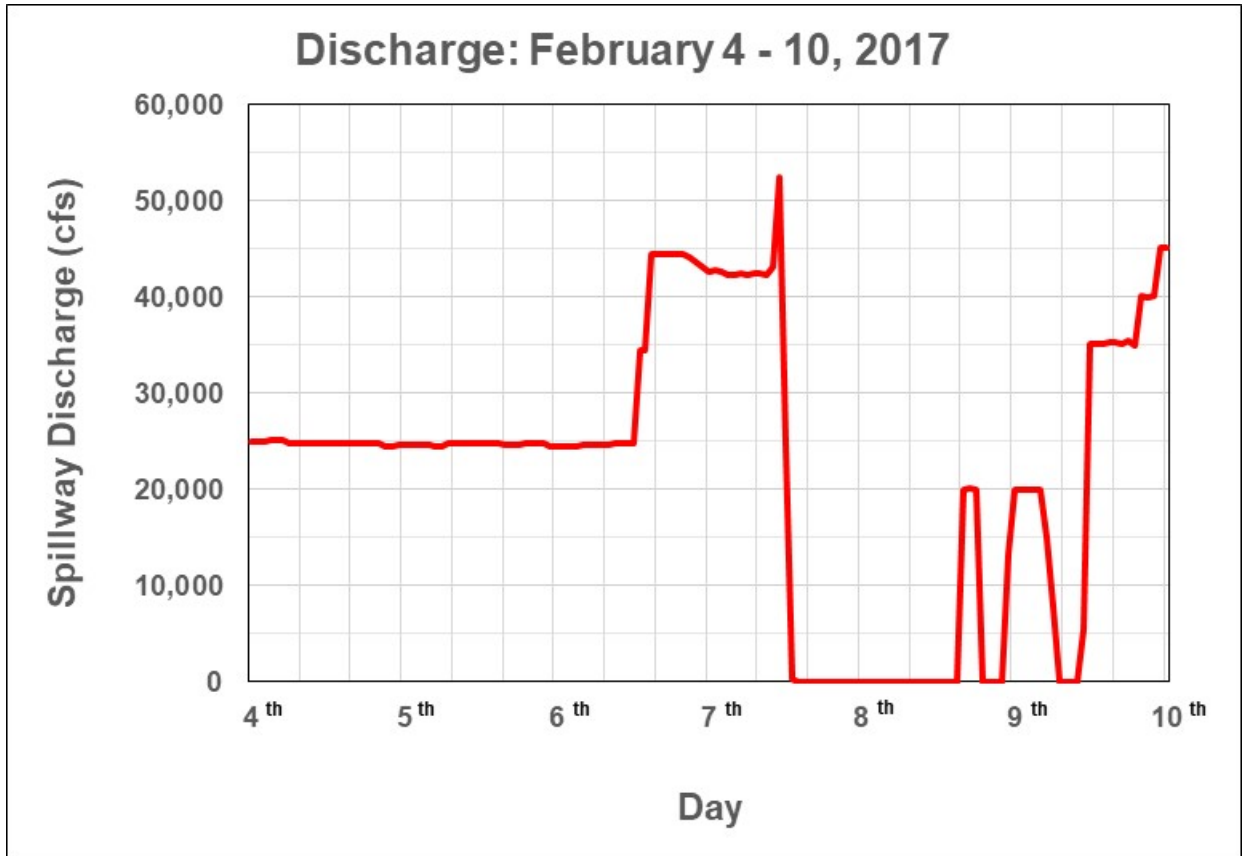
On February 7, 2017, extensive damage occurred downstream of Station 33+00 after the flow was increased from about 42,500 cfs to 52,500 cfs at about 10:00 am that morning, as shown on Figure I-1. The point where zero flow occurs on the February 7 (Figure I-19) is the time when the spillway gates had been closed after the damage was discovered on February 7.

Figure I-19: Spillway Flow History, February 4 to 10, 2017 (data provided by DWR)
