INDEPENDENT FORENSIC TEAM REPORT OROVILLE DAM SPILLWAY INCIDENT

JANUARY 5, 2018

SUMMARY

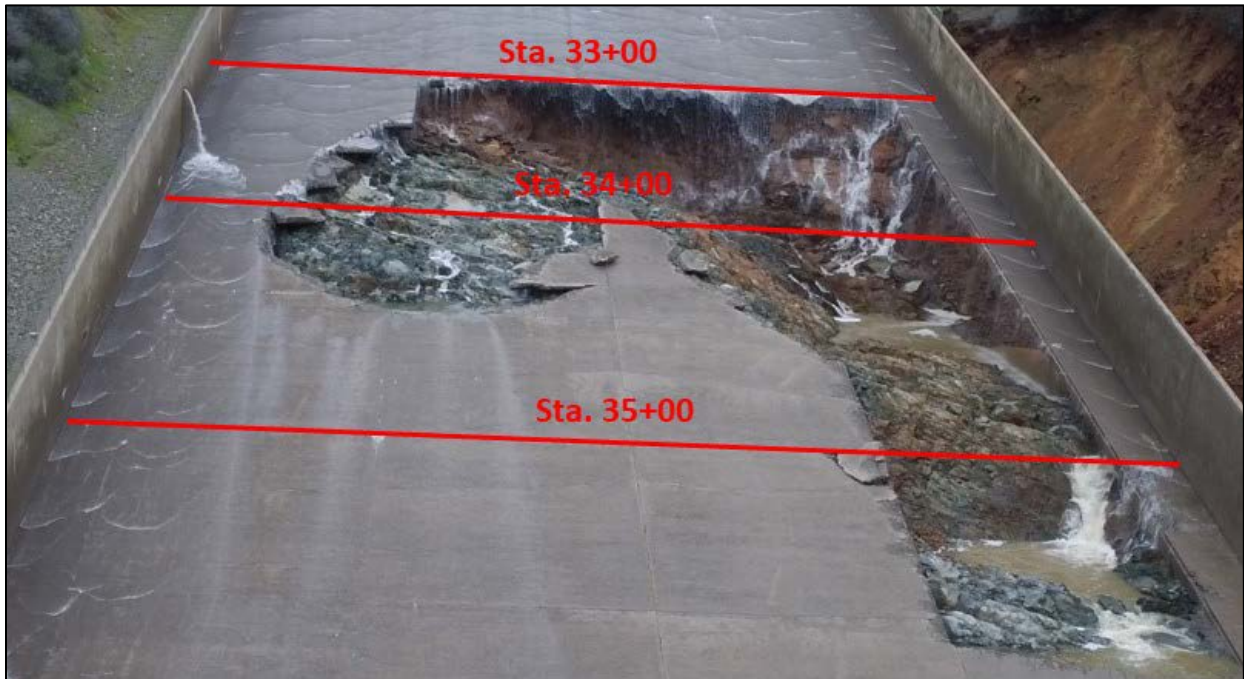
The damage downstream of Station 33+00 is shown in a February 8 photo (Figure I-1). This figure also shows the drain set that did not flow on the left side of the chute (the outfall for the herringbone drains from 31+00 to 33+00, opposite the drain seen flowing on the right side) and the drain set that flowed intermittently on the right side of the chute (the outfall for the herringbone drains from 29+00 to 31+00). A close-up of this damage and approximate spillway stationing can be seen in Figure I-20.

Figure I-20: Closeup of Damage on February 8, 2017 [I-2]

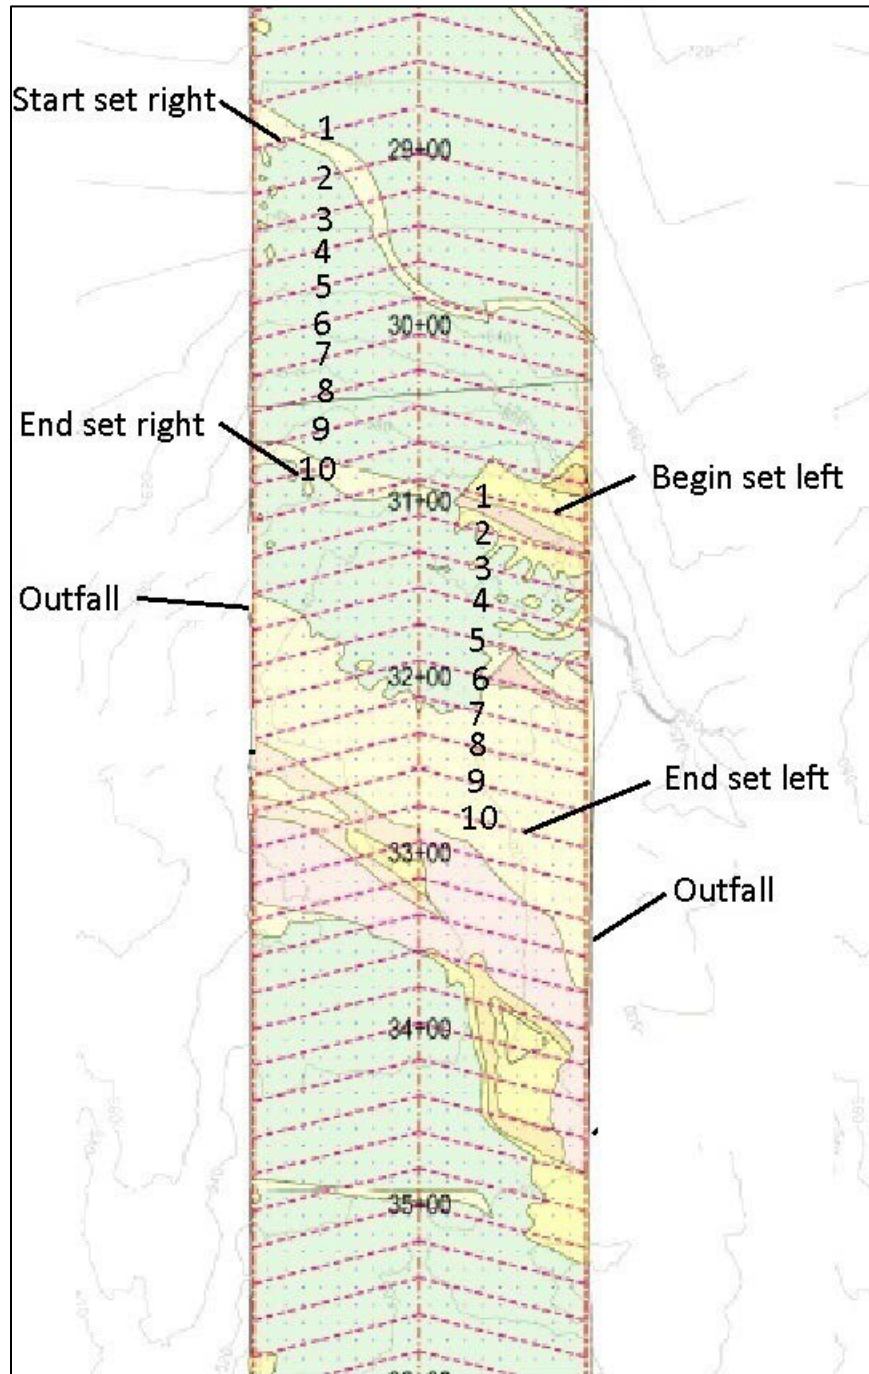
The light orange shaded areas shown in Figure I-21 are strongly weathered foundation materials. These materials are in an area of very weak and erodible foundation material. This material was present in the foundation from Sta. 33+00 to 35+00. Over time some of this material could have experienced erosion from water flowing into the foundation from the chute surface, creating void areas under the slab where water could accumulate once the drain capacity is exceeded. The IFT believes that the voids would have been relatively shallow, because the material included fines and

rock fragments. Once fines are removed, the rock fragments would tend to armor the surface, preventing deep erosion.

Figure I-21: Problematic Drain Sets (from DWR)

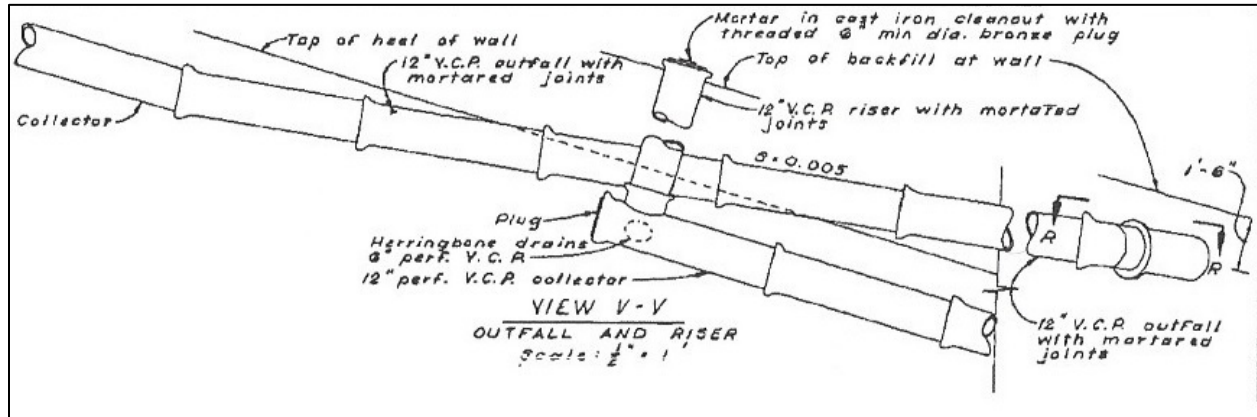
Figure I-22: Collector Drain Detail [I-7]

This 12-inch VCP outfall pipe is set on a 0.005 slope. If the pipe becomes 82 percent full, it can carry the same amount of water as if it were full. With a Manning Coefficient $n = 0.012$, the maximum discharge when the discharge collector pipe flows full is 3.25 cfs. For higher flow rates, the collector pipe and herringbone drains will flow full. In Appendix B, the computed flow into a crack in the damaged area through a 1/2-inch gap is given as 0.28 cfs/foot when the spillway discharge is 54,000 cfs. At this rate, the flow through just 16.75 feet of open transverse joint matching this condition would be 4.7 cfs. Thus, flow through transverse cracks or joints, if only a small percentage of the cracks or joints were partially open, could exceed the capacity of the collector drains. With over 800 feet of herringbone drains feeding a single collector drain, the cumulative flow from all contraction joint and herringbone crack repair failures within the collector drain set would add to the total discharge. The local drain set flows combined with possible flow passing under the slab from upstream of Station 33+00 when the failure occurred, could have easily exceeded the collector drain capacity, allowing pressure to back-up under the slab.

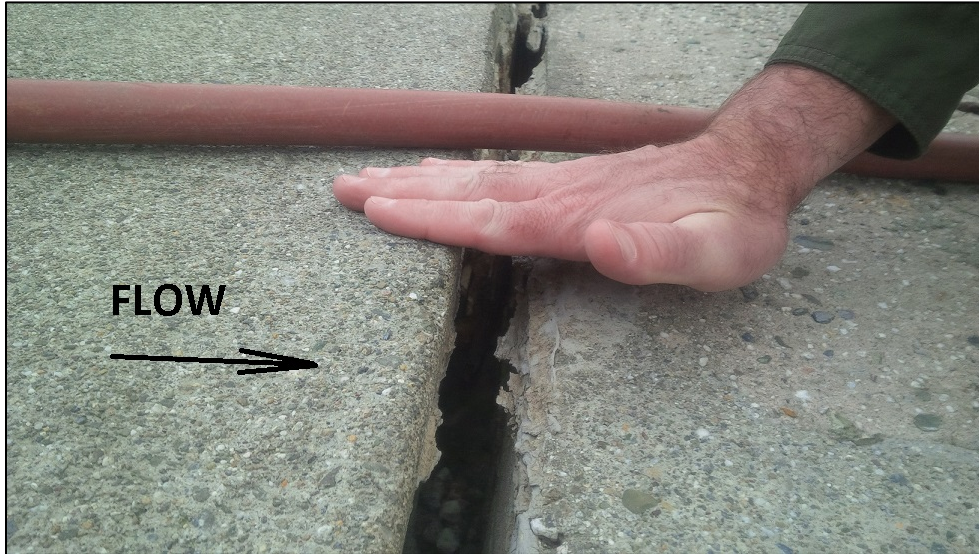
The computations for flow into cracks and open joints as presented above and in Appendix B are assuming only minor offsets into the flow. Where spalling occurred above a crack or joint, the offset into the flow at the deepest part of the spall could be several inches, which would result in much higher stagnation pressures and flow into the foundation. If the top of a herringbone pipe and surrounding gravel envelope were to be exposed to chute flows, foundation inflows could be significantly higher. In addition to the potential spall at Station 33+00 and at nearby cracks and joints, the downstream slab may have slipped downstream along the weak foundation material left on the surface before the slab was placed. This movement could open a gap that would allow water to enter the foundation more easily. The tendency of the slabs to slide downstream can be seen in the gap that developed in the existing spillway at Station 29+00 following the failure of the chute up to Station 30+00, Figure I-23. In the winter months, the slab joint and crack can be expected to

be near their maximum opening. If a slab has a tendency to slid downstream, it would likely happen during the winter with flows being injected into the foundation.

Figure I-23: Gap in Invert Slabs at Station 29+00 [I-2]

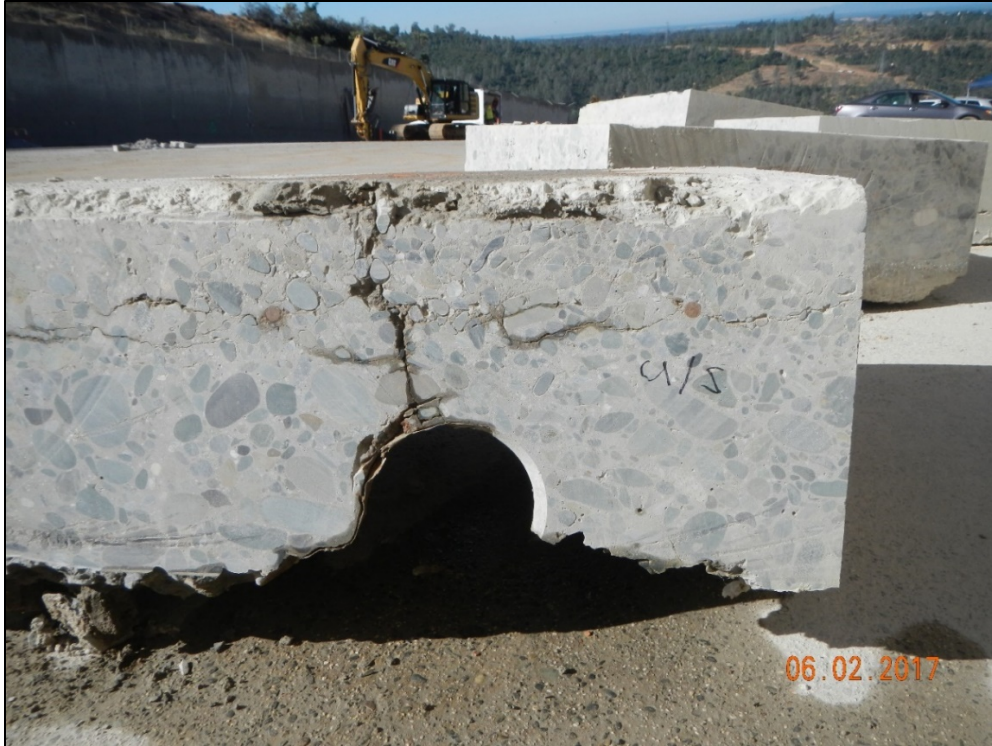
A forensic investigation of the existing spillway was conducted by cutting sections of the chute invert away and lifting out sections of the concrete (see Appendix D). This investigation showed that many of the repairs had delaminated from the original concrete and that in some cases, the delamination extended into the previously undamaged slab, Figures I-24 and I-25.

Figure I-24: Delamination of Slab (IFT photo)

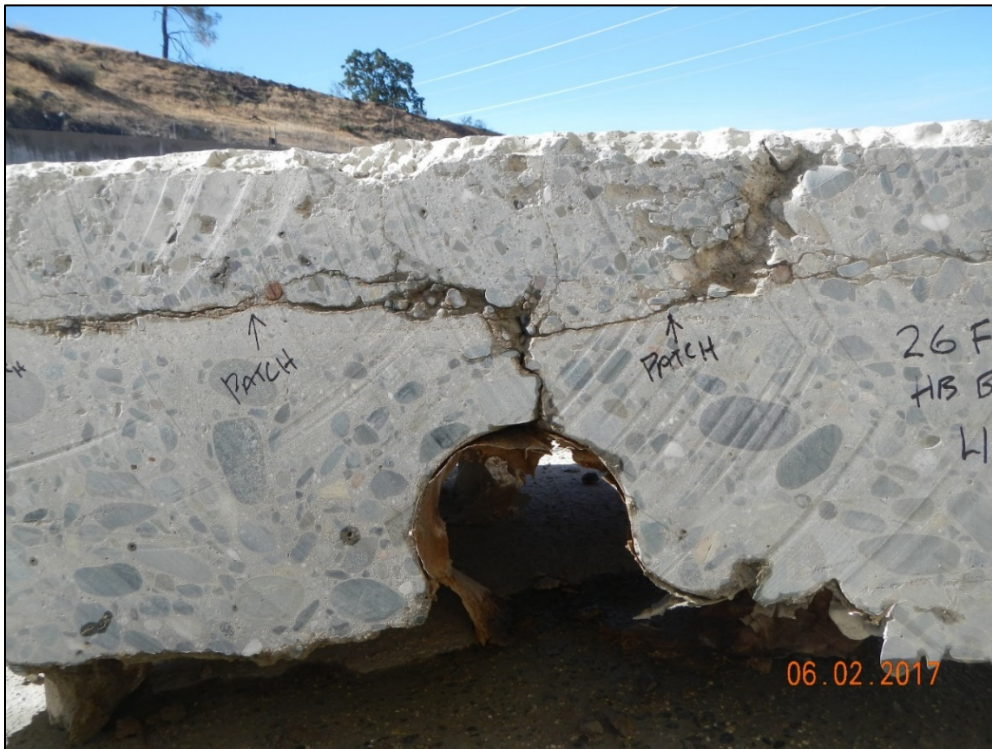
Figure 25: Delamination of Slab (IFT photo)

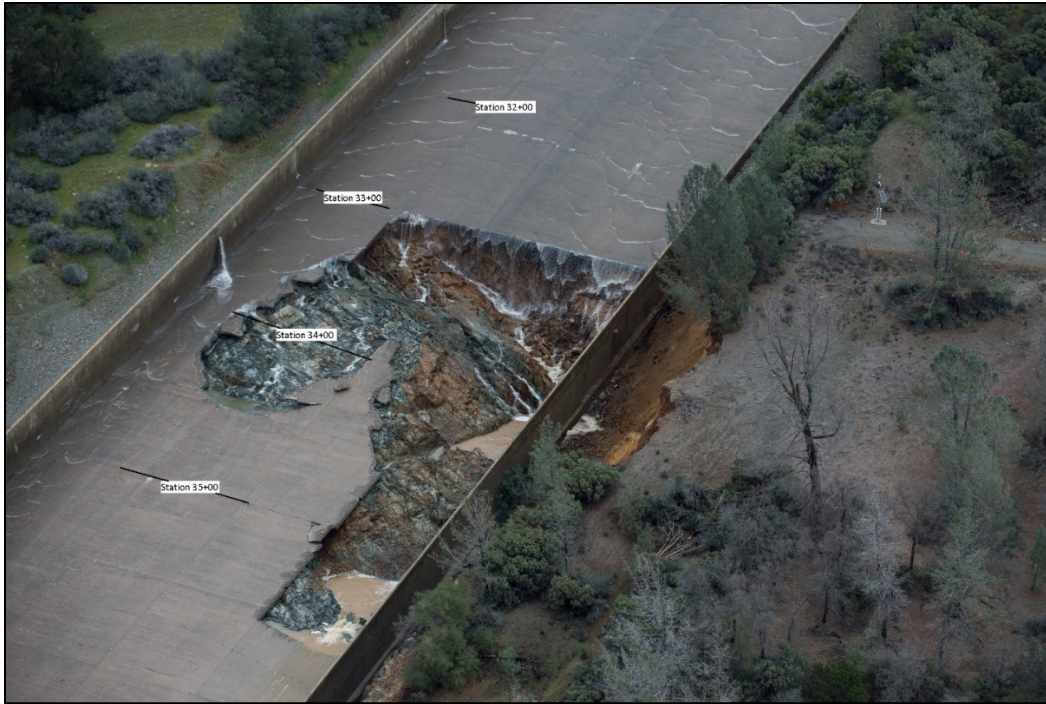
Figure I-27: Detail of Initial Spillway Damage [I-2]

Simultaneously, slabs upstream of initial failure were likely undermined and removed once foundation support was lost and the joints or cracks opened enough to expose the underside to direct flow. The process of head cutting then proceeded laterally and upstream to Station 33+00, leaving the hole seen in Figures I-1, I-9 and I-27.

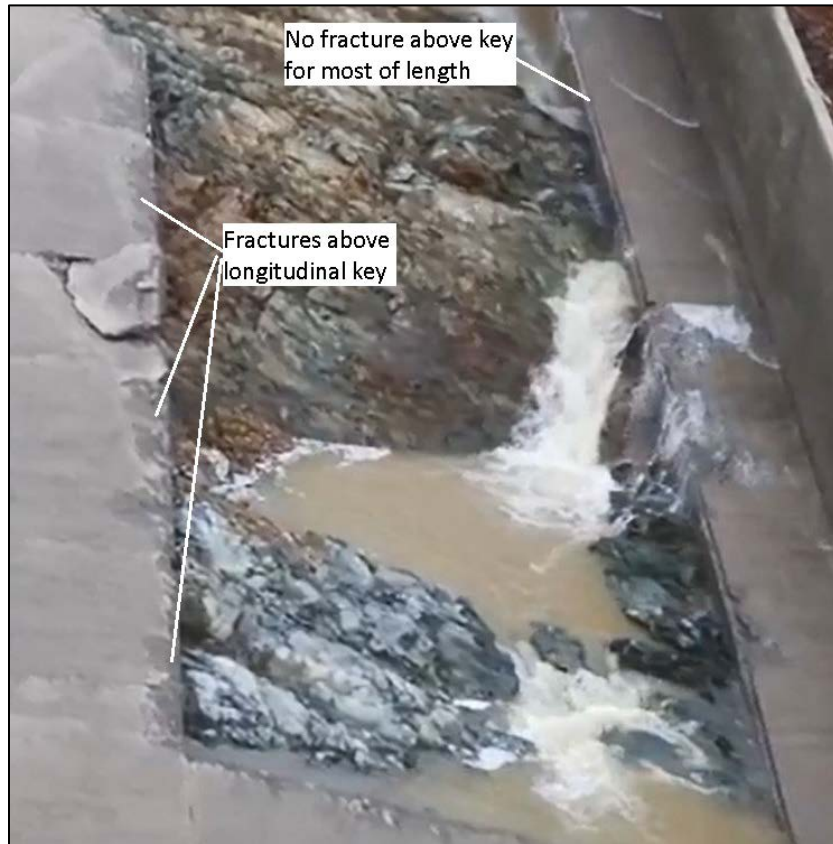
there are significant spalls between Station 35+00 and 35+50. The observed conditions in Lane 6 are the result of the key at the Lane 5-6 being configured such that the Lane 5 concrete laps over the Lane 6 concrete. Consequently, the spalling is caused by pull out of the dowels only, and the key does not need to be sheared for the Lane 5 slab sections to be lifted out. In contrast, at the Lane 4-5 joint the lapping key concrete in Lane 4 must be sheared for the Lane 5 slab sections to lift out. In combination this observed damage indicates that the slabs in Lane 5 between Stations 34+50 and 35+50 were likely rotated out of position about an axis that corresponds with the downstream end of the damage in Lane 5. Based on the evidence from these images, it seems that this is a location where the slab was jacked out as high velocity spillway chute flows produce high stagnation pressures beneath the slab. The edge spalling seen in figure I-28 and the bent bars seen in Figure I-10 are considered signs that the slab failed by jacking.

Figure I-28: Detail of Damage Downstream of Station 34+50 [I-2]

The slabs downstream to about 35+50 were then lifted and removed by the flowing water. This probably occurred after the initial slab section failed. Note that a portion of the slab in Lane 4

downstream of Station 35+00 was lifted and partially broken, see Figure I-28. This damage in Lane 4 likely occurred as the slab in Lane 5 was lifted and load was transferred to Lane 4 through the keys and dowels at the joint.

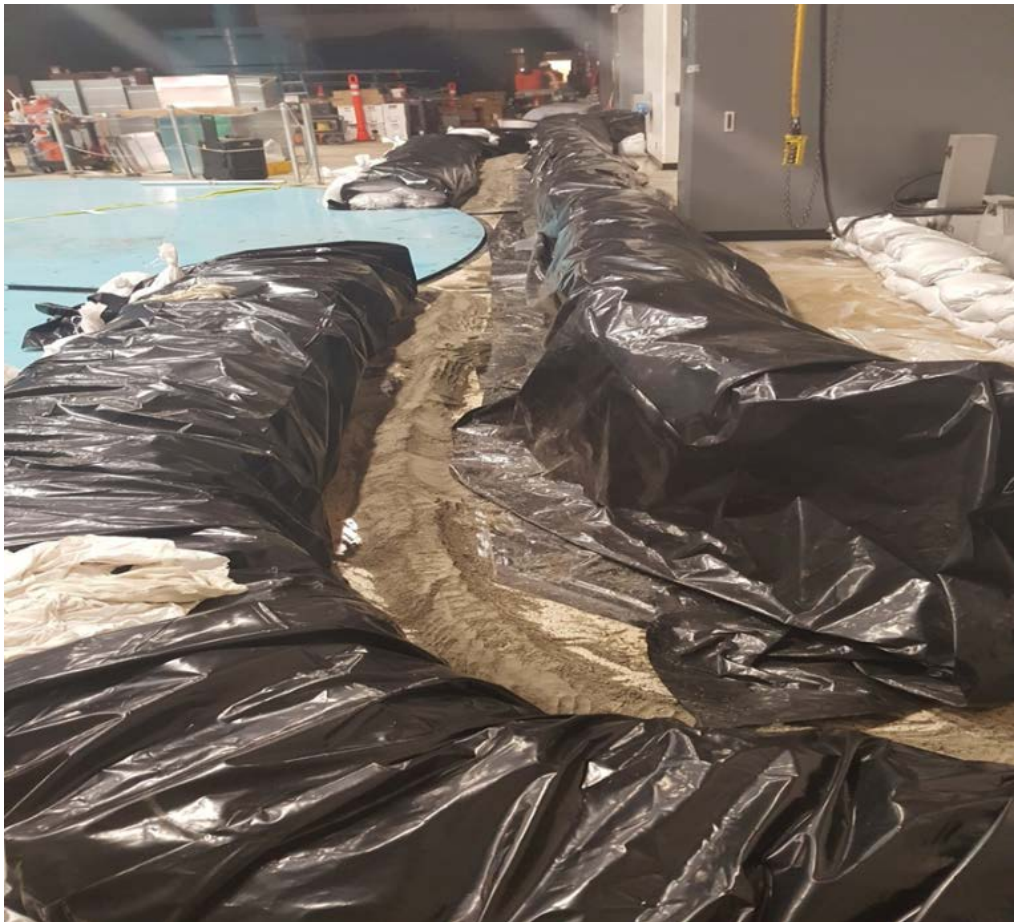
By this time, the sandbag berms around the stoplog hatch covers in the powerhouse had been reinforced, as shown in Figure L-3. Additional measures to seal the covers were also put in place. The tailrace level stabilized more than 2 feet above the powerhouse flood level, while the 100,000 cfs service spillway flow continued until midway through February 16. The Hyatt powerhouse did not flood due to, in the words of one interviewee, “the heroic efforts of the crew using jury-rigged sealed covers designed by O&M staff.”

Figure L-3: Sandbags in Hyatt Powerhouse [L-4]

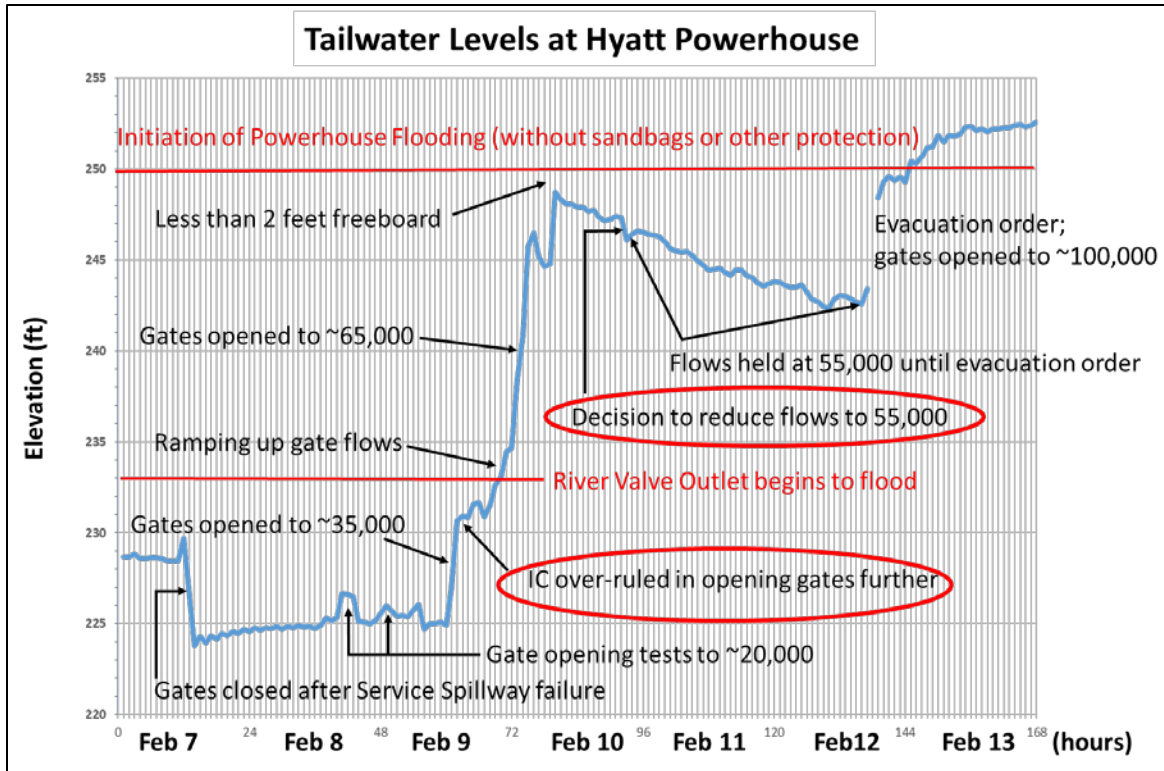
The annotated graph shows tailwater response due to service spillway gate operations. Tailwater first drops when the gates are closed soon after the service spillway chute failure to allow inspection of the initial failed area, and then rises when the gates are re-opened for a number of trial flows. The first decision, overruling the Incident Command to increase flow beyond 35,000 cfs, was made at a time when powerhouse flooding was not a serious threat. However flooding of the River Valve Outlet System (RVOS) was imminent, and the potential for loss of the transmission tower had already been identified:

Figure L-4: Tailwater Levels During the Oroville Incident
