Middlemore Hospital – Galbraith Building

Independent Structural Review

Prepared for Counties Manukau District Health Board

26 April 2018

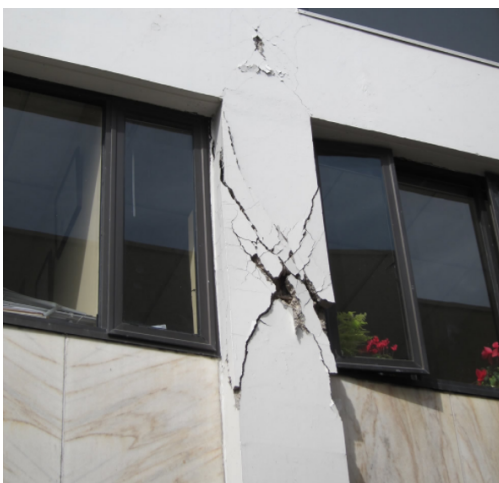
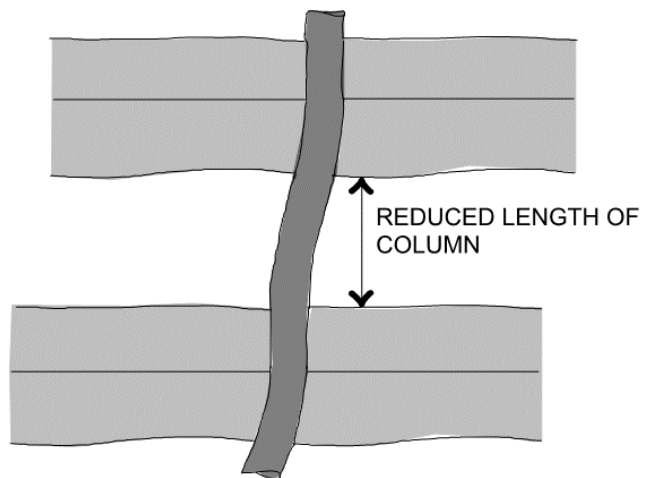
Figure 3.1: Example of shear failure of a short column, caused by influence of adjacent partial height infill (Kam, 2011) (L) and illustration of a 'short column' (R).

The primary frames score is limited by the performance of the tower structure, in particular the perimeter frames in both directions. The eastern and western elevation frames are limited by their flexural and shear strength from two influences the reinforced concrete partial height walls have on the frames. Firstly the concrete upstands increase the lateral stiffness of the perimeter frames, which cause them to resist proportionately more load than the internal frames. The second impact is the 'shortening' of the columns. The concrete upstand reduces the effective length of the column, meaning that any hinges must form between the clear length of the beam above, and the upstand below. This significantly increases the shear demand on the column, leading to a premature shear failure of the column. The primary longitudinal frame has thus been scored 25%NBS (IL4) based on the performance of these columns.

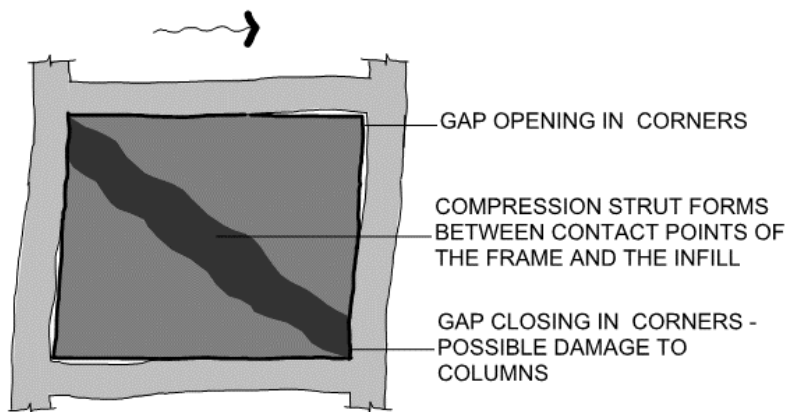
Figure 3.2: Illustration of compression strut forming between corners of frame due to interaction between frame and infill. Note that a column to column mechanism is shown.

Infill walls causing failure of end frame: In this mode, the infill walls do not fall out, and instead 'lock up' against the end frames. This serves to stiffen the end frame and concentrate seismic load into this frame. The resulting end frame damage is therefore triggered much earlier that would be the case without the infill walls. This could in turn lead to wider failures in the end-most bay of the building, resulting in life safety risk to occupants.

The assessment of the infill walls has a very high level of uncertainty. This is because of the construction gap that has been built around the infill walls. Our understanding is that this gap has been formed by plasterboard at the time of construction, which is not a reliable method for forming a seismic gap, but will non-the-less provide some level of separation.

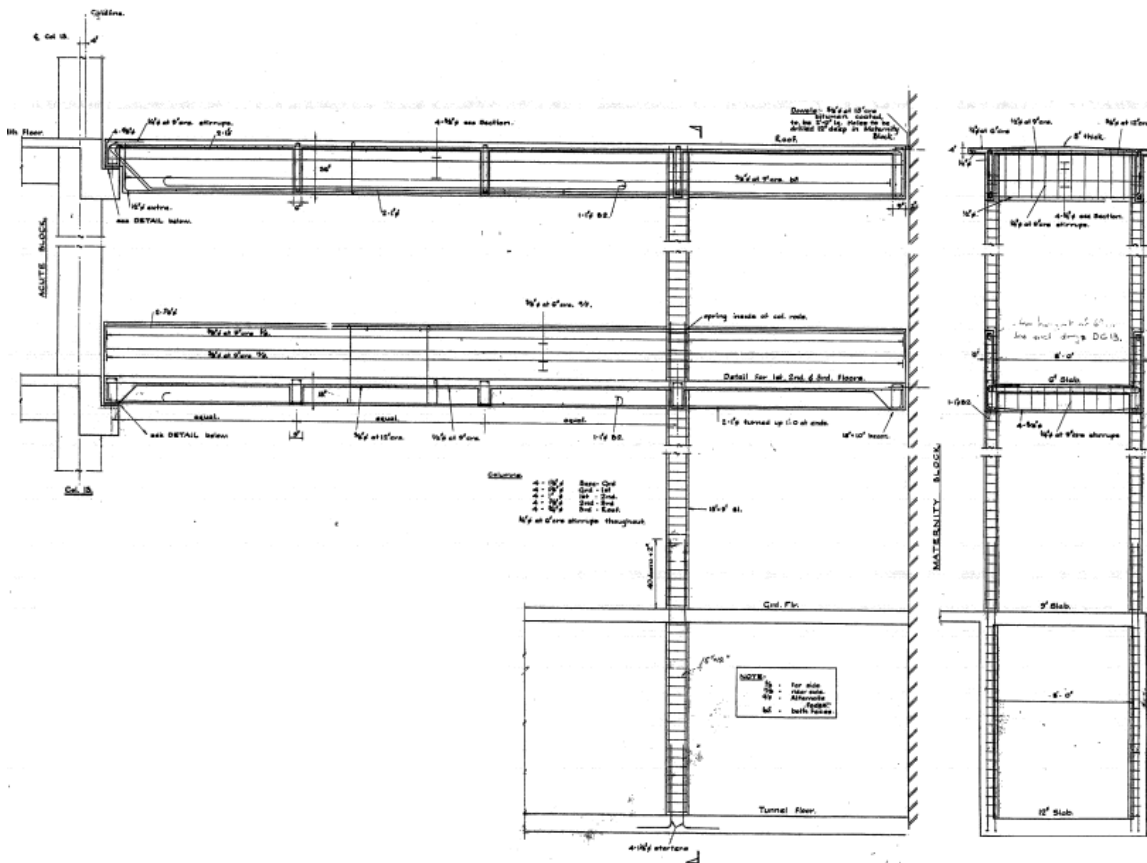
Fig.4.5.1 Link Structure Section

The lateral load resisting system in transverse direction comprises a slender reinforced concrete frame as shown below. Beca has undertaken an independent assessment of the frame which has resulted in 25%NBS (IL4) in the transverse direction. The seismic response of the link structure in these directions is governed by ground floor column flexural failure, leading to large storey displacements and eventual loss of gravity support.

Holmes Consulting has quantified the rating of the transverse frame as 30%NBS (IL4).
