SUBJECT: A CORROSION MITIGATION PROGRAM FOR THE REDWATER
OIL FIELD

T.A. Scott
Esso Chemical Canada

B.E. Fowlie
Imperial Oil Limited

A Corrosion Mitigation Program for the Redwater Oil Field

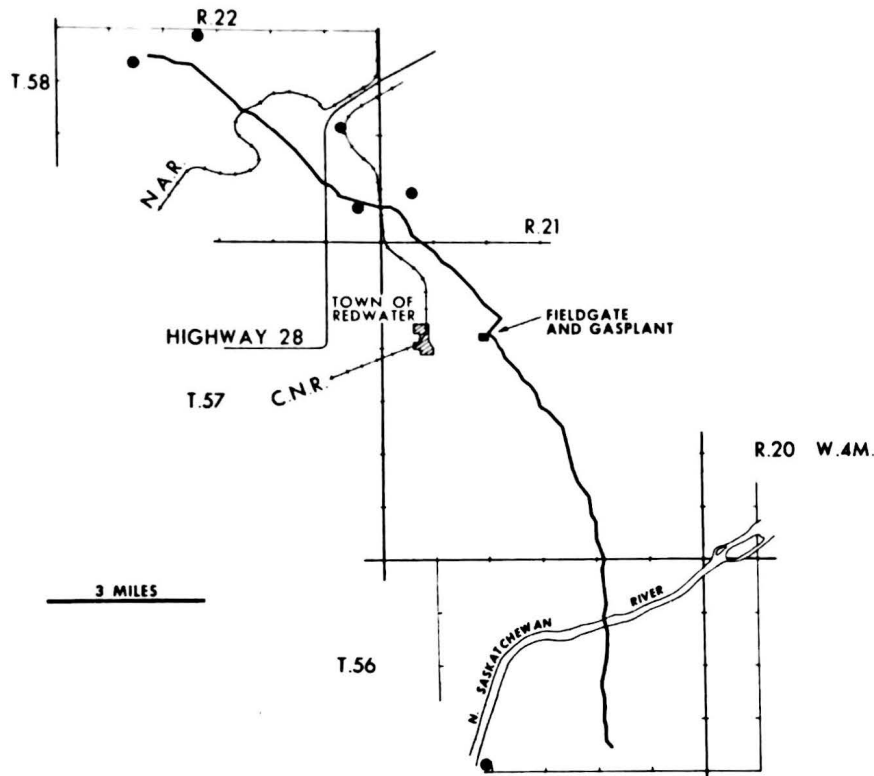
From 1964 through 1972, minor and infrequent corrosion of downhole equipment became apparent. Figure 3 shows the well locations at which the initial downhole corrosion problems occurred.

Figure 3 - Map of the Redwater oil field showing location of wells where downhole corrosion occurred prior to 1973.

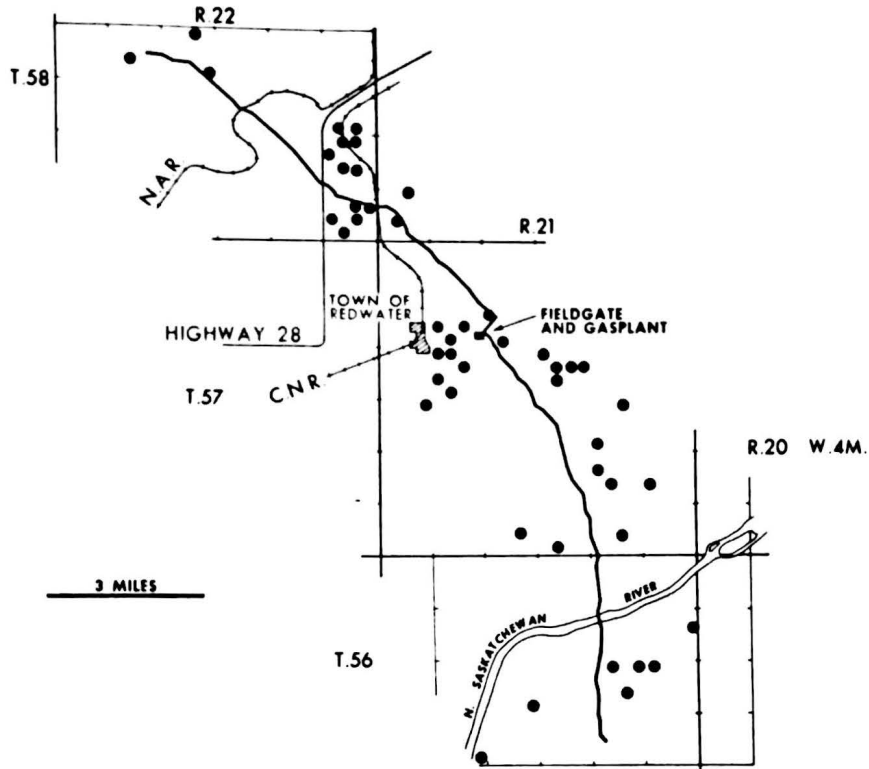
Beginning in 1973 the frequency of corrosion related damage of downhole pumps and sucker rods in the Northern section of the field where produced fluids contain 90% water began to increase at an alarming rate. Within twelve months the downhole corrosion spread across the complete field inclusive of those areas where the produced fluid contained less than 1% water. Figure 4 shows the location of those additional problem wells.

Figure 4 - Map of the Redwater oil field showing location of wells having downhole corrosion by the end of 1973.

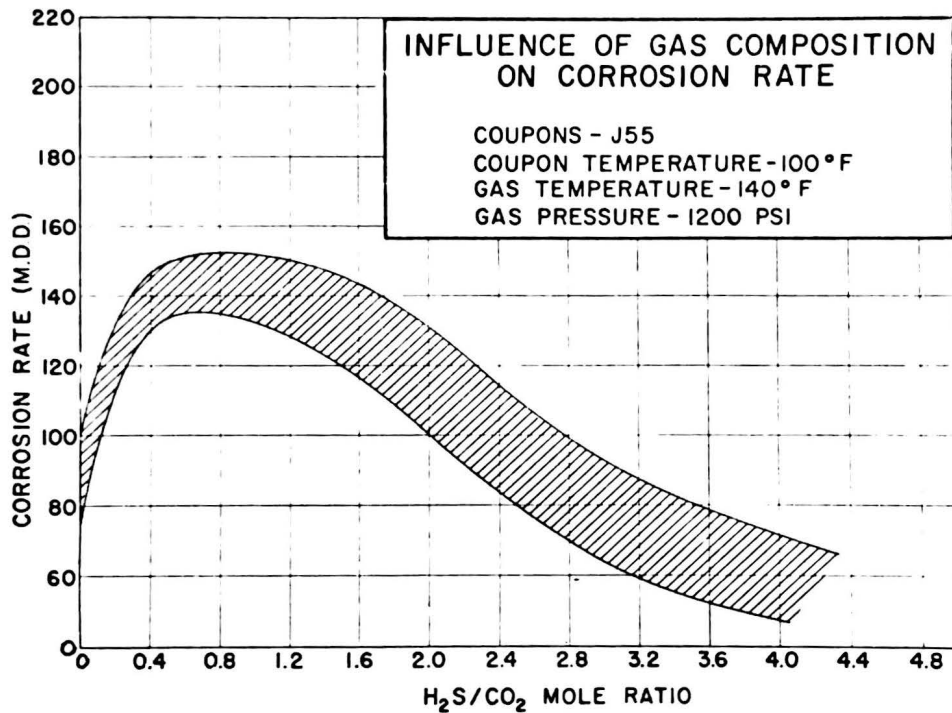
Contour plots of the gas composition revealed that 32 of the 40 wells with the most serious corrosion problems fell within areas bordered by either hydrogen sulfide/carbon dioxide mole ratios of 0.48 or total acid gas contents of 6.0 or greater mole percentage. Previous studies conducted by Imperial Oil's Production Research and Technical Service Laboratory showed that hydrogen sulfide/carbon dioxide mole ratios of 0.4 to 1.2 caused the most extreme corrosion rates. (See figure 6)

Figure 6 - Influence of gas composition on corrosion rate.
