**KOMITE NASIONAL KESELAMATAN TRANSPORTASI
REPUBLIC OF INDONESIA**

KNKT.18.10.35.04

Aircraft Accident Investigation Report

**PT. Lion Mentari Airlines
Boeing 737-8 (MAX); PK-LQP
Tanjung Karawang, West Java
Republic of Indonesia
29 October 2018**

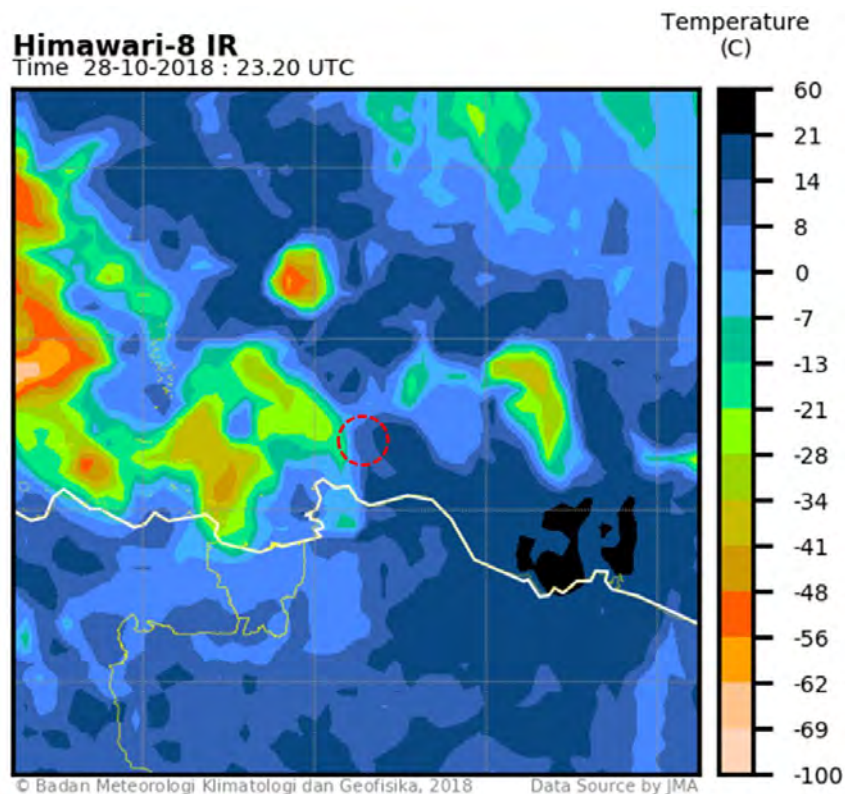
The *Badan Meteorologi Klimatologi dan Geofisika* (BMKG – Bureau of Meteorology, Climatology and Geophysics) provided enhanced infrared satellite images. The enhanced infrared satellite images at 2320 UTC (0620 LT) up to 2330 UTC (0630 LT) indicated that the temperature at the accident site (red circle) was from 0 up to 8°C.

Figure 1: Enhanced infrared satellite image at 2320 UTC (0620 LT)

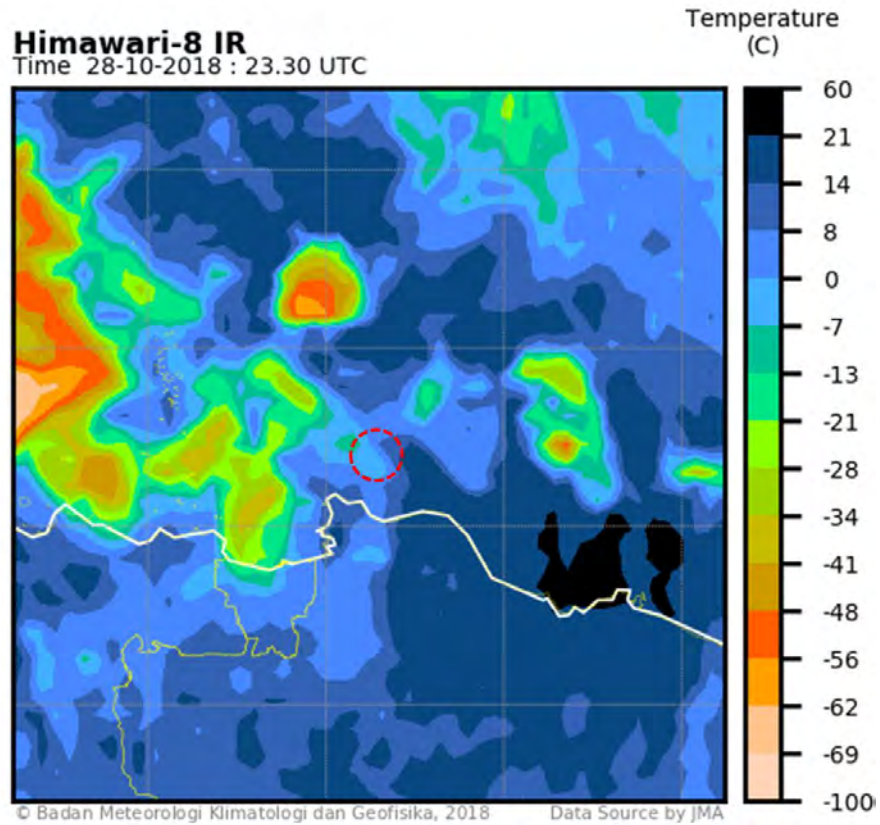
Figure 2: Enhanced infrared satellite image at 2330 UTC (0630 LT)

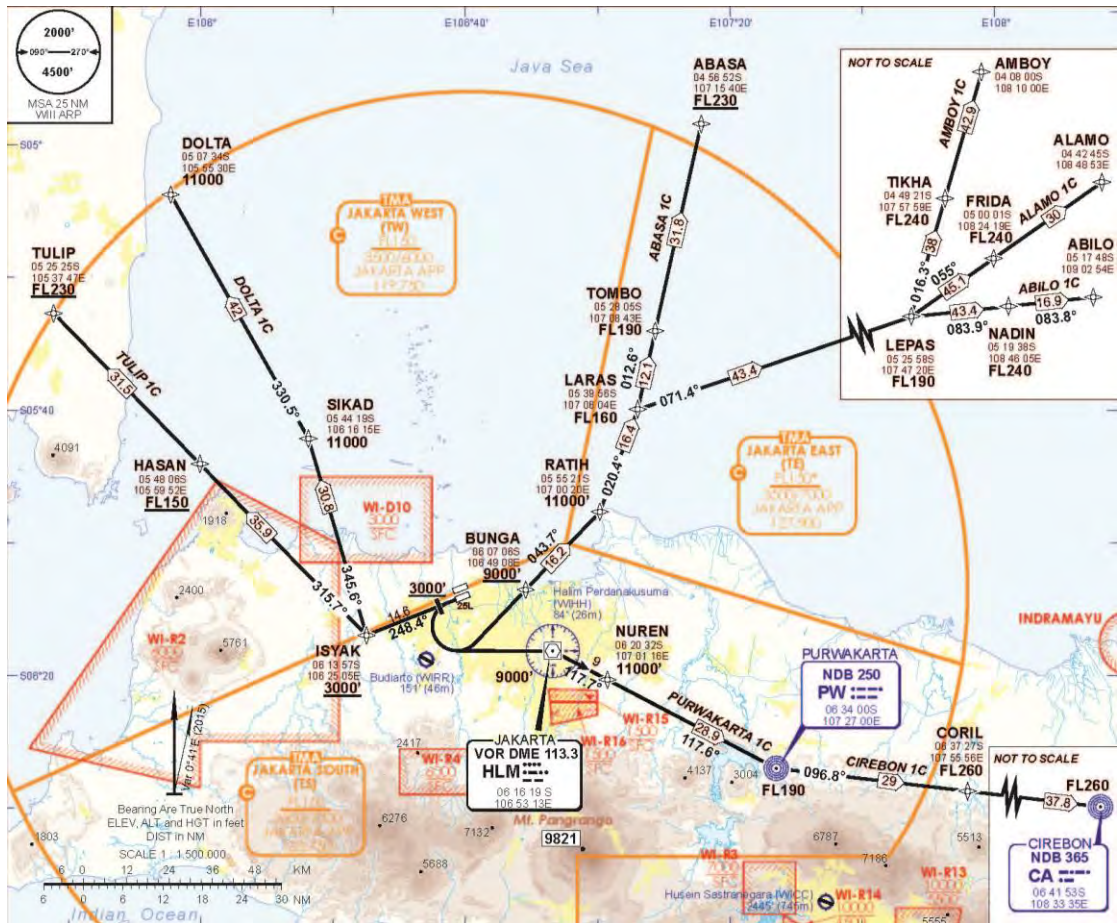
The runway 25L utilized RNAV-1 Standard Instrument Departure (SID), one of the SID was ABASA 1C which is after departure the pilot has to climb on heading 248.4°, at or above 3,000 feet then turn left direct to BUNGA – RATIH – LARAS – TOMBO – ABASA (figure 3).

Figure 3: The RNAV-1 runway 25L (extract from AIP Volume II)
