KIRKLAND & ELLIS LLP
AND AFFILIATED PARTNERSHIPS

July 26, 2019

As you requested, this is a letter report on the vegetation management field inspections ("VM inspections") the Monitor team is conducting pursuant to the Court's April 3, 2019 Order ("April 3 Order"). This submission includes: (1) background information on the VM inspections; (2) an explanation of the VM inspections process; (3) the Monitor team's preliminary observations; (4) PG&E's feedback based on the Monitor team's preliminary findings; (5) the Monitor team's preliminary suggestions to PG&E, as shared with the Company on July 17, 2019; and (6) concluding thoughts.

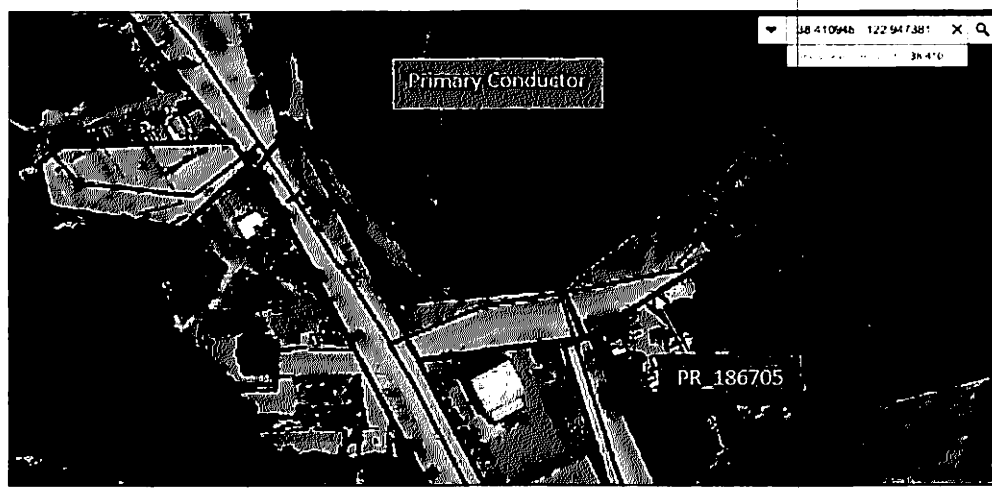
A potential hazard tree was found during a Monitor Inspection on June 18, 2019 of Project *PR_186705* on Circuit *Molino 1102*. In general terms, this circuit is located on the outskirts of the city of Sebastopol, CA, running approximately 10 miles to the west of the city. This circuit is located in/near a Tier 3 fire threat area pursuant to the ArcCollector database. The approximate position of the tree is denoted as the red circle in the second graphic below.

Figure 6: Excerpts of the first page of a sample potential exception report, reflecting the project location and description.
