Overpressurization of Natural Gas Distribution System,
Explosions, and Fires in
Merrimack Valley, Massachusetts
September 13, 2018

NTSB/PAR-19/02
PB2019-101365

Pipeline Accident Report

The National Transportation Safety Board determines that the probable cause of the overpressurization of the natural gas distribution system and the resulting fires and explosions was Columbia Gas of Massachusetts' weak engineering management that did not adequately plan, review, sequence, and oversee the construction project that led to the abandonment of a cast iron main without first relocating regulator sensing lines to the new polyethylene main. Contributing to the accident was a low-pressure natural gas distribution system designed and operated without adequate overpressure protection.

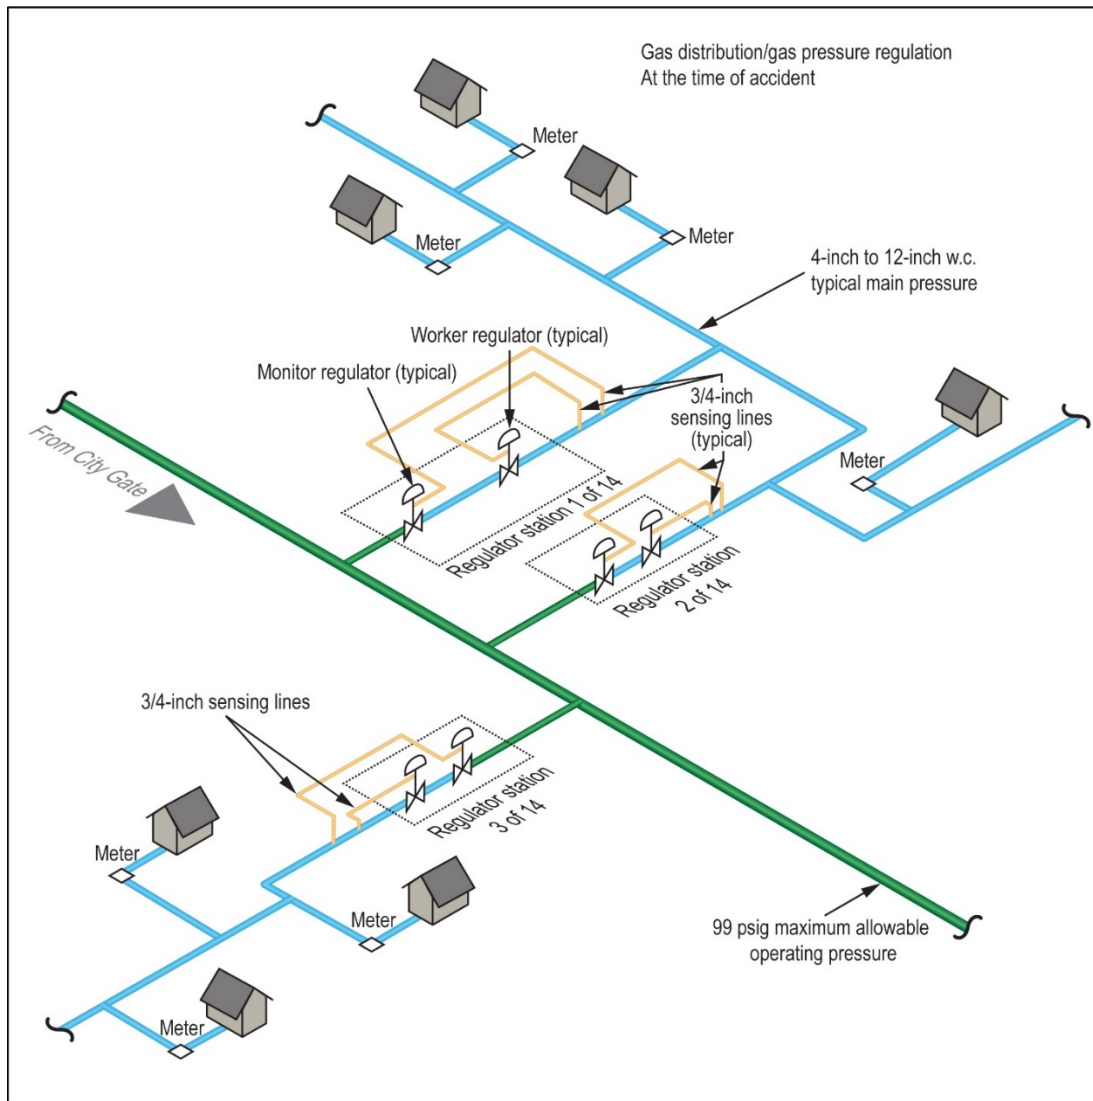
Since the regulator stations are the primary means of pressure control in the low-pressure systems, an overpressure condition in a natural gas distribution system could affect all customers served by the system. This is an inherent weakness of a low-pressure natural gas distribution system.

Figure 3. Typical configuration of the Merrimack Valley low-pressure natural gas distribution system.

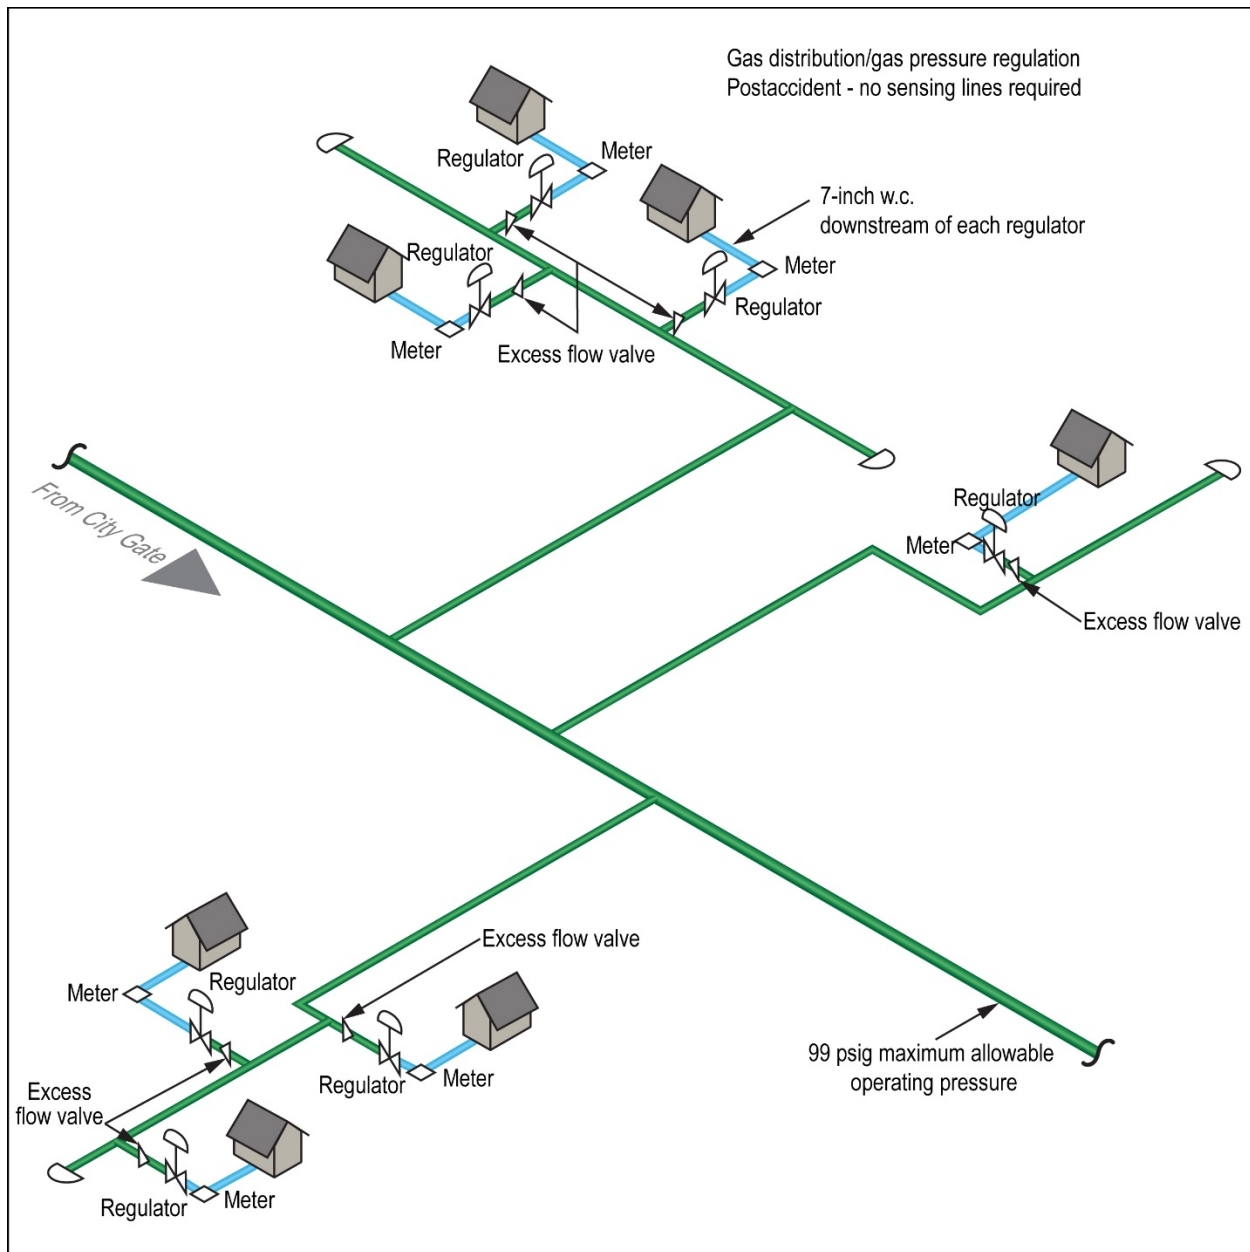
In a high-pressure natural gas distribution system, the natural gas pressure in the main is substantially higher than that required by the customer. A pressure regulator is installed at each meter to reduce the pressure. These regulators incorporate an overpressure protection device to prevent overpressurization of the customer's piping and appliances should the regulator fail. Additionally, excess flow valves are installed in the service line.⁷ Because each customer's service in a high-pressure natural gas distribution system is protected by an excess flow valve and a pressure regulator, it is highly unlikely that an overpressure condition in the main would impact multiple customers. Figure 4 shows a typical high-pressure natural gas distribution system. This is the type of natural gas distribution system that was installed postaccident in the Merrimack Valley.

Figure 4. Typical configuration of high-pressure natural gas distribution system installed postaccident.

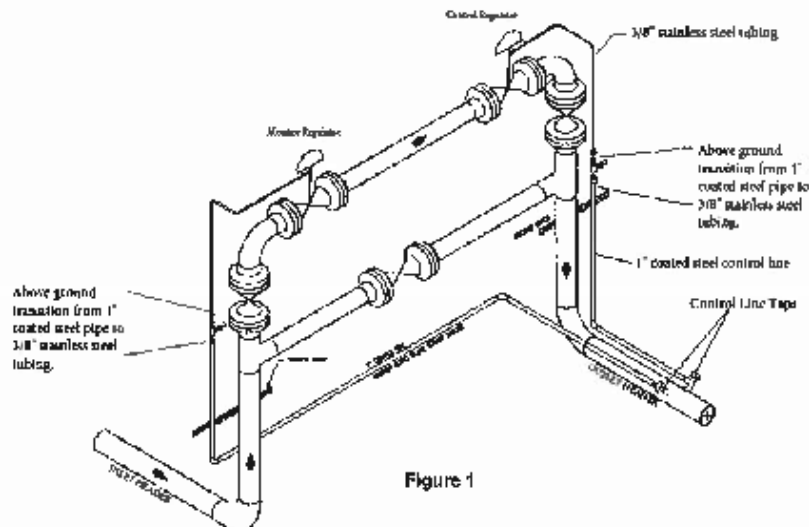
Figure 1 is a schematic drawing showing a regulator setting with control lines extending below grade.

Other lines if damaged, such as telemetry sensing lines and electric lines to equipment at the City Gate/Town Border/POD, District Plant Regulator or Customer M&R station, may also result in pressure monitoring and control issues, which may lead to a catastrophic event.
