SED Incident Investigation Report for 2018 Camp Fire with Attachments

Incident Investigation Report

Incident Number: E20181108-01

Utility Facilities involved: Caribou-Palermo 115 kV Transmission Line and Big Bend 1101 12 kV Distribution Circuit

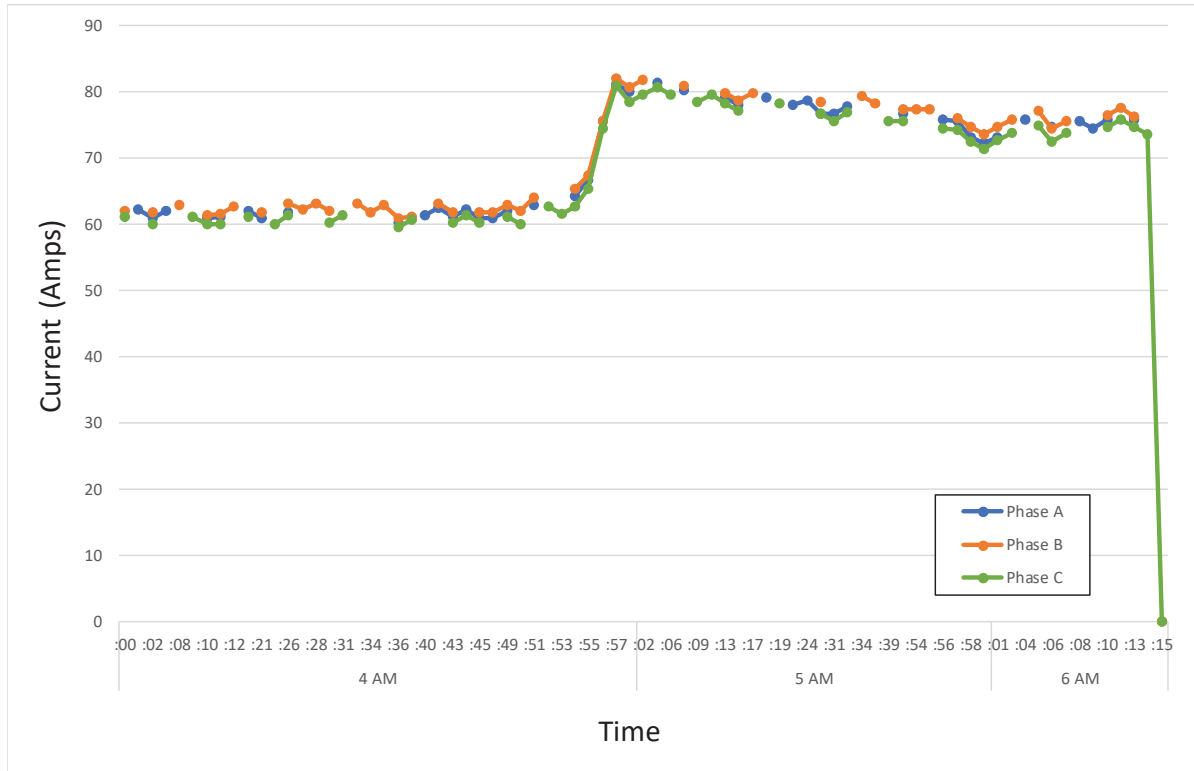
- At approximately 0457 hours on November 8, 2018, the Supervisory Control and Data Acquisition (SCADA) data from the Palermo Substation¹⁵ showed the current in the line reached approximately 80 Amps¹⁶ as shown in Figure 1.

Figure 1: Chart of SCADA data recorded at Circuit Breaker 152 on the Caribou-Palermo 115 kV Transmission Line just before the incident.⁷⁷

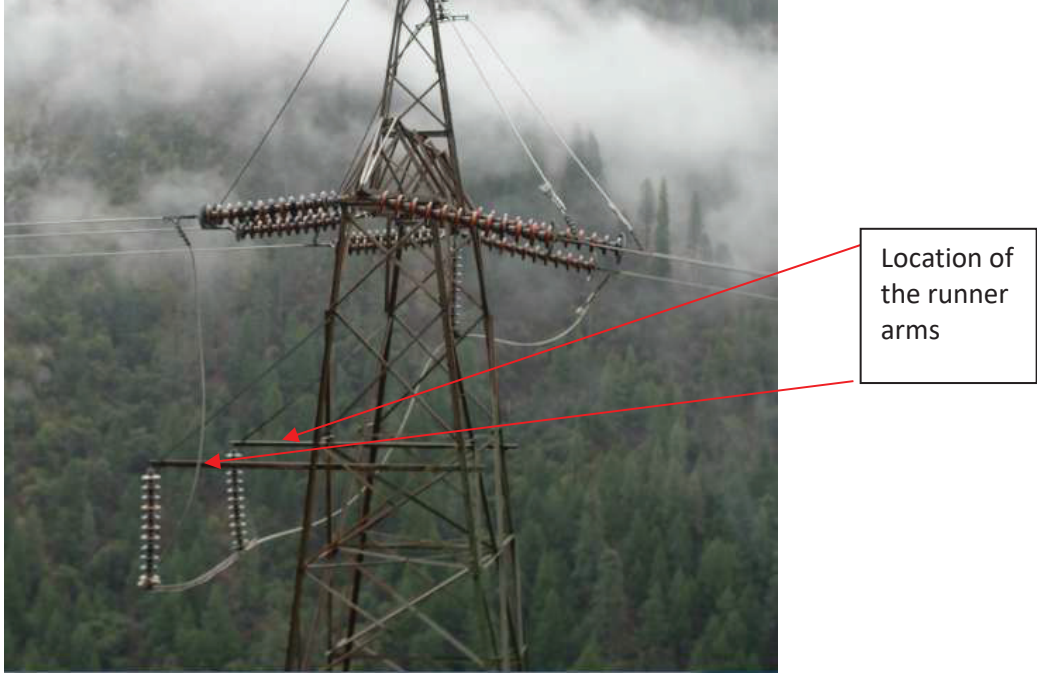
elongated holes in Figure 6 and Figure 7. For reference, Figure 8 shows a typical location of runner arms on transmission towers that have them.

Figure 8. Typical location of runner arms on transmission towers similar to the Incident Tower. This is PG&E Tower :20/160 of the Caribou-Palermo 115 kV Transmission Line.⁸⁴
