Public Meeting on Remedial Activities at Badin Business Park

Tuesday November 19, 2019 Stanly County Commissioners Meeting Room

Presentation by Anna Wade and Sam Olson, Duke Environmental Law & Policy Clinic

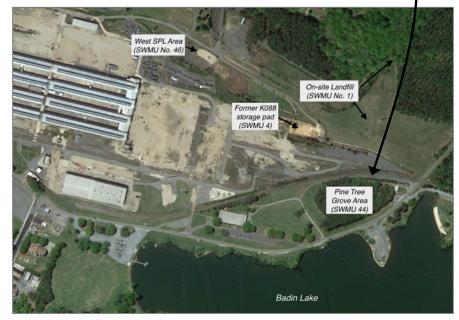
Soil samples below water table at PTG

Buried spent potliner found throughout fill material in 1989, and still in 2001

CN and F in mg/kg in both tables

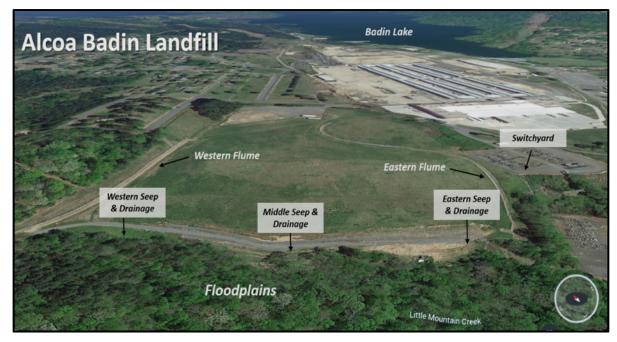
SMWU No. 2: Alcoa-Badin Landfill

- Accumulated waste from 1916 to 1980
- Caught fire in 1991 and burned for 3+ months
- Deepest deposits of fill material, > 42 feet deep

SWMU No. 2 was a natural valley used as a dump (right), graded between mid-1970s and 1990s (left)

Red arrow points to natural valley draining into Little Mountain Creek

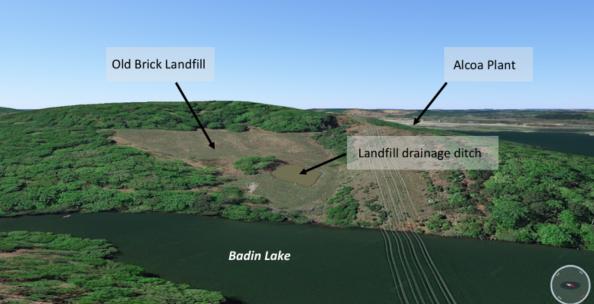
- Disposal site for spent potlining from 1915 to 1960
- Approximately 22,000 cubic yards of hazardous waste

- Hillside adjacent to Badin Lake
- Missing estimates of fill material and cross-section diagrams

2004 and 2005 study concluded cap on landfill installed in 1990s not sufficient to prevent infiltration into the landfill
