August 24, 2020

Re: Discharge from the San Antonio Creek Wet Weather Facility and Alice Street Overflow Structure

Attachment 8

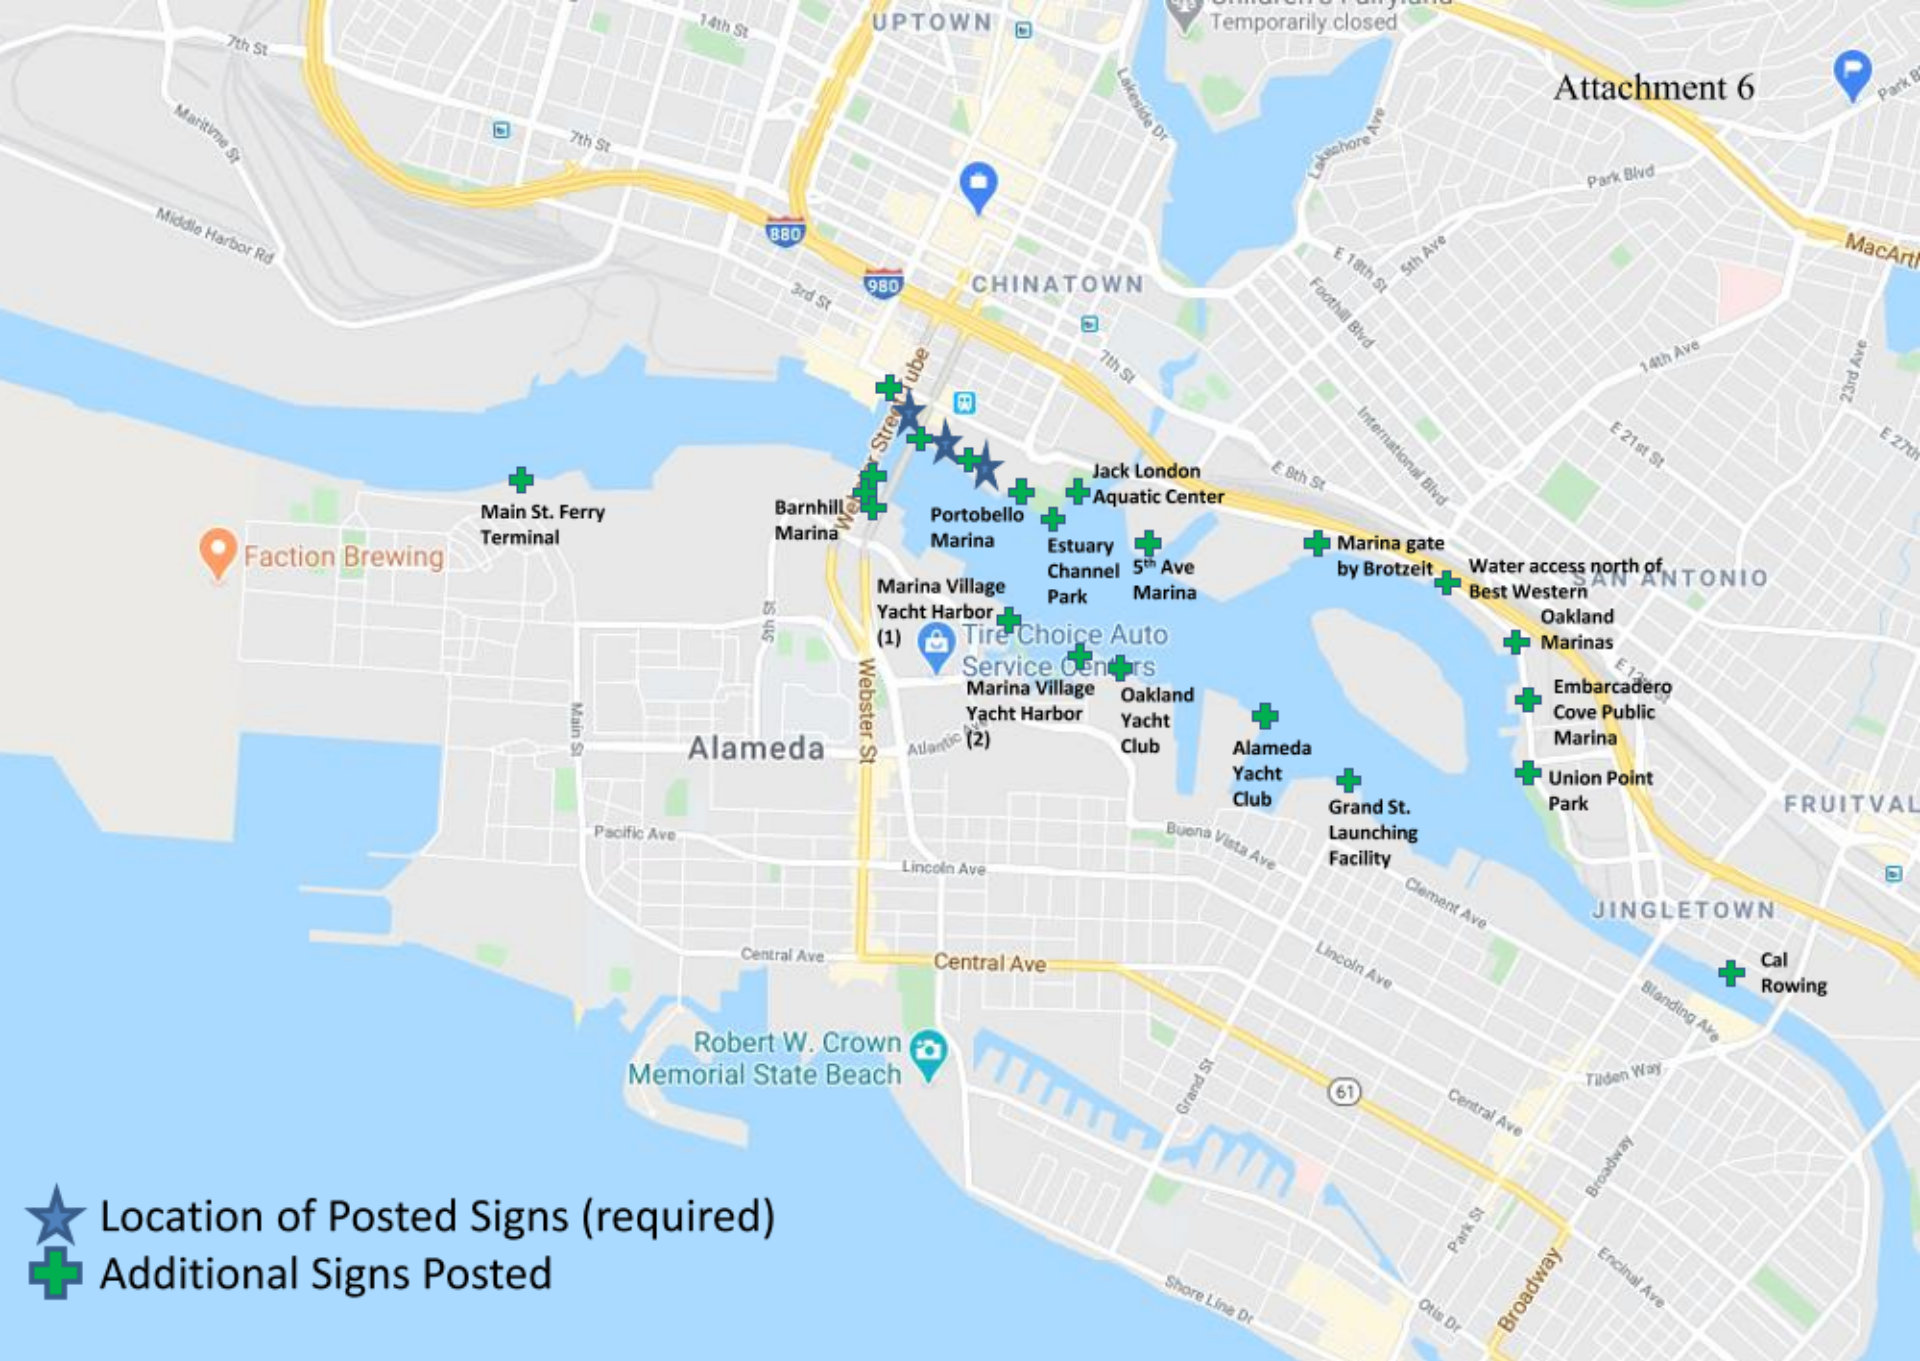
Attachment 6

- ★ Location of Posted Signs (required)
- ✚ Additional Signs Posted

Required Signs in Vicinity of Alice Street Overflow Structure

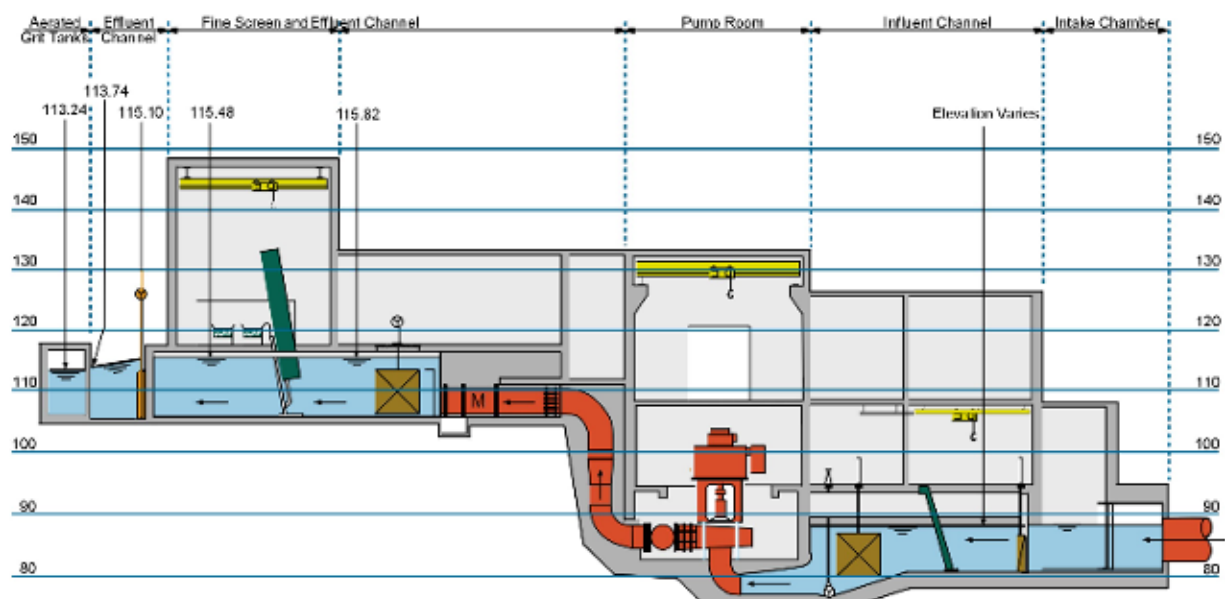
On August 14, 2020, Main Unit 5 pump at IPS was the only pump operating. When power was lost, it is believed that the discharge valve failed to close. This caused water in the channel downstream of IPS to flow backwards through the valve and fill the coarse screen room. As noted above, this valve operates as a check and isolation valve.

- Replace inspection plates as soon as work is complete or at the end of the shift;
- Fabrication of new lighter inspection plates so that they can be easily installed during inspections to prevent wastewater from traveling through a pump to the dry well and causing flooding;
- Procuring additional submersible pumps for emergency use; and
- Repairing the leaking valve on the influent pump (as planned).
