Economic Benefits of Code Compliant Non-Structural Elements in New Buildings

Ministry of Business, Innovation & Employment

Date: 20 March 2017
Reference: 6-DP292.01
Status: Final

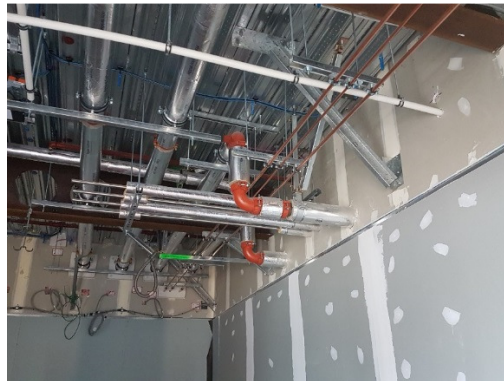
Figure 1: Seismic Restraints of Services

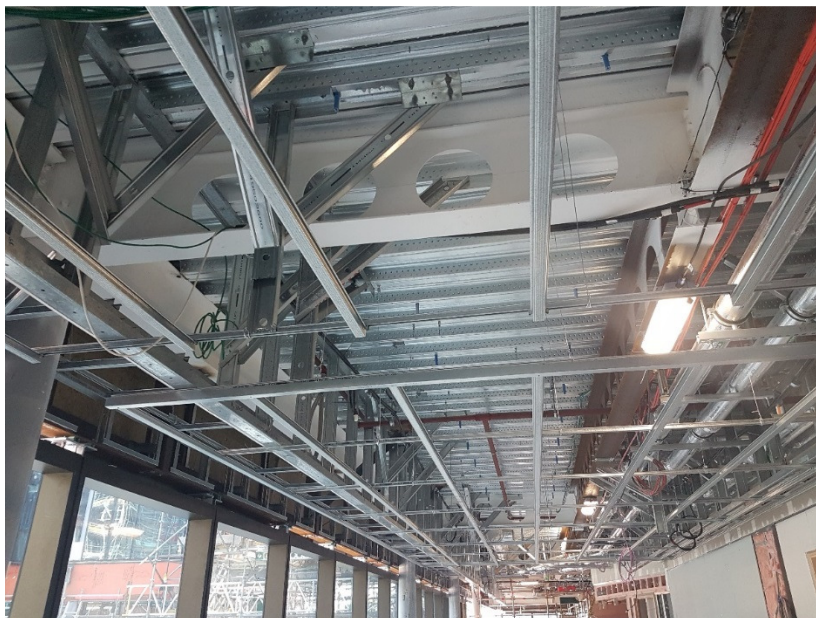
Figure 2: Seismic Restraint of Services and Ceilings

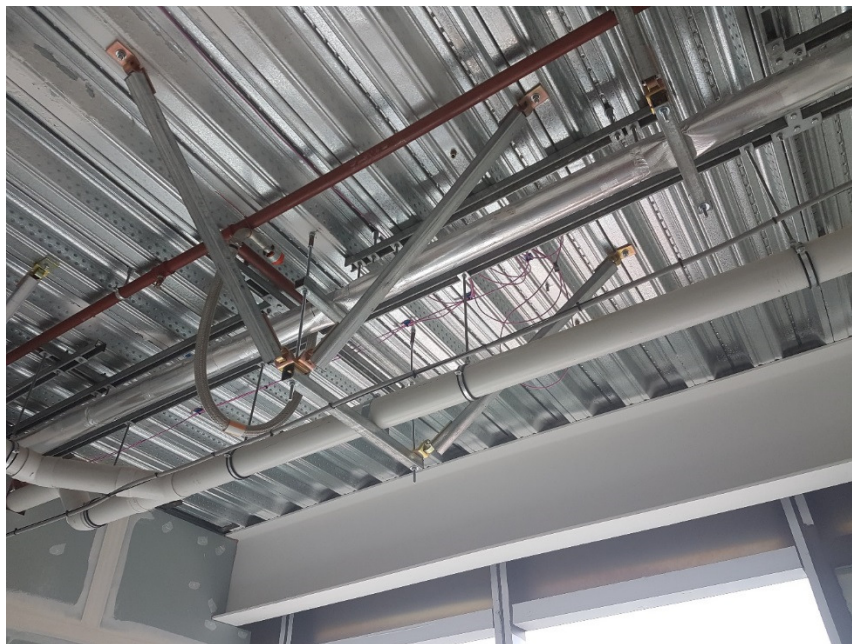
Figure 3: Seismic Restraint of services

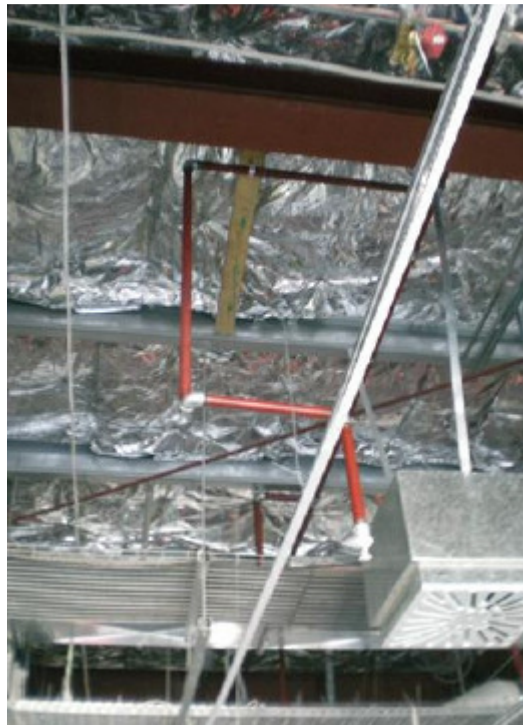
- Ventilation grilles and diffusers weighing in excess of 10kg were observed to be unrestrained. This does not comply with Clause 5.9 of NZS 4219 and leaves the equipment at significant risk of failure. The economic cost of failure of the diffuser needs to be considered in the context of what is around the diffuser/grille. The damage and associated repair costs is likely to be more than just the diffuser/grille itself, as the effect of this equipment swinging around is likely to cause damage and require repairs to nearby pipework, connections, equipment, ceiling hangers and other near-by services, and may also cause suspended ceilings and other equipment to fall and render the area unusable and cause interruption to business operations.

Figure 7: Unrestrained diffusers

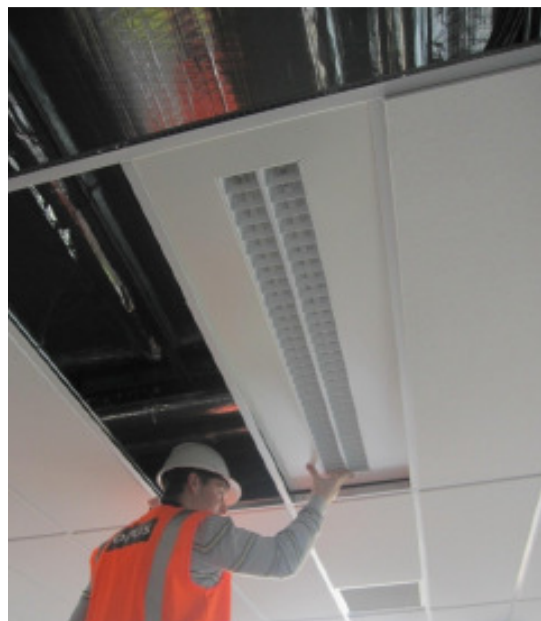
- Luminaires dislodged from ceiling grids
 - Installations were observed where recessed luminaires did not appear to be positively fixed to the ceiling grid and therefore failed to comply with Clause 5.14 of NZS 4219. The weight of recessed luminaires can be significant and if they fall they risk injuring occupants below and causing business interruption.

Figure 8: Unsecured recessed luminaires

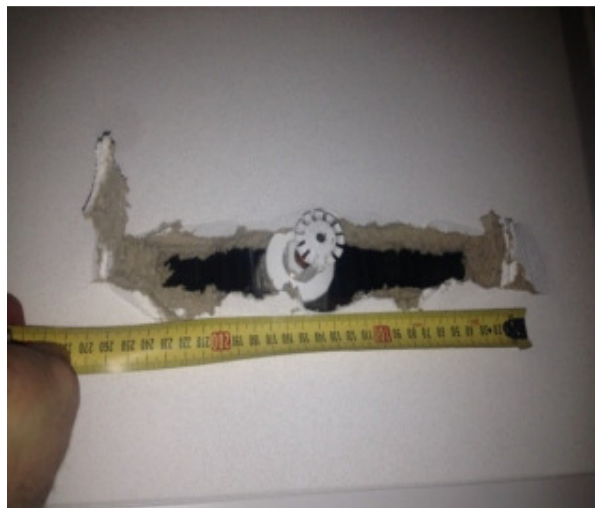
- Direct connection of sprinkler droppers to fixed cable tray and ductwork supports did not meet the code (NZS 4541) requirement that the sprinkler pipes and joints will not experience undue deflection. In particular failure was observed when the dropper arm was connected to heavily loaded unrestrained cable tray. The costs of consequential damage and business interruption due to failure of the sprinkler head is substantial with the potential for water damage that drains to multiple floors.

Figure 10: Relative movement of sprinkler and ceiling

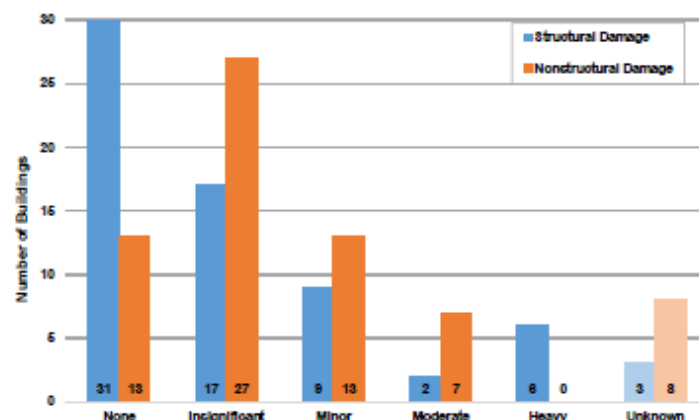
The following graph shows the distribution of commercial building damage according to the general damage classification. 80% of the buildings in the 300m radius of the strong motion recording station were observed to have some degree of non-structural damage, whilst 54% were observed to have some degree of structural damage.

Figure 11: Distribution of building damage according to general classification

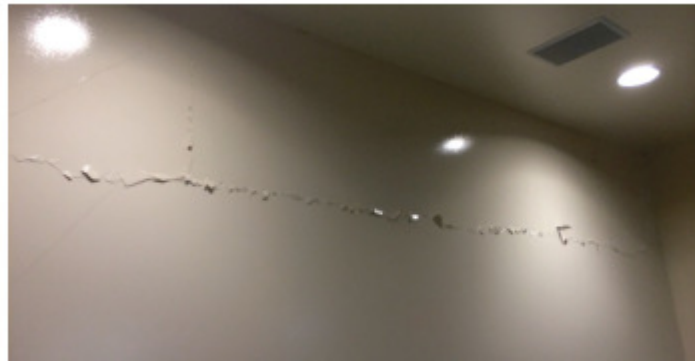
Figure 12: Cracked gypsum board wall in hospital

Both new and older hospital buildings experienced some non-structural damage which, in a larger earthquake with longer duration, could have impacted the continuity of service. In particular, damage to walls and ceilings in operating rooms was observed to have affected the ability to maintain the required positive air pressure and the required number of air changes, thus impacting the sterile environment.

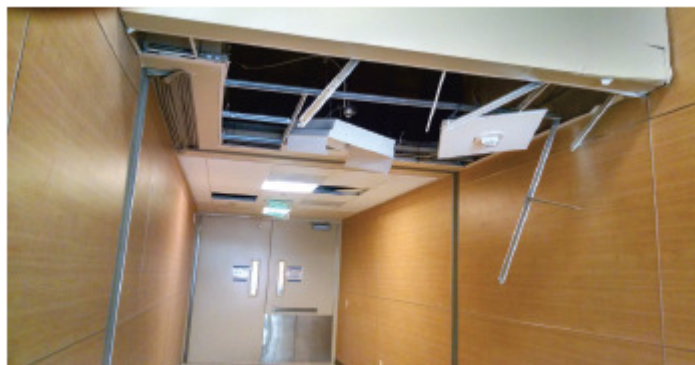
Figure 13: Ceiling damage in hospital corridor link

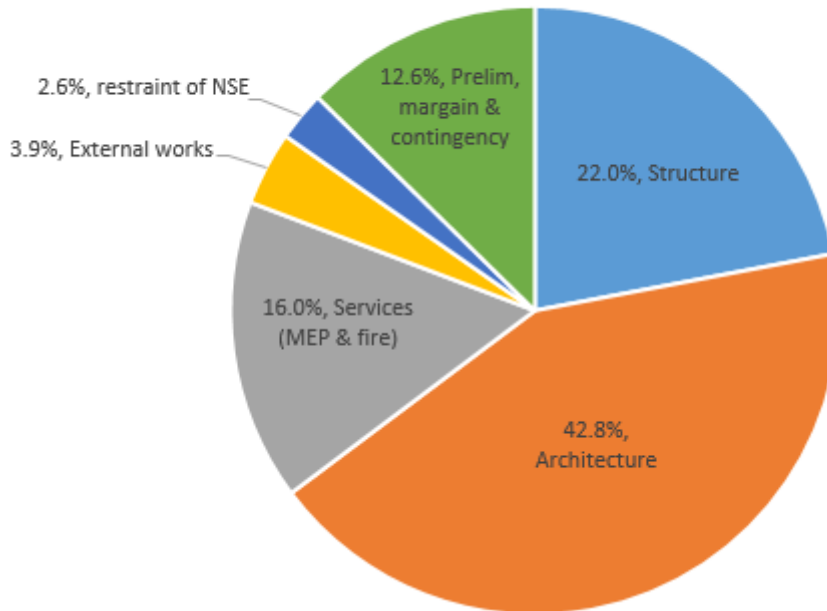
Fire Station - single storey

The following charts show the cost breakdown of building elements for each of the chosen study buildings. The dark blue pieces represents the cost to provide seismic restraints to the ceilings, partitions, mechanical, electrical, plumbing and pipework and sprinkler systems.

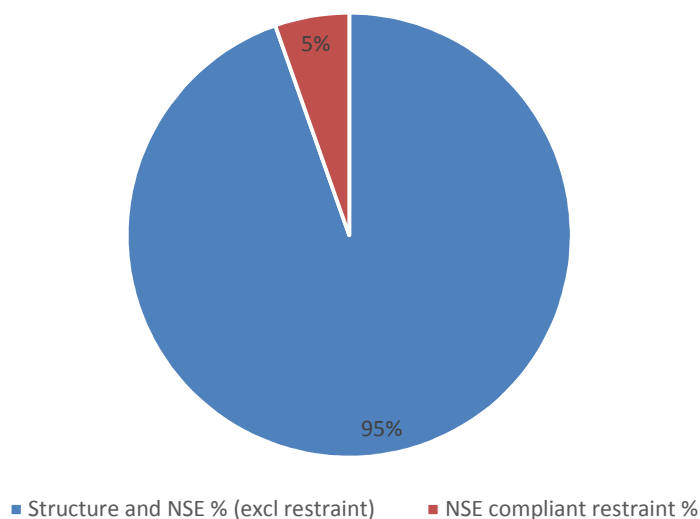
Average annual NZ Construction value (2016)

While the minor 'Heavy Industry / Energy' and 'Sports' categories are not covered in the table above these account for only \$700m. For the remainder of the \$8.7b of non-residential building construction in New Zealand the cost of NSE restraint can therefore be extrapolated be in the order of \$423m or around an average of 4.9% of the total annual construction spend.

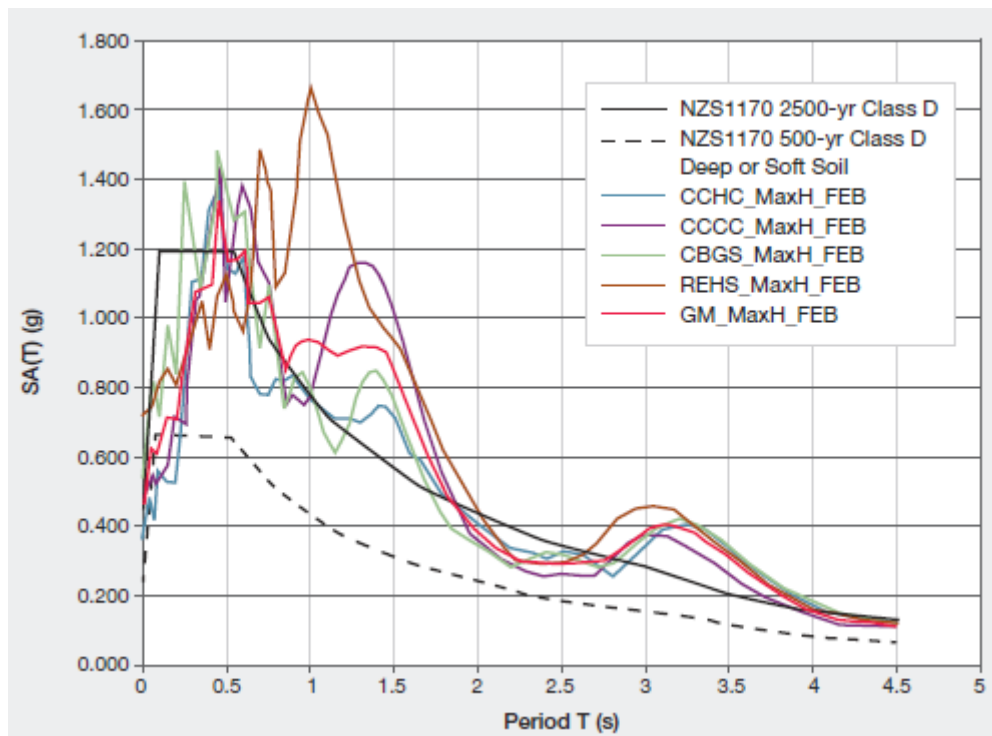
The most destructive earthquake of the Canterbury earthquake sequence was the Mw 6.2 earthquake which occurred at 12.51pm on 22 February 2011 with an epicentre under the Port Hills. The resulting horizontal ground motions reached 1.7g in the Heathcote Valley near the epicentre and up to 0.8g in the CBD. Vertical accelerations of 2.2g were recorded in the Heathcote Valley. The ground motions significantly exceeded the design 500-year return period earthquake for Christchurch as can be seen in the following figure.

Recorded response spectra in Christchurch CBD compared with NZS 1170.5 for deep soil sites
