PFAS Preliminary Site Investigation: HMNZS Devonport Naval Base & Satellite Sites

New Zealand Defence Force

• October 2017

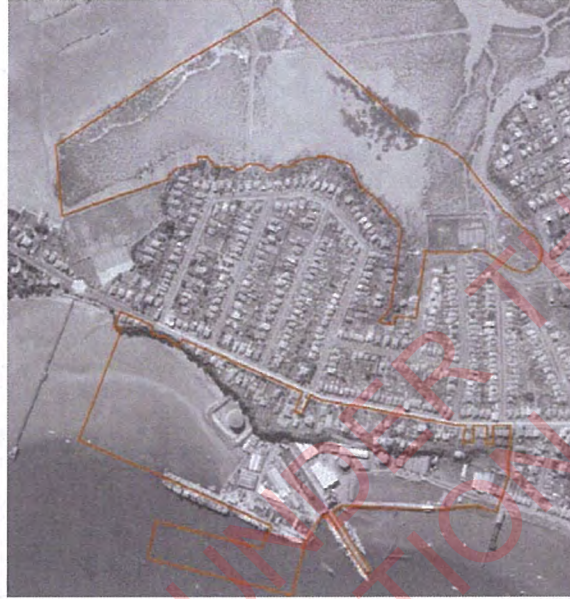
**1940 Aerial – North and South Yard (NZDF)**

The 1940 aerial is limited to North Yard and South Yard. At the South Yard the dry dock and a number of large buildings are present including the Palmer Building, Blacksmiths and the former plumbing and battery shop. There is a wharf extending south east from the dry dock and another running northwest towards Stanley Bay. Three large tanks, understood to be for bulk fuel storage, are visible to the north west and east of the dry dock.

North Yard has not yet been constructed. There is evidence of some filling of the estuary, however, the majority of North Yard and the SSTS are undeveloped mangroves and tidal flats. The surrounding land use is residential.

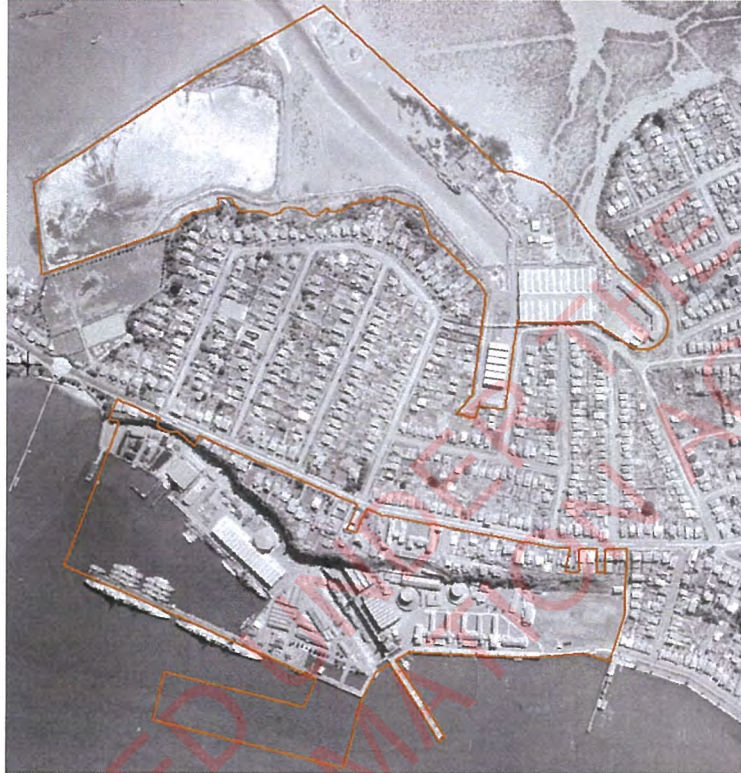
1950 Aerial – North and South Yard (NZDF)

At South Yard, additional land has been reclaimed in the northwest of the site and a number of buildings have been constructed including one of the current Babcock workshops (SY86) and the historic Boat Shop (SY100). In the east of the site a large complex of buildings housing administration and barracks have been constructed along the sea wall. The wharf extending in to Stanley Bay has been extended to the northwest.

A significant amount of reclamation has occurred at North Yard and Ngataringa Bay. A number of buildings have been constructed at North Yard including the original Naval Supply Depot (HL_62_DPT), the hazardous goods store (HL_51_DPT), the former vehicle workshops (HL_60_DPT) and the coal storage shed (HL_61_DPT). The SSTS has not been constructed.

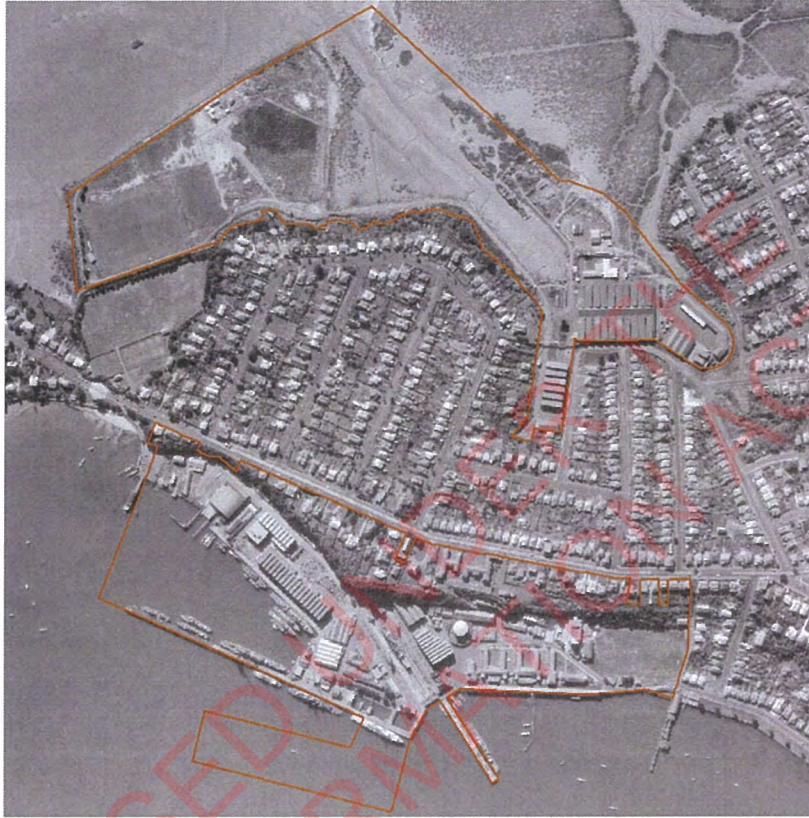
1963 Aerial – North and South Yard (NZDF)

At South Yard the western (No. 3) and eastern bulk fuel storage tanks have been removed. Additional buildings including the former paint shop (HL_15_DPT) are visible.

Reclamation has occurred in the western section of Ngataringa Bay. A number of buildings have been constructed at the historical Damage Control School (HL_08_NGA). There is little change in the North Yard.

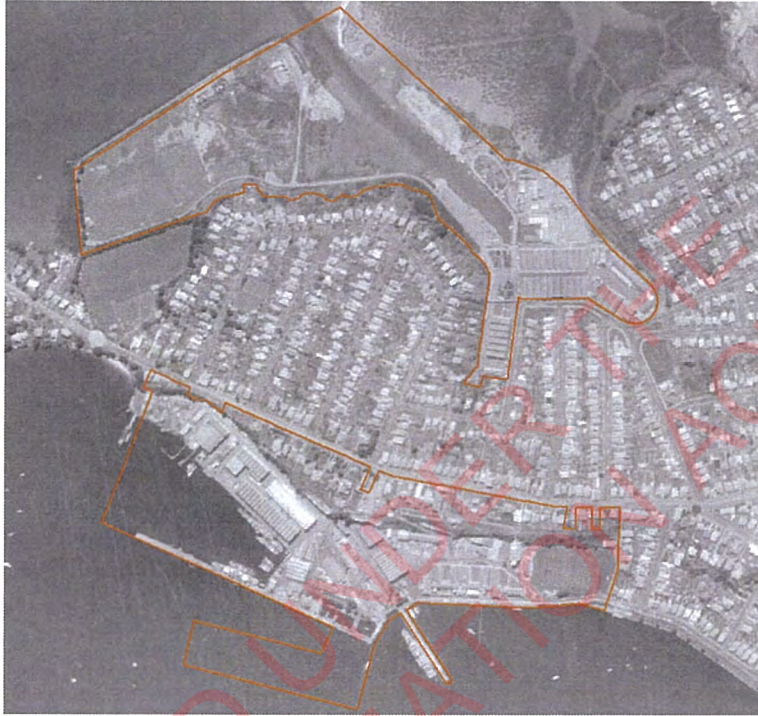
1968 Aerial – North and South Yard (NZDF)

In the 1986 aerial the former E.M. Workshop (HL_41_DPT) had been constructed and the northern bulk fuel storage tank (HL_14_DPT) has been demolished.

The North Yard and Ngataringa Bay have remained unchanged.

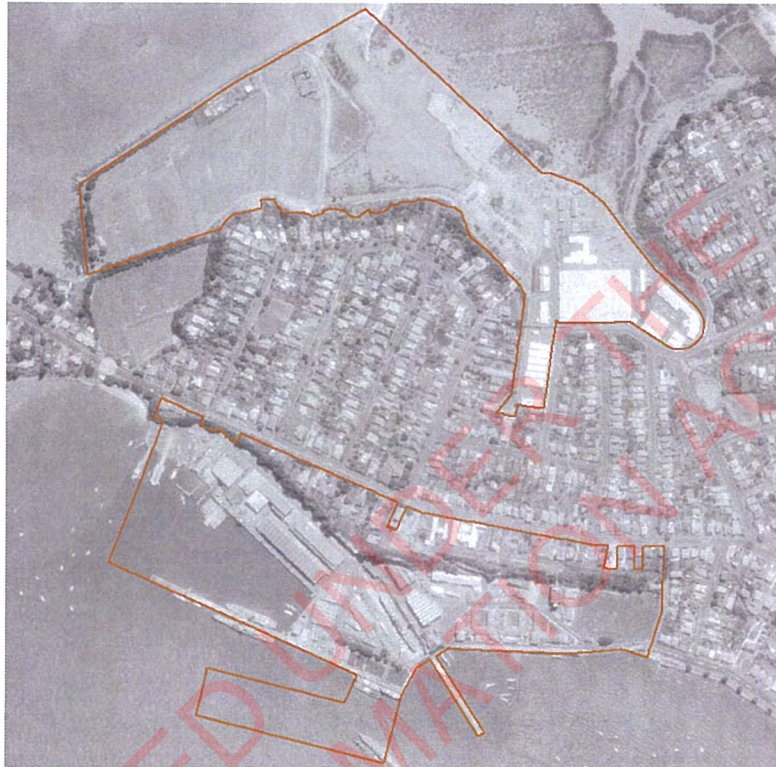
1980 Aerial – North and South Yard (NZDF)

The original Naval Supply Depot has been demolished and upgraded to what it is today.

There is no change at the South Yard between the 1977 and 1980 Aerial.

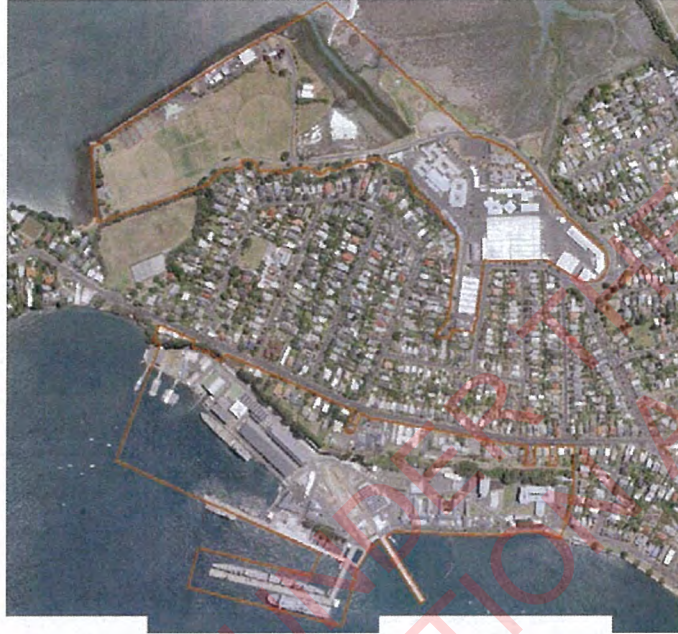
2008 Aerial – North and South Yard (Auckland Council)

A number of buildings have been constructed at the North Yard and are used for administration, accommodation and training purposes. The Captain Fleet Personnel and Training facility (HL_59_DPT) has been built since the 1980 aerial.

At South Yard, the office buildings (located at the end of Queens Parade) have been constructed. The building in the area which is now used for storage along Cliff Road (HL_12_DPT) has been demolished. The Former Plumbing and Battery Shop (HL_44_DPT) and the Property Maintenance and Lagers Workshop (HL_49_DPT) have been demolished and replaced.

The former Ministry of Works Workshop (HL_22_DPT) has been demolished.

The SSTS has been upgraded and the site layout is essentially as it is today.

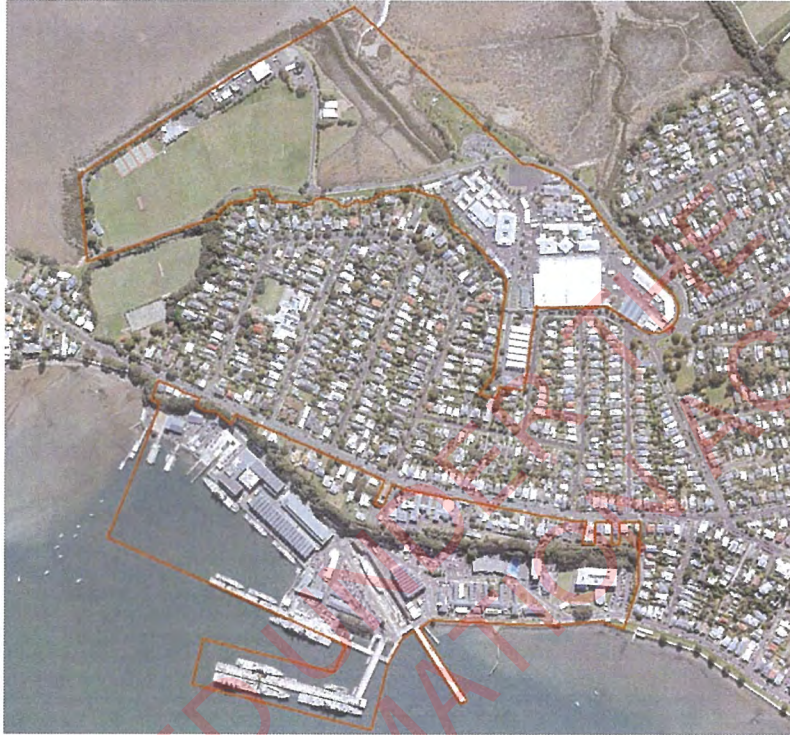
2015-2016 Aerial – North and South Yard (LINZ Data Services)

The 2015-2016 aerial shows North and South Yard essentially as they are today. At South Yard, the former paint shop (HL_15_DPT) and the historic Boat Shop (SY100) have been demolished. The wharf extending southeast from the drydock has not yet been demolished. At North Yard there is little change since the 2008 aerial. The former vehicle workshops (HL_60_DPT) and the coal storage shed (HL_61_DPT) have not yet been demolished.

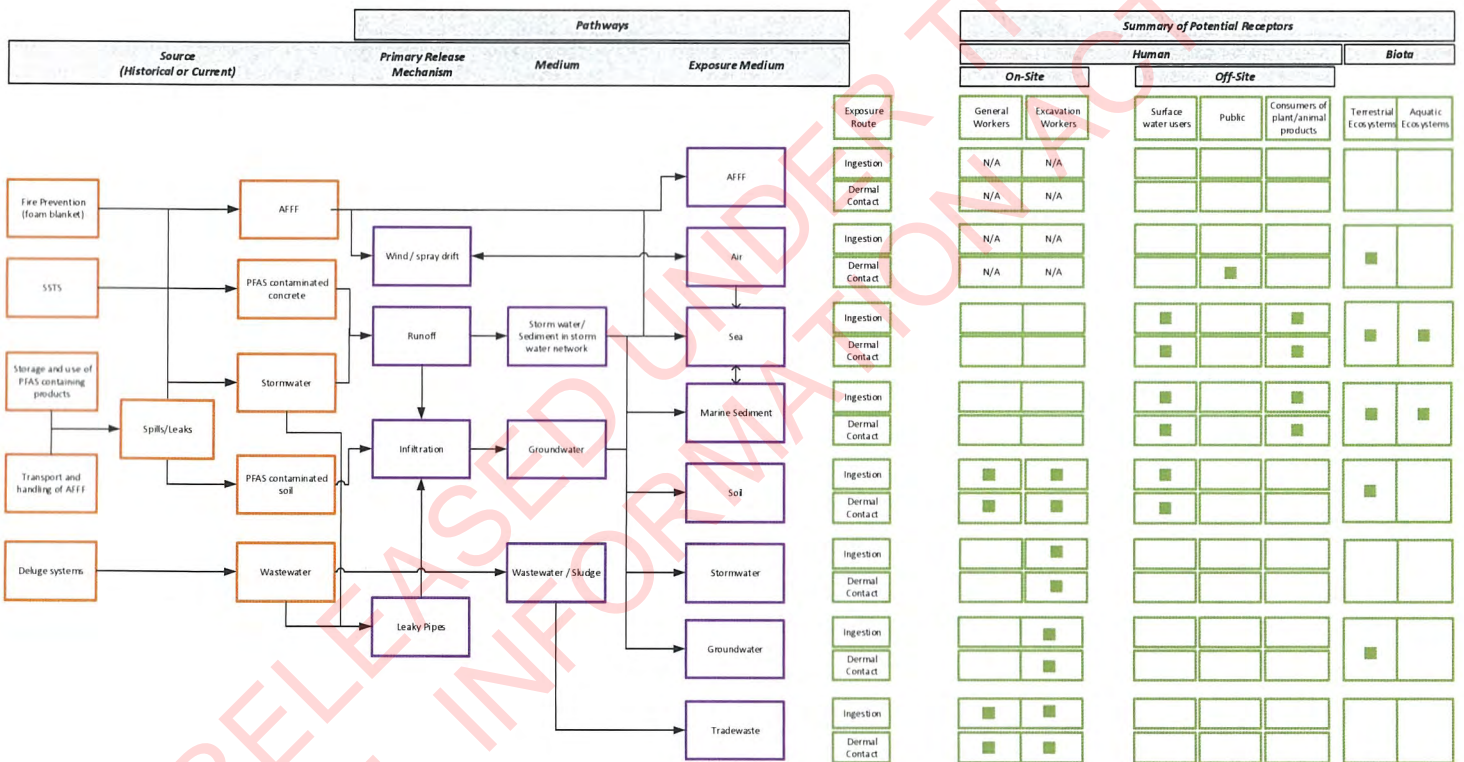
Conceptual Site Model – Devonport Naval Base

Key:
■ Potentially Complete Pathway
□ Incomplete Pathway
N/A Addressed under the Health and Safety at Work Act, 2015
