Re: Information Request Regarding Monitor Team Field Inspections

Exhibit – Tree Report

**PG&E Monitor Team Immediate Hazard
Reported October 4, 2020**

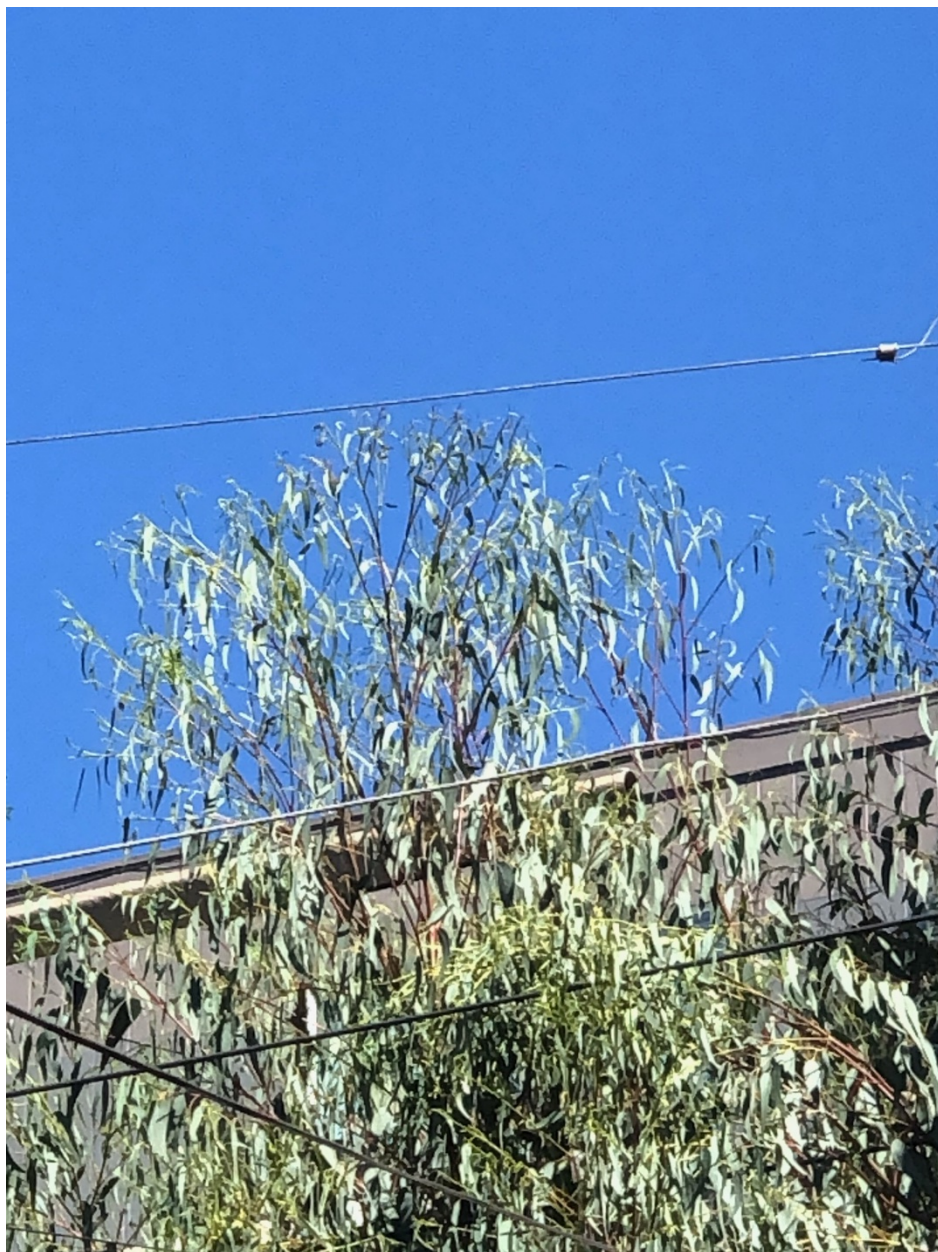
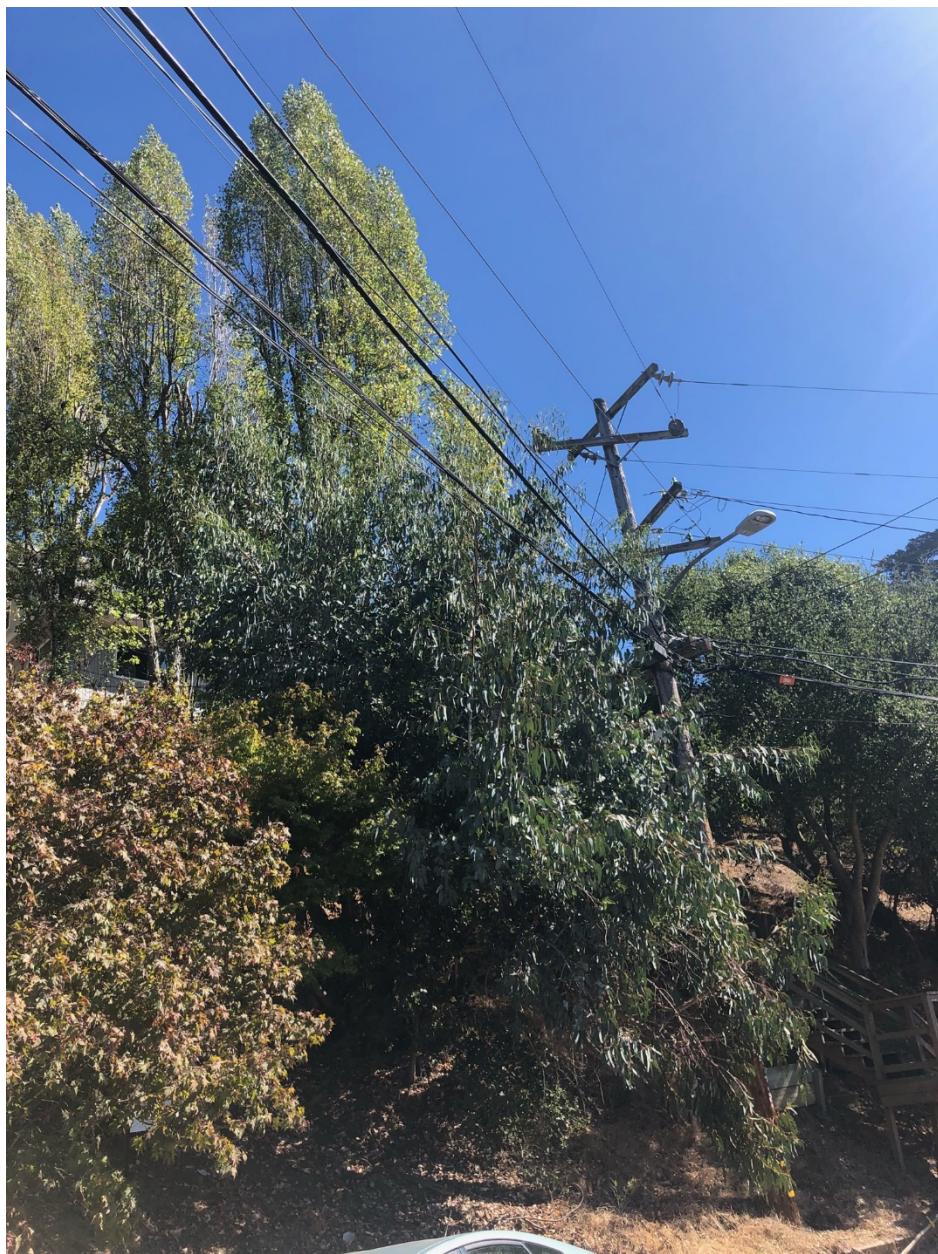
- Segment ID: CIL_AO123-K17_233536
- GPS Coordinates: 37.8359150, -122.2016603
- Nearby Address: 6924 Snake Road, Oakland, CA 94611
- Veg Point ID: VP_AO123-K18_1733229_2020
- HFTD: Tier 3
- Species: Blue Gum / Eucalyptus
- Height: 38
- DBH: 54 (including multiple stems)
- Monitor Team Observations: Leading sprouts of tree observed within one inch of primary conductor, and tree shows evidence of singeing from prior contact with conductor. Tree also located on steep slope with exposed roots.
- PI Comments field in Arc Collector states: "L/O PI 0907 Uphill Multistem, sent to HN URG 8/12/2020 M8D9 - revisited 8/31/2020, HN not complete, created WI point for removal M8D9"
- Photos of the potential exception are included below.

Following the Monitor team's identification of the tree and immediate escalation to PG&E management, PG&E removed the tree within 24 hours.
