On the Sixth Mechanism of Lightning Injury

On the sixth mechanism of lightning injury

A thesis submitted to the Faculty of Engineering and the Built Environment, University of the Witwatersrand, Johannesburg, in fulfilment of the requirements for the Degree of Doctor of Philosophy.

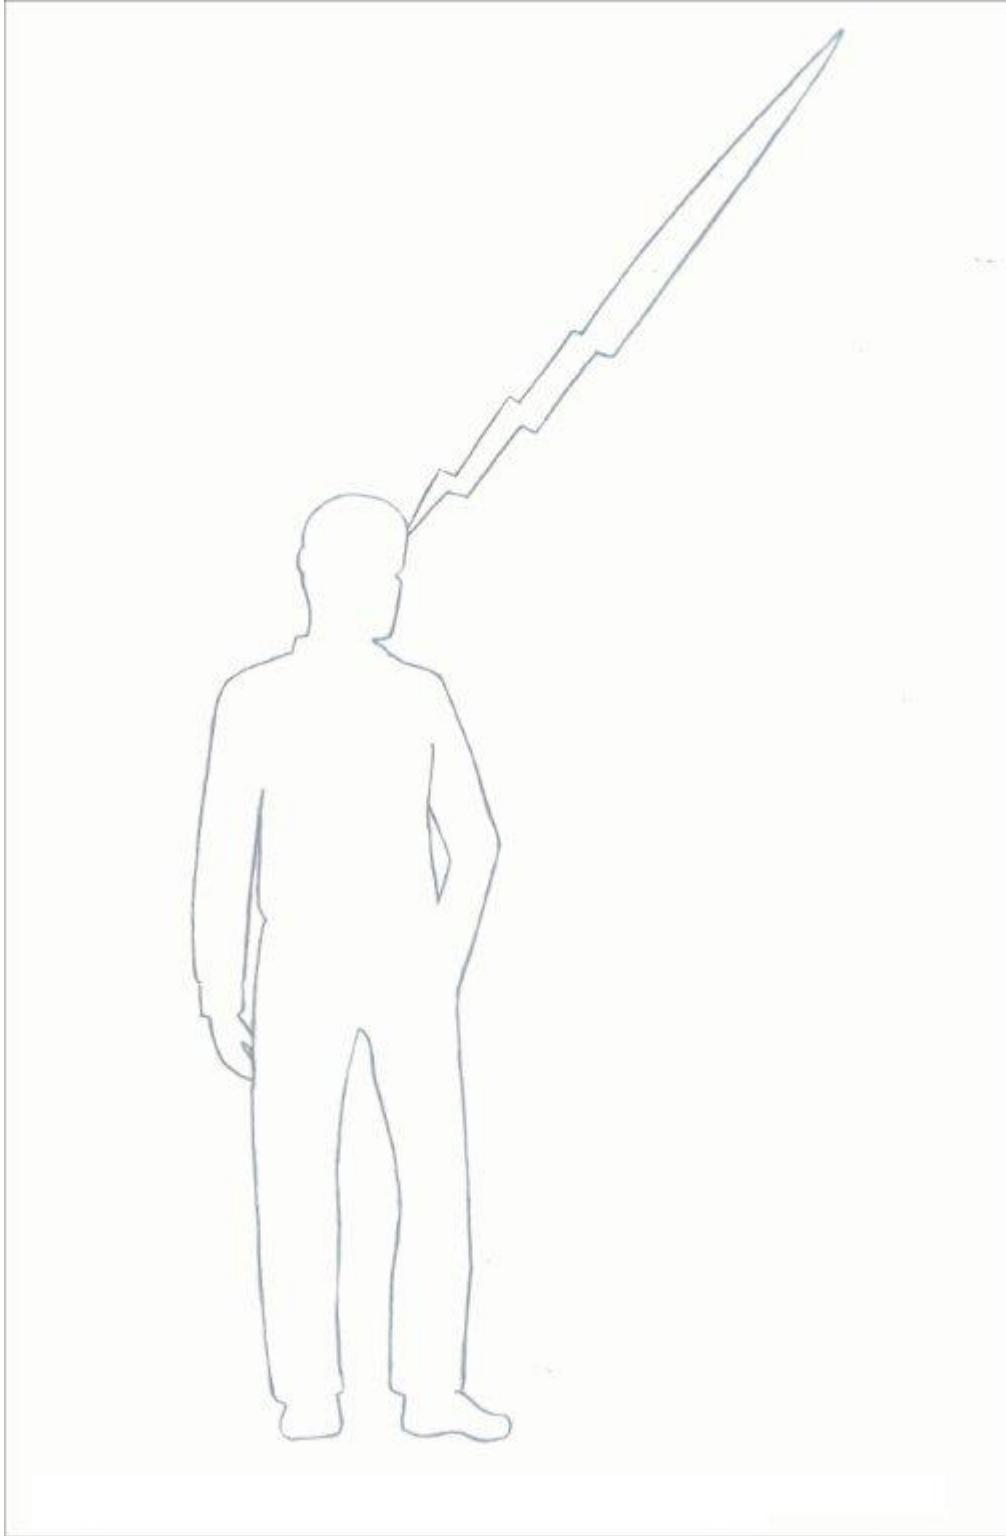
Figure 1.1: The first mechanism of lightning injury: Direct strike.

"A direct strike occurs when the lightning stroke attaches directly to the victim. This is most likely to occur outdoors when a person has been

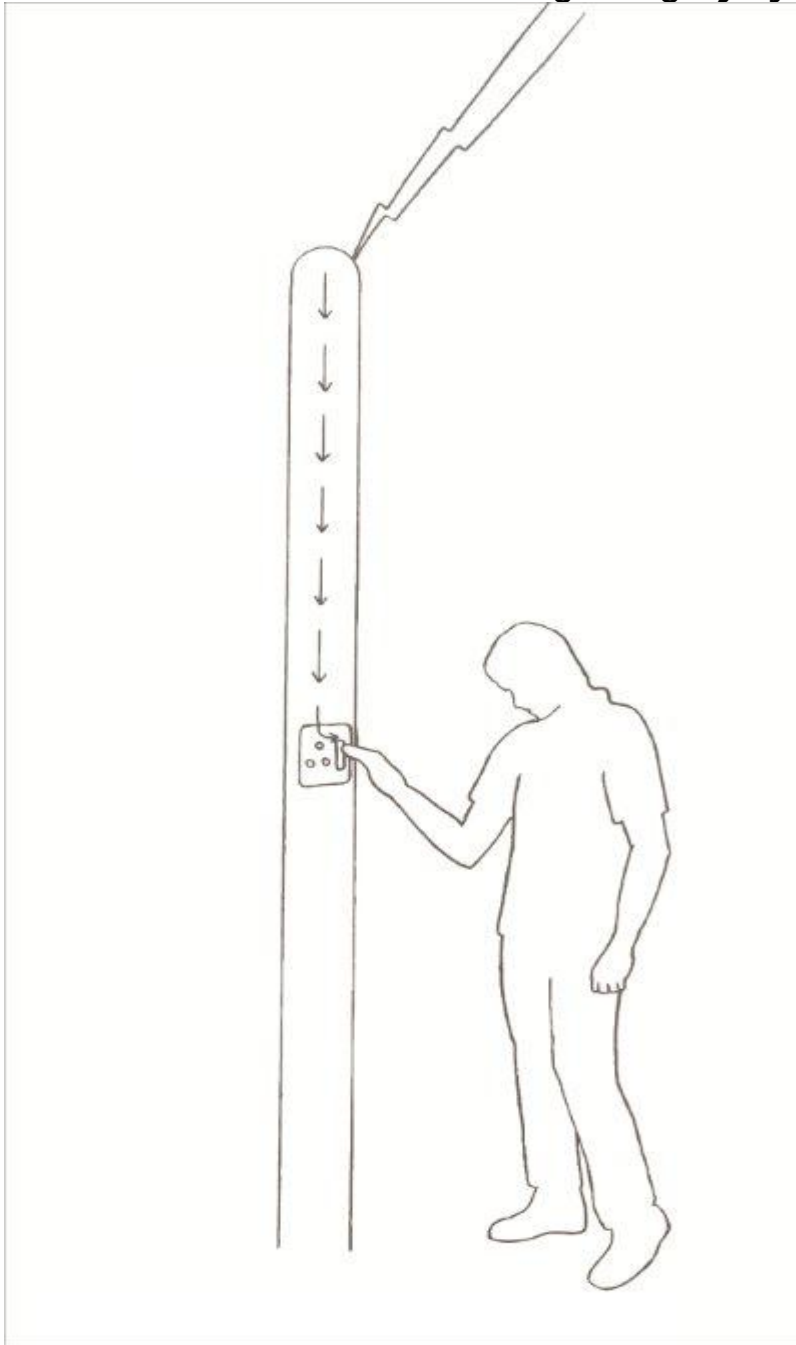
Figure 1.2: The second mechanism of lightning injury: Indirect strike.

“Contact, or touch potential, injury occurs when the person is touching or holding onto an object to which lightning attaches such as wire fencing or indoor hard-wired telephones or plumbing, that transmits the current to the person as shown in Figure 1.2. A voltage gradient is set up on that object from strike point to ground, and the person in contact with the object is subject to the voltage between the contact point and the earth. A current therefore flows through them. Contact injury probably occurs in about 3% to 5% of injuries” (Cooper and Holle, 2008, 2010; Auerbach 2012: 75).

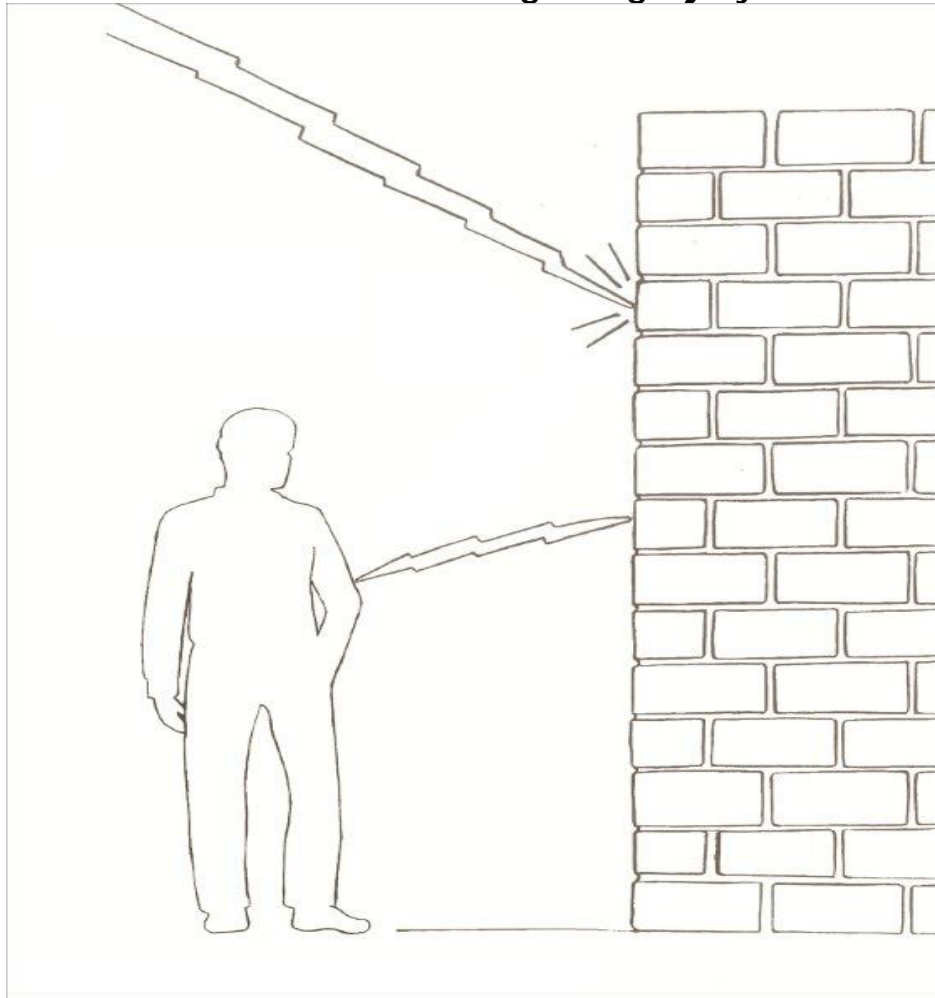
Figure 1.3: The third mechanism of lightning injury: Side flash.

"A more frequent cause of injury, perhaps as much as 30% to 35%, is a side flash, also termed "splash". Side flashes occur when lightning that has hit an object such as a tree or building travels partly down that object before a portion "jumps" to a nearby victim. Standing under or close to trees and other tall objects is a very common way in which people and animals are splashed. Current divides itself between the two or more paths in inverse proportion to their resistances. The resistance of the "jump" path represents an additional path separate from the path to earth from the stricken object. Side flash may also occur from person to person" (Cooper and Holle, 2008, 2010; Auerbach 2012:77).

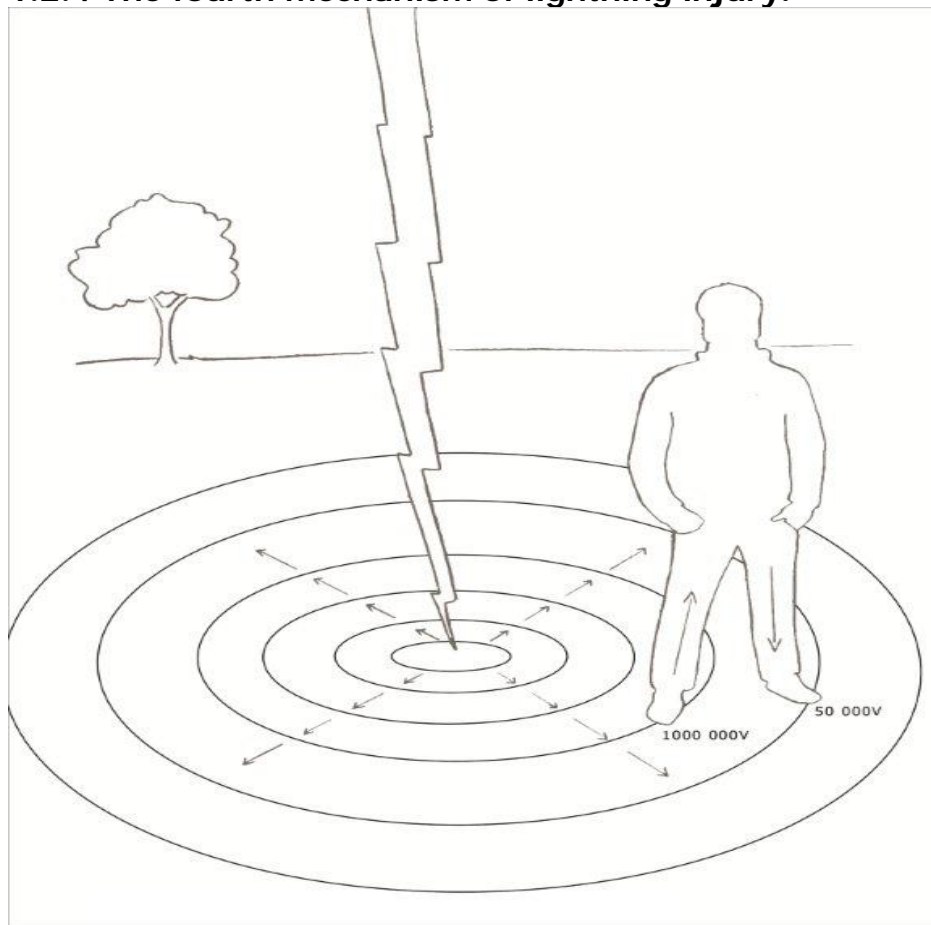
Figure 1.4: The fourth mechanism of lightning injury: Step potential.

"Earth potential rise (EPR), also known as ground current, arises because the earth, modeled ideally as a perfect conductor, is not so in reality.

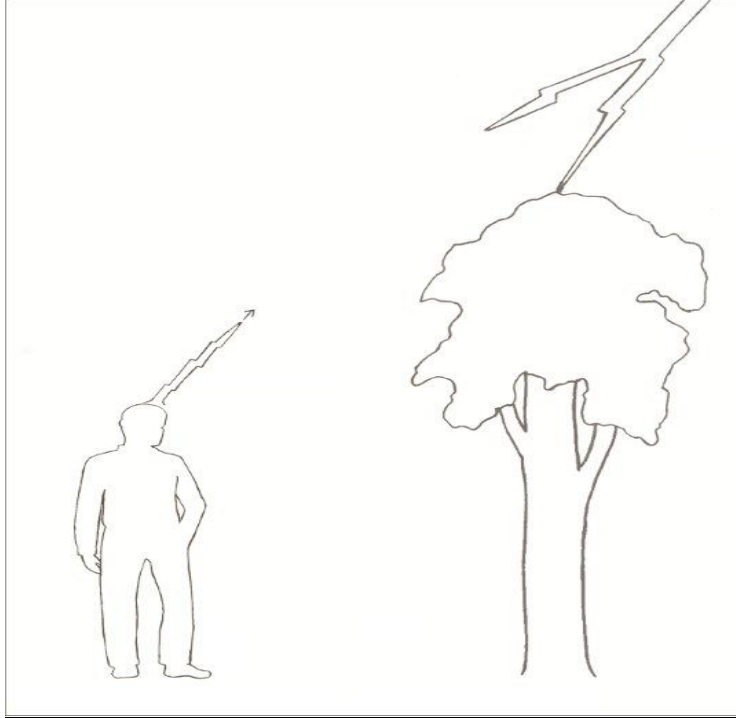
Figure 1.5: The fifth mechanism of lightning injury: The upward streamer mechanism.

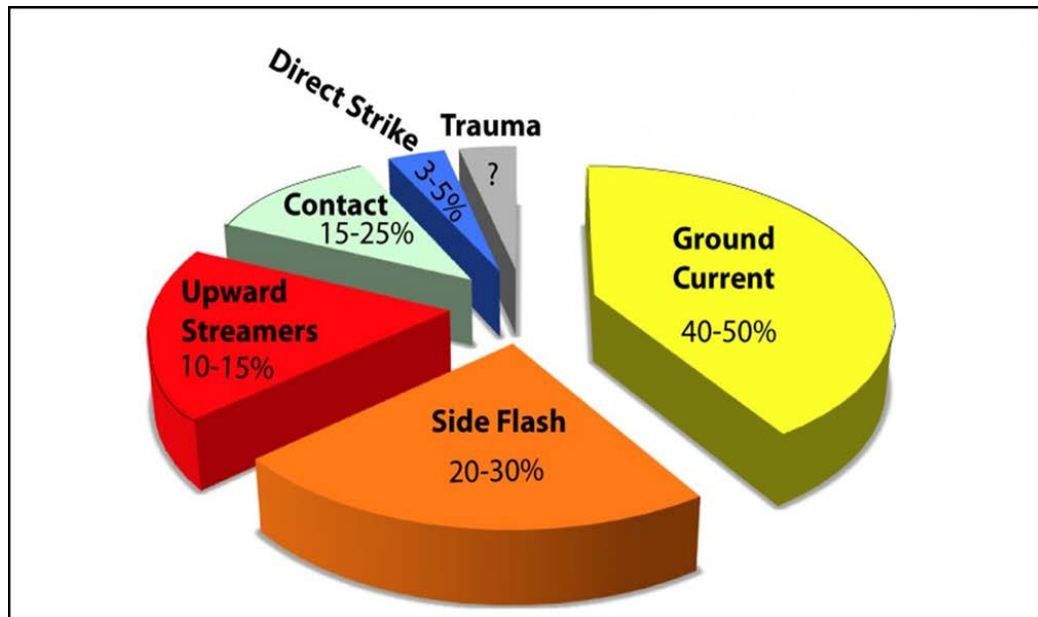
Figure 1.6: This chart shows the frequencies of the primary lightning fatality mechanisms (Cooper & Holle, 2008; Auerbach 2012: 77).

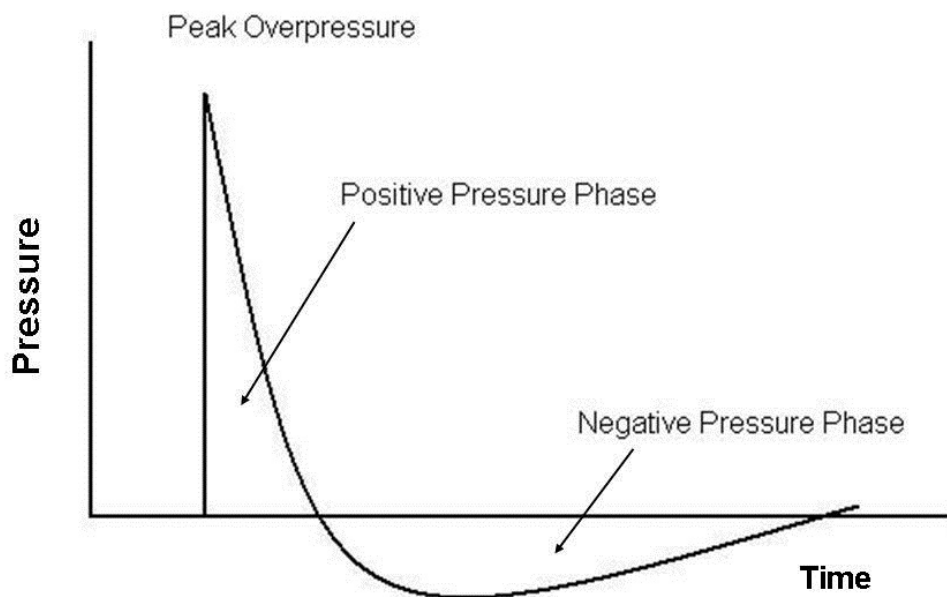
Figure 1.7: The idealized blast waveform, adapted from the work of Nabil M Elsayed and James L Atkins (2008).

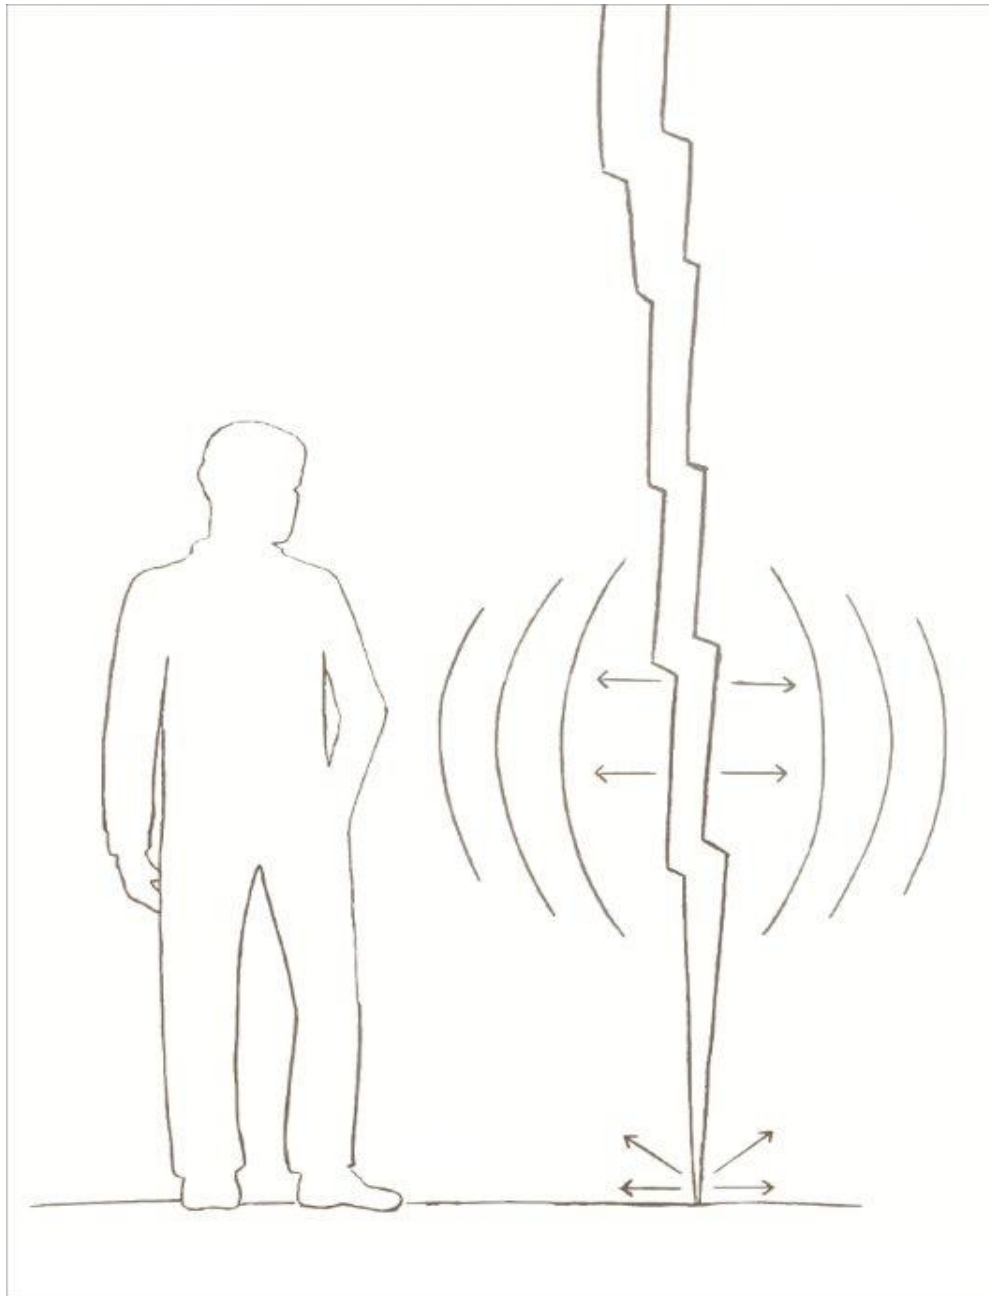
Figure 1.8: The sixth mechanism of lightning injury: Lightning explosive barotrauma, imagined as a 'pressure-shock wave' immediately surrounding lightning's luminous channel.

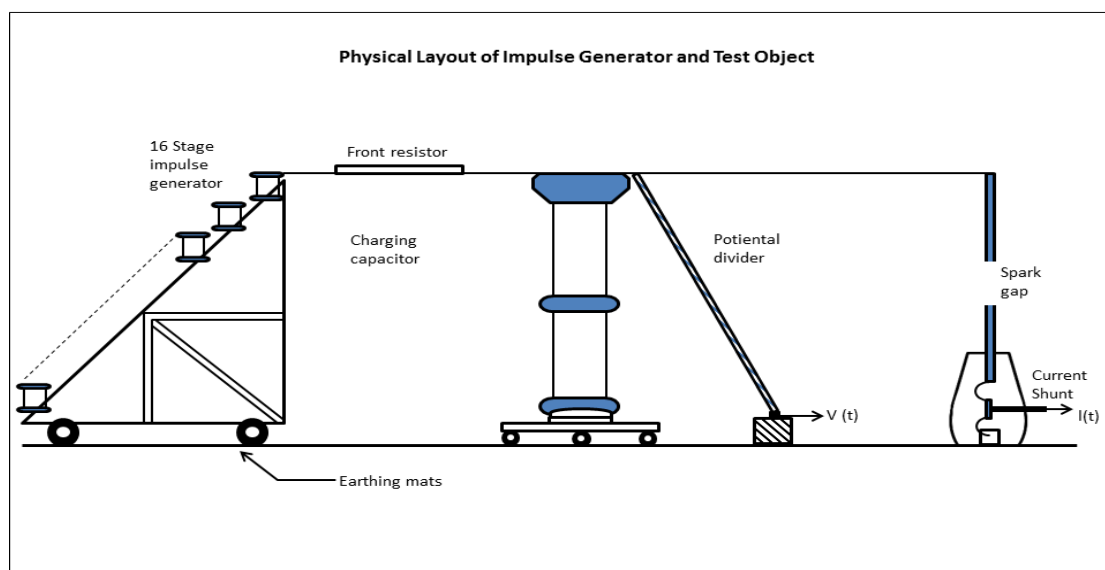
Figure 2.1: The experimental layout of McKelvie, Page and Mackerras' experiment. (7th Australasian Hydraulics and Fluid Mechanics Conference, Brisbane, 18-22 August, 1980).

In 1980 a paper was presented at the 7th Australian Hydraulics and Fluid Mechanics Conference entitled 'Strength of Shock Waves produced by Electrical Discharges' (McKelvie, 1980). The paper described an experimental study of the shock wave radiating from an electrical spark discharge in atmospheric air. Further measurements of this type have been reported by Page and McKelvie (1977). Of particular interest was the proportion of the total energy deposited into the discharge channel that was related via blast wave theory to the pressure disturbance propagating away from the channel. McKelvie's (1980) paper described a measurement of the electrical and gas dynamic parameters describing the acoustic radiation from a laboratory spark discharge in which the problems associated with earlier measurements were avoided. This was achieved by using a unique fibre-optic link to permit an electrically isolated pressure transducer to be placed very close to the discharge channel as shown in figures 2.1 and 2.2, and careful treatment of the channel tortuosity and the various dissipative elements in the electrical discharge circuit.

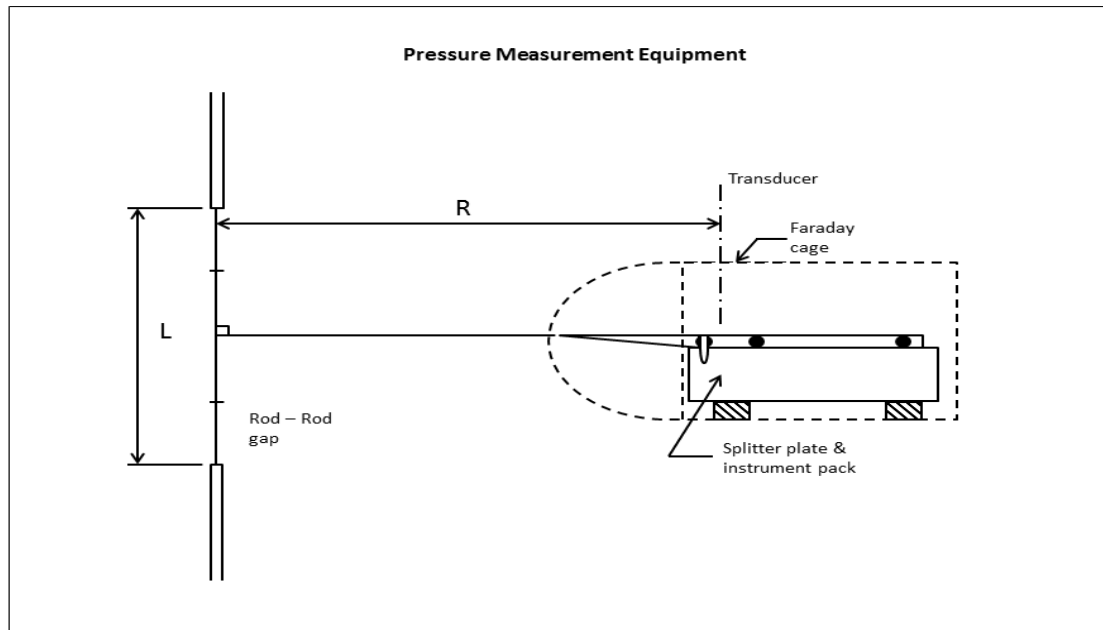
Figure 2.2: The experimental layout of McKelvie, Page and Mackerras' experiment. (7th Australasian Hydraulics and Fluid Mechanics Conference, Brisbane, 18-22 August, 1980).

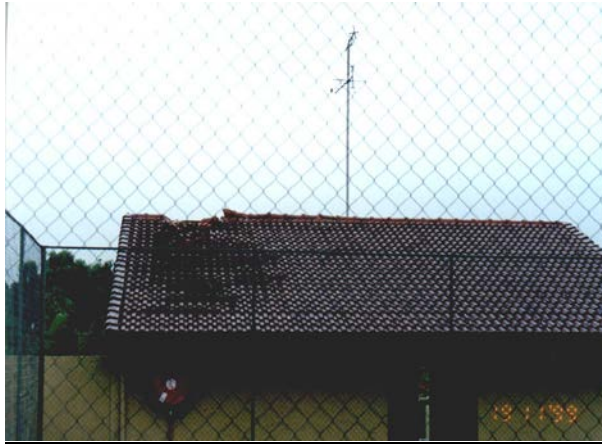
Figure 2.3: Structural damage to a club house due to direct lightning strike (McKechnie and Jandrell, 2008).

The case studies reported by McKechnie and Jandrell are important to this thesis and form the basis of the argument for the sixth mechanism. Their reports describe the popping of nail-supported drywall away from horizontal and vertical wooden studs inside houses and broken glass windows (McKechnie, 2008).

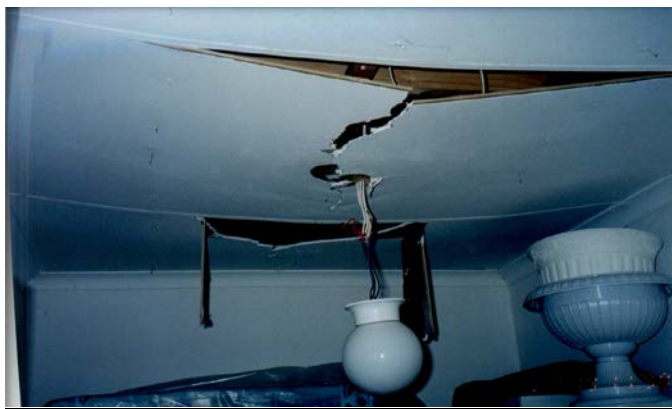
Figure 2.4: Signs of a roof having collapsed. Structural damage caused to a club house building as a result of direct lightning strike (McKechnie and Jandrell, 2008).

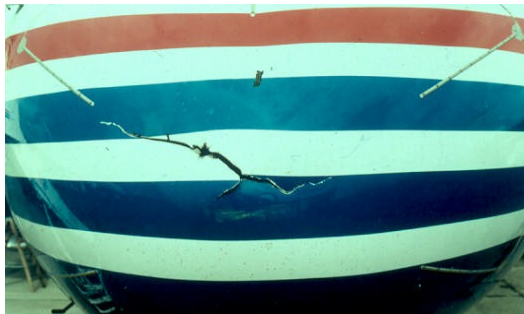
Figure 2.5: *Photograph: Aircraft nose radome punctured by lightning (American Airlines photo).*

The 'punctured' radomes however are important to this thesis and also form the basis of the argument for the sixth mechanism.

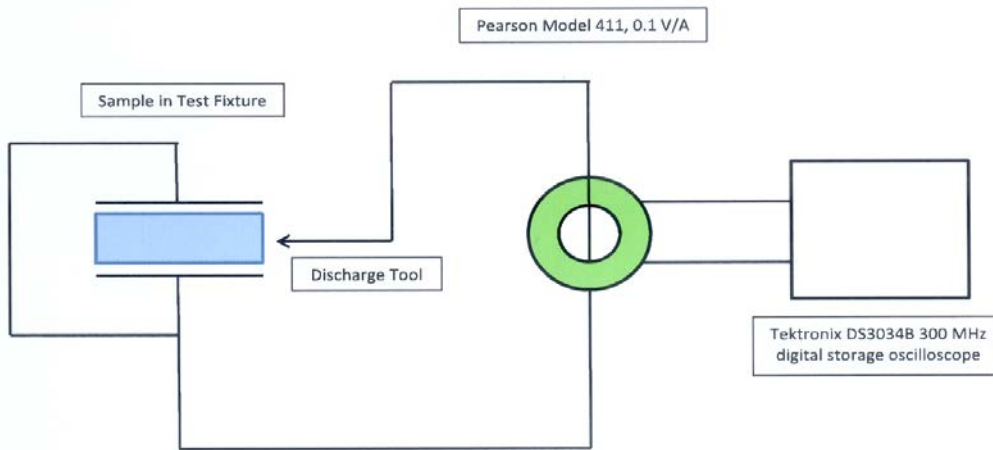
Figure 2.6: Schematic diagram of Hickman's experiment.

Solid dielectric breakdown phenomena have been studied for over a decade (Hickman, 1999-2012). Hickman's production runs represent the closest experiment to the '2012 sixth mechanism experiment', in that both use currents passing through solid, block-like structures. Further details on Hickman's experiments may be found on their website (Hickman, 2013). Please refer figure 2.6.

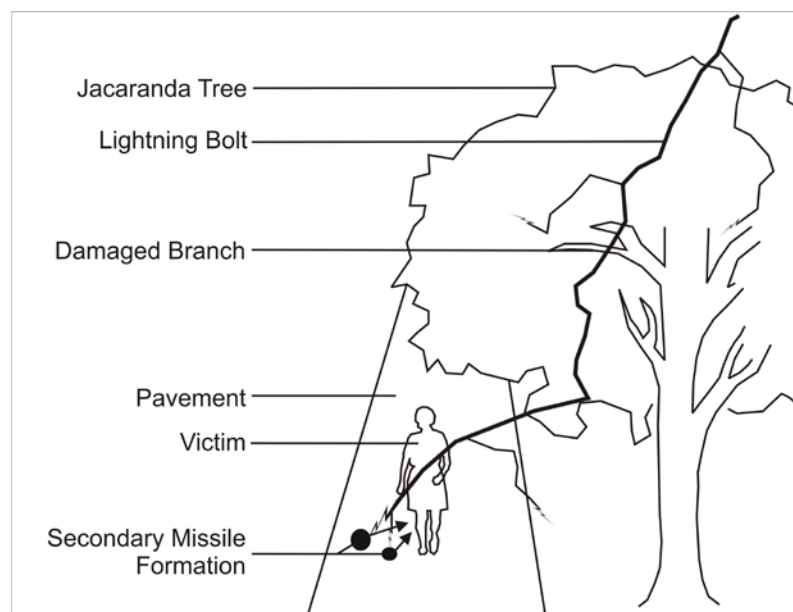
Figure 3.1: Diagrammatic representation of the lightning strike event as described. Note the lightning 'splashing' and/or 'flashing' off the tree (third mechanism), striking the victim and then striking the concrete pavement. The concrete pavement 'exploded' (sixth mechanism).

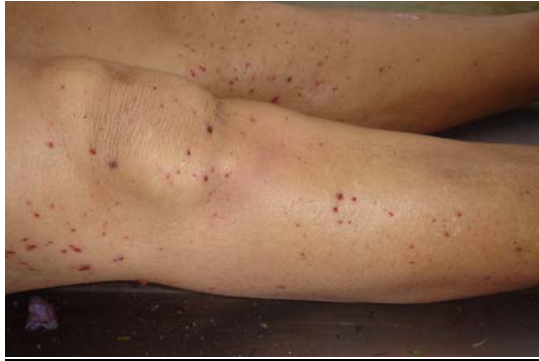
Figure 3.2: Shrapnel wounds noted on the right side of the victims lower legs. Examination showed multiple small pieces of concrete shrapnel lodged within the victim's wounds. Note the 'shadow' area on the medial aspect of the left upper thigh region, where the right leg served as protection from the shrapnel. Such a finding can help recreate the exact position of the legs of the deceased at the time of strike.

Features were in keeping with secondary missile injury (shrapnel injury) from lightning strike. This is the first time such a finding has been reported in the literature.

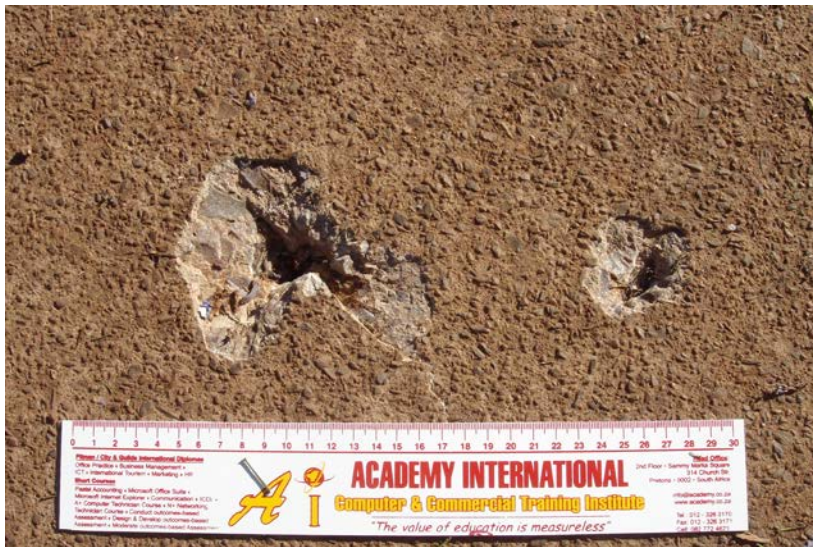
Figure 3.3: Blast / explosion effects from the lightning noted on the concrete pavement on the right side of the victim.

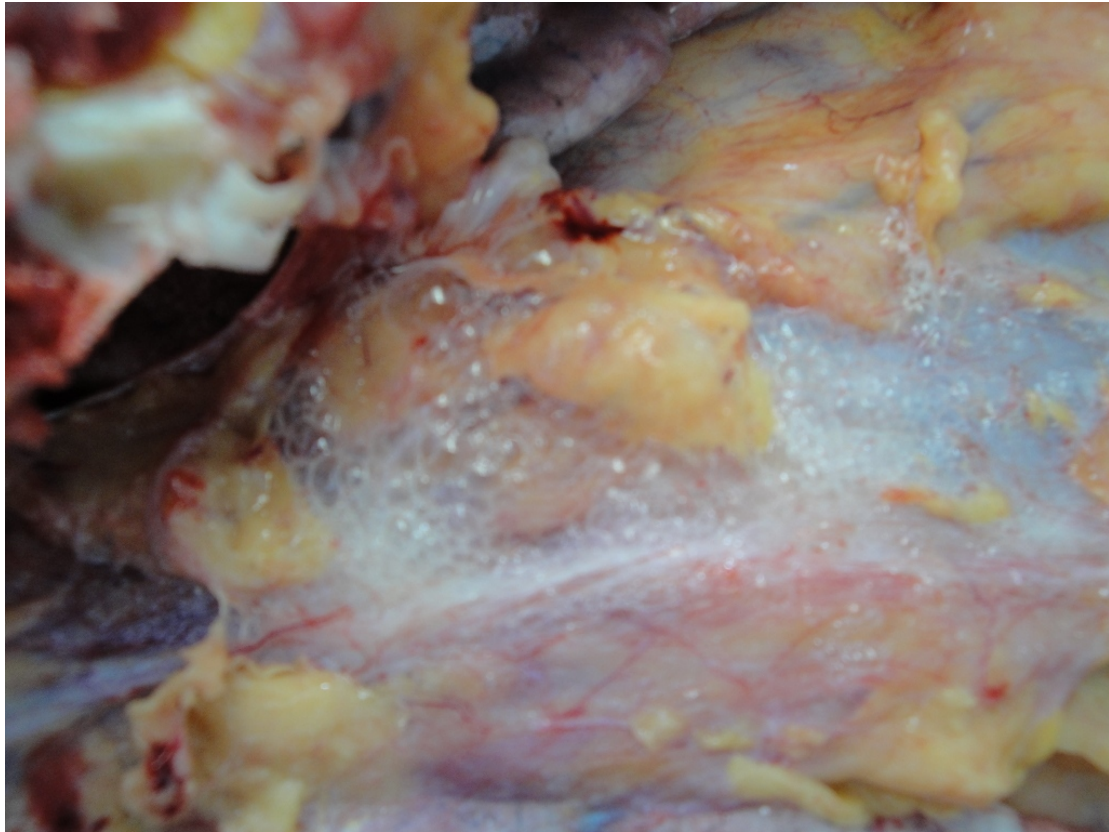
Figure 3.4: Pneumomediastinum noted on the posterior aspect of the sternum. Note the multiple small 'bubbles' in the soft tissue. (Photograph courtesy of Prof G Saayman from the Department of Forensic Medicine, University of Pretoria).

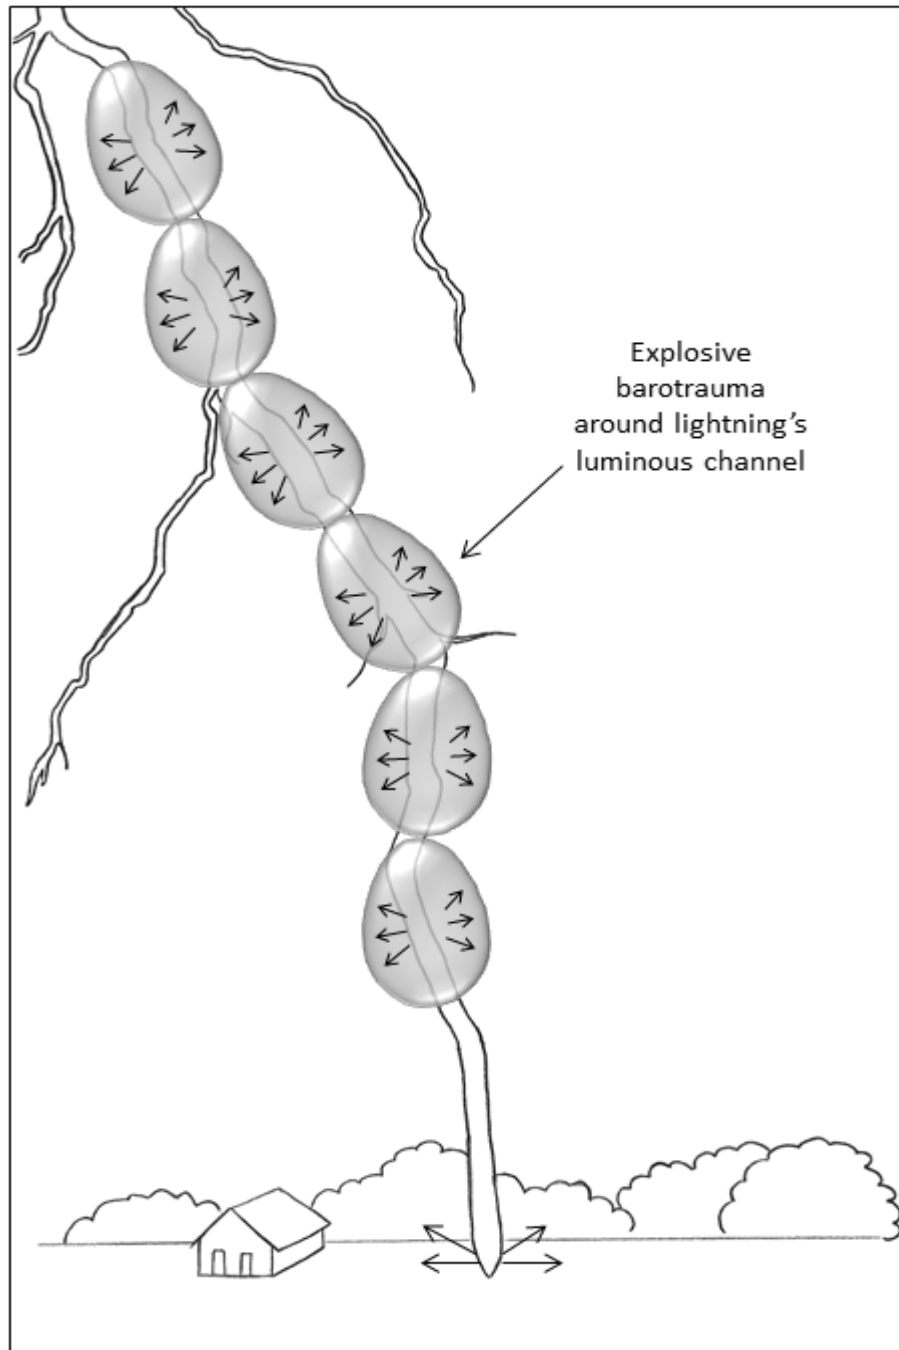
Figure 4.1: Proposed appearance of the sixth mechanism of lightning injury. Please keep in mind that the lightning channel is three-dimensional.

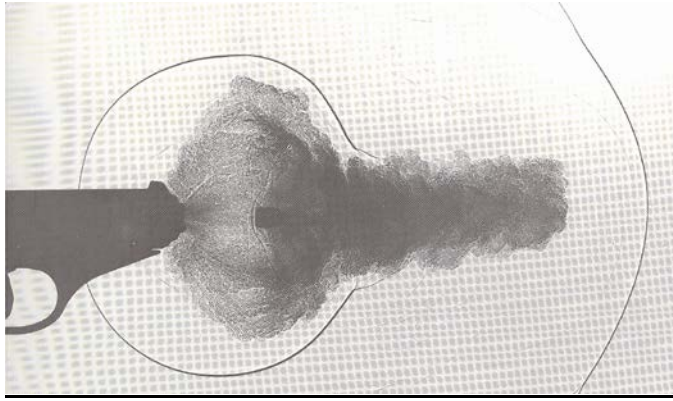
Figure 4.2: Gas flows at a muzzle having just fired a shot. Note the shock wave at the tail of the bullet, showing the high gas velocity (Sellier & Kneubuehl, 1994).

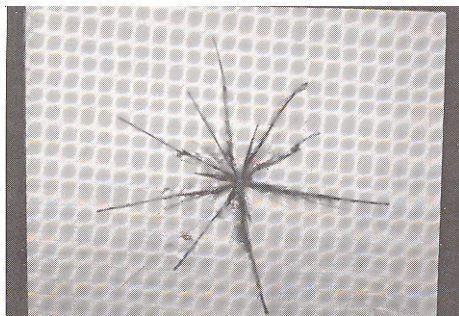
Figure 4.3: Axial view in the direction of the gunshot. Gelatine block with a gunshot (Sellier & Kneubuehl, 1994).

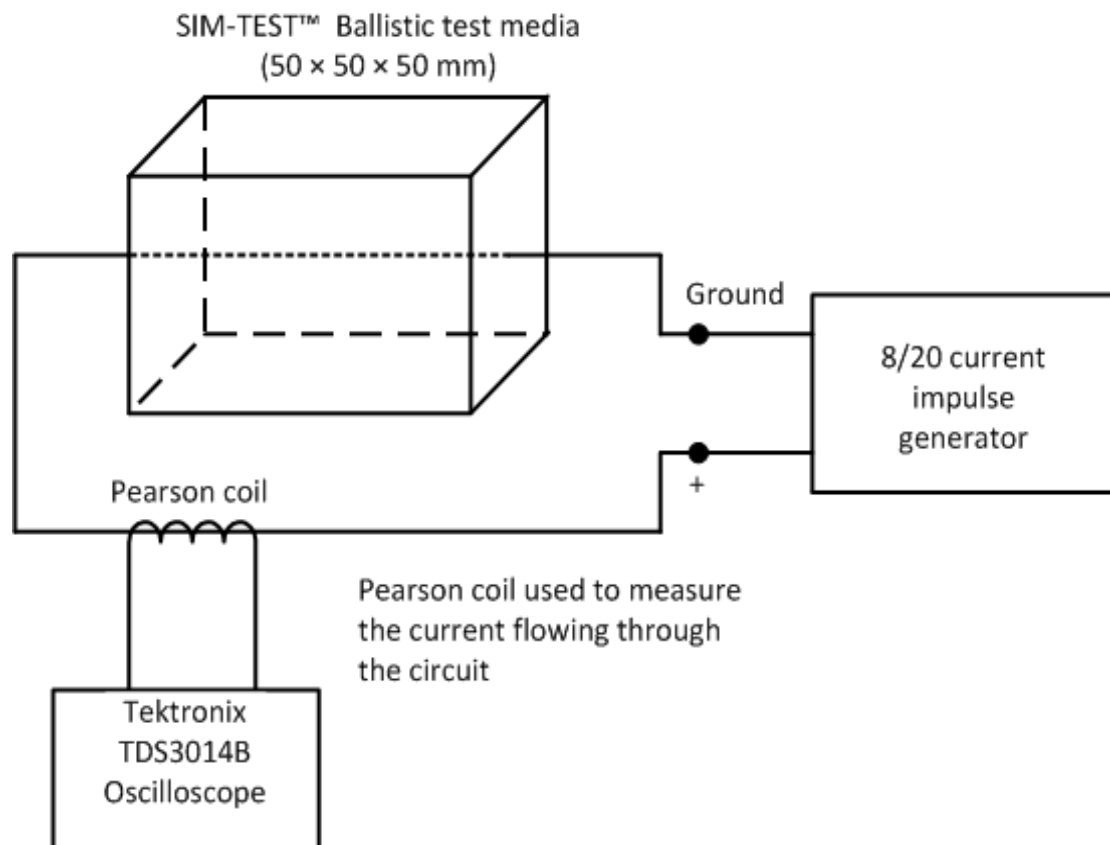
Figure 4.4: The 2012 'sixth mechanism gel experiment': Physical layout of current impulse generator and test object (the gelatine block).

The aim of the experiment was to determine the shape and nature of the 'pressure shock-wave' surrounding the long electrical spark. The wire made sure that the long electrical spark did not flash over the gelatine blocks. What is important to realise is that, all things being equal, (the wire and the gelatine blocks for example – with all their associated contaminants), the only things being tested for in this experiment were current, voltage and size and shape of the cavity.

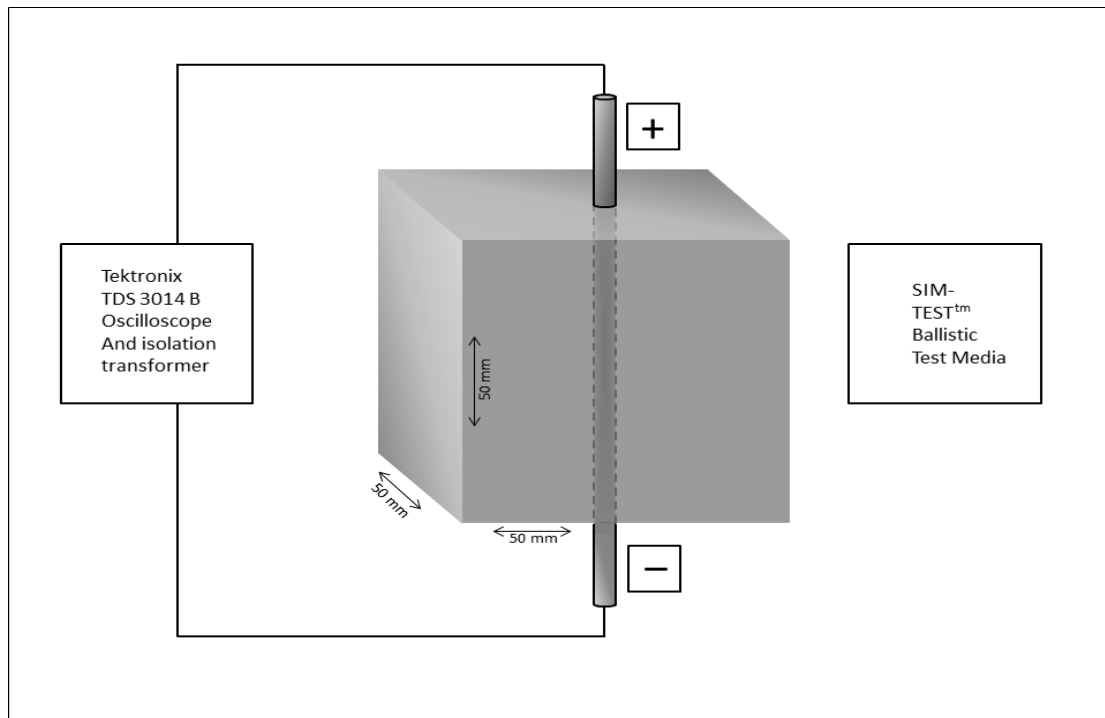
Figure 4.5: Three dimensional view of the 2012 'sixth mechanism gel experiment'.

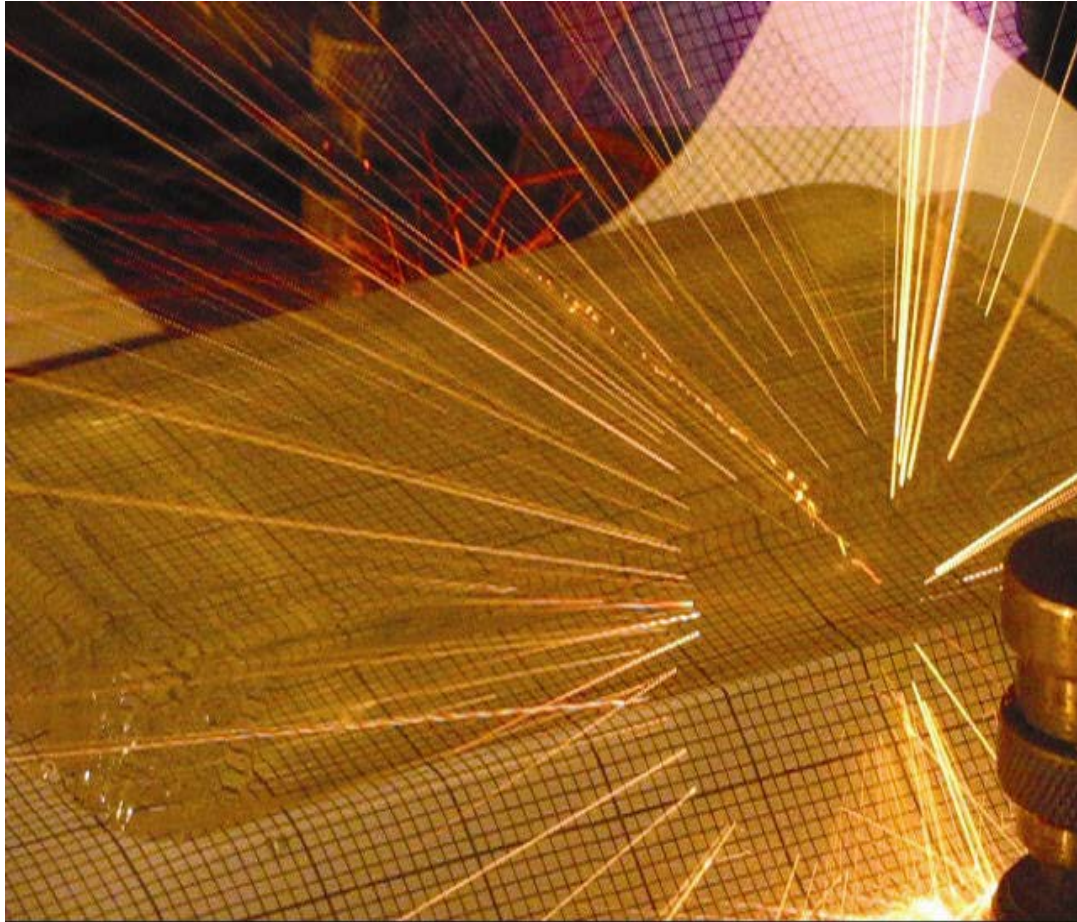
Figure 4.6: High-speed camera footage showing the moment of impulse generation. Note the radial explosion from the wire. The propagation mode of the blast wave through the jelly was visibly noted. Current impulse generated through gel showing radial explosion.

Gelatine proved an excellent medium to study the behaviour of the shock wave in that it was transparent and allowed for optical measurements. High-speed photography was performed in second-phase experimentation and the propagation mode of the blast wave was visibly noted. Since gelatine is made of natural substances, (water and proteins), disposal was also not a problem.

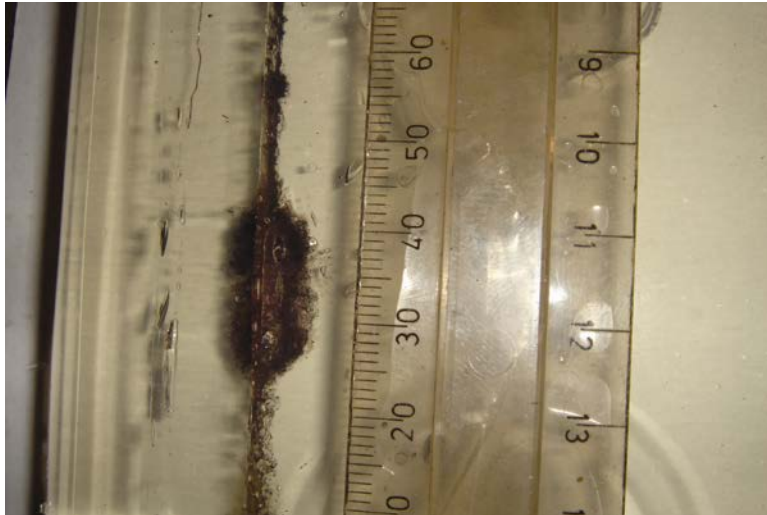
Figure 4.7: Permanent cavity formation. A so-called 'smoke node'. Permanent cavity formation noted in the softer gelatine media. Caterpillar-like explosion defect noted in the gelatine surrounding the disintegrating wire. The 'shape' of the surrounding blast wave is suggested by this imprint defect.

Initial findings were in keeping with the so-called “wound profile” of Fackler (1985). The size of the permanent cavity could easily be seen within the test gelatine. Fackler (1985) called the description of the totality of the projectile effects on gelatine a “wound profile” (Fackler, 1985.)

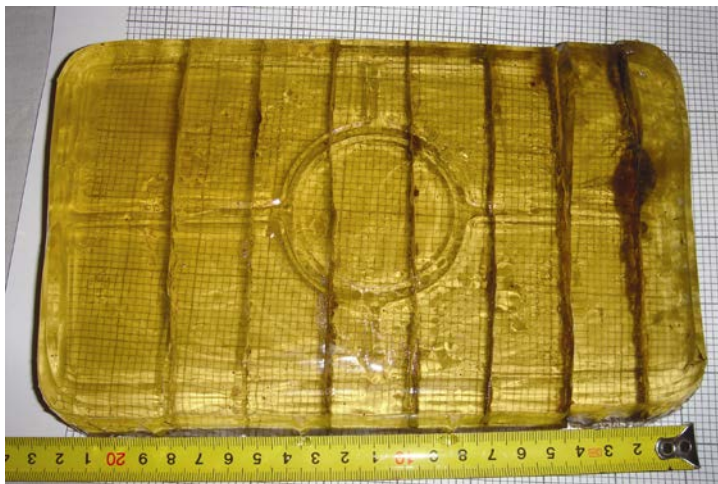
Figure 4.8: Incremental permanent cavity formation. Incremental destruction of surrounding gelatine as demonstrated from left to right at increasing voltages. The voltages were increased incrementally from 1 kV to 6 kV. This represented a serial increase in current from 1,52 kA to 9,0 kA. The gelatine / water ratio represented a 30 mg / 500 ml mix. Notice no visible reaction within the wire at 1 kV (1,52 kA) on the far left. Notice complete wire disintegration with cylindrical 'smoke node' formation at 6,0 kV (9,0 kA) on the far right.

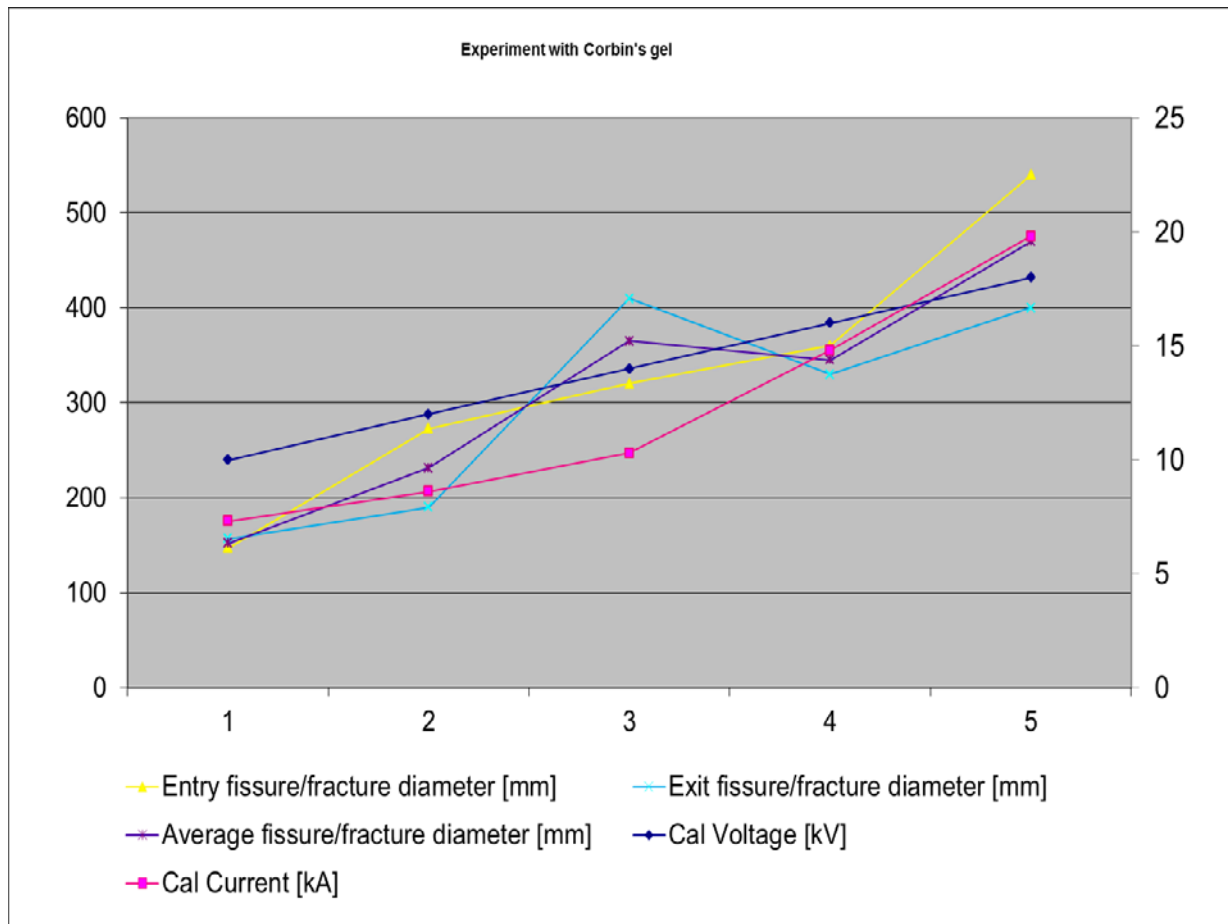
Figure 4.10: Initial testing with Corbin's gel. The x axis plots the current (kA) whereas the y axis plots the fissure/fracture diameters in millimetres. Due to the fact that this represents a 2-D chart with values from a data series which vary widely, and which contain mixed-type of data, a further analysis using a secondary axis in the chart was employed. This method enabled the author to plot one data series (kA) on a secondary vertical axis. A correlation between kA and the entry and exit fissure/fracture diameters exists. It appears from the graph that kA and the fissure/fracture diameters are directly proportional to one another. Please note that the findings were based on objective, descriptive appearance of the so-called 'wound profiles'.

Cal Voltage [kV]	Cal Current [kA]	Entry fissure/fracture diameter [mm]	Exit fissure/fracture diameter [mm]	Average fissure/fracture diameter [mm]
10	7.3	147	157	152
12	8.6	273	190	231.5
14	10.3	320	410	365
16	14.8	360	330	345
18	19.8	540	400	470

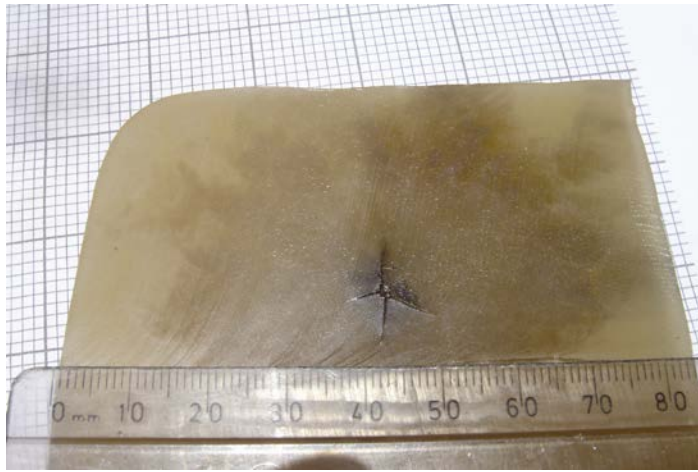
Figure 4.11: Axial view. Corbin's gel. 10 kV. (7,30 kA). Temporary cavity formation demonstrated in the harder gelatine media. Small fissure fracture noted similar to that seen in projectile testing experiments. The current strength measured 7,30 kA.

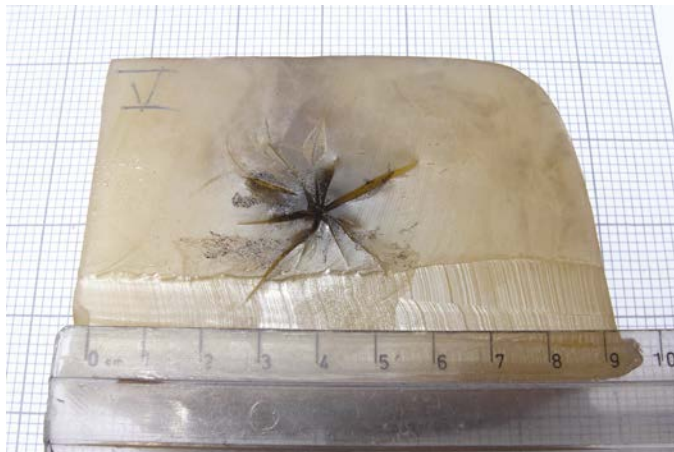
Figure 4.12: Axial view. Corbin's gel. 18 kV. (19,8 kA). Temporary cavity formation demonstrated in the harder gelatine media. Large fissure fracture noted similar to that seen in projectile testing experiments. The current strength measured 19,80 kA.

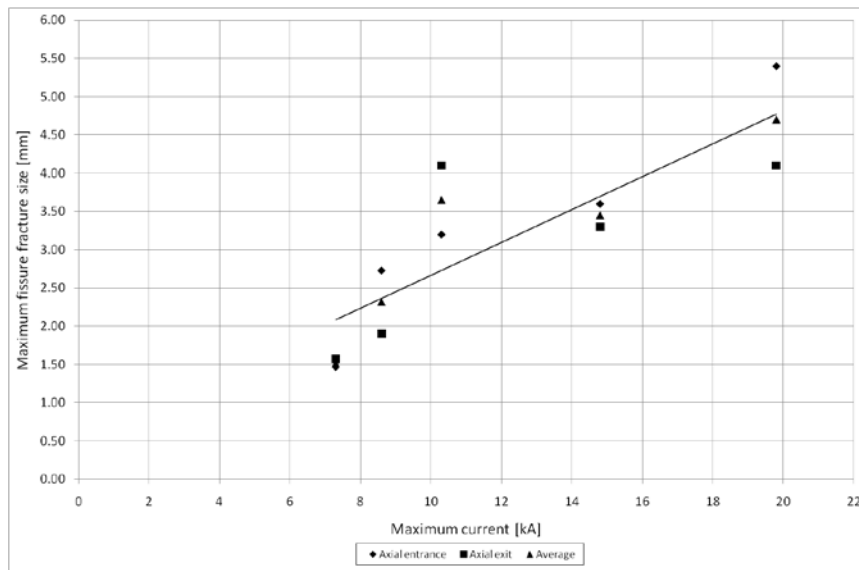
Figure 4.13: Graph demonstrating incremental fissure/fracture cracks in Corbin’s gel. As the current increased through the wire, the size of the temporary cavity also increased in a directly proportional manner
