On the Sixth Mechanism of Lightning Injury

On the sixth mechanism of lightning injury

A thesis submitted to the Faculty of Engineering and the Built Environment, University of the Witwatersrand, Johannesburg, in fulfilment of the requirements for the Degree of Doctor of Philosophy.

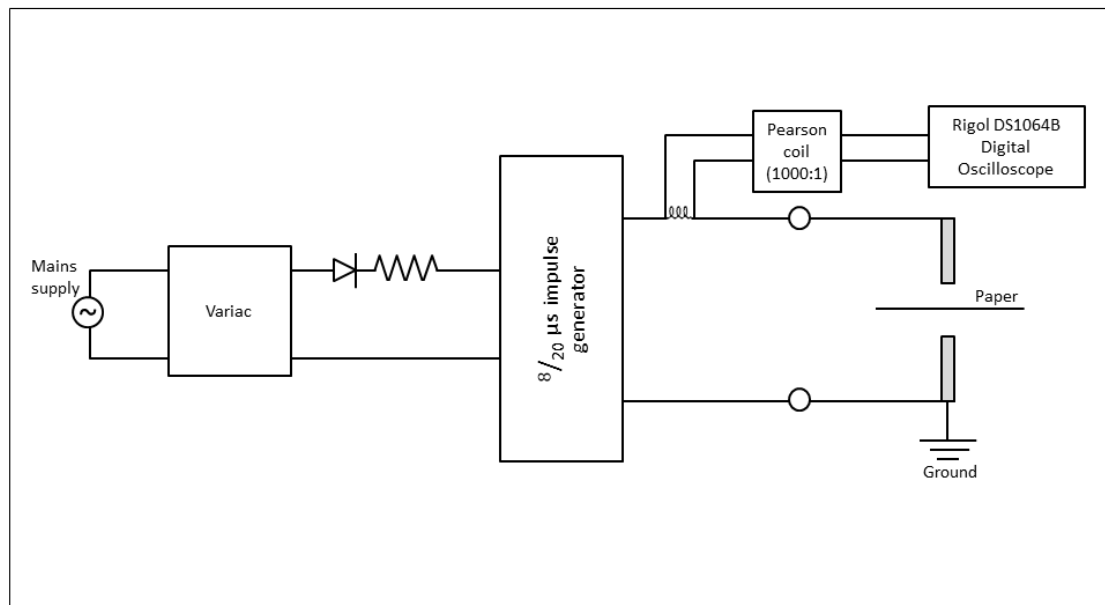
Figure 4.14: The 2014 'sixth mechanism paper experiment': Physical layout of current impulse generator and test object (graph paper)

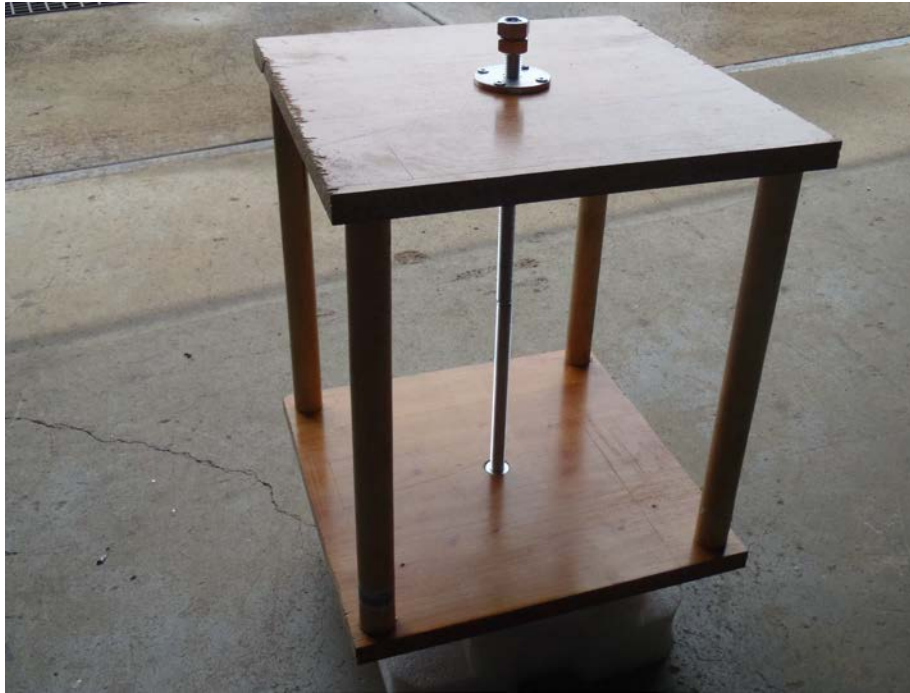
Figure 4.15: The test box, specifically constructed to create a spark gap of 5mm.

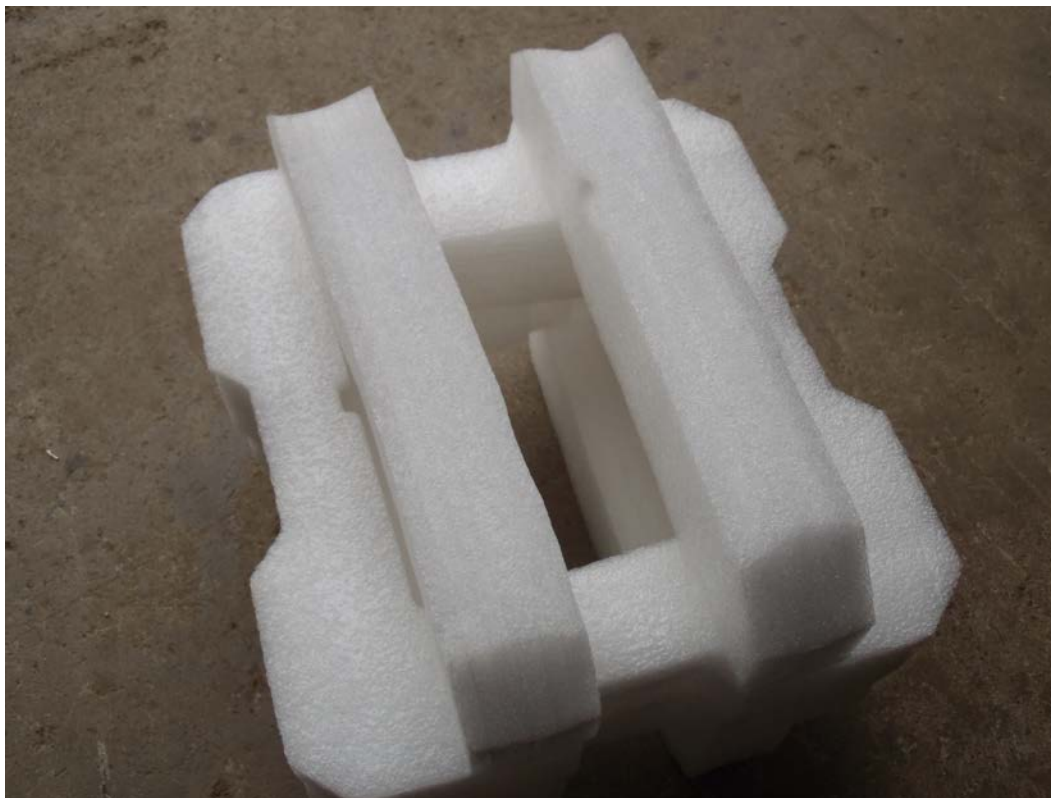
Figure 4.16: The polystyrene 'clamp' designed to clamp the graph paper and not cause any undue forces on the graph paper, thereby enabling the tearing and tattering to take place without any undue influence.

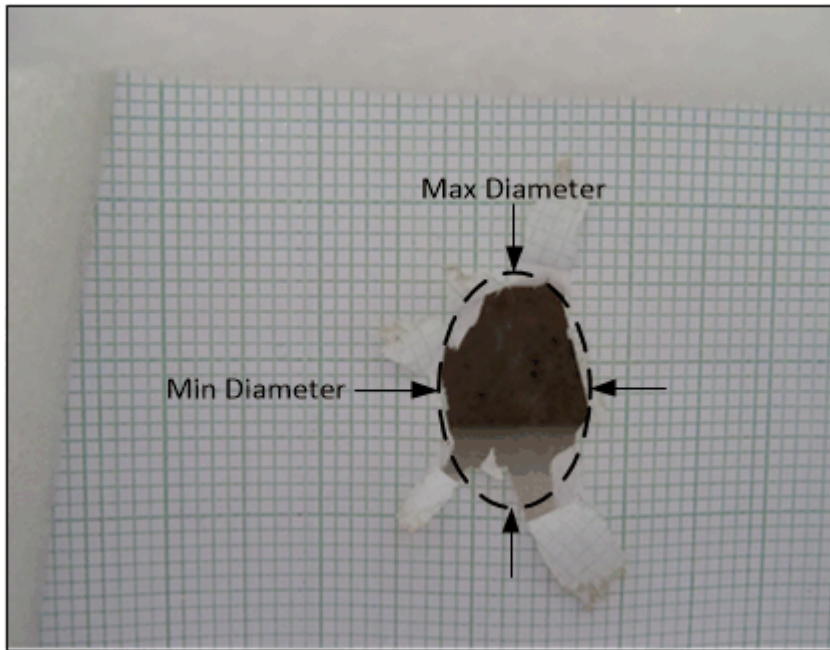
Figure 4.17: Tearing and tattering of dry graph paper to a maximum diameter of 29 mm. 15 kV. 24 kA.

Figure 4.17 and Figure 4.18 show what happened to the graph paper after having been subjected to an impulse. The majority of knowledge related to lightning parameters has been derived by 'scaling up' the equivalent information obtained during experimentation with the use of long linear electrical discharges generated under laboratory conditions (Uman, 1970).

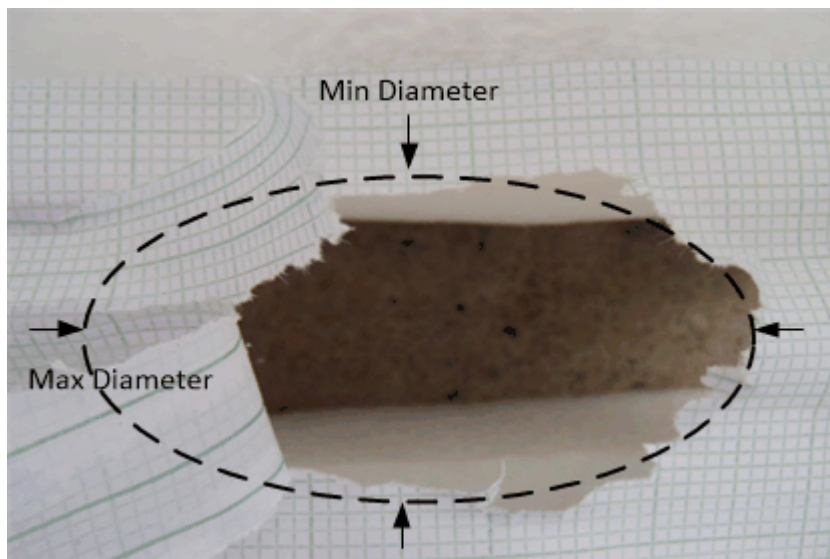
Figure 4.18: Tearing and tattering of saline-soaked graph paper to a maximum diameter of 80 mm. 20 kV. 32,8 kA.

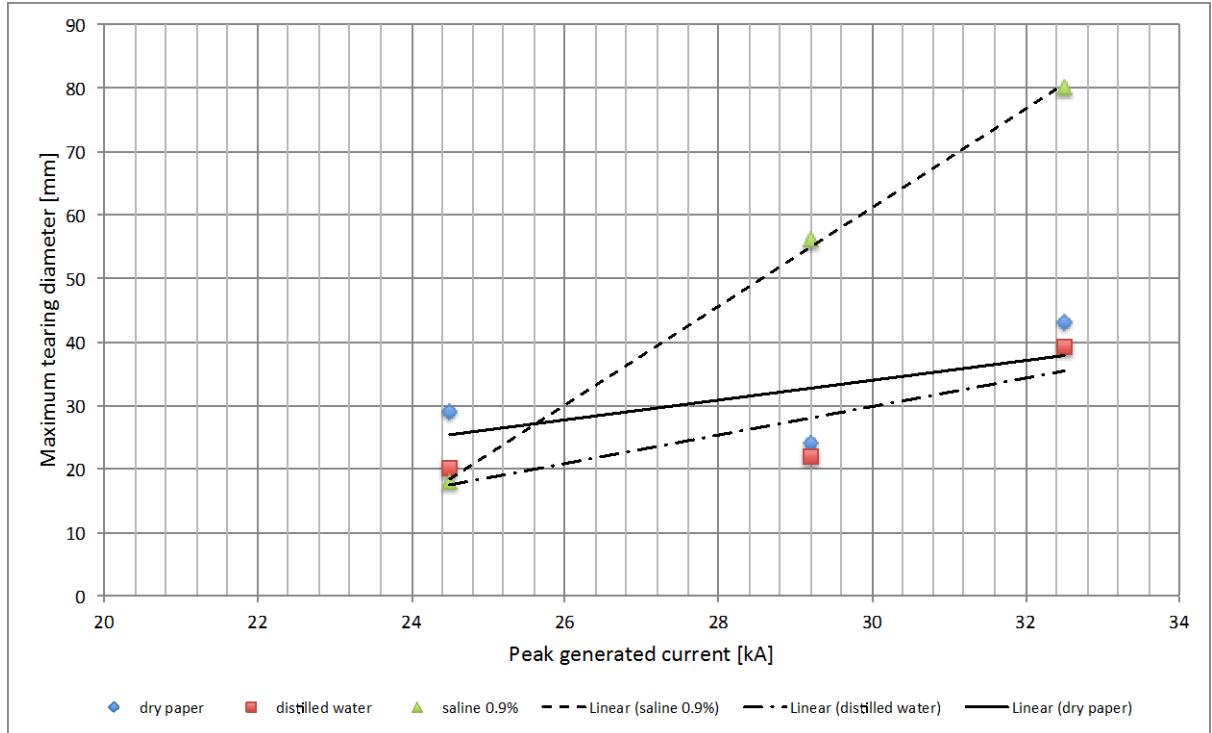
Figure 4.19: Trend lines showing significantly higher tearing of the paper soaked in 0.9% saline solution.

The graph illustrated in Figure 4.19 shows the maximum tearing diameters against the peak generated currents for dry, distilled and saline-soaked graph papers.

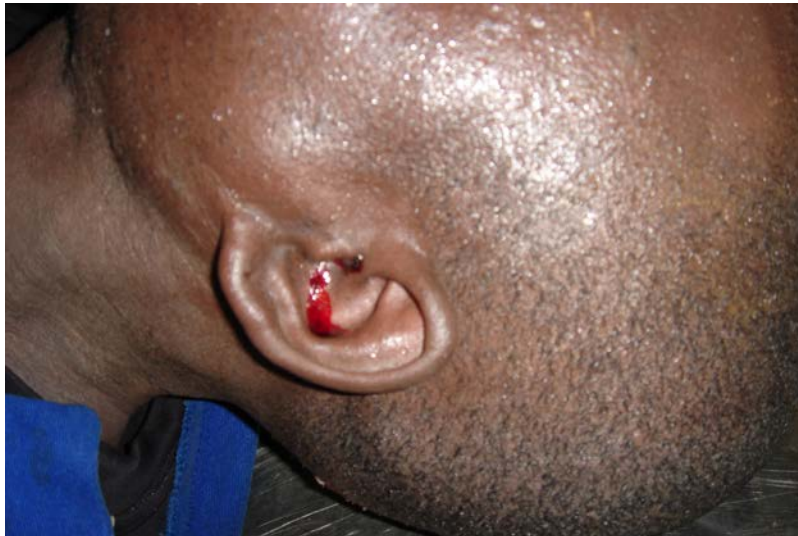
Figure 5.1: Photograph of a lightning victim showing blood at the external auditory meatus due to ruptured left tympanic membrane. (Photograph courtesy of dr R. Blumenthal, Department of Forensic Medicine, University of Pretoria).

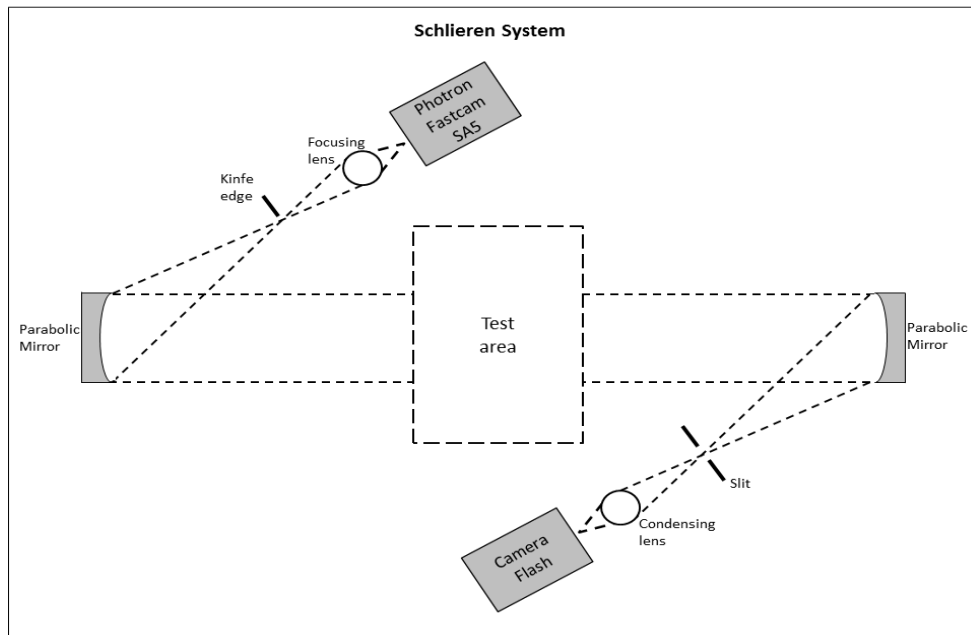
Figure 6.1: Proposed Z-configuration Schlieren test to photograph the lightning blast wave around a spark.

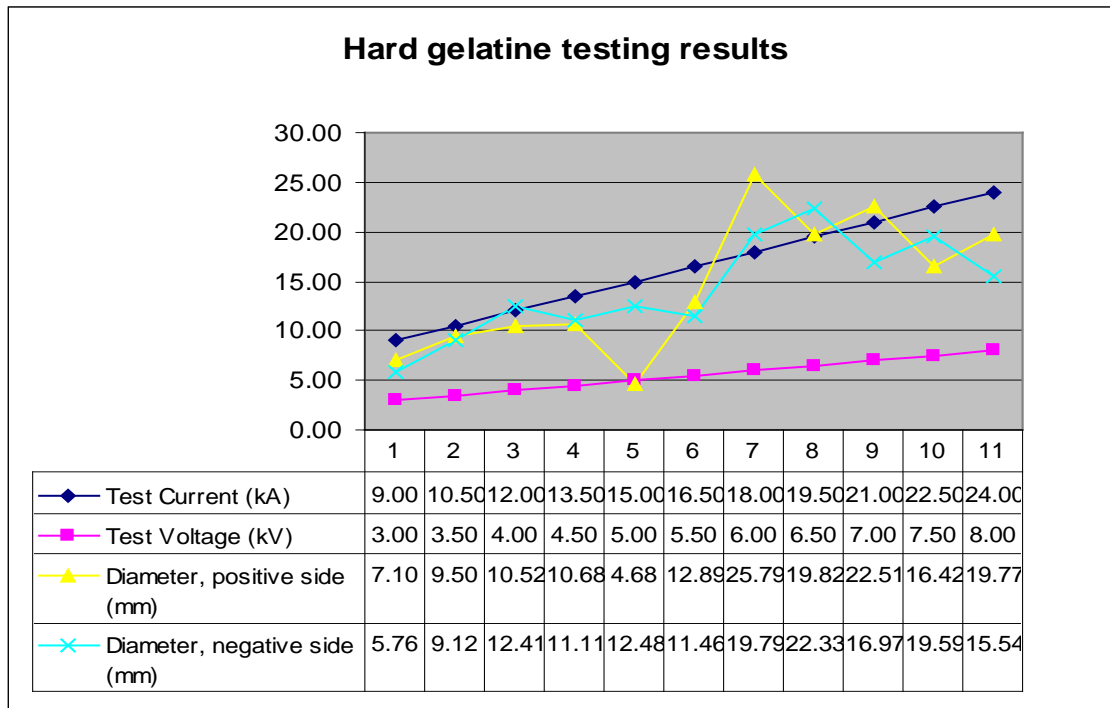
Table 7.2: Graph demonstrating incremental fissure/fracture cracks in Corbin's gel. As the current increased through the wire, the size of the temporary cavity also increased in a directly proportional manner

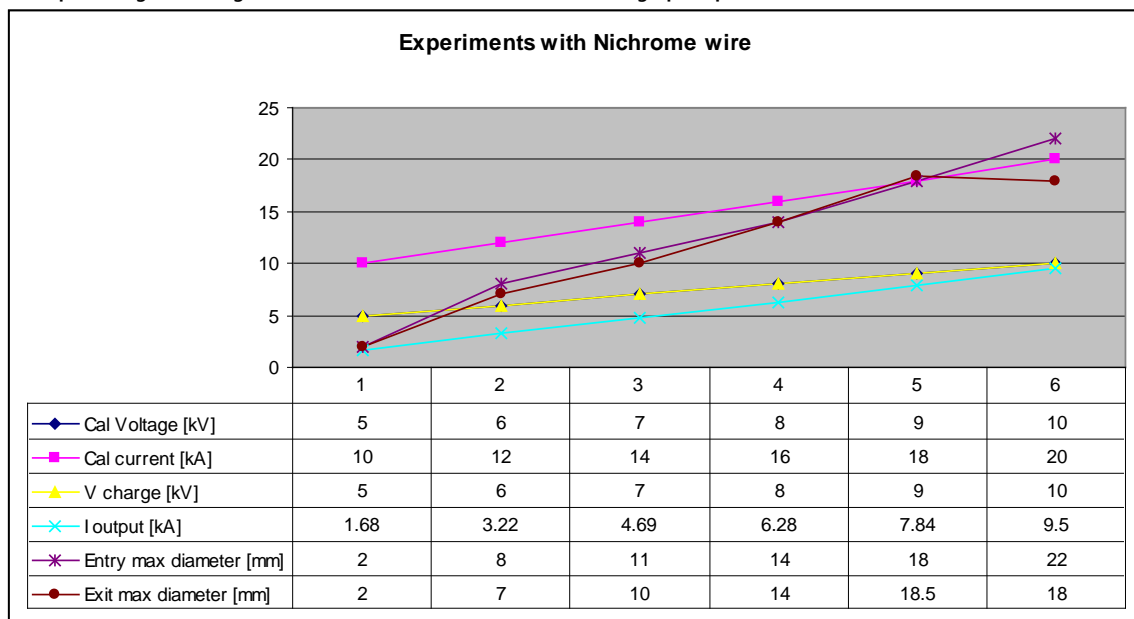
Table 7.3: Graph demonstrating incremental fissure/fracture cracks in Corbin's gel. As the current increased through the wire, the size of the temporary cavity also increased in a directly proportional manner

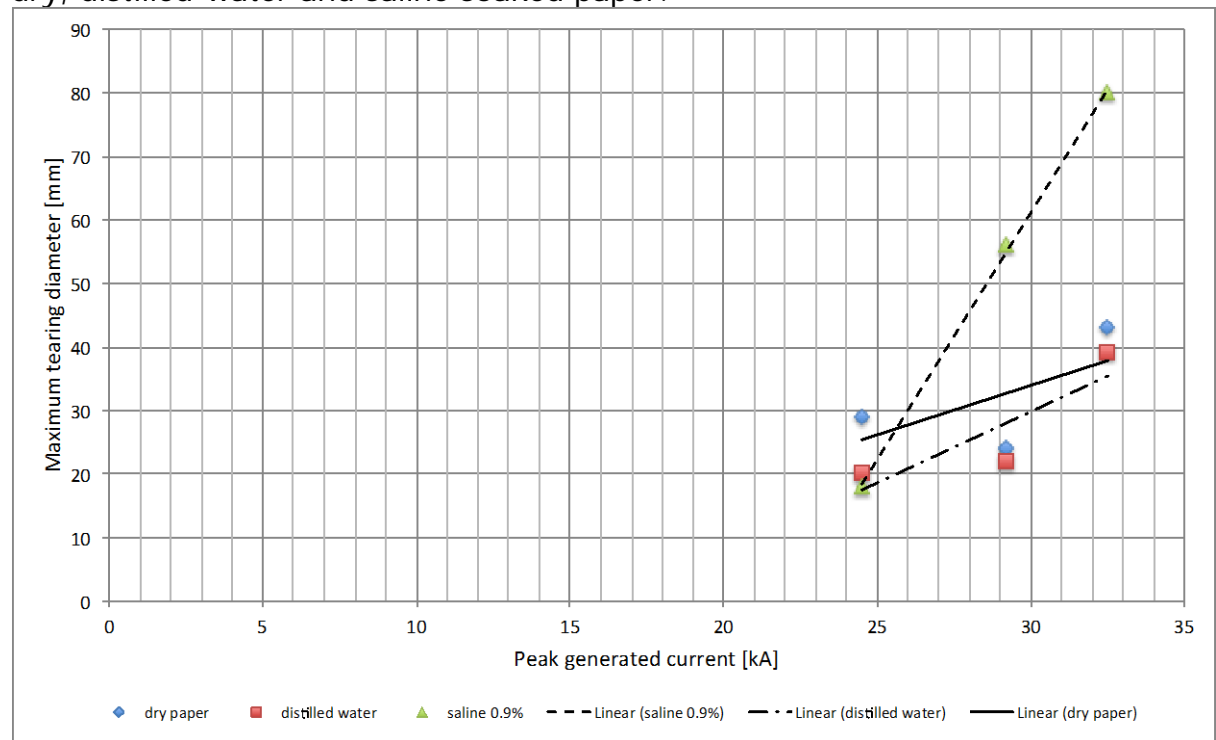
Table 7.4: Graph demonstrating incremental fissure/fracture cracks in dry, distilled-water and saline soaked paper.
