## Investigation Report

Published: June 2019

The CSB determined that the cause of the highly toxic methyl mercaptan release was the flawed engineering design and the lack of adequate safeguards.<sup>e</sup> Contributing to the severity of the incident were numerous safety management system deficiencies, including deficiencies in formal process safety culture assessments, auditing and corrective actions, troubleshooting operations, management of change, safe work practices, shift communications, building ventilation design, toxic gas detection, and emergency response. Weaknesses in the DuPont La Porte safety management systems resulted from a culture at the facility that did not effectively support strong process safety performance.

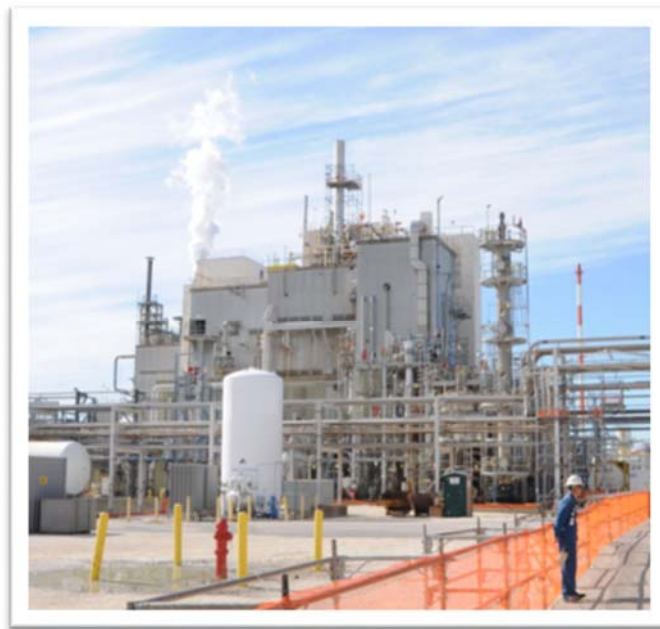
**Figure 1.** The Lannate<sup>®</sup> Manufacturing Building. The methyl mercaptan release occurred in the manufacturing building. Source: CSB.

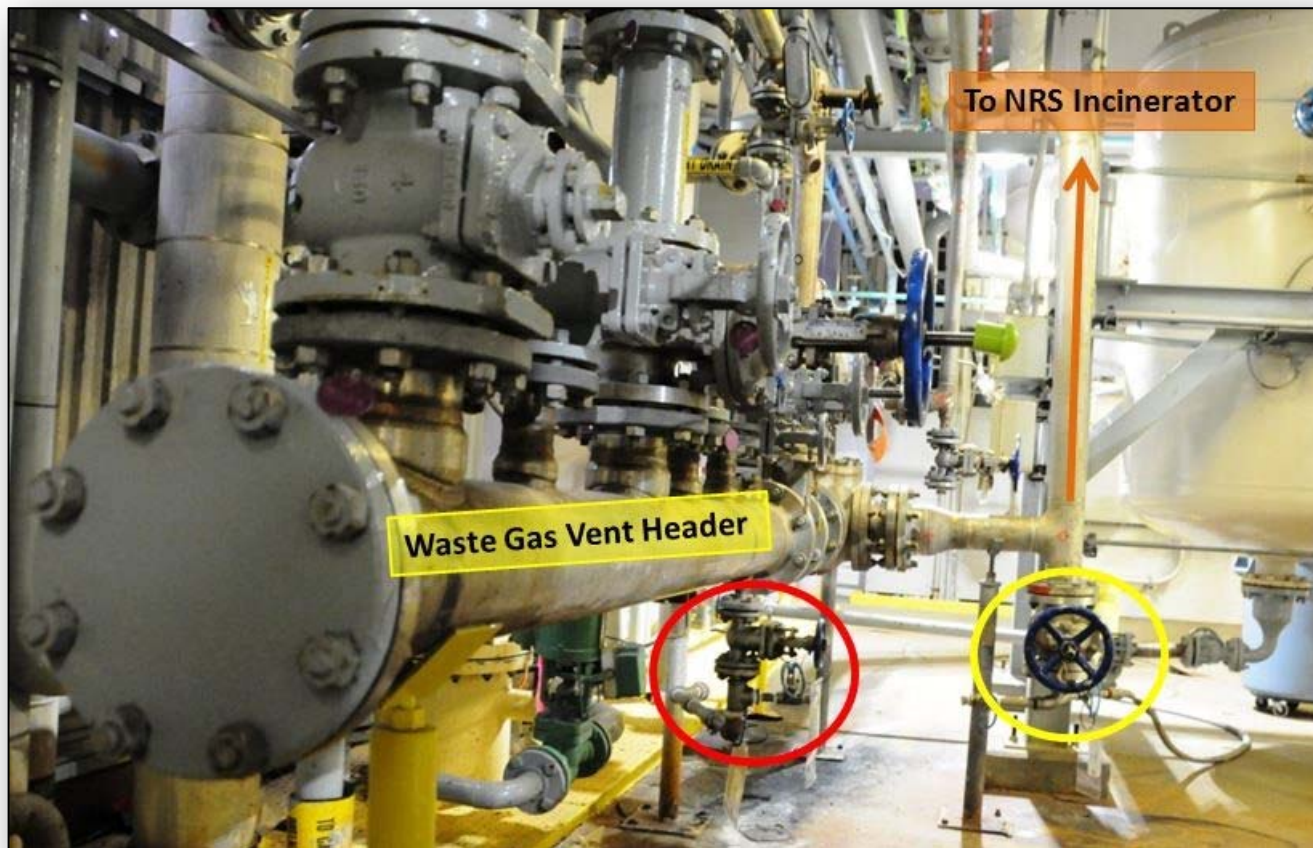
**Figure 2.** Waste Gas Vent Header Piping on the Third Floor of the Manufacturing Building. This portion, where several waste gas sources come together, is referred to as the *waste gas vent header*. Waste gas from this portion of the vent header traveled up to reach the NRS incinerator, a piping configuration that created a low spot where liquid accumulated. To remove the liquid during waste gas vent header piping high-pressure events, operators were instructed to open valves (yellow circle) and drain the system through a hose routed to a floor drain located near a safety shower. The floor drain is connected an open trench-type sump on the first floor. At the time of the incident, a second set of drain valves (red circle) were also opened directly to the floor inside the manufacturing building. Source: CSB.

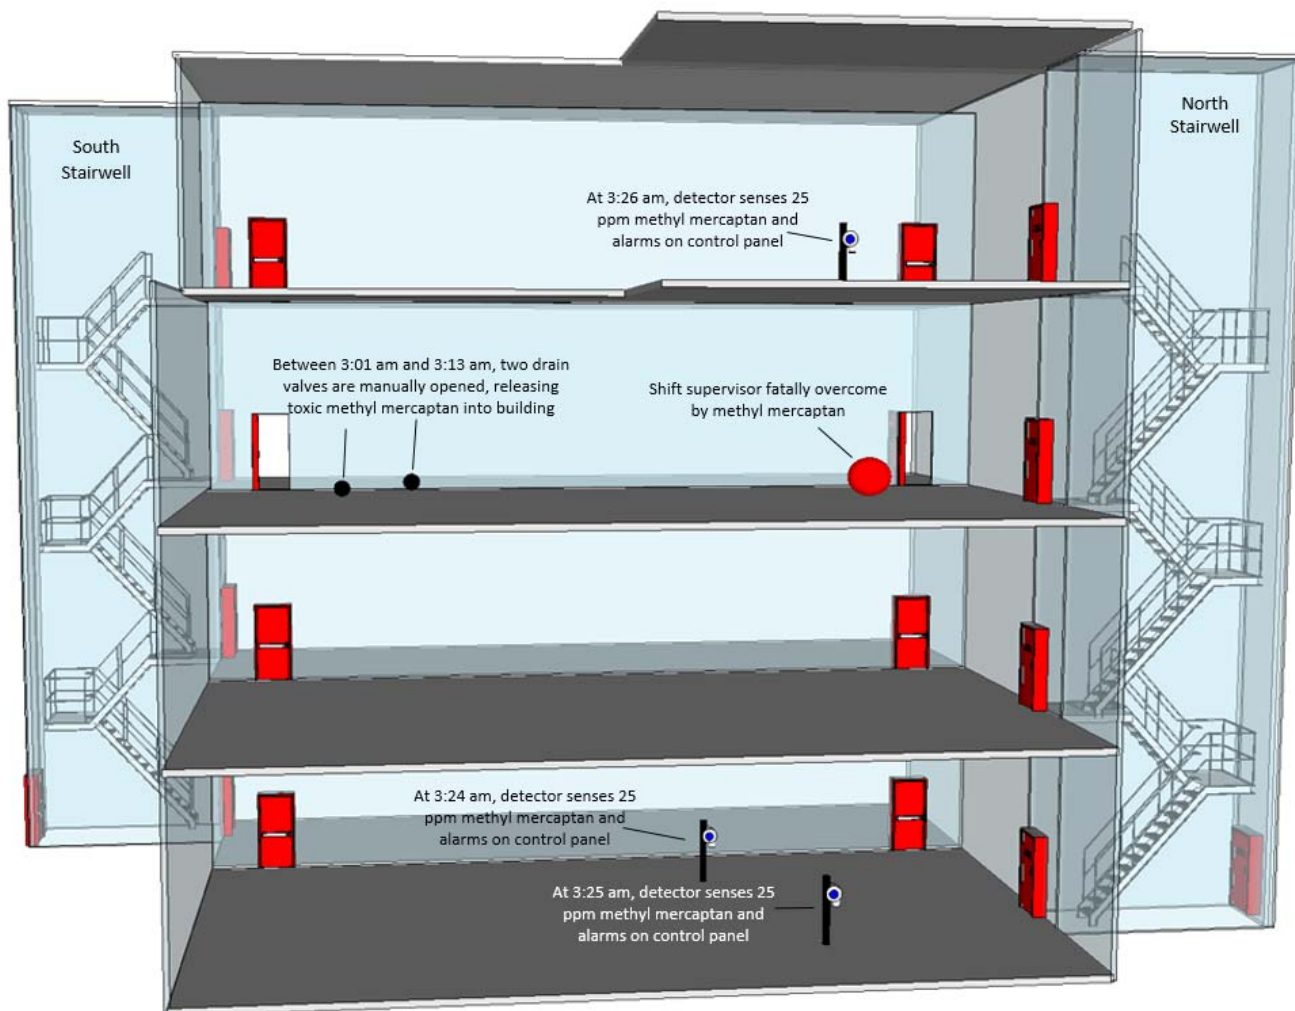
**Figure 3.** Depiction Showing Where Drain Valves Were Opened. These drain valves released toxic methyl mercaptan into the manufacturing building. Methyl mercaptan detectors on the first and fourth floors detected high concentrations of methyl mercaptan shortly after the release began. This depiction is a simplified graphic of the manufacturing building (see Section 4.5) and does not show the location of Operator 1. Source: CSB.

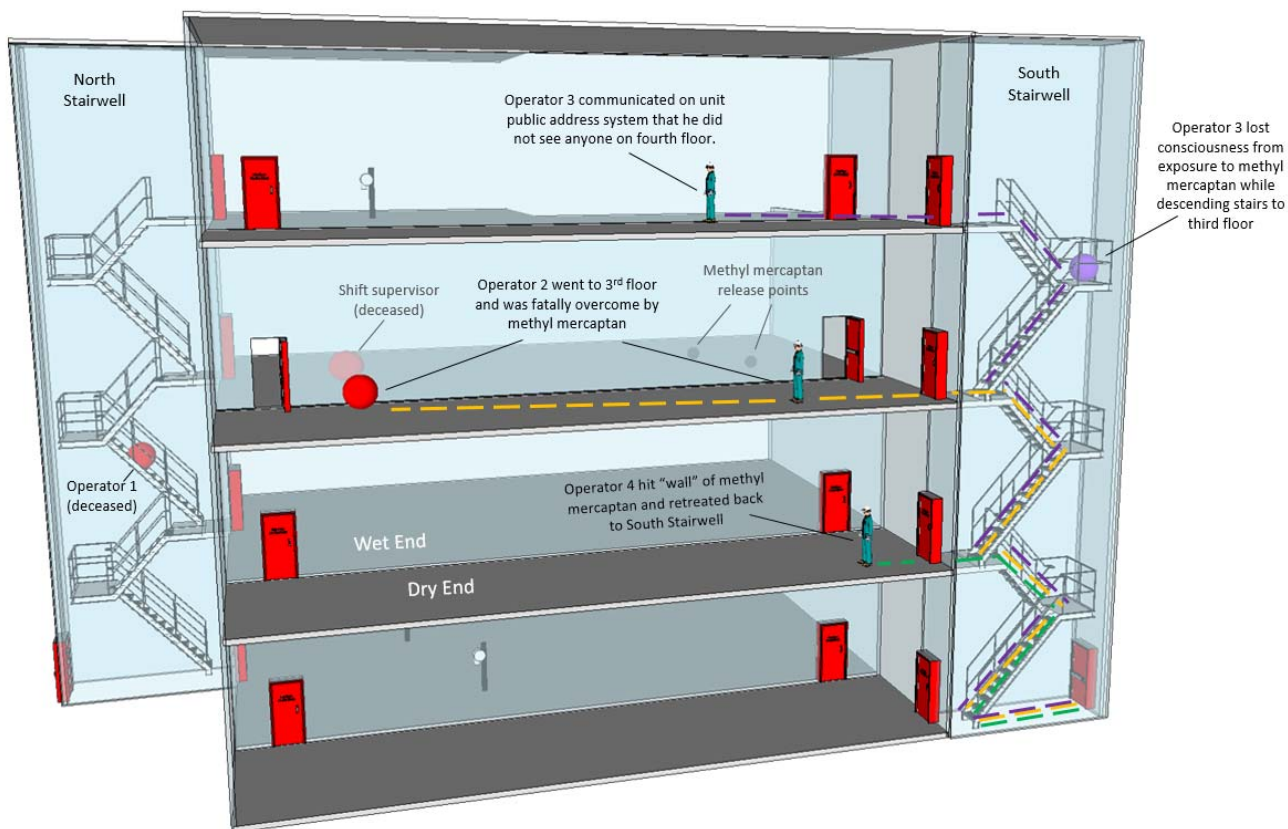
**Figure 4.** Depiction of Paths Taken by Operator 2, Operator 3, and Operator 4 When They Responded to Operator 1’s Distress Call. Locations of the deceased Shift Supervisor and Operator 1 are also shown. Operator 2 was killed by methyl mercaptan exposure, and Operator 3 and Operator 4 were exposed to high concentrations of methyl mercaptan. This figure shows the opposite side of the manufacturing building from the view in Figure 3. Source: CSB.

Operator 2, Operator 3, and Operator 4 each entered the south stairway and took different a route inside the manufacturing building to try to find Operator 1 (Figure 4). Operator 2 went to the third floor, where he was fatally overcome by methyl mercaptan [1, p. 29]. Operator 4 went to the second floor. He walked about 10 feet and hit what he later described as a "wall" of methyl mercaptan, but he managed to retreat to the stairwell [1, p. 29]. Operator 3 went to the fourth floor but did not find anyone. He then announced on the Lannate<sup>®</sup> Unit's public-address system that he did not see anyone on the fourth floor. The Board Operator responded that the Shift Supervisor and Operator 1 may be on the third floor [1, p. 29]. Operator 3 then began to feel light-headed. He made his way to the stairwell and lost consciousness while descending from the fourth floor [1, p. 29].

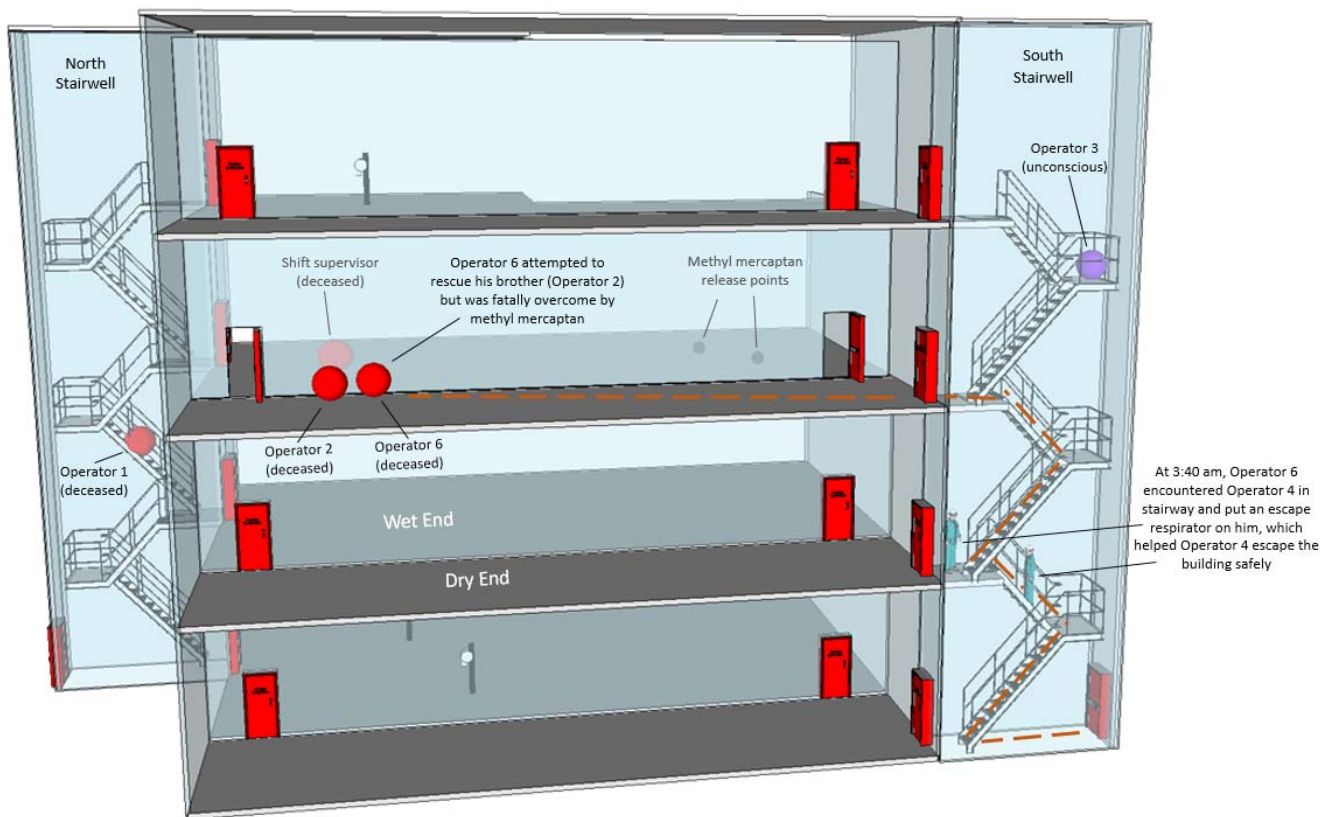
**Figure 5.** Depiction of the Path Taken by Operator 6 Inside the Manufacturing Building. Operator 6 helped Operator 4 escape by providing him with a respirator. Operator 6 was fatally overcome by methyl mercaptan when trying to rescue his brother, Operator 2, on the third floor. Source: CSB.

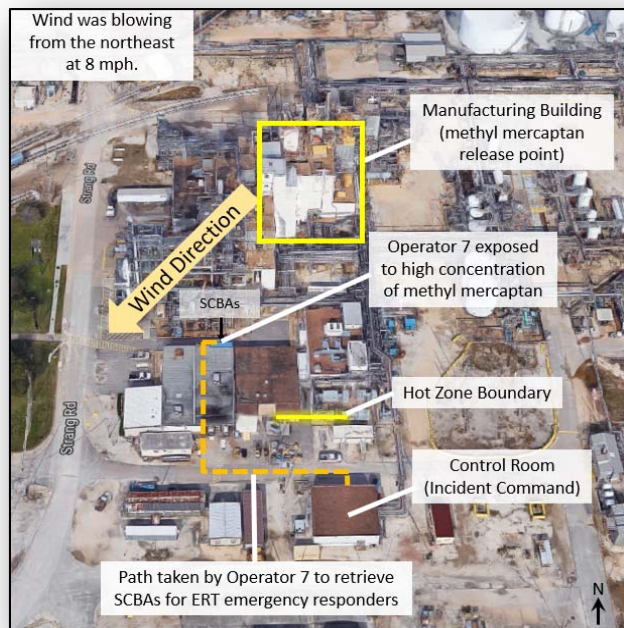
**Figure 6.** Depiction of Path Taken by Operator 7 to Retrieve SCBAs for ERT When the Mini Pumper Truck Would Not Start. The hot zone was not controlled adequately to ensure that personnel did not enter a hazardous area. Source: Google Earth, with annotations by CSB.

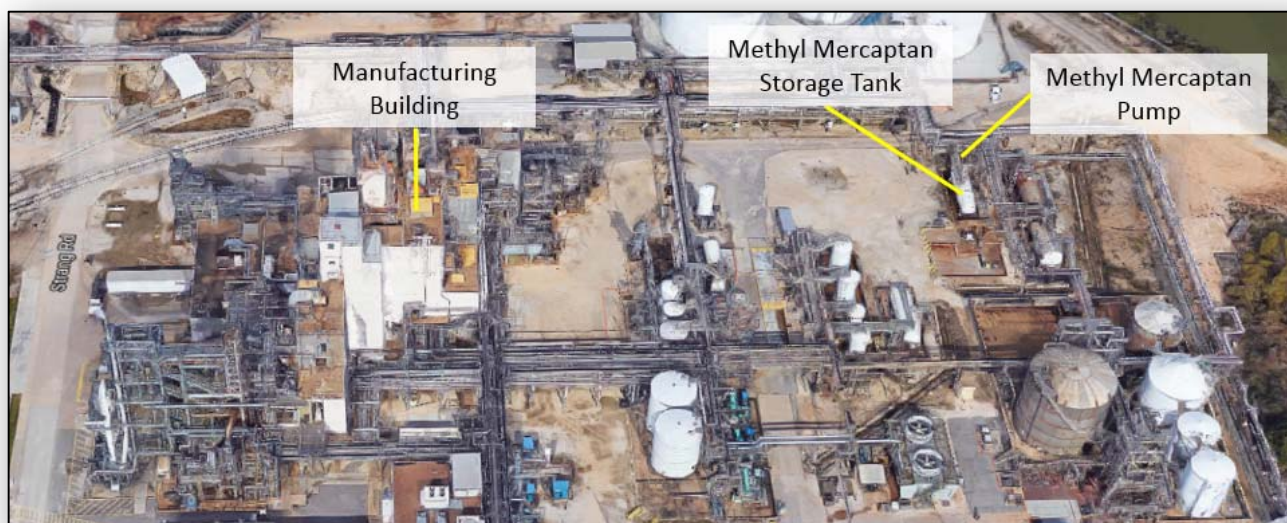
**Figure 7.** Location of Methyl Mercaptan Pump. The pump was turned off nearly three hours after the release began. Source: Google Earth, with annotations by CSB.

At 6:02 am, approximately three hours after the release started, DuPont La Porte personnel turned off the methyl mercaptan storage tank pump, which had been operating since the last startup attempt, before the release began (Figure 7). Shutting off this pump significantly slowed the methyl mercaptan release rate (Section 4.6).<sup>a</sup>

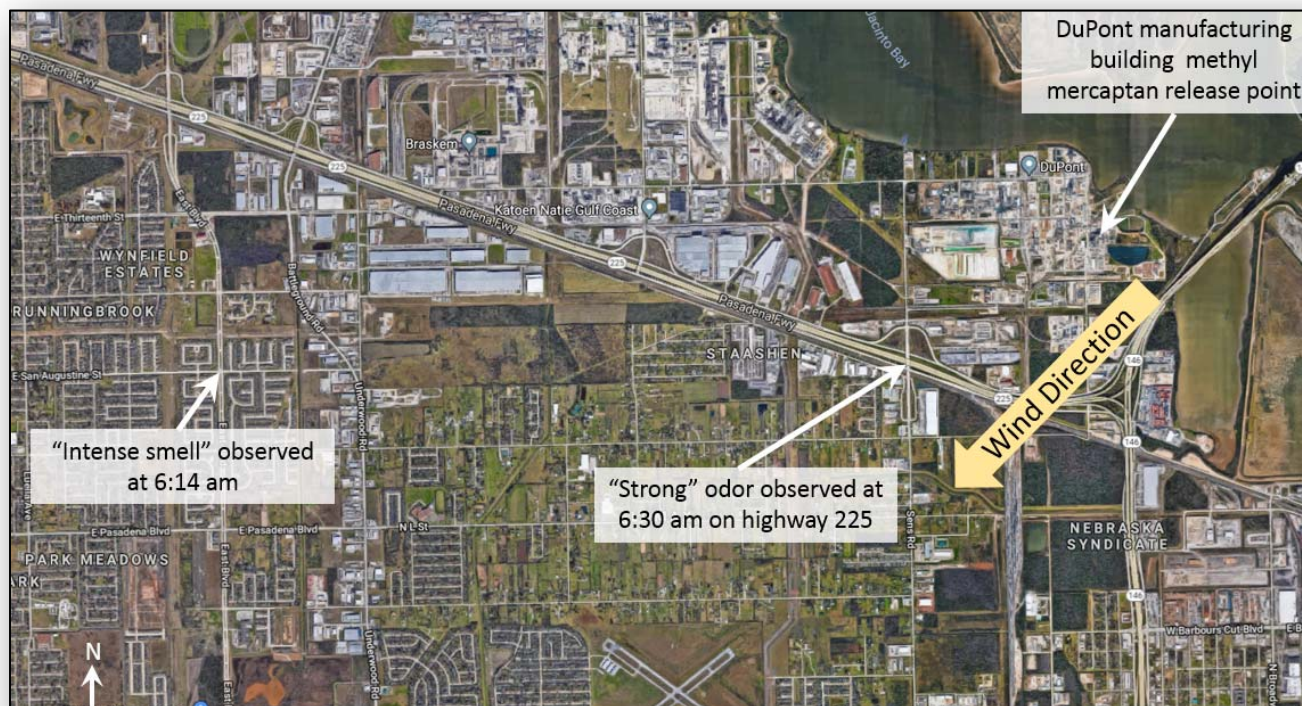
**Figure 8.** Locations Where a Sheriff's Sergeant Reported Strong Methyl Mercaptan Odor During the Incident. Source: Google Earth, with annotations by CSB.

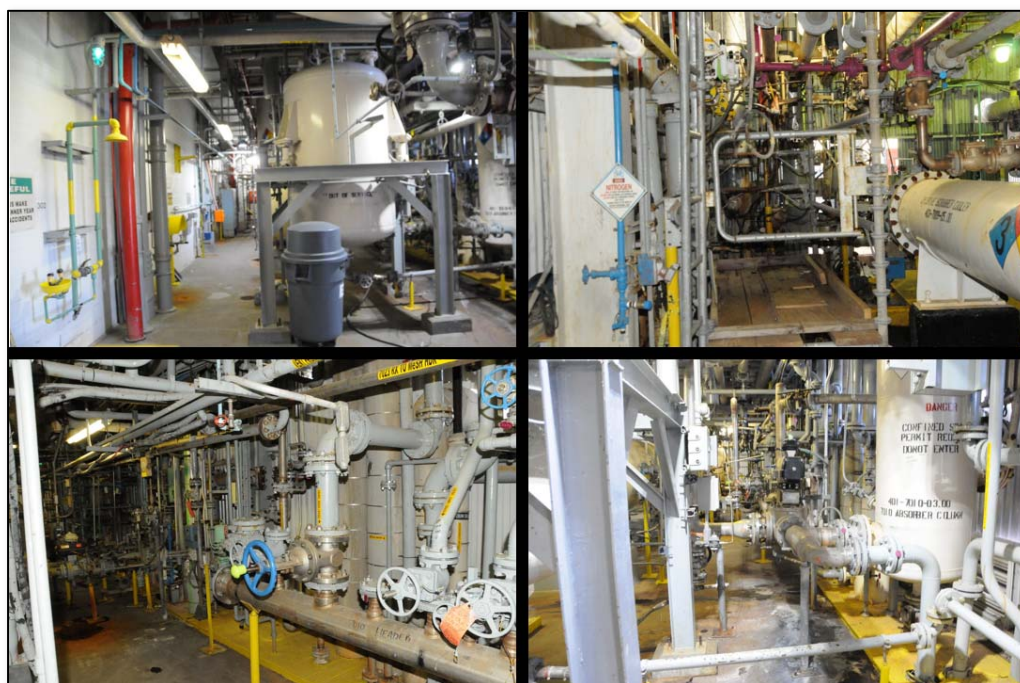
Figure 11. Photos of the Interior of the Lannate® Manufacturing Building. Source: CSB.

Many of the emergency responders searching the manufacturing building worked at the La Porte site as operators in other units or for other companies located there. Some of these responders, therefore, were unfamiliar with the manufacturing building—a four-story building containing a large amount of piping and process equipment, dividing walls, multiple stairwells, and an elevator. Figure 11 shows photos taken inside the manufacturing building, illustrating the complexity of the layout inside the building.

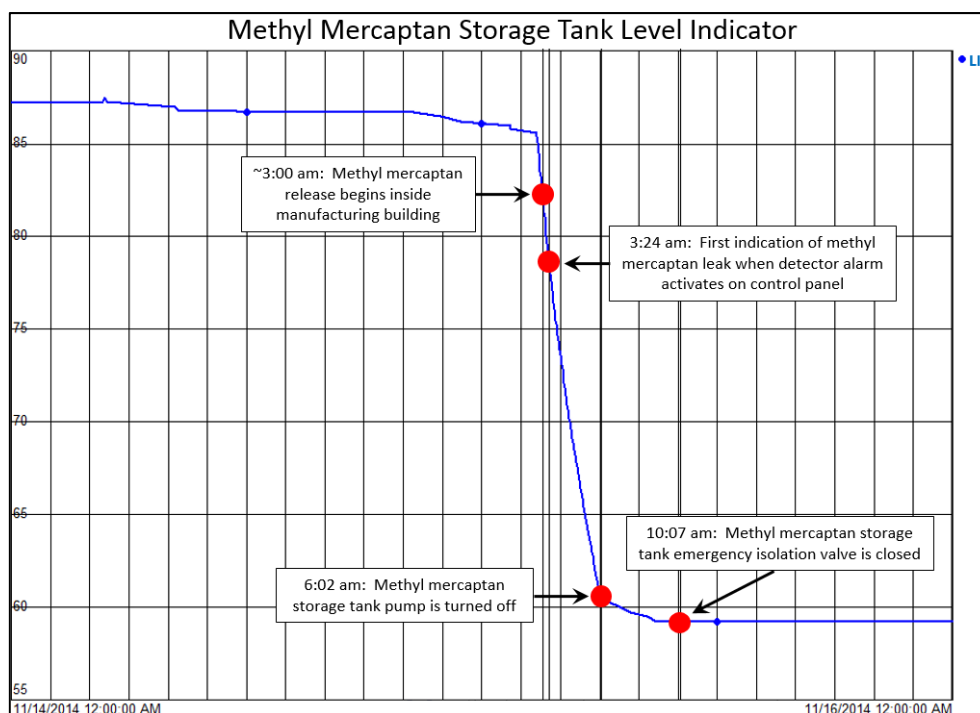
**Figure 14.** Process Data from November 15, 2014. Data shows that methyl mercaptan was abnormally flowing from the methyl mercaptan storage tank. No one analyzed these data during the first hours of the incident. Source: CSB graph based on DuPont data.

1. Personnel did not recognize the need to close the methyl mercaptan storage tank isolation valve when they determined that methyl mercaptan was the chemical being released inside the manufacturing building.
2. No one evaluated process data to determine what was causing the release until hours into the response efforts. Had personnel looked at the process data earlier during the release, it should have been clear that methyl mercaptan was flowing from the methyl mercaptan storage tank, requiring closure of the emergency isolation valve (Figure 14).

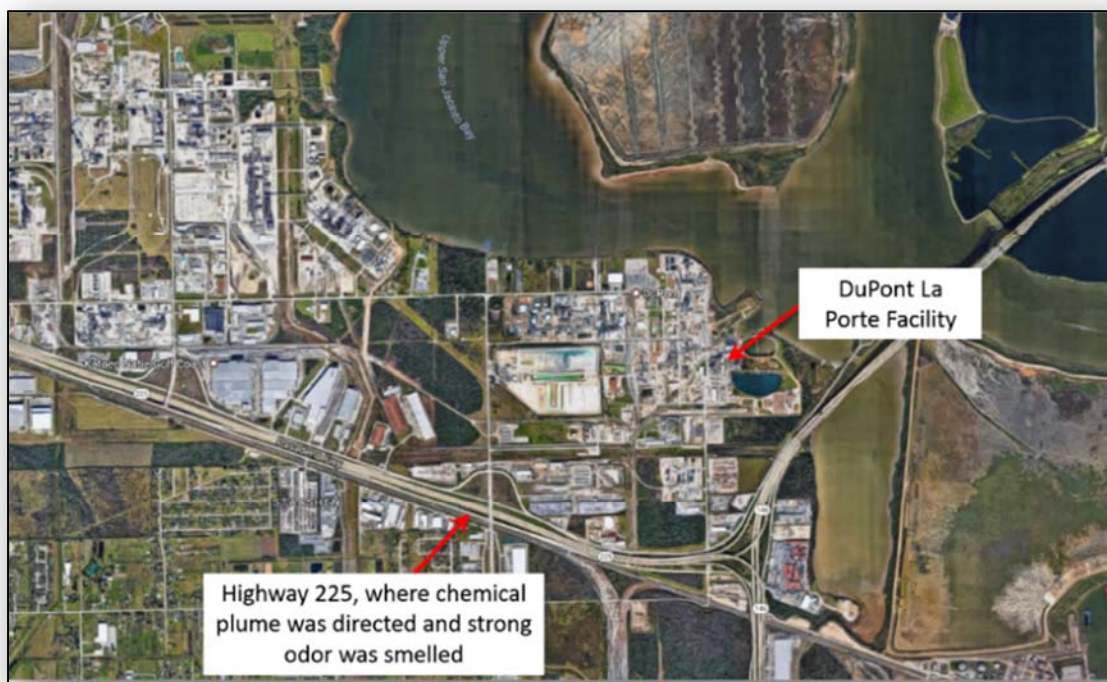
**Figure 16.** Overhead Image of DuPont La Porte Facility. A plume of methyl mercaptan left the DuPont property in a southeasterly direction toward a major highway and residential area. Source: Google Earth, with annotations by CSB.

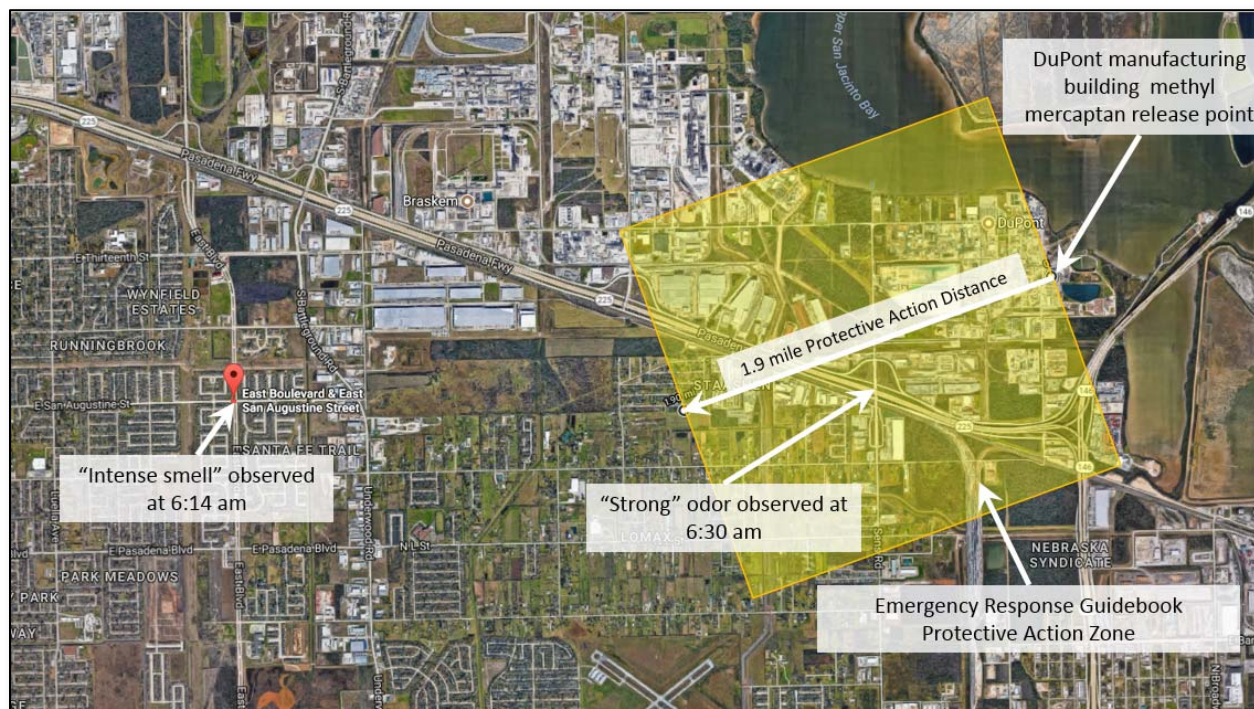
**Figure 17.** Overhead Image of DuPont La Porte Facility with Recommended Downwind Protection Zone (Shown in Yellow) Based on the 2016 *Emergency Response Guidebook* [12, p. 297]. Downwind sections of Highway 225 and residential areas were within the area recommended for public protection from a methyl mercaptan chemical leak. Source: Google Earth, with annotations by CSB.

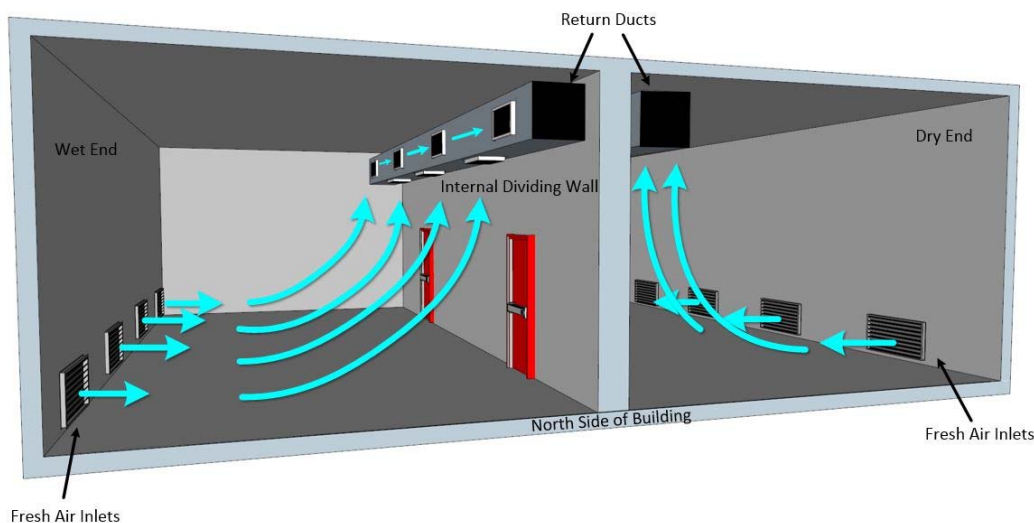
**Figure 27.** Simplified Graphical Representation of a Typical Floor of the Manufacturing Building. It shows how fresh air was pulled in from the outside walls, swept across the floor, and entered the exhaust return air ducts on each side. Source: CSB.

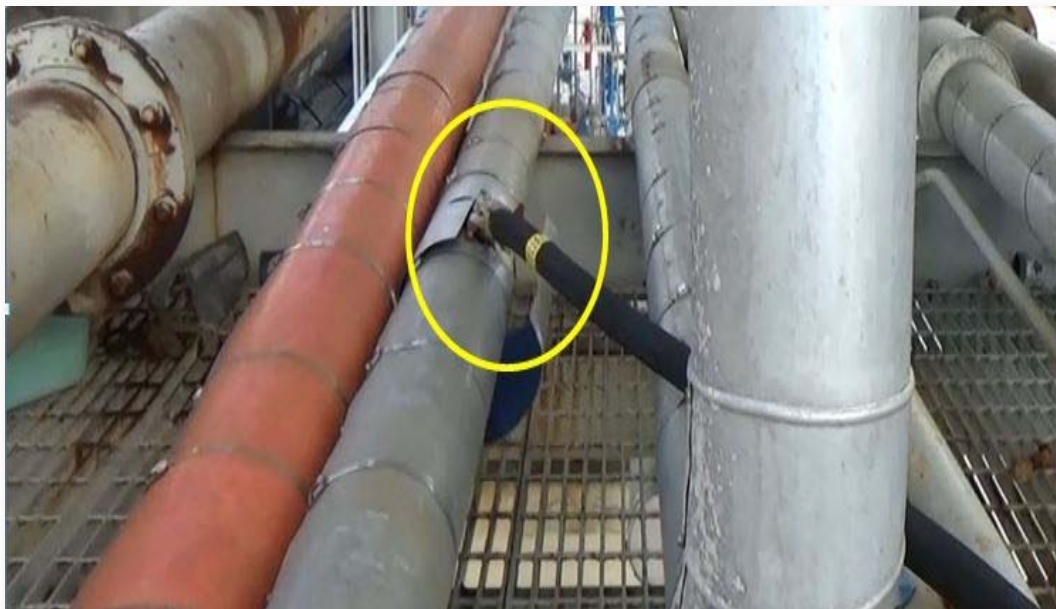
**Figure 30.** Hot Water Hose Positioned on the Liquid Methyl Mercaptan Feed Piping. Hot water flowed between the piping and the insulation to heat the piping and dissociate the solid hydrate that had formed after water inadvertently entered the methyl mercaptan storage tank. Source: CSB.

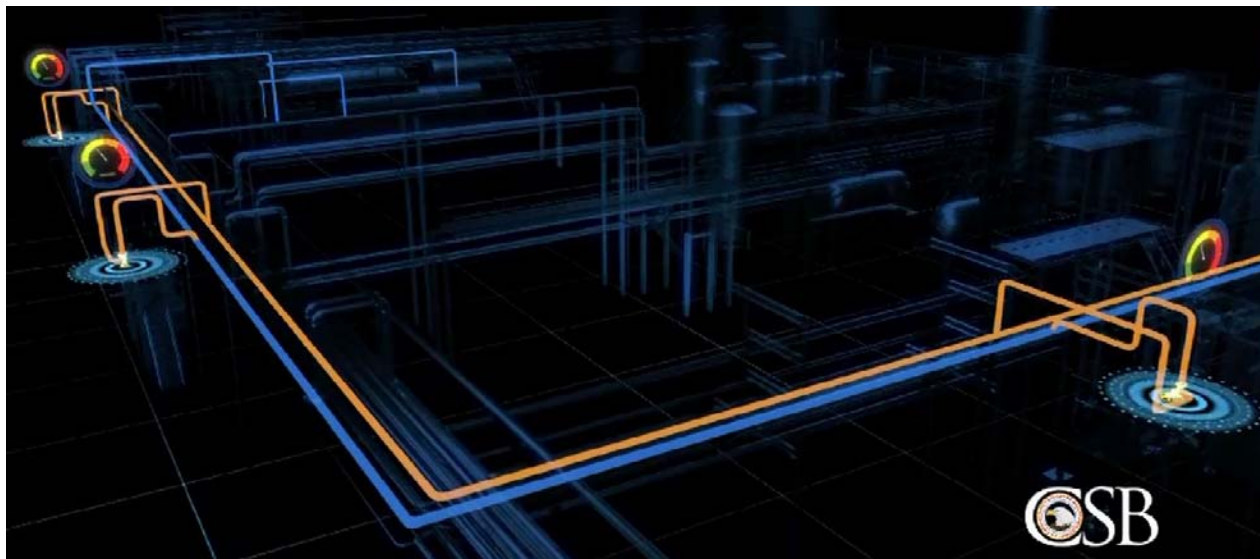
**Figure 31.** Excerpt from CSB Animation. It depicts the three locations where valves connected the methyl mercaptan feed piping (blue) to the waste gas vent header piping (orange). Workers used the pressure gauges shown at these locations to monitor the progress of clearing the hydrate blockage inside the methyl mercaptan feed piping. Source: CSB.

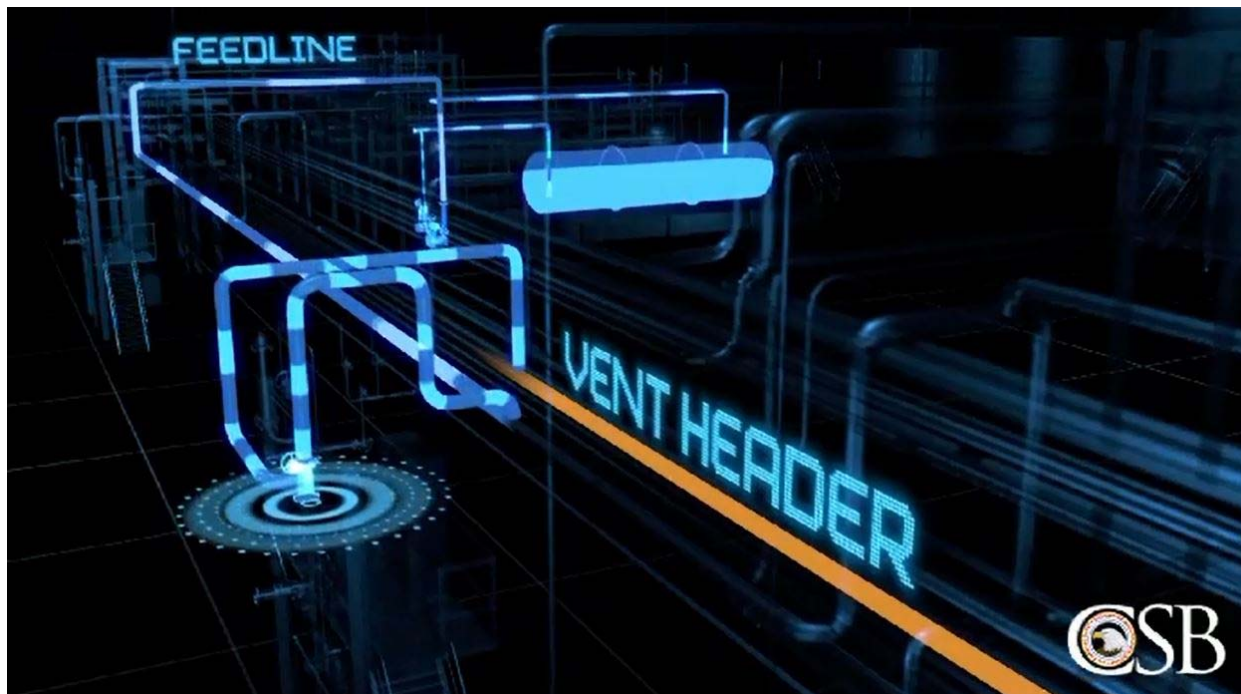
**Figure 32.** Excerpt from CSB Animation. It depicts the piping arrangement that allowed liquid methyl mercaptan from the feed line (blue) to flow into the waste gas vent header piping (orange). Source: CSB.

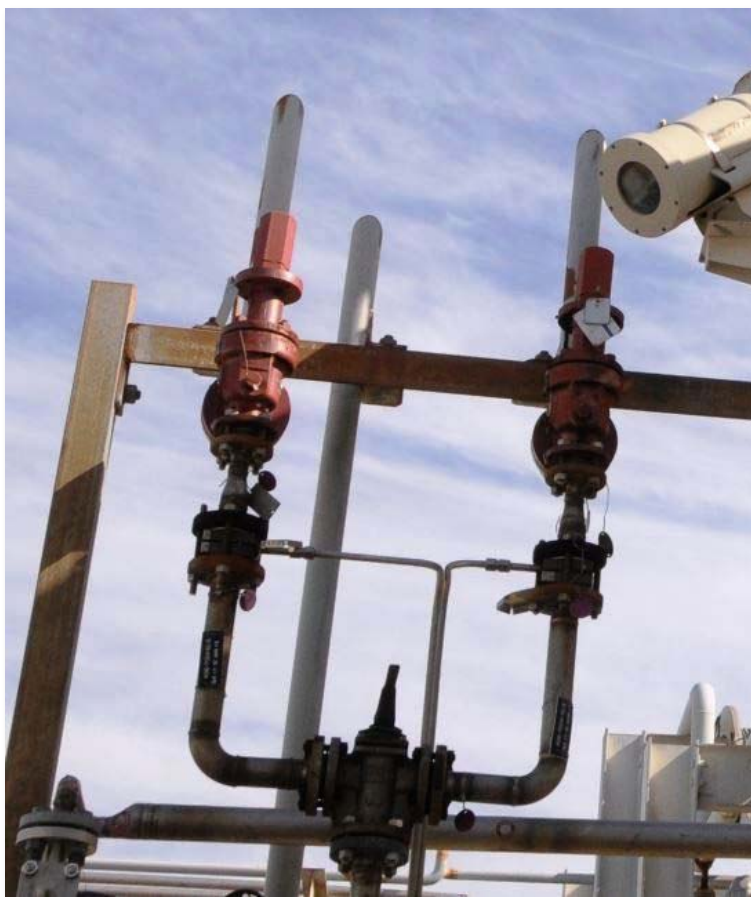
**Figure 33.** Nitrogen Relief Valves at One of the Two Methyl Mercaptan Railcar Unloading Stations. DuPont PHAs and relief valve design documents never considered the possibility of lining up the methyl mercaptan storage tank pumps to these relief valves—as they were at the time of the incident. As a result, liquid methyl mercaptan was discharged from a system designed for nitrogen vapor. Source: CSB.

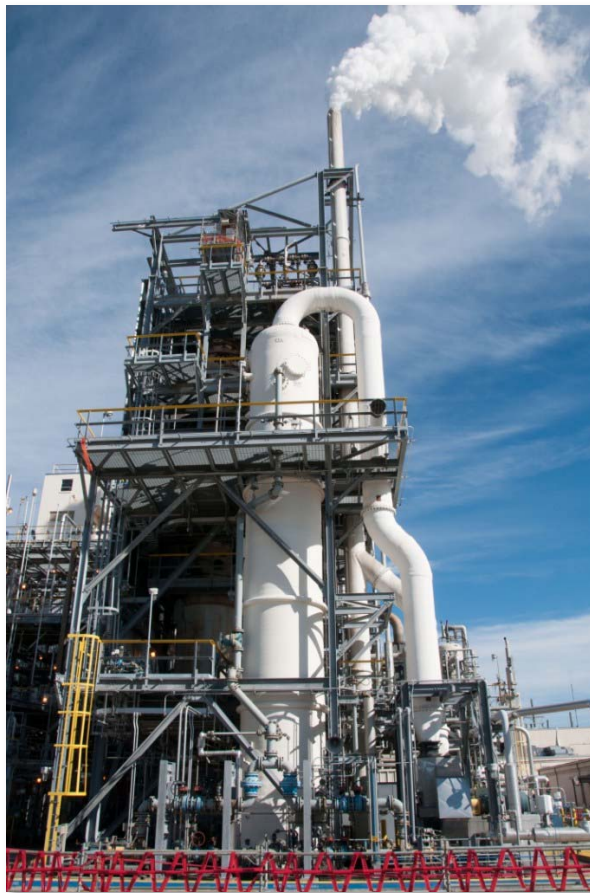
**Figure 34.** NRS Incinerator. NRS was installed in 2011 to reduce emissions and allow increased production at the DuPont La Porte facility. Source: CSB.

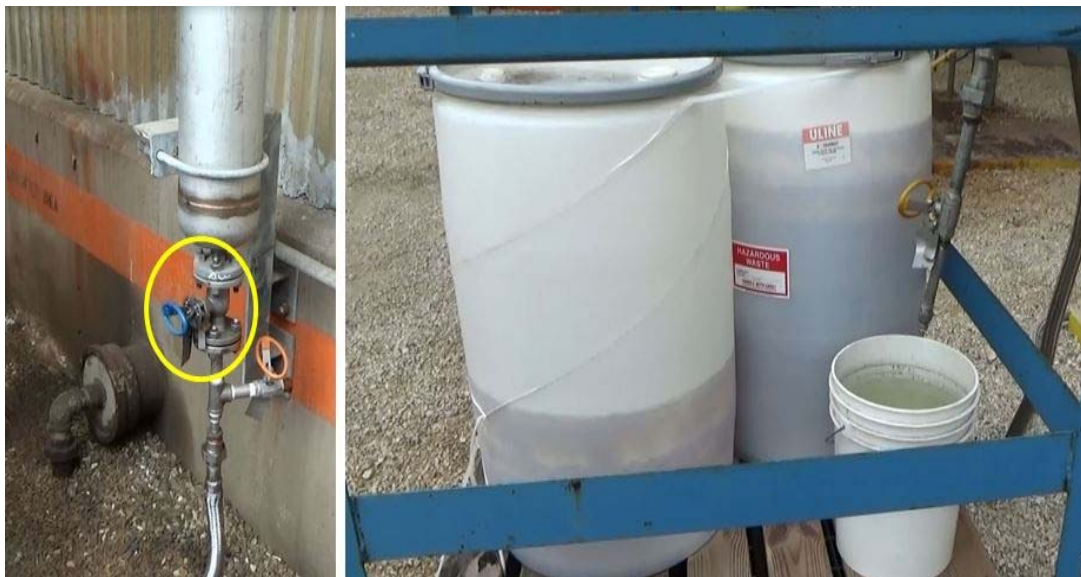
**Figure 37.** Photo Showing Another Line Break. Operators drained liquid accumulation in another vent header without using line-breaking procedures. Source: CSB.

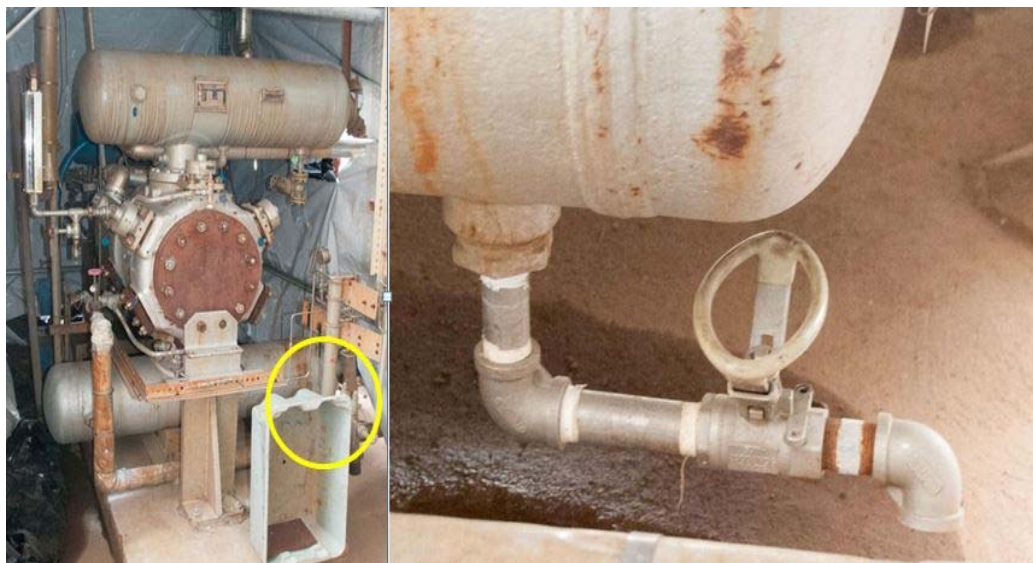
**Figure 38.** Methylene Chloride<sup>a</sup> Compressor. Photo shows where operators routinely drained liquid accumulation from a methylene chloride compressor without using line-breaking procedures. Source: CSB.

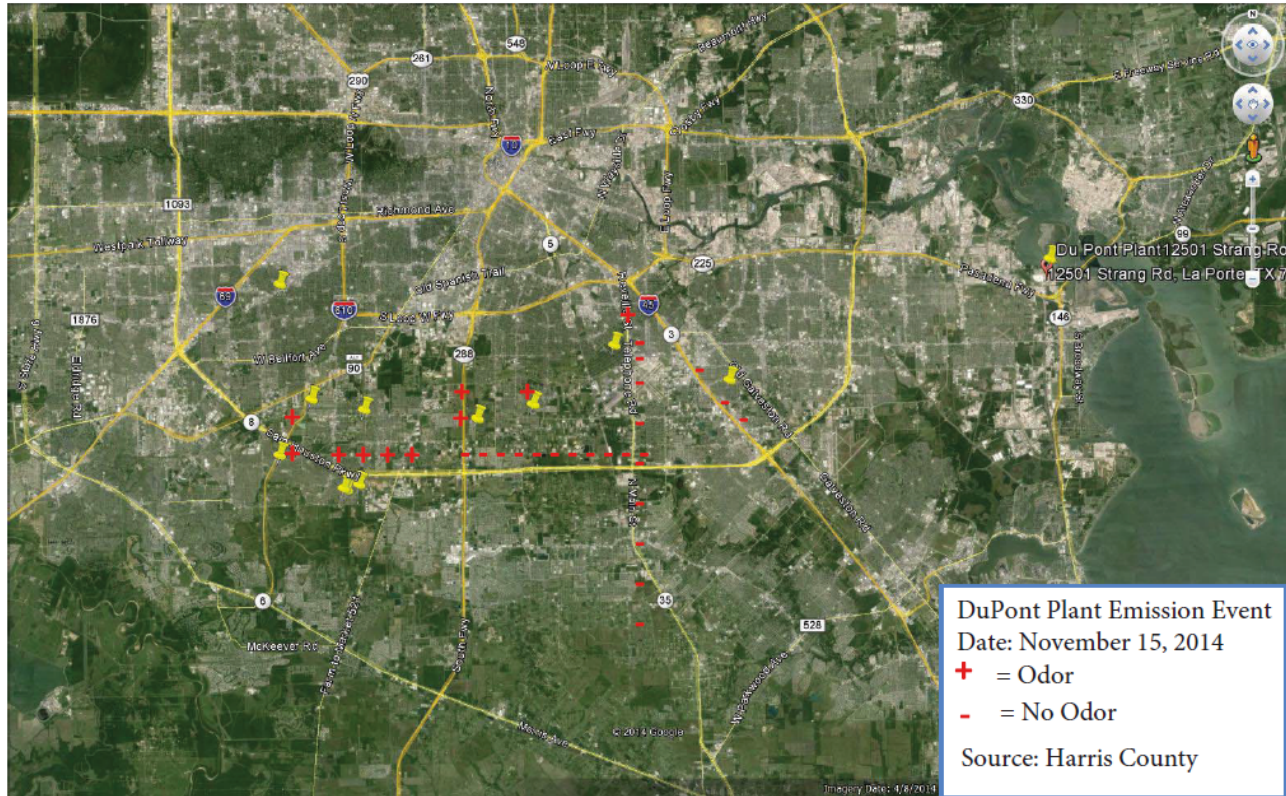
Figure 40. Map of the Odor Complaints (Yellow Pins) from the November 15, 2014 Incident. Source: Harris County, Texas.
