MEMO

SUBJECT: Conceptual Modes of Failure of the West Seattle High Bridge

DATE: May 15, 2020

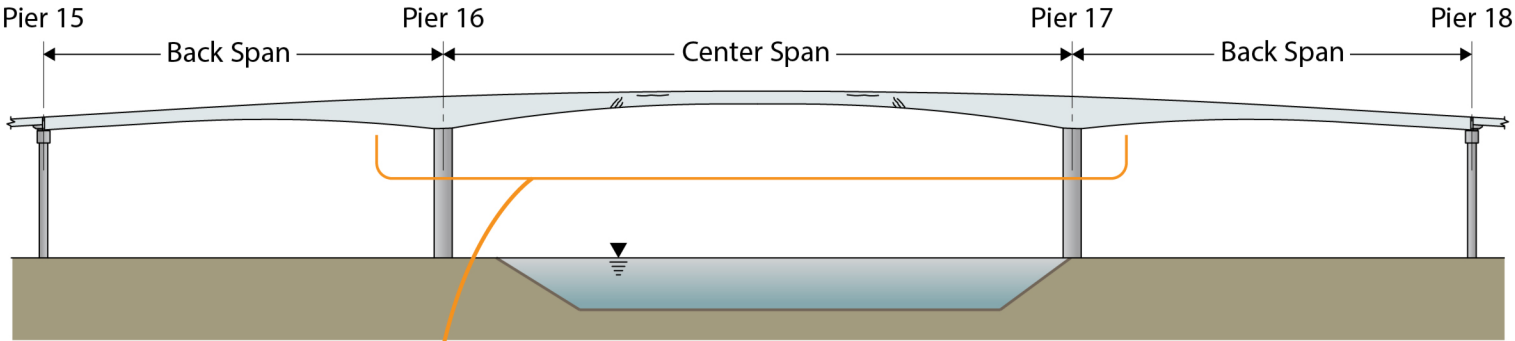
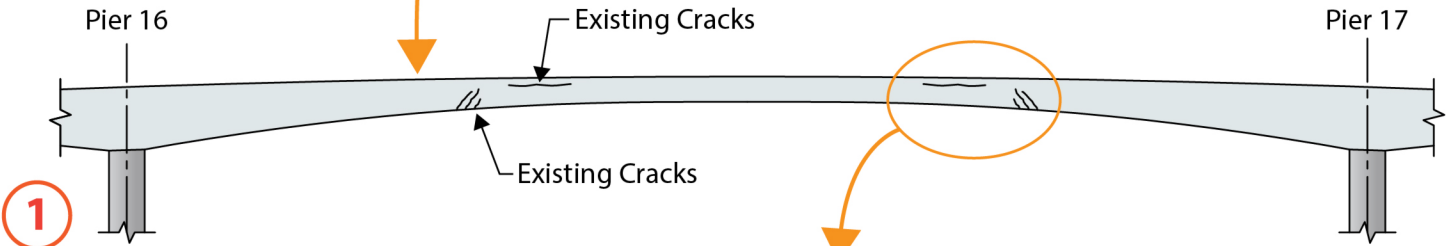
Elevation - Existing Bridge

The bridge is currently exhibiting progressive crack growth at two critical locations (Joints 38) of the four quarter points of the twin-box main span between Pier 16 and Pier 17. This is where the first failure mechanism has appeared. While a progressive failure does not mean collapse is imminent, it does illustrate an unintended redistribution of forces within the bridge that could lead to further damage.

Main Span Failure Scenario

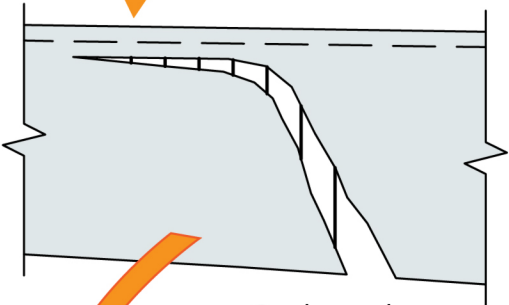
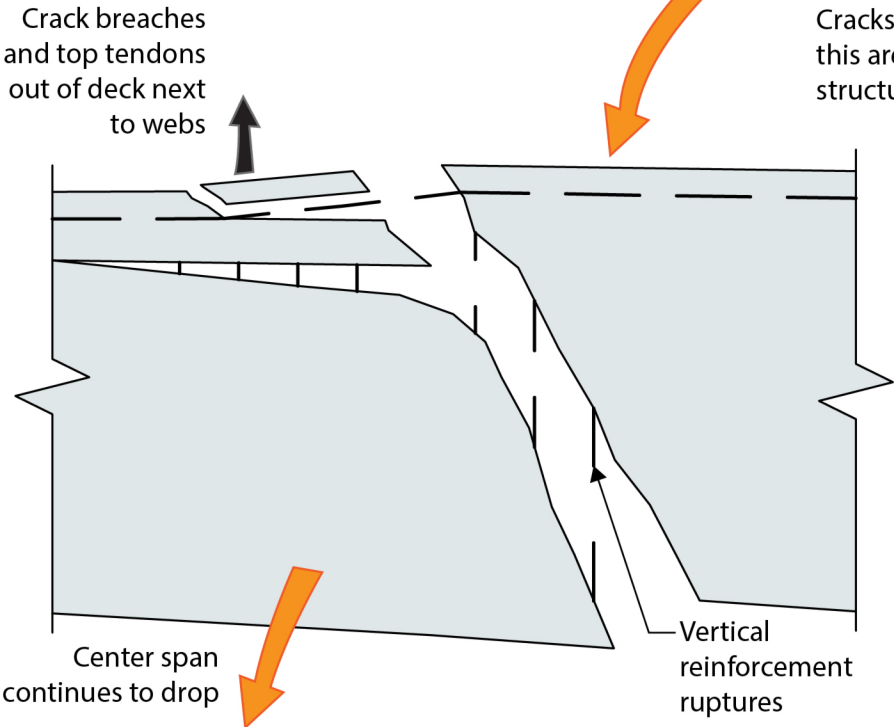
The cracks have opened and propagated where the internal reinforcement has yielded (stretched) but has not broken. The cracks, without any mitigation, could stop, and the bridge could redistribute load until internal forces stabilize. However, this is not considered likely as the bridge will continue to creep (slowly deform under static load) over time and thus continue to crack.

Cracks weakens this area of the structure

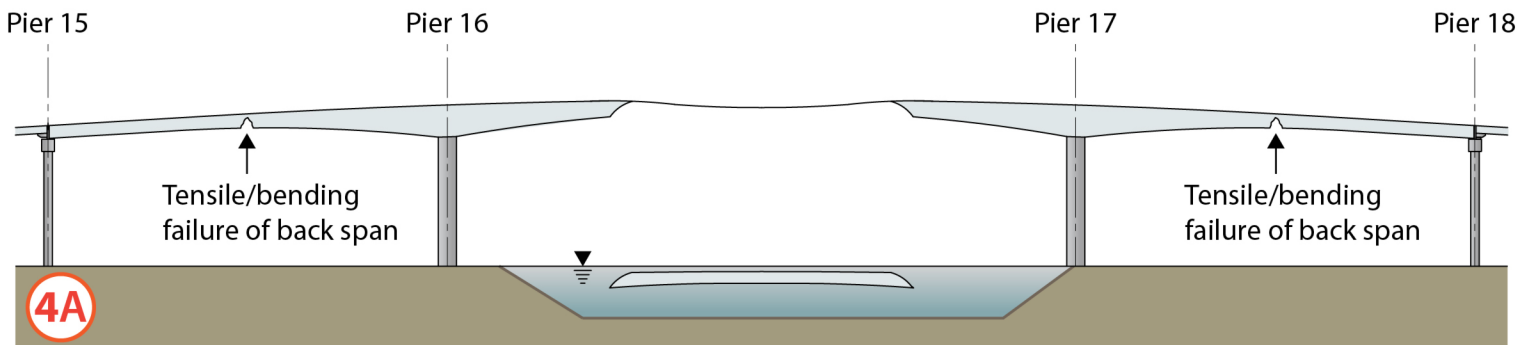
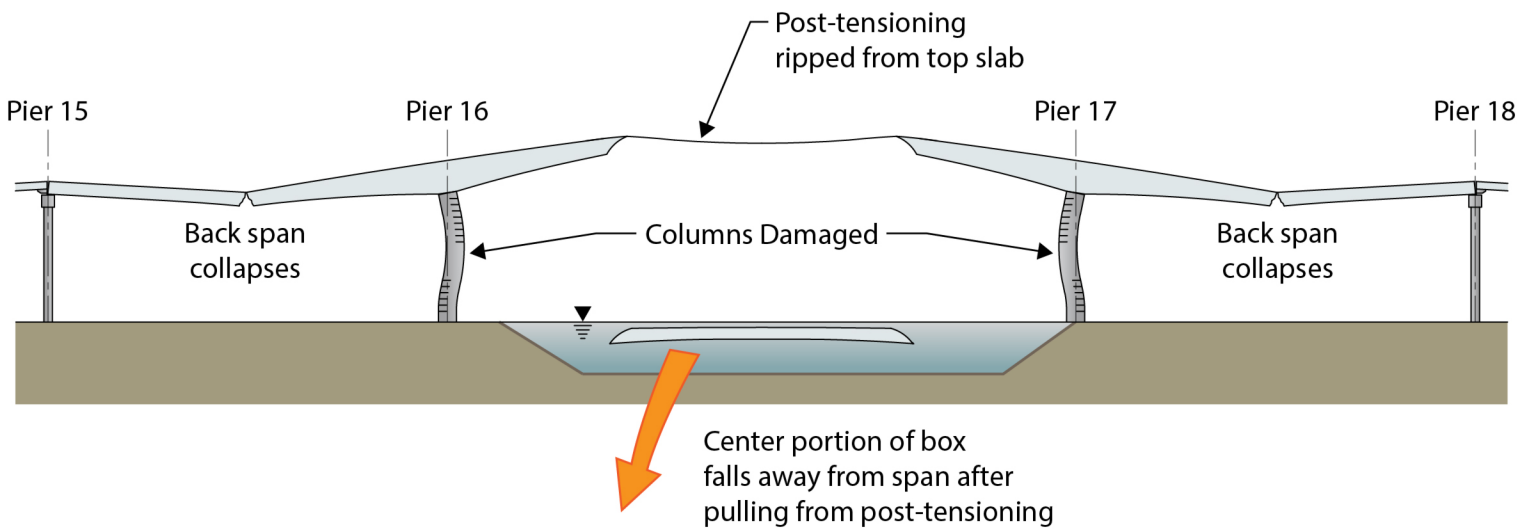
Symmetric Bridge Failure Scenario

The second mode could occur in one of two ways. One scenario is symmetrical, in which pieces of concrete detach and begin falling from the bridge at both critical locations. The distress could continue simultaneously with a portion of the main-span bridge box girders separating and falling into the waterway below. It is possible that due to arching effects, portions of the deck remain but in severely deflected state.

In both scenarios it is possible to load the columns with unbalanced loads, creating damage in the columns. It is also likely that tensile or bending damage to the back spans between Piers 15 and 16 and Piers 17 and 18 would occur due to the removal of beneficial balancing load from the center span.

Both second mode of failure scenarios would require the bridge to be either partially or completely demolished. The remaining portions of bridge superstructure and foundations may be salvageable if they sustain no or minor damage.

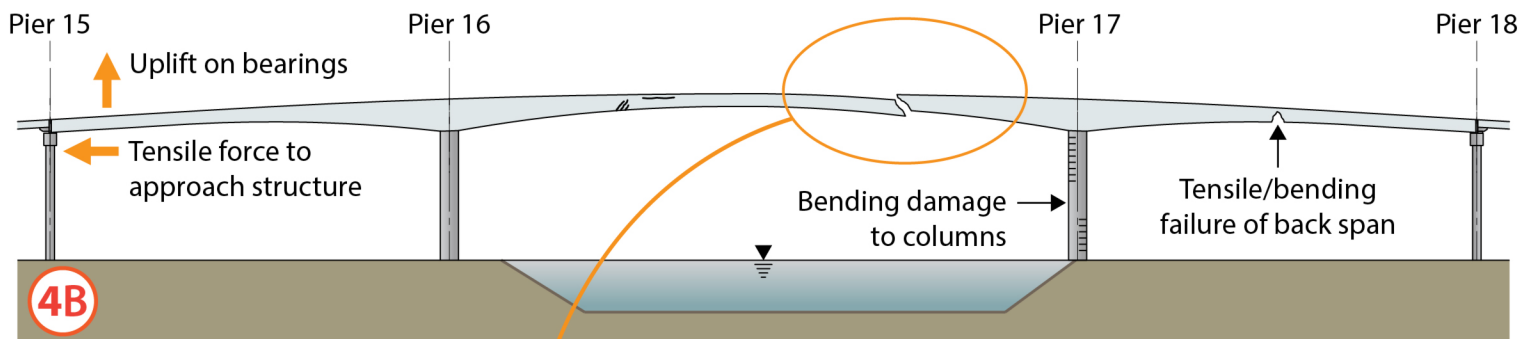
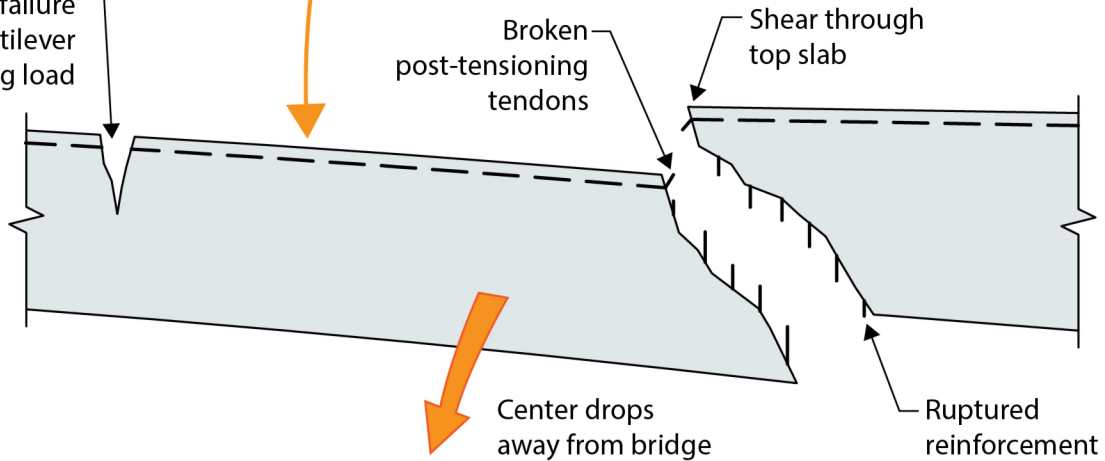
Asymmetric Bridge Failure Scenario

The other partial collapse scenario is an asymmetrical collapse, in which pieces of concrete at one location detach and begin falling from the bridge, and then a shorter portion of the main-span bridge box girder separates and falls below. This would result in an unbalanced condition, with overloading of the long cantilever extending out from the opposite pier.

Not long after joint at right breaks, tensile/bending failure of longer cantilever breaks, relieving load
