## OBSERVATION REPORT

PARKSIDE I AND II, ELDERLY HOUSING

BRANFORD HOUSING AUTHORITY

DB FILE 9693

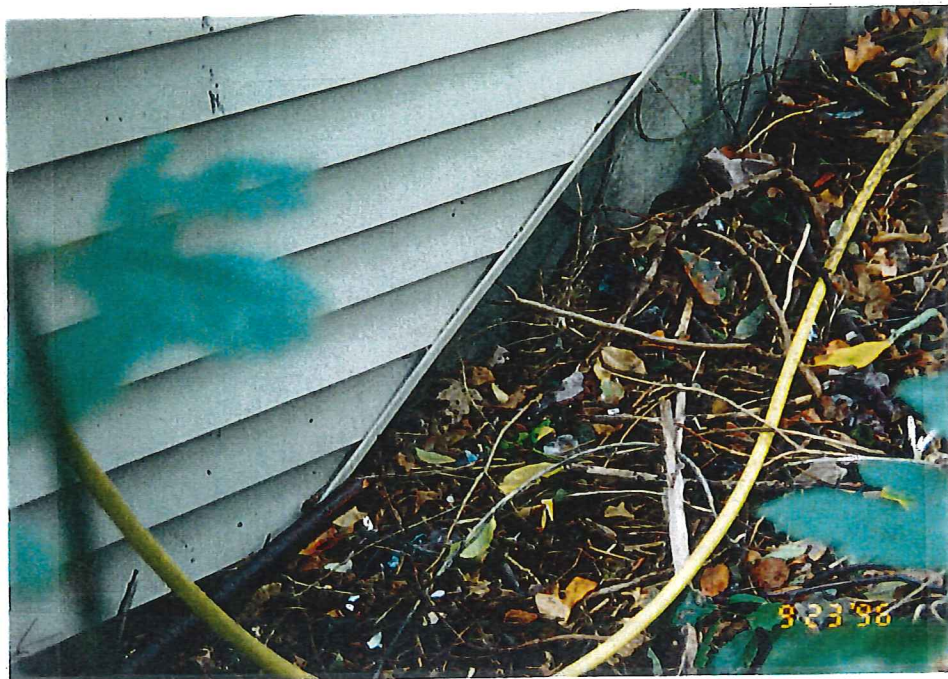
HIGH GRADE AT PRIMARY STAIR ENCLOSURE.

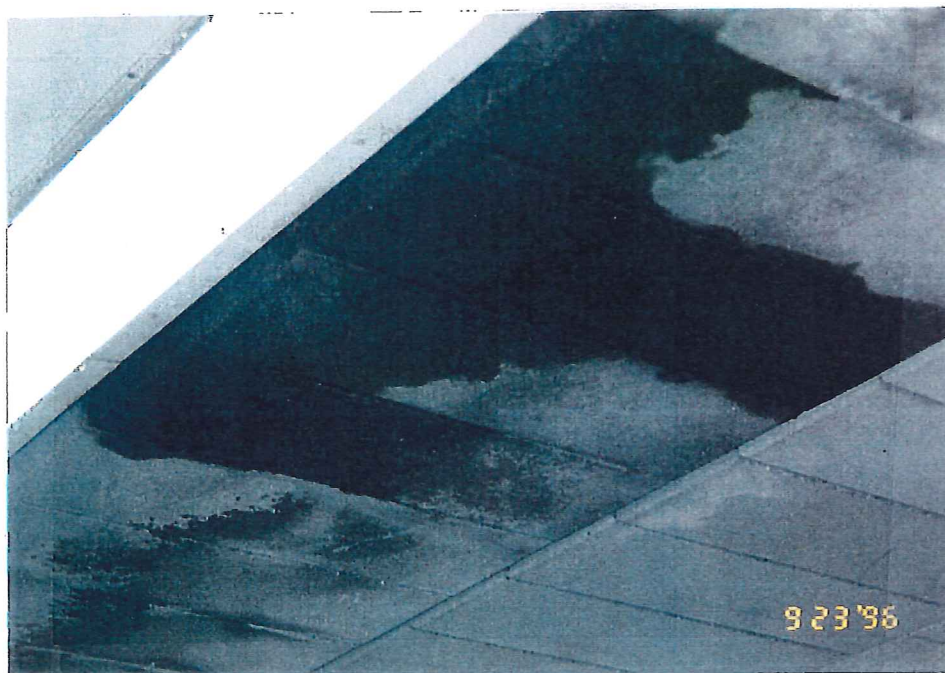
STAINS ON WALKWAY SOFFIT,  
FROM WATER WHICH RUNS  
OVER EDGE.

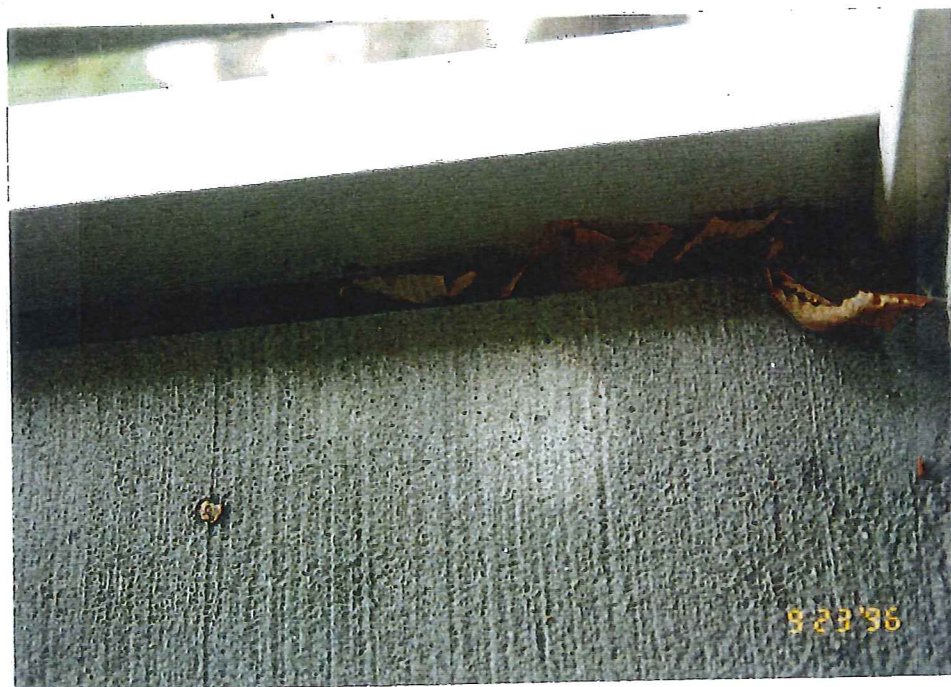
SAME, SEEN FROM ABOVE.

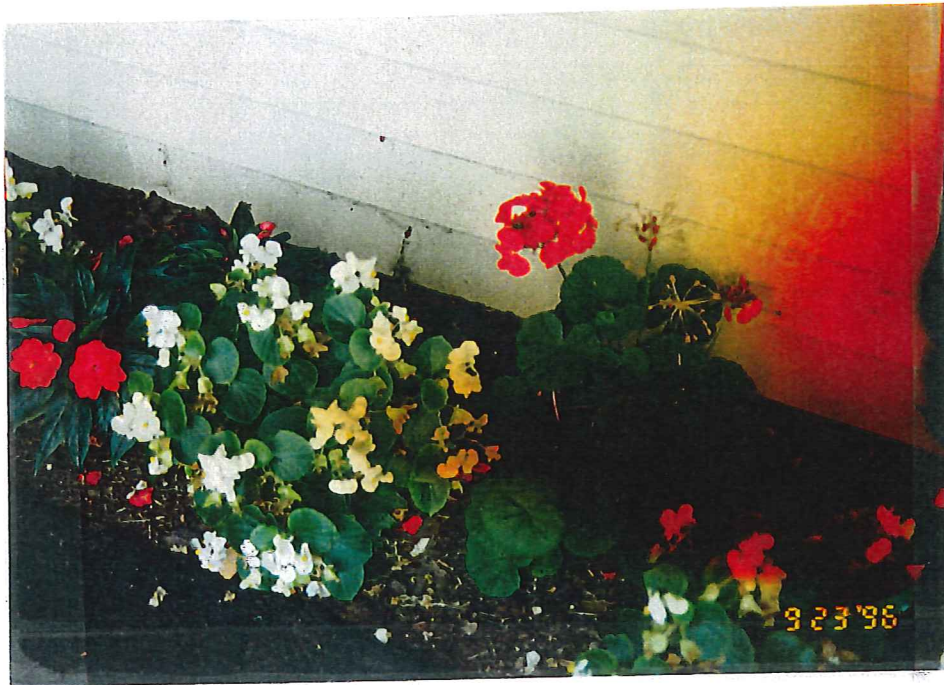
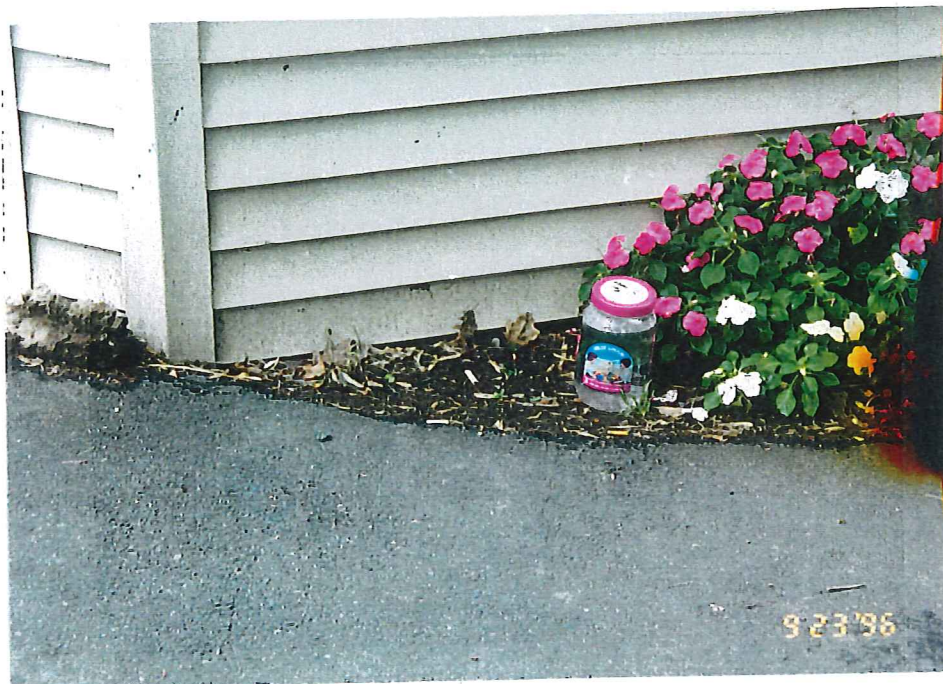
SIDING EXTENDS DOWN TO & BELOW GRADE; NICE  
FLOWERS.

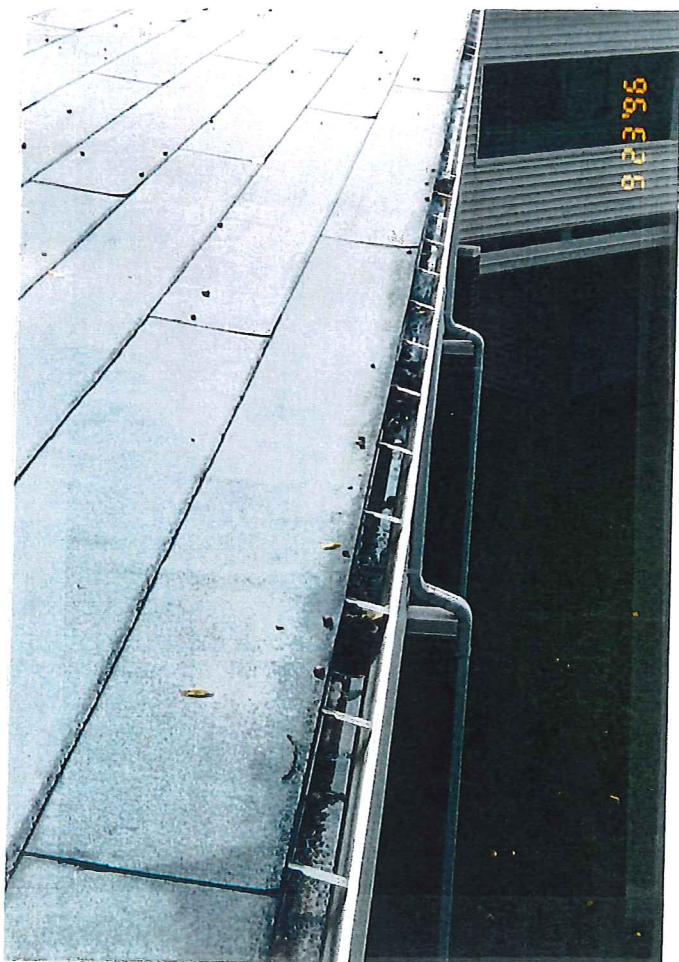
ROTTED DEBRIS IN GUTTER.

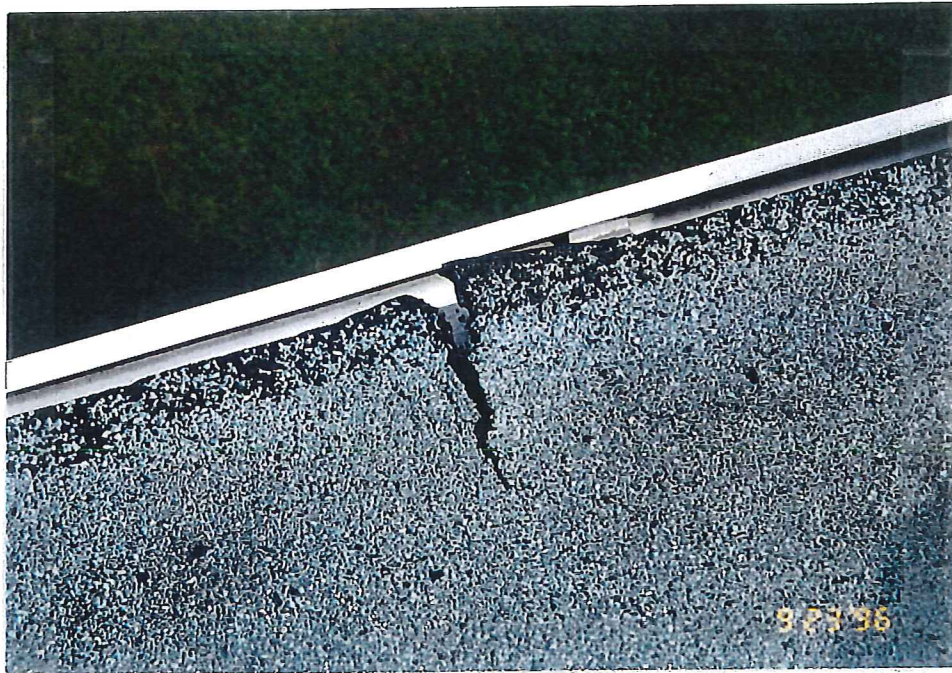
TEARS IN ROOFING.

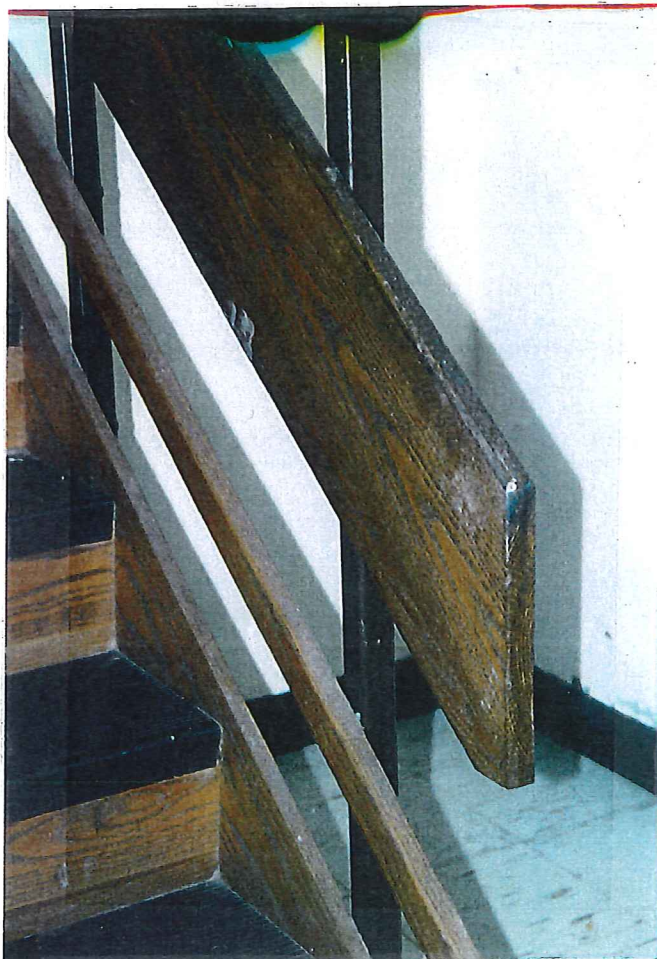
STAIR RAILS NOT ERGONOMICALLY CORRECT; VERTICAL BARS PREVENT CONTINUOUS GRIP ON HANDRAIL.

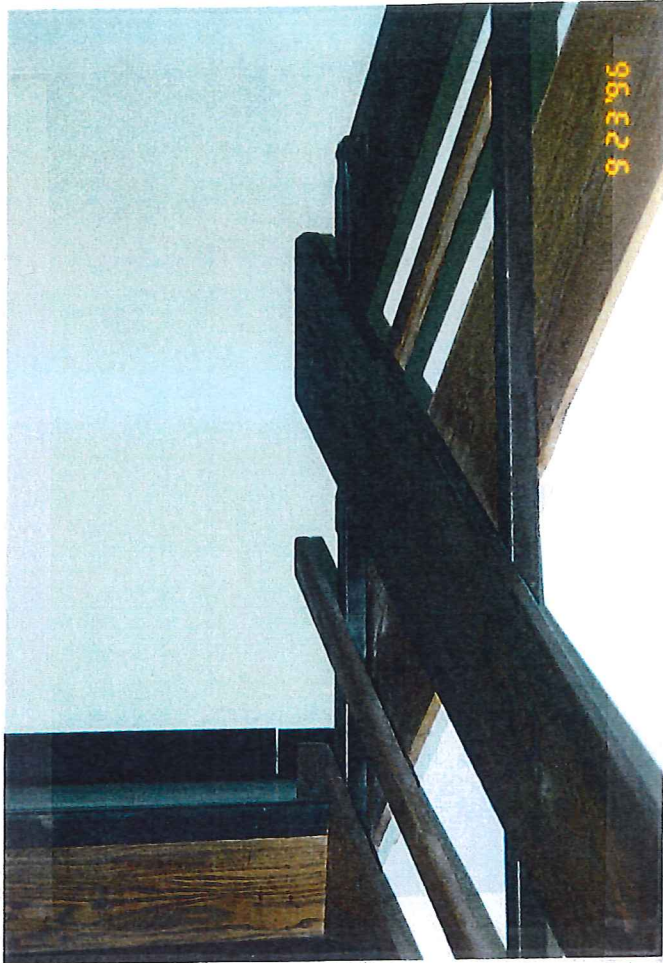
← STAIR RAILS NOT  
ERGONOMICALLY CORRECT;  
VERTICAL BARS PREVENT  
CONTINUOUS GRIP ON  
HANDRAIL.

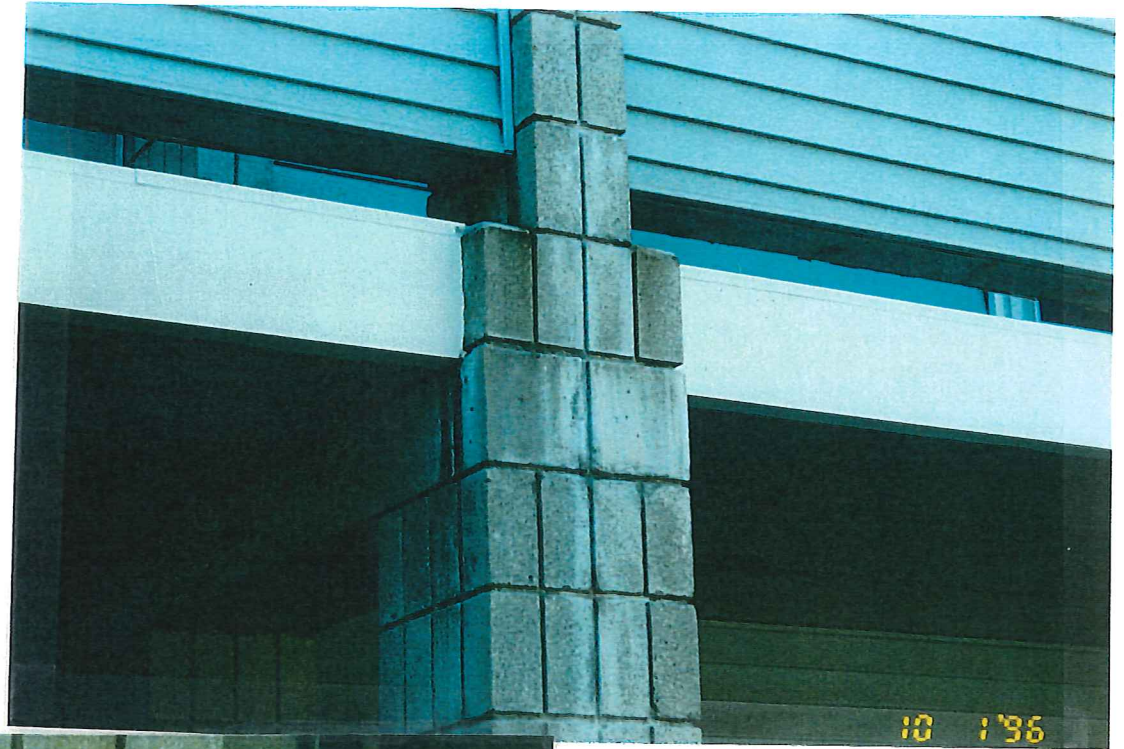
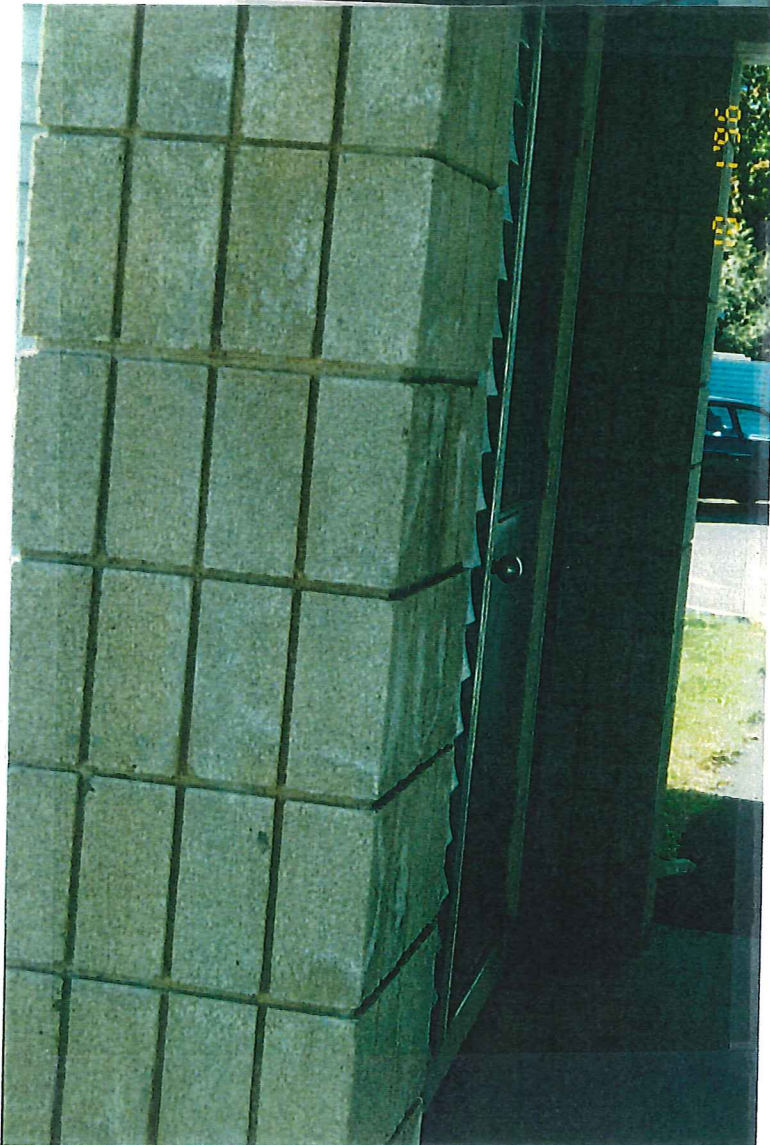
MINOR EFFLORESCENCE AT  
MASONRY PIERS.

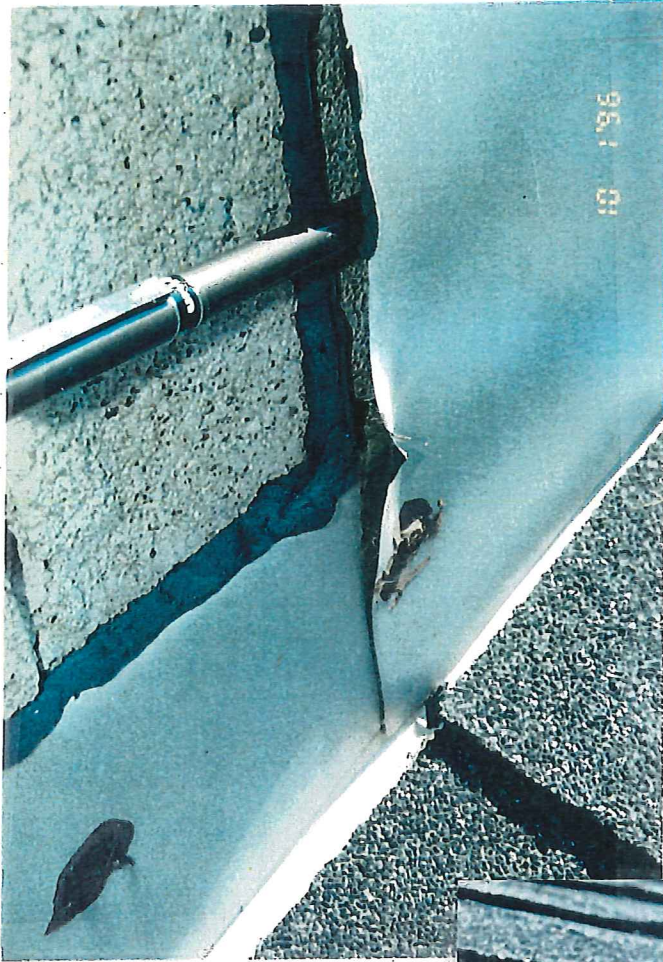
SEALANT IS AT SURFACE  
ONLY.

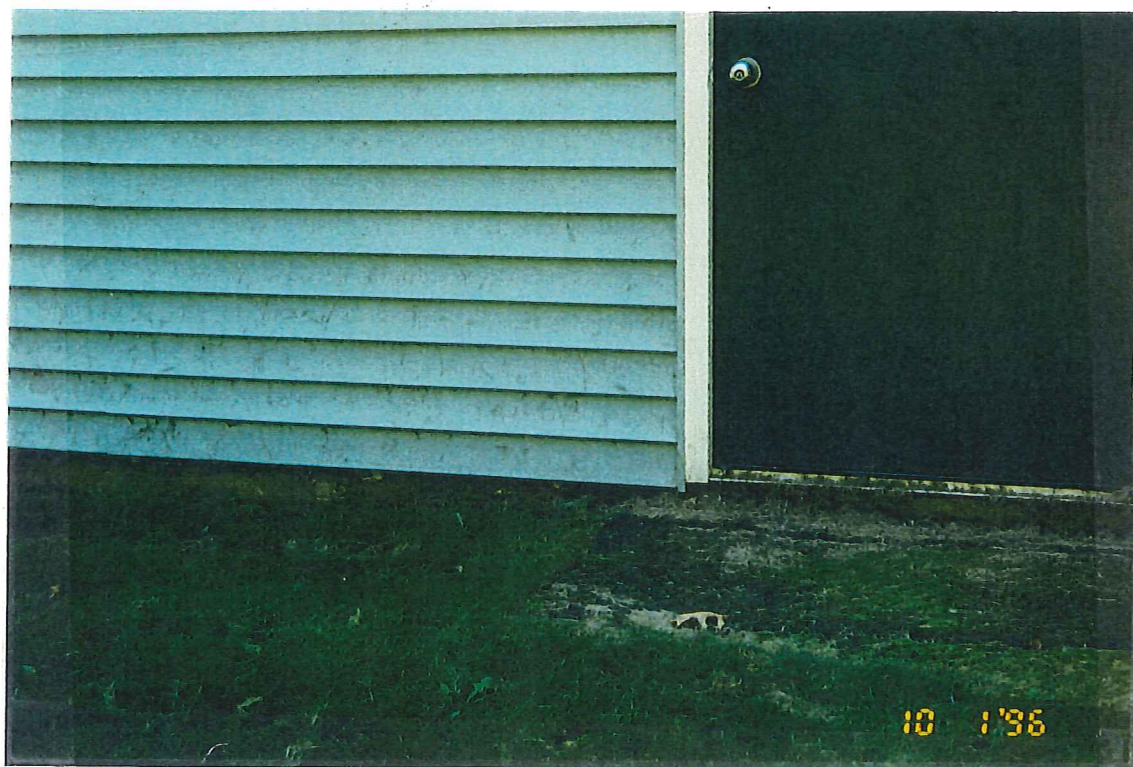
GRASS CUTTINGS ALL OVER DOOR & SIDING.
