EXISTING FACILITY ASSESSMENT

at THE ALFRED C. PRIESTLEY SCHOOL New Orleans, Louisiana

Waggonner & Ball *Architects* New Orleans, Louisiana

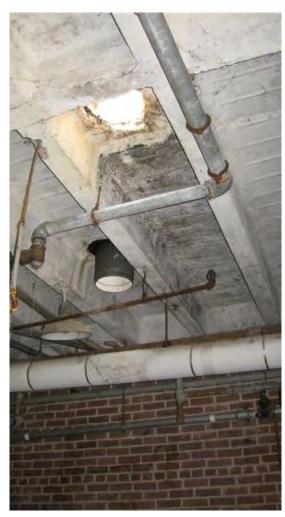
A119 Typical Exposed Sprinkler and Electrical at Cafeteria

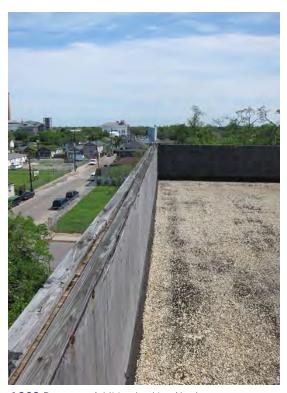
A201 Roof Looking South

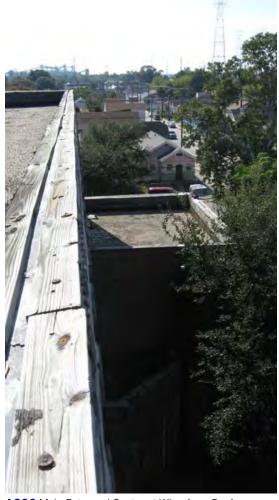
A209 Roof at Main Building
