# **Preliminary Root Causes Analysis of Failures of the Oroville Dam Gated Spillway**

R. G. Bea

Center for Catastrophic Risk Management  
University of California Berkeley  
April 17, 2017

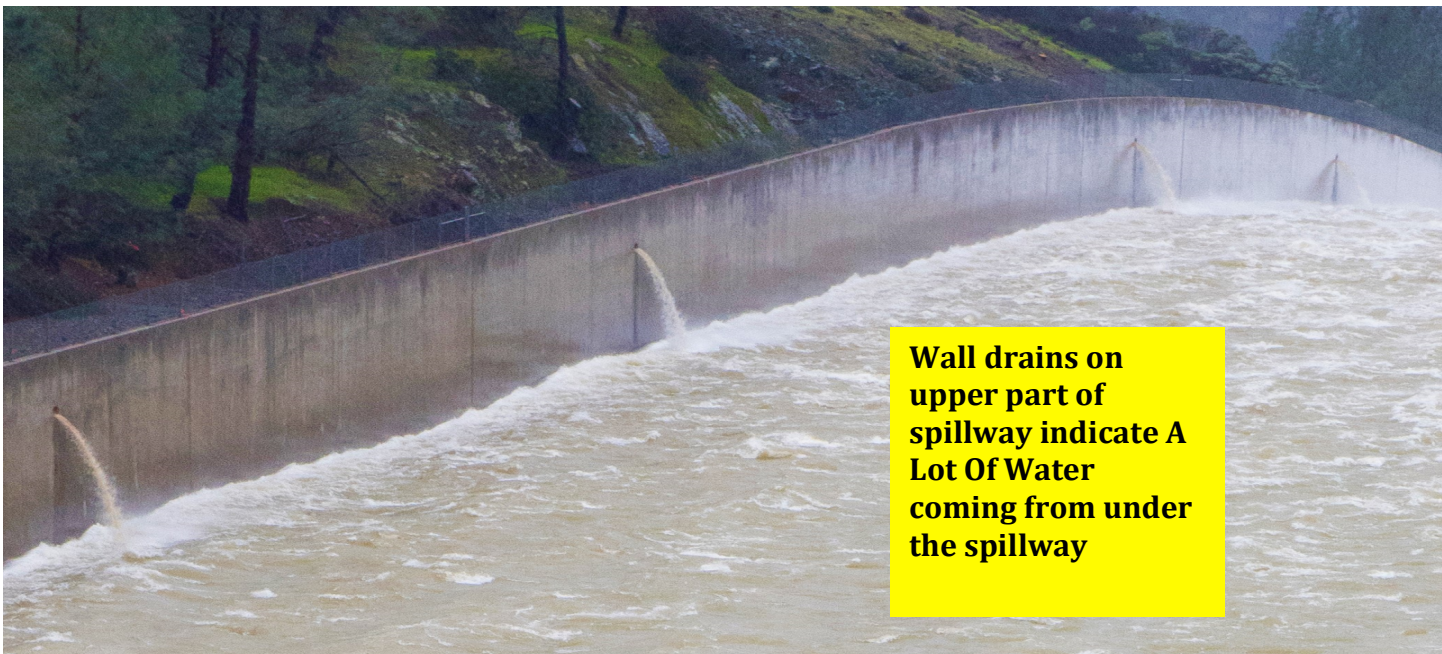
**Wall drains  
emptying water  
collected from  
under spillway**

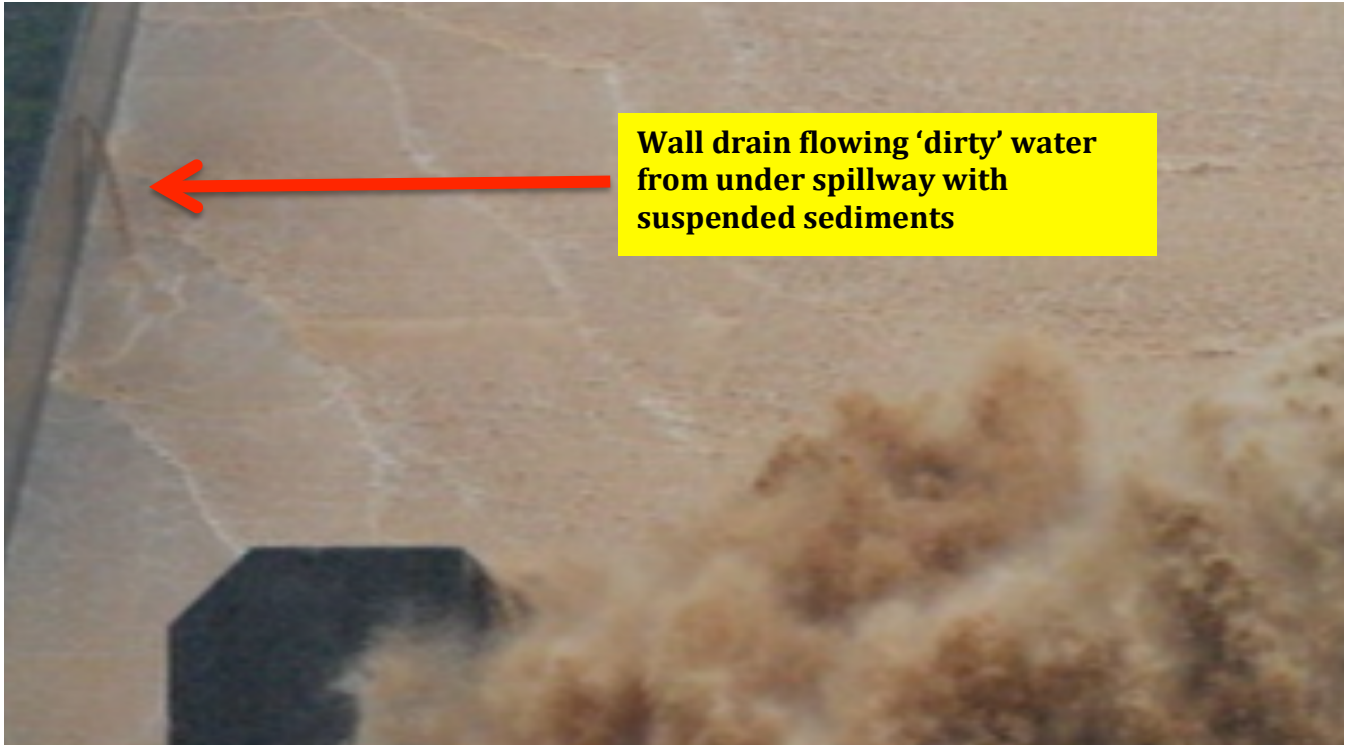
**Two streams of 'dirty' water indicating more exposed erodible sediments under chute slabs**

**Dirty water exiting from lower sidewall drains**

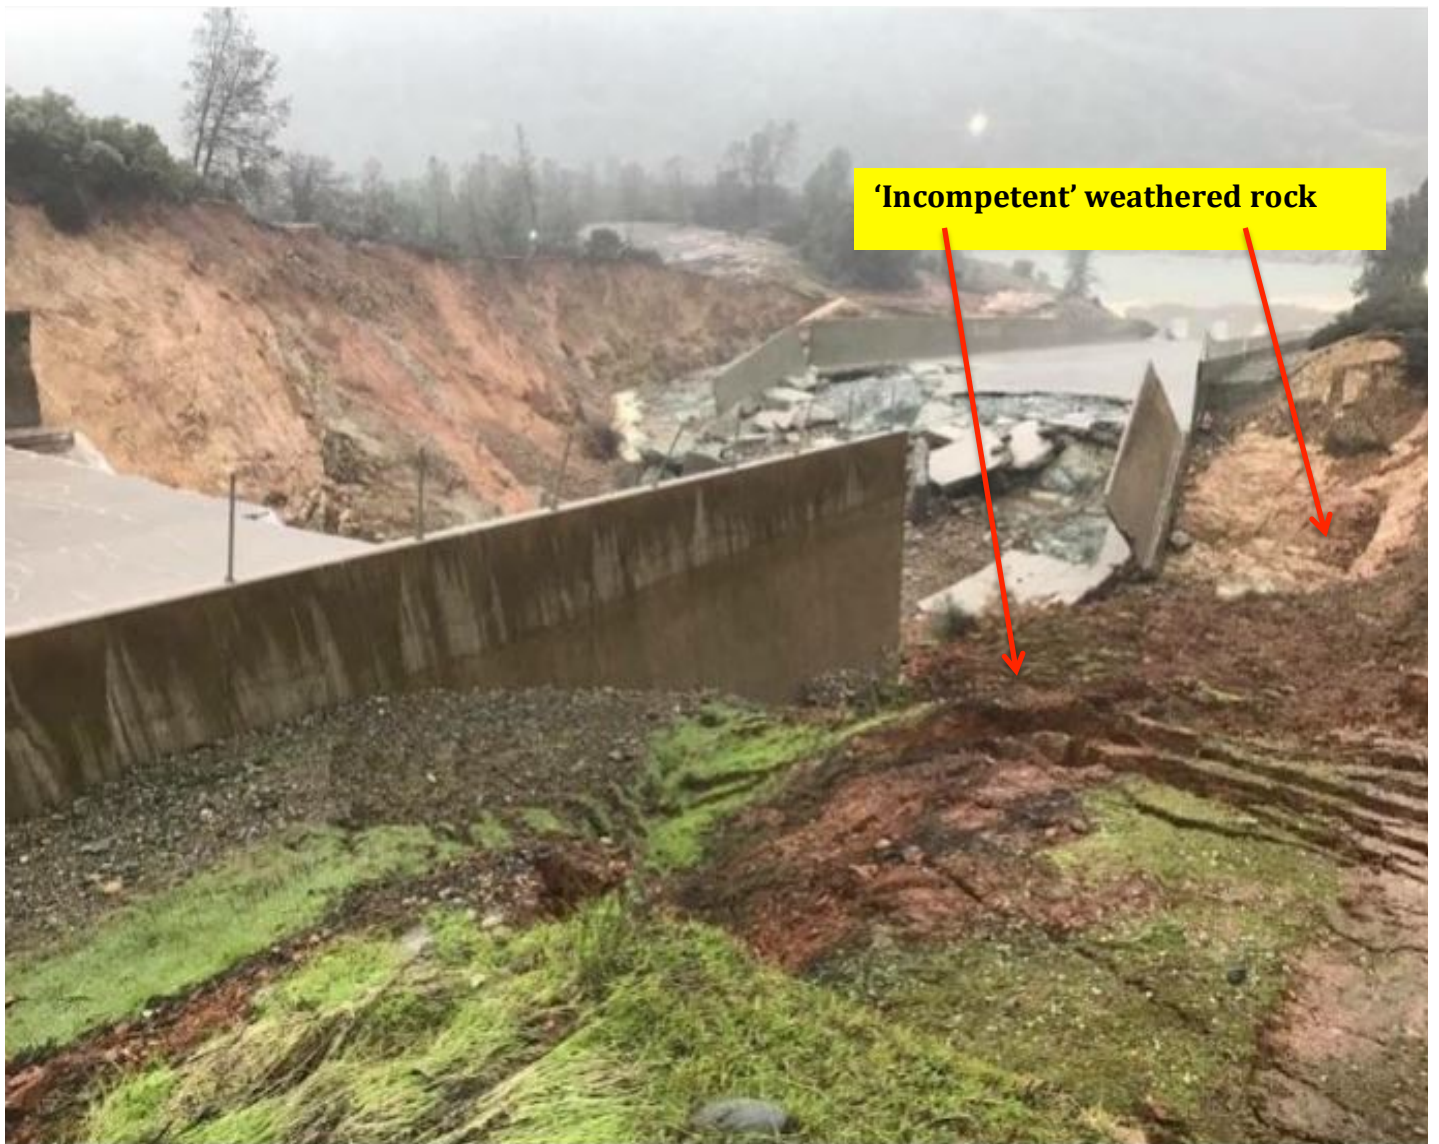
**'Incompetent' weathered rock**

**'Competent' non-weathered rock**

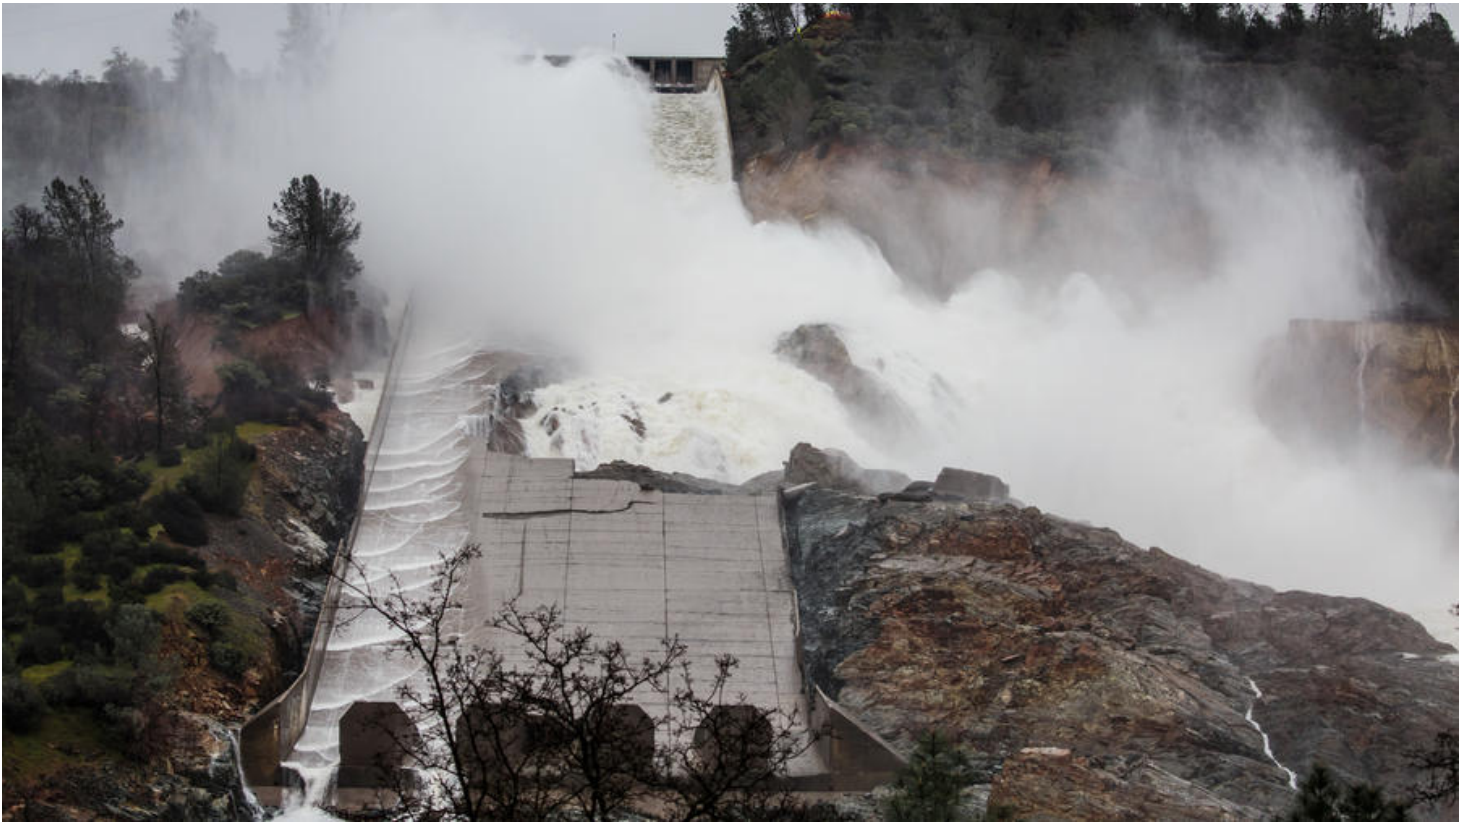
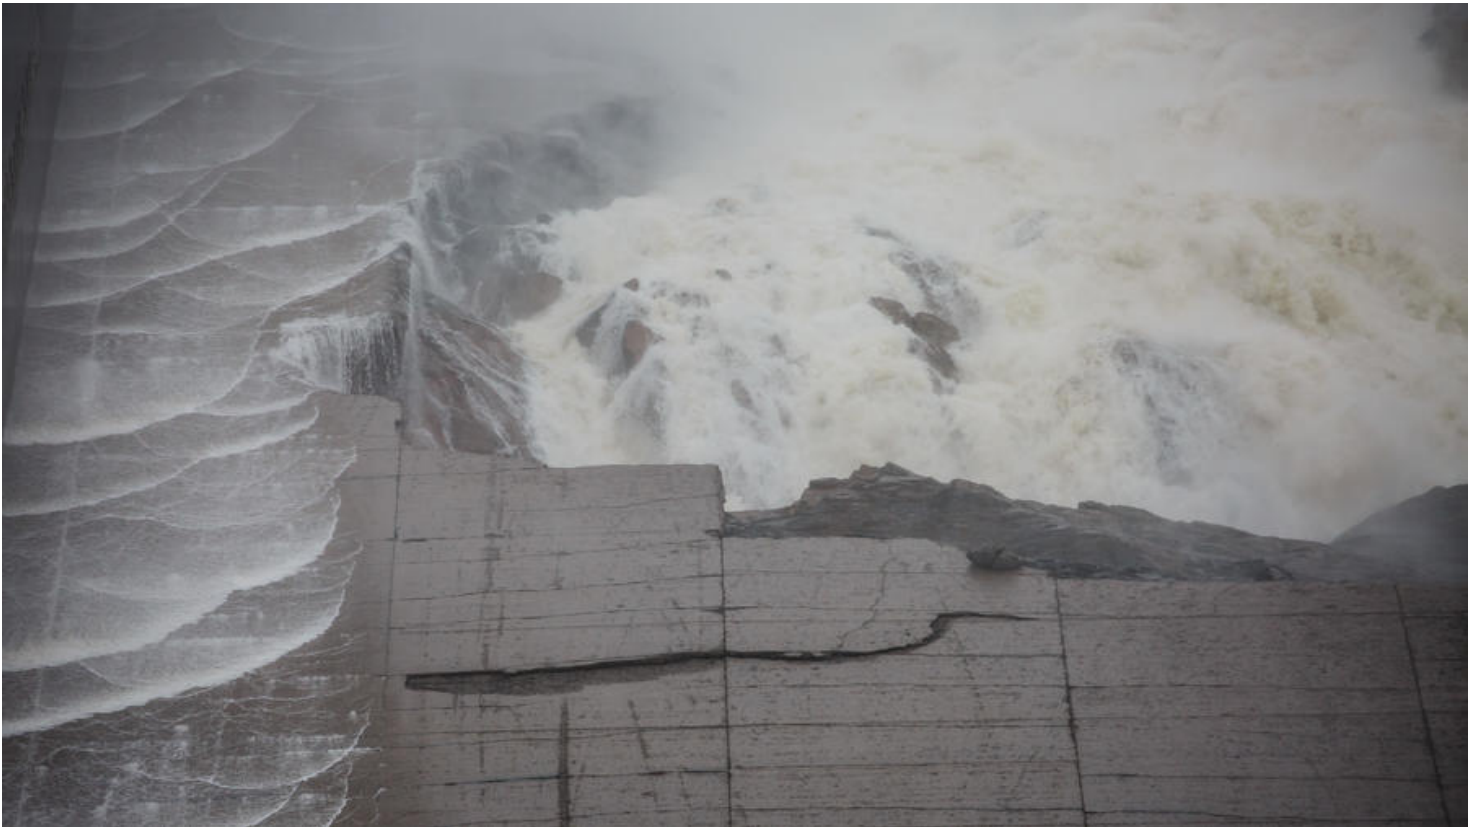
**Water flowing from broken longitudinal drain pipe outside spillway training wall**

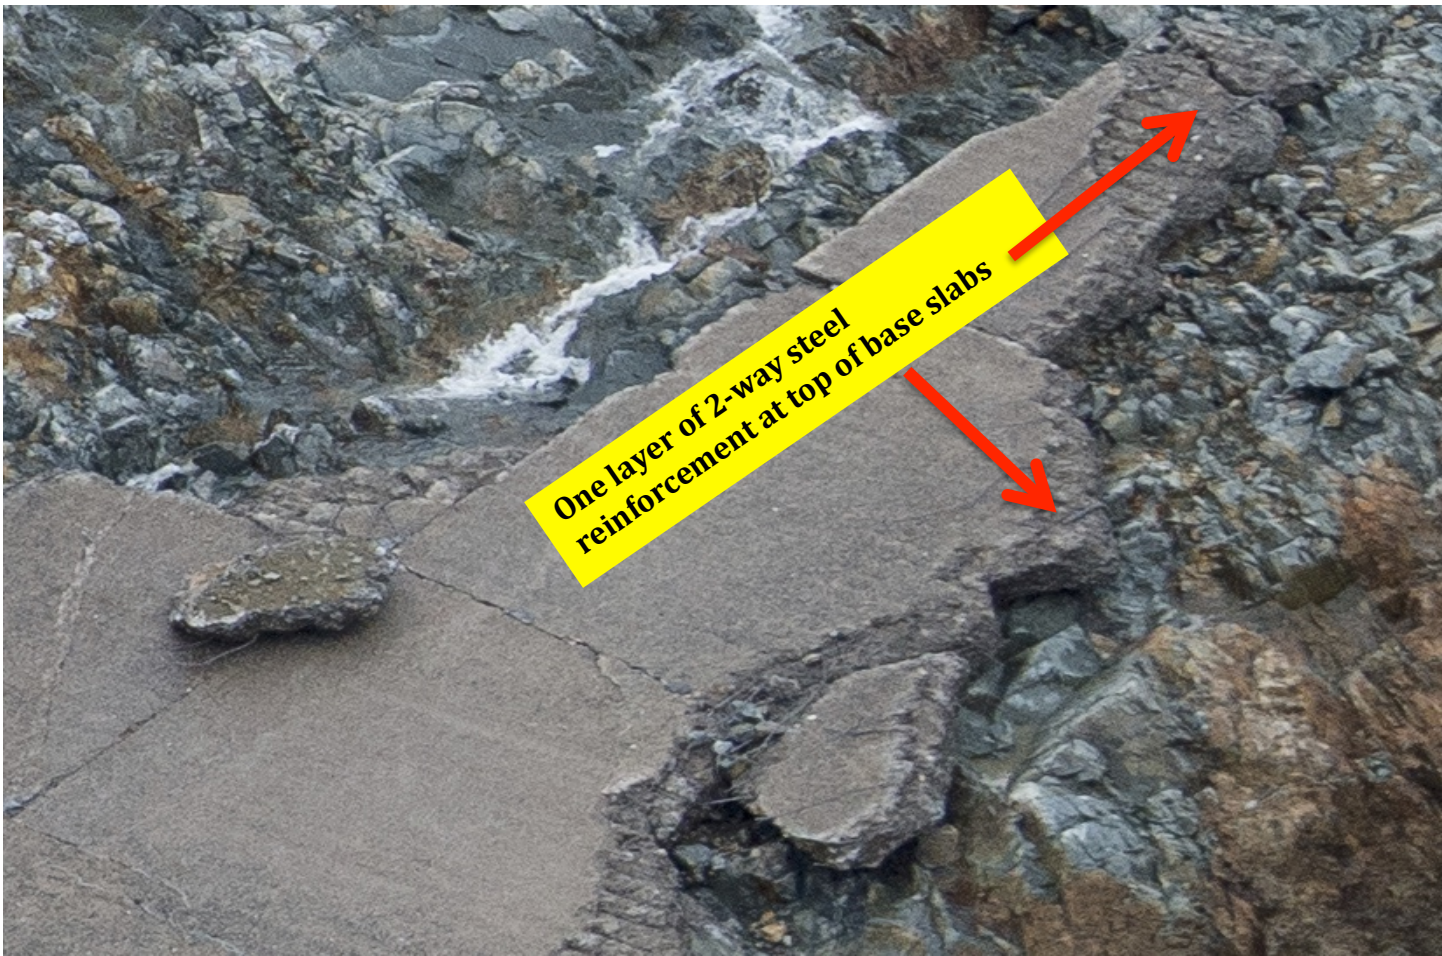
**One layer of 2-way steel reinforcement at top of chute slabs**

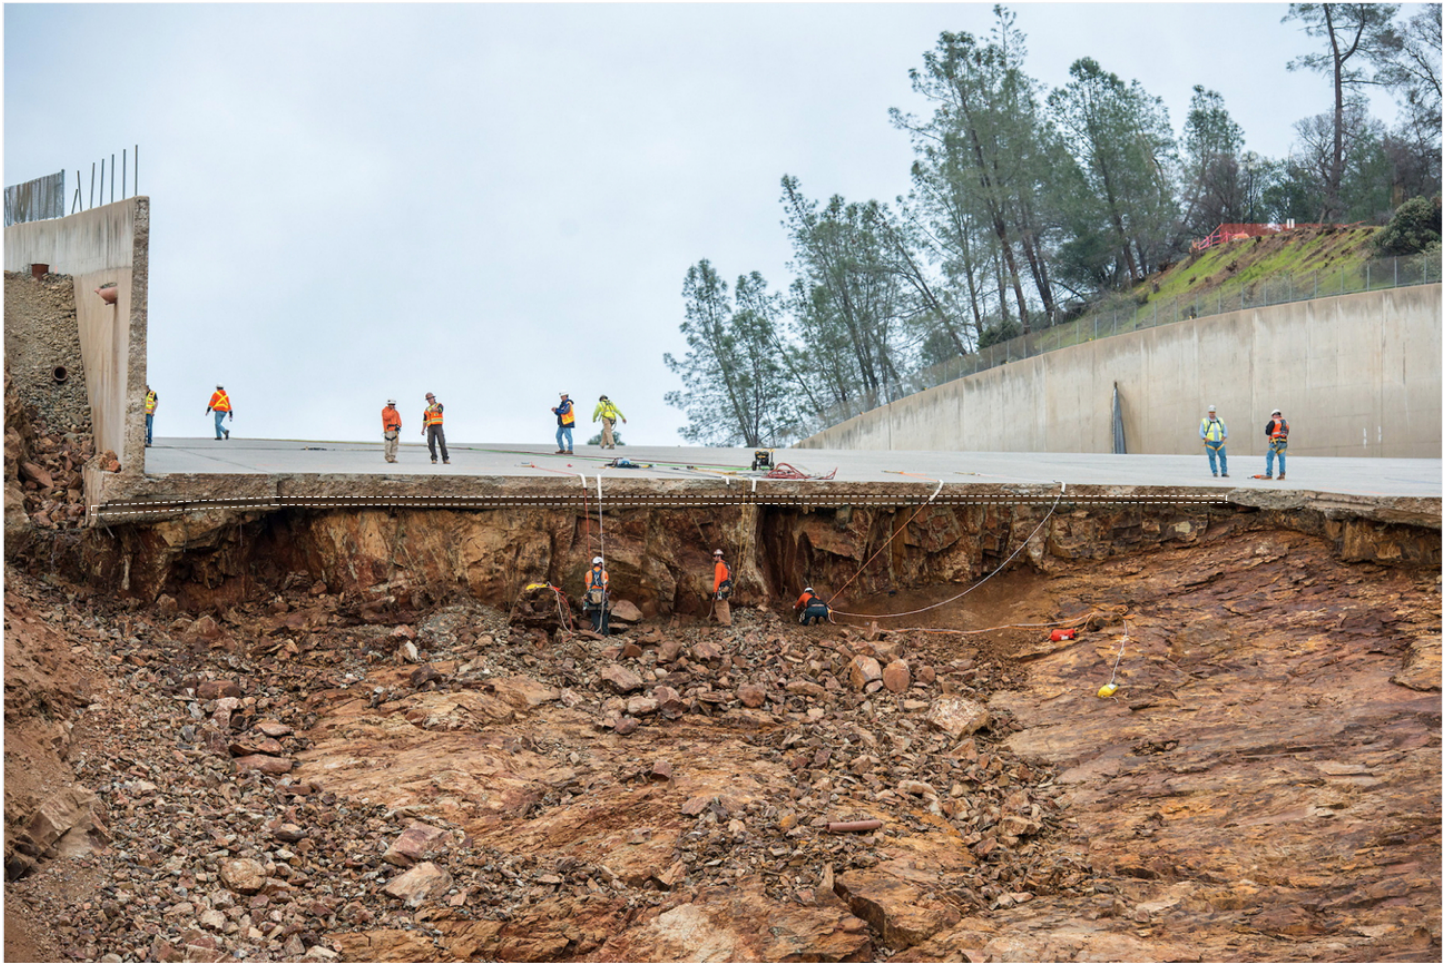
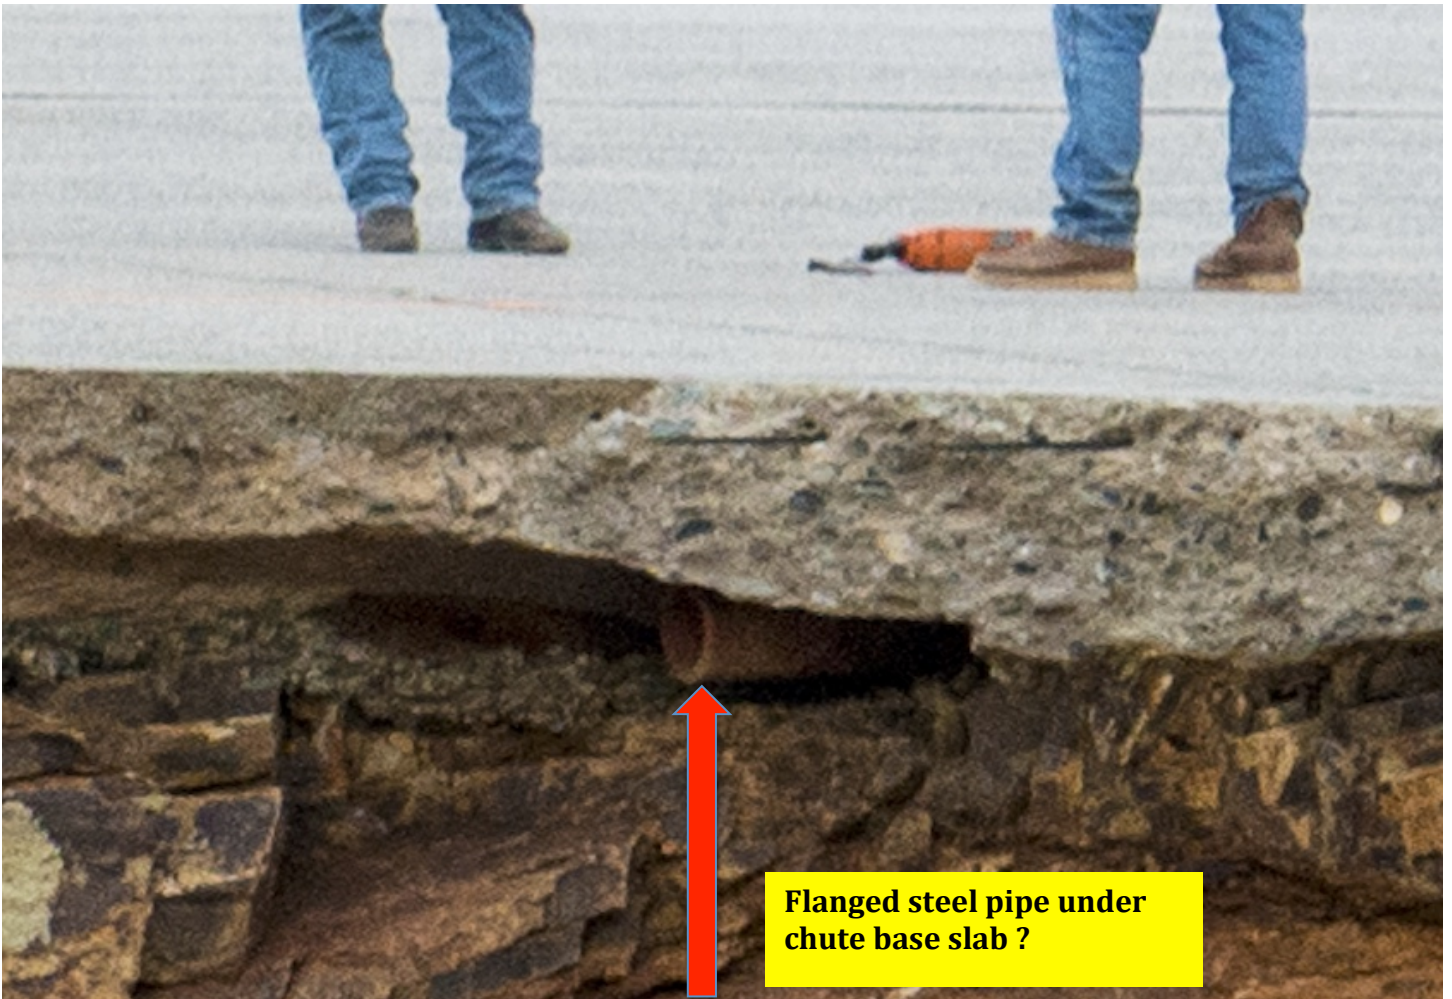
Concrete fractured along  
drain pipe emplacement

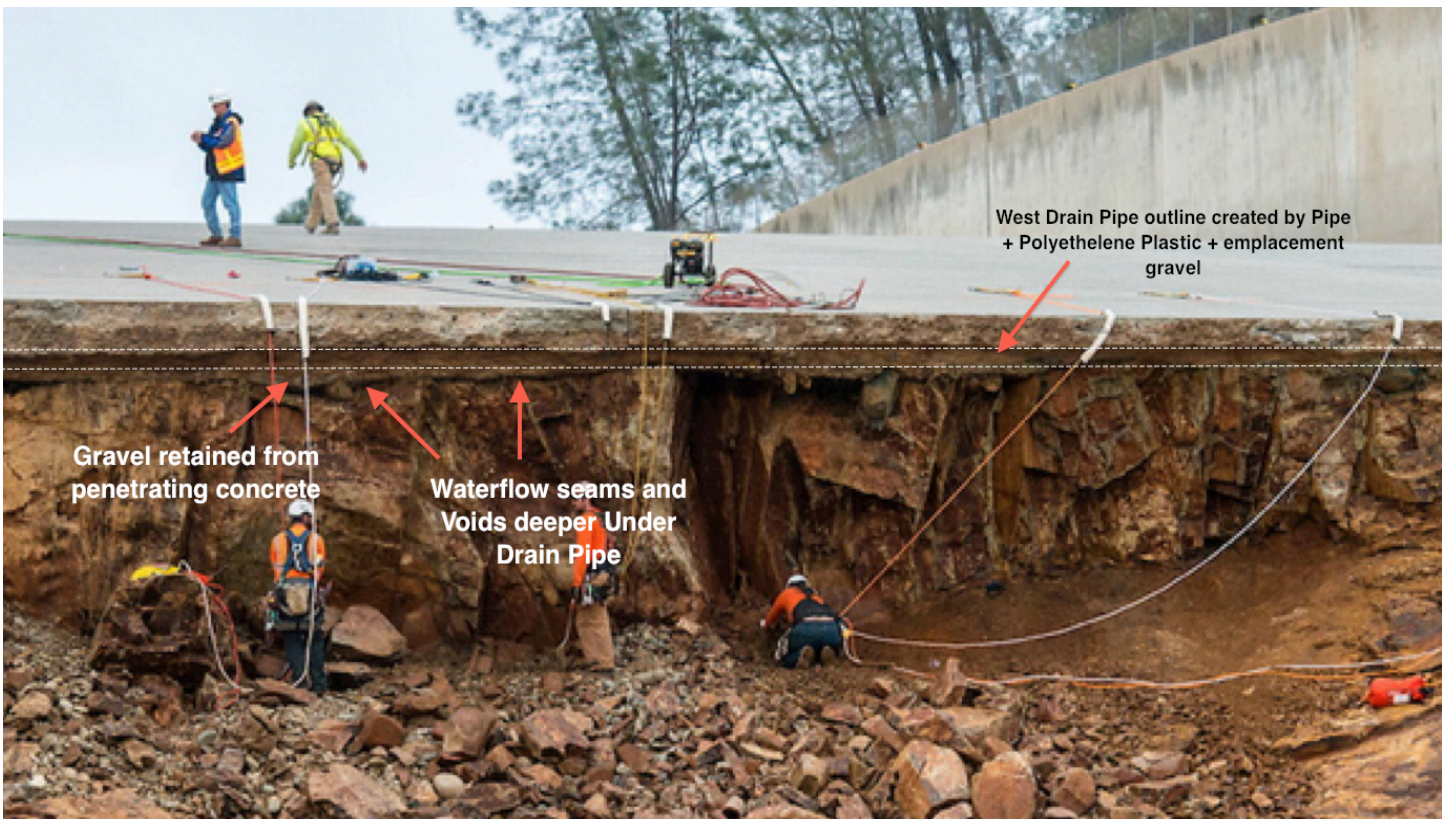
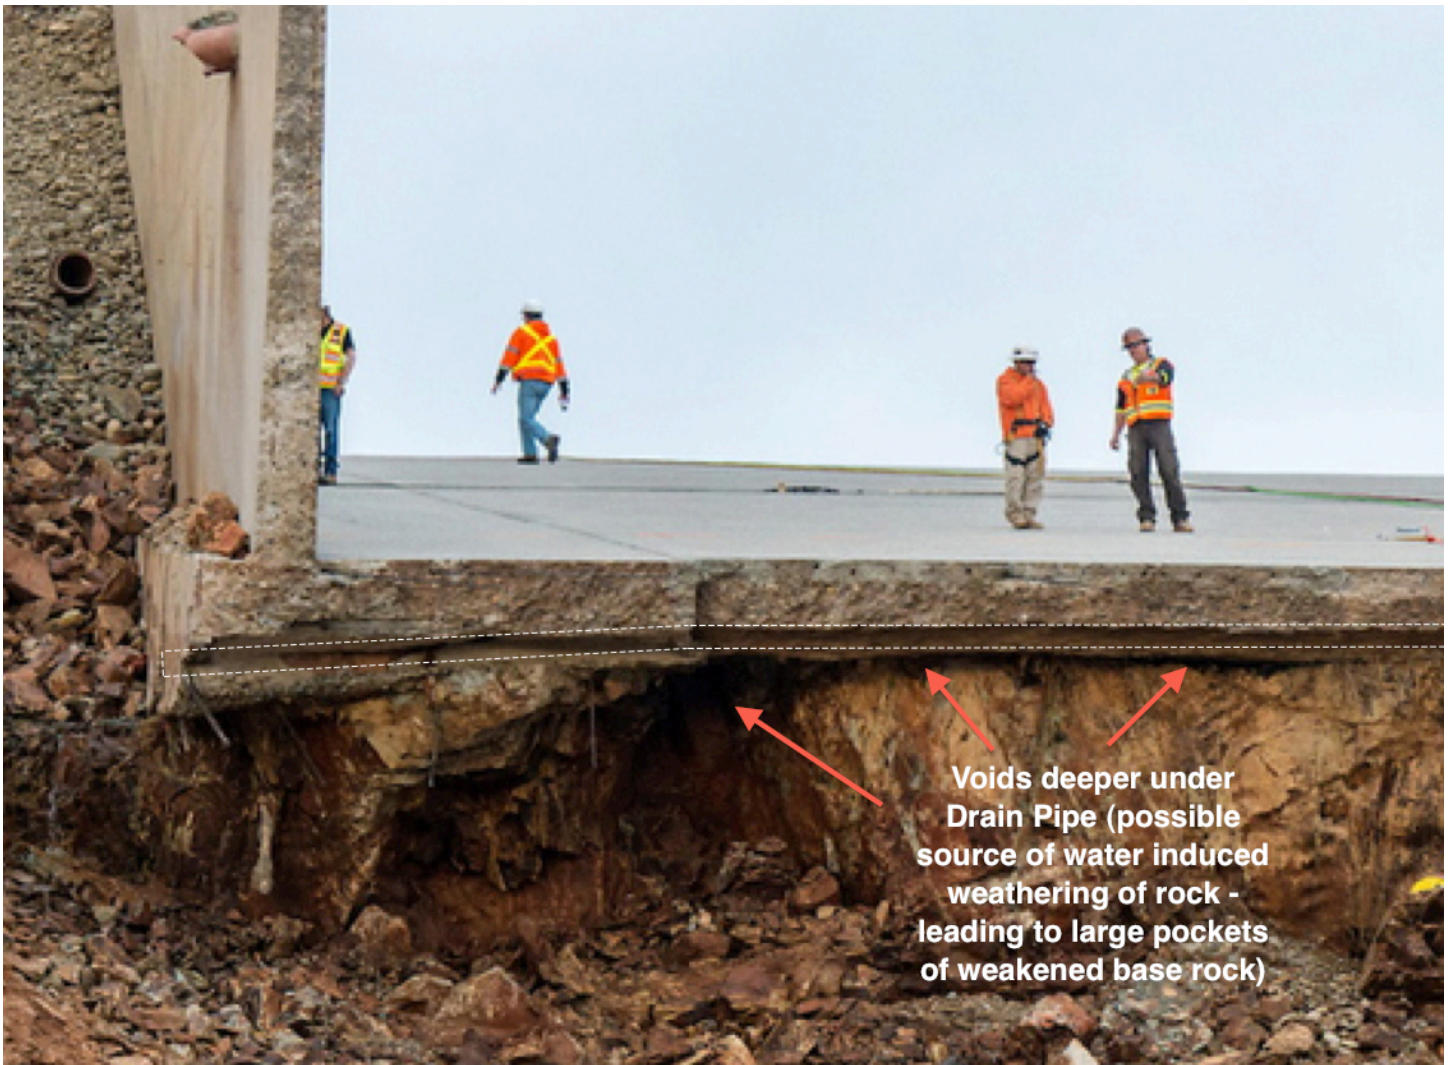
"pulling away" gap in wall and spillway slab.

gap narrowing further down spillway indicates a "rotation"

Erosion of foundation base of wall from broken drain at 5th fence post behind spillway wall.

Rotation indicators of section of main spillway (gaps, broken drain erosion on wall foundation, and spillway backcutting).

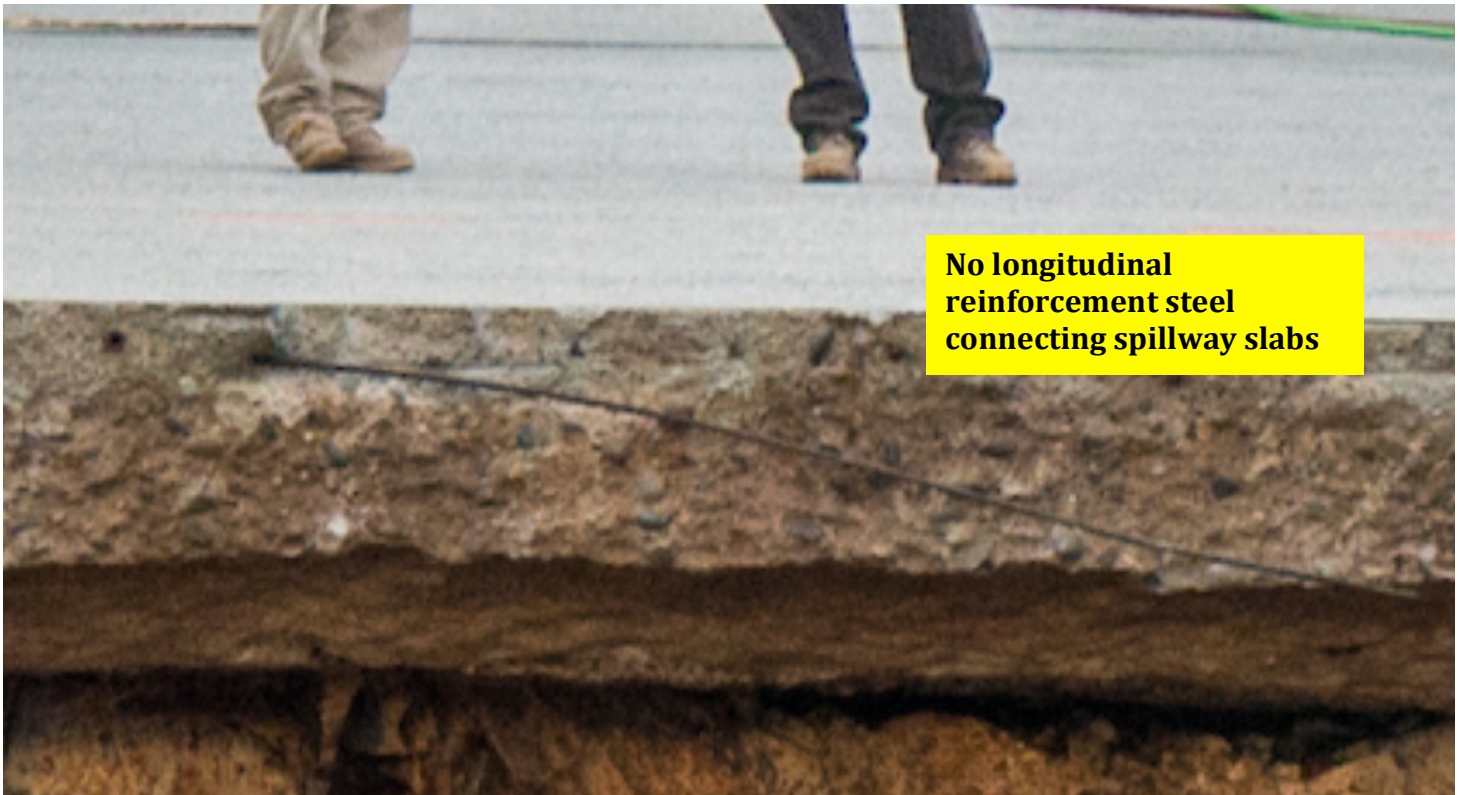
**No longitudinal reinforcement steel connecting spillway slabs**

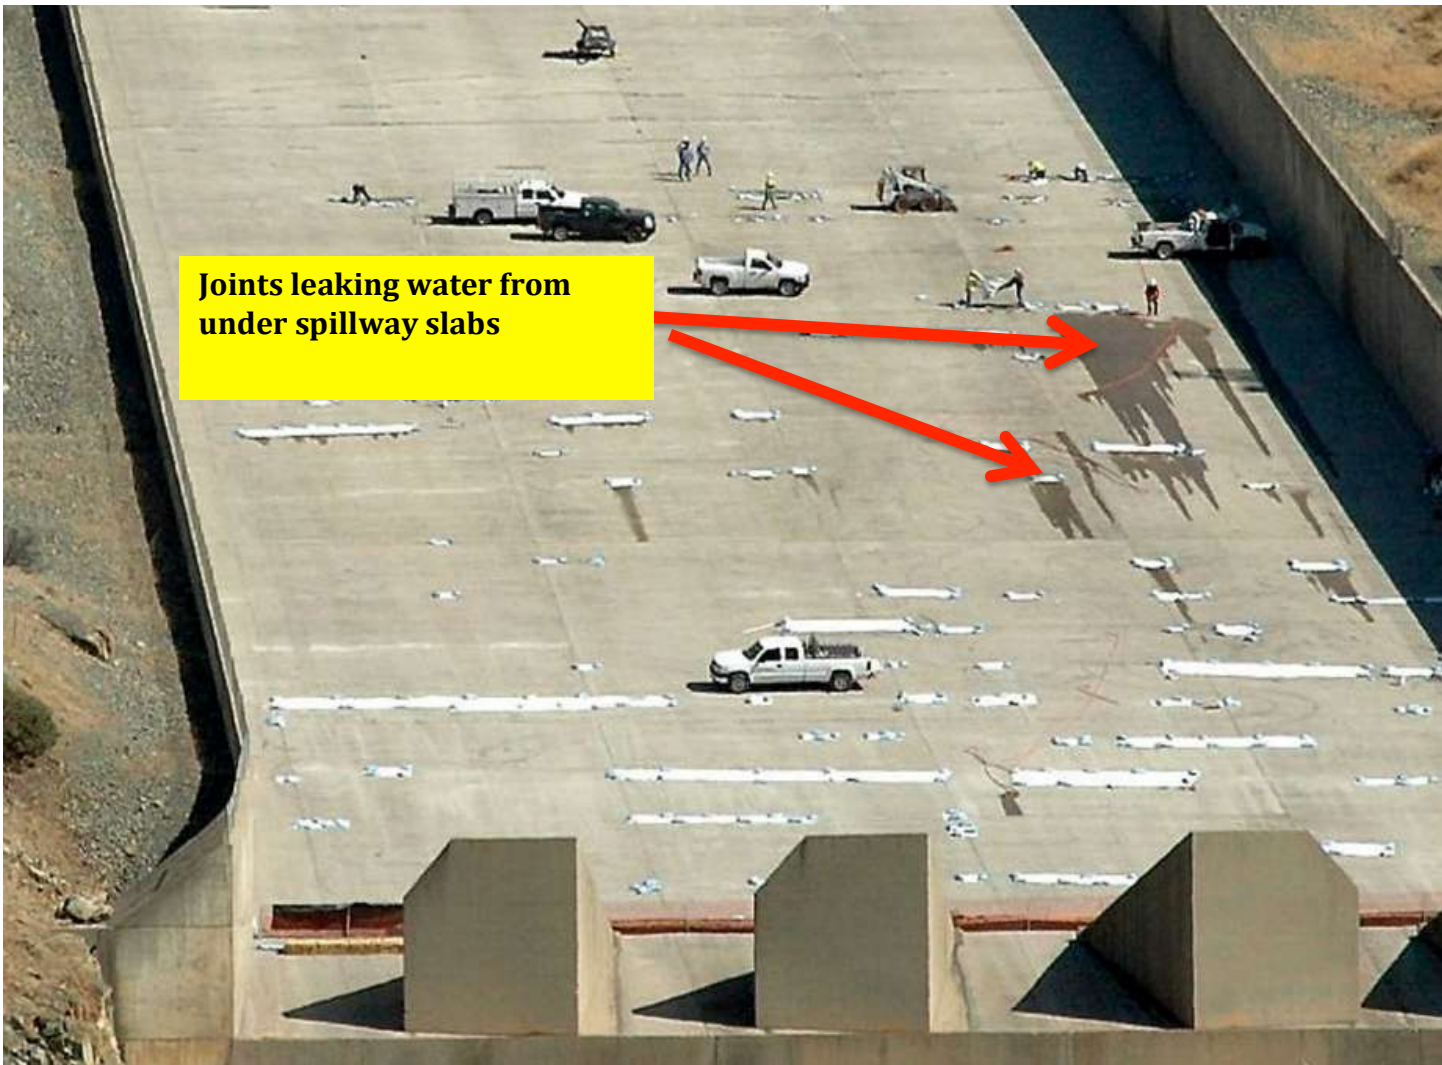
October 7, 2009 – Repairs being made to spillway base slabs

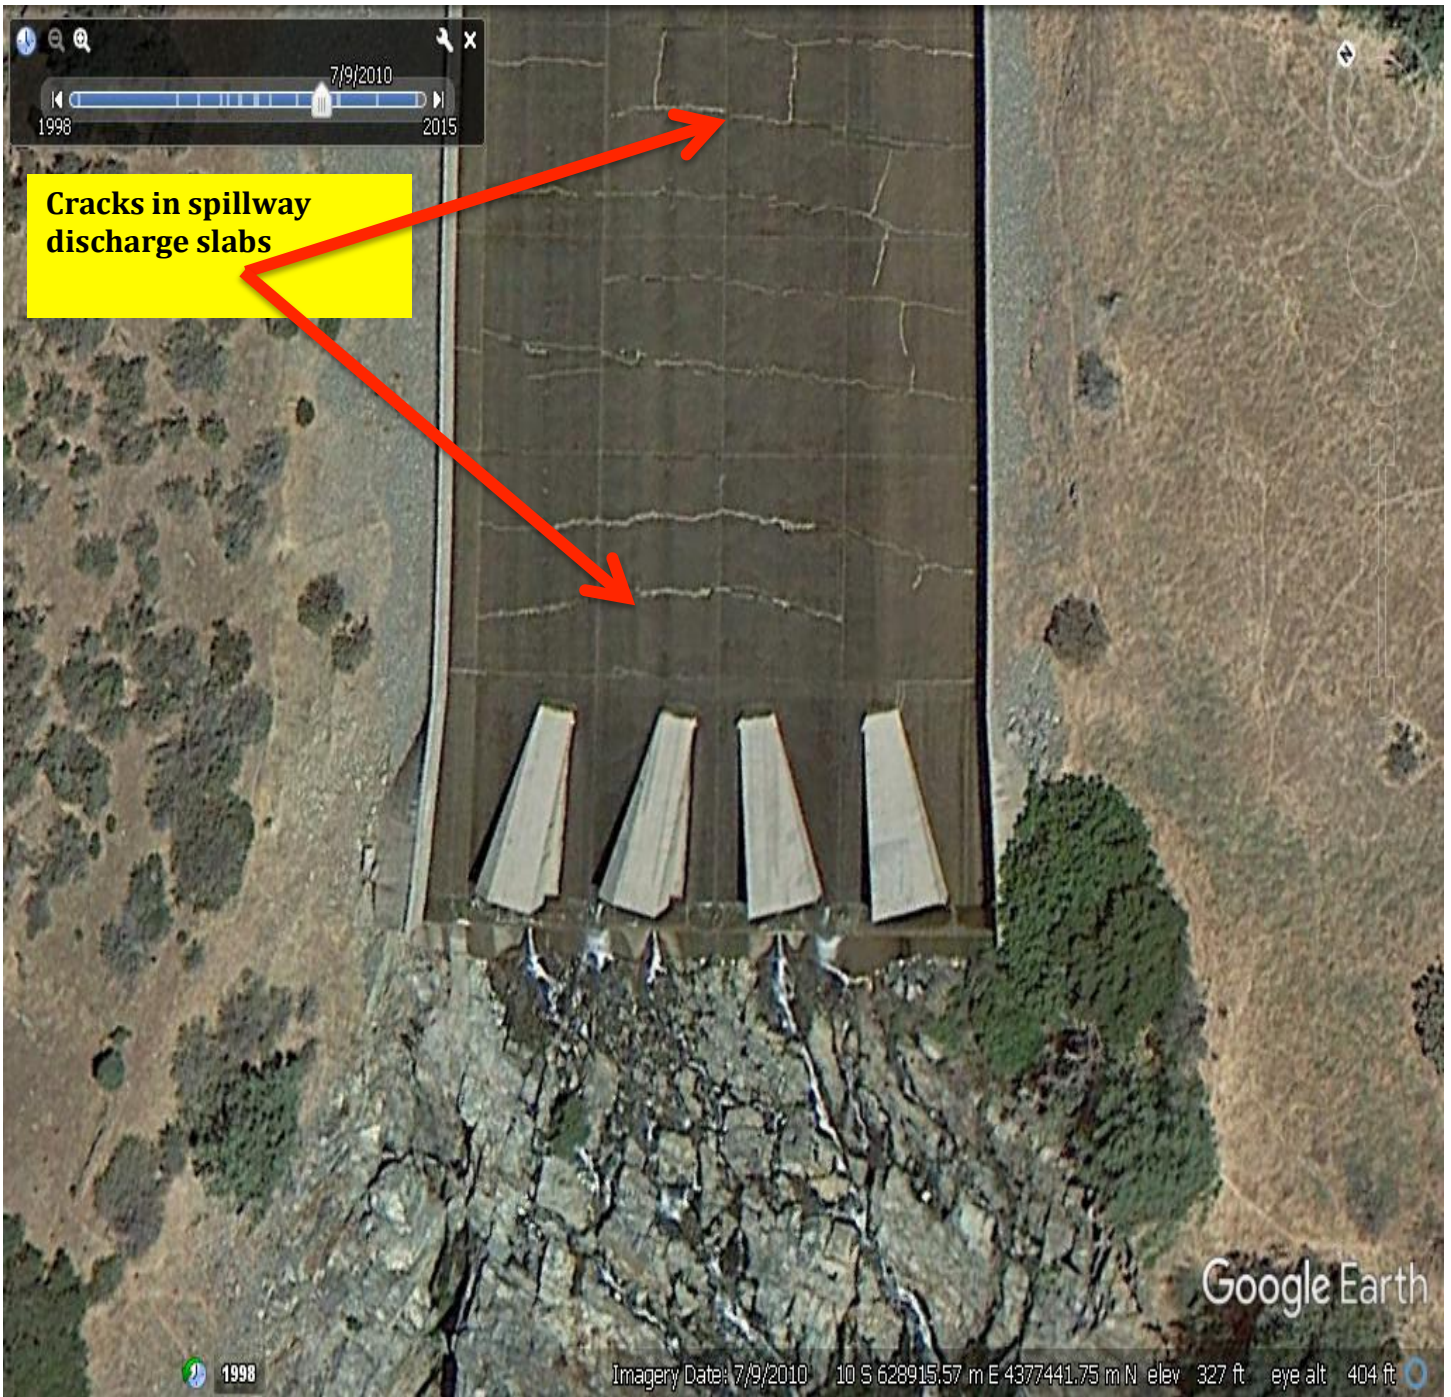
**Cracks in spillway chute slabs**

**Large trees growing adjacent to spillway wall - roots able to penetrate and plug drains**

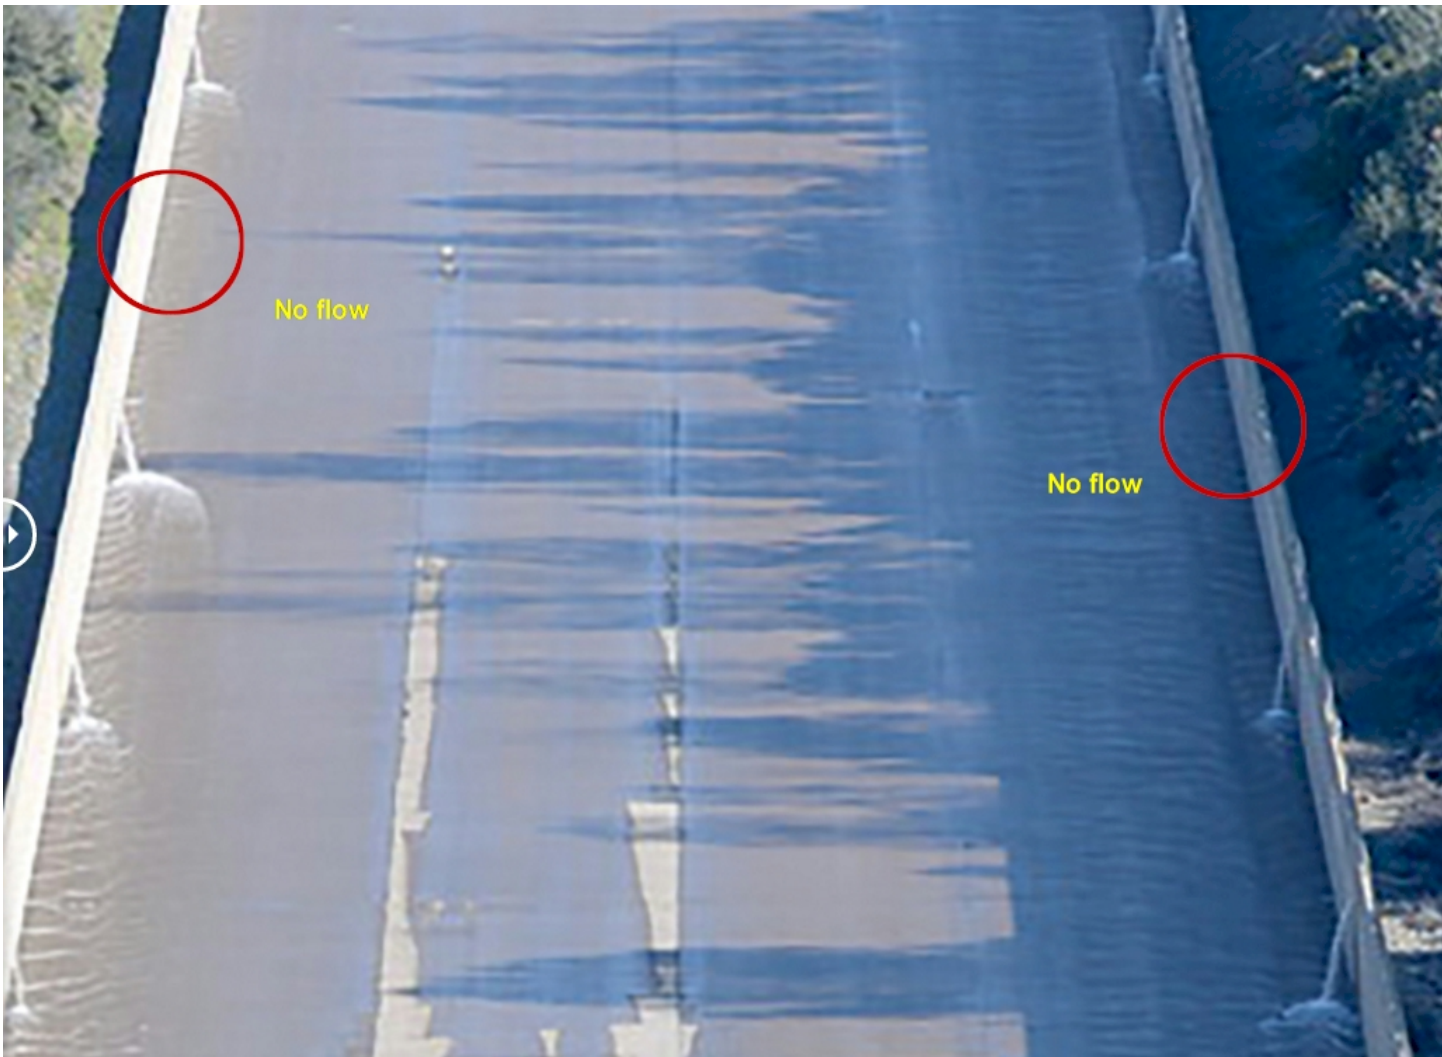
**Wall drains not  
flowing - plugged**

**Large trees growing  
adjacent to spillway  
wall - roots able to  
penetrate drains**
