Shoreline Structural Classifications & Design Water Levels, Lake Ontario

Prepared By Todd Monson

AECOM

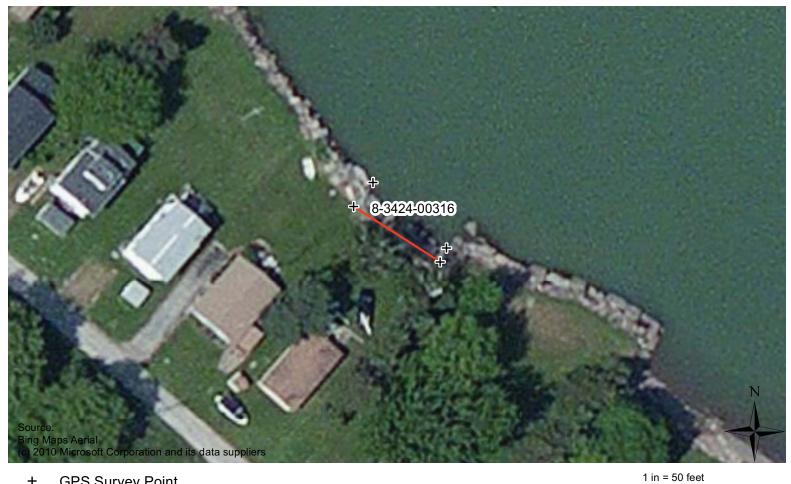
Page: 4 of 49

Condition: **Moderate Quality**

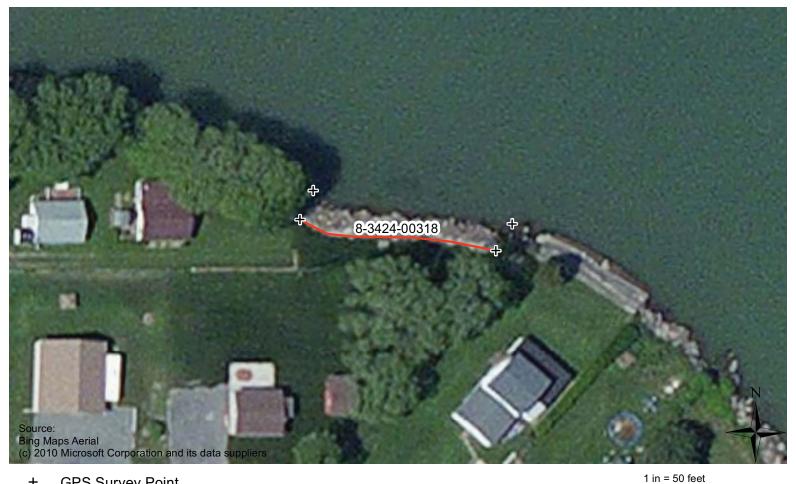
Condition: Moderate Quality

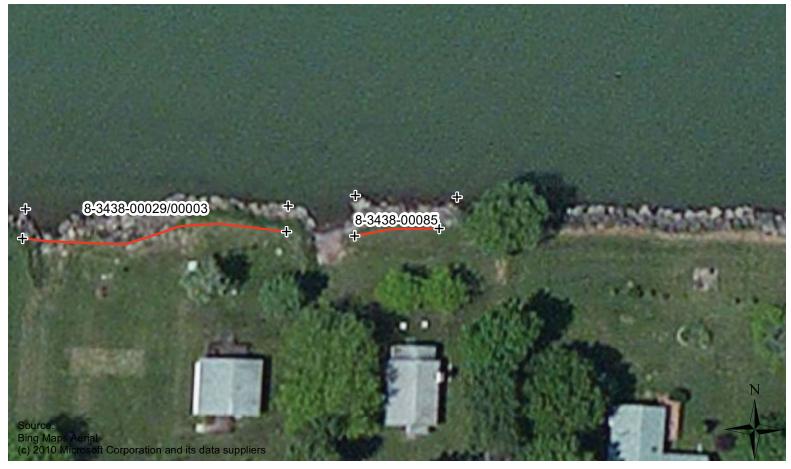
Page: 7 of 49

Condition: Moderate Quality

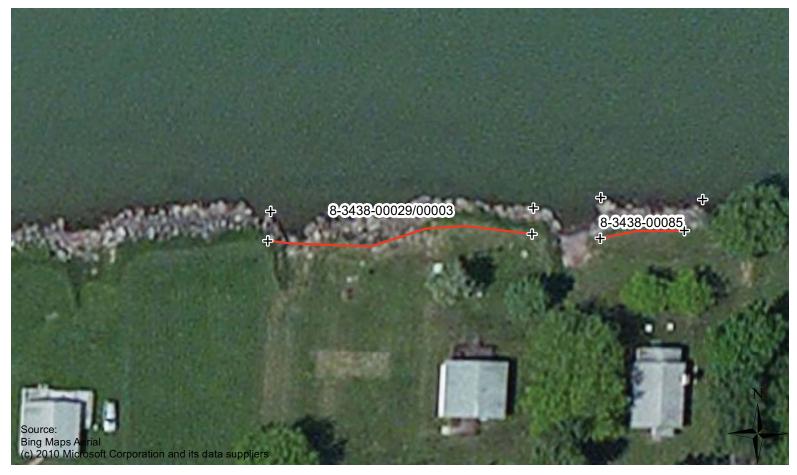
Page: 8 of 49

Condition: Moderate Quality

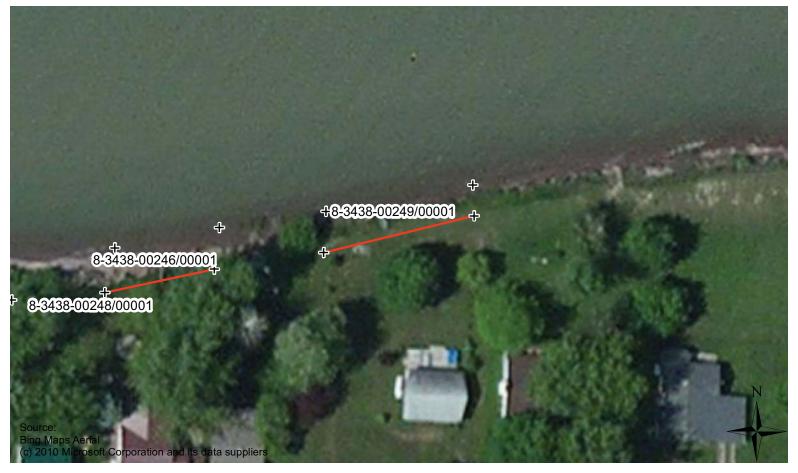
Page: 9 of 49

Condition: **Moderate Quality**

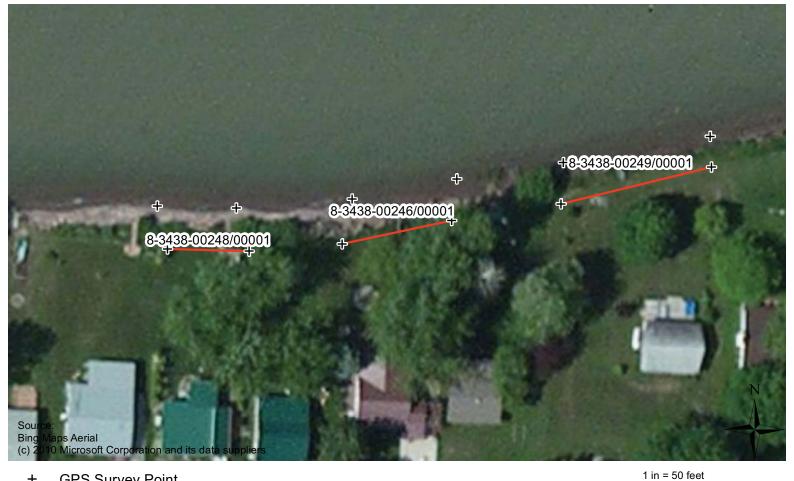
Page: 10 of 49

Condition: **Moderate Quality**

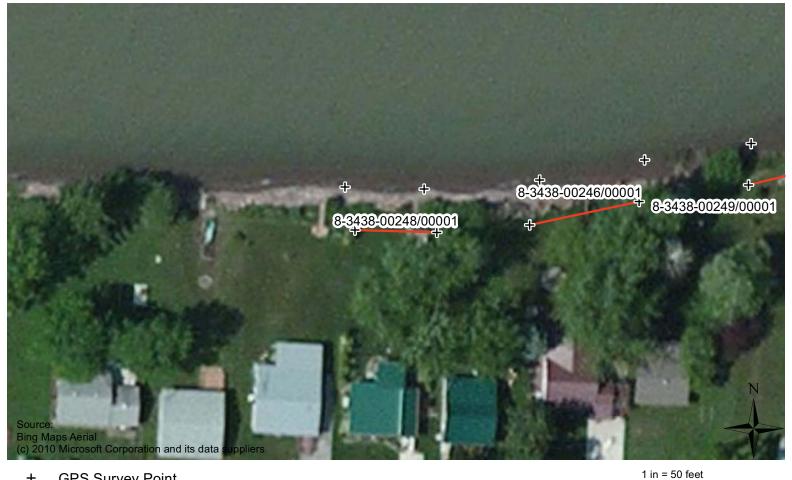
Page: 11 of 49

Condition: **Moderate Quality**

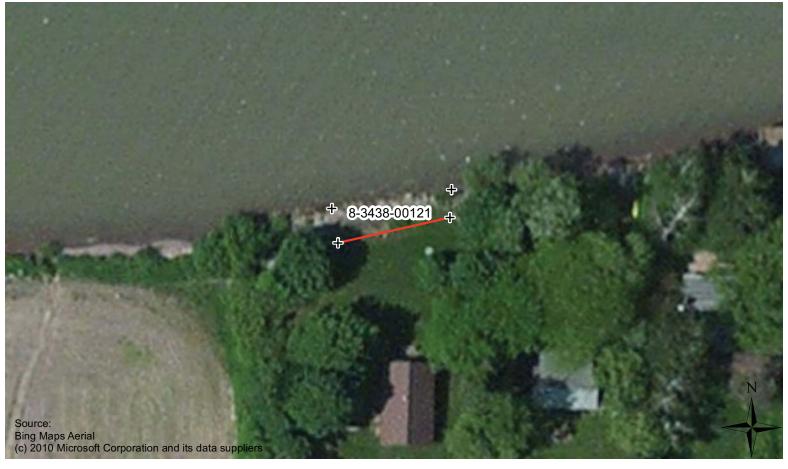
Condition: Poor Quality

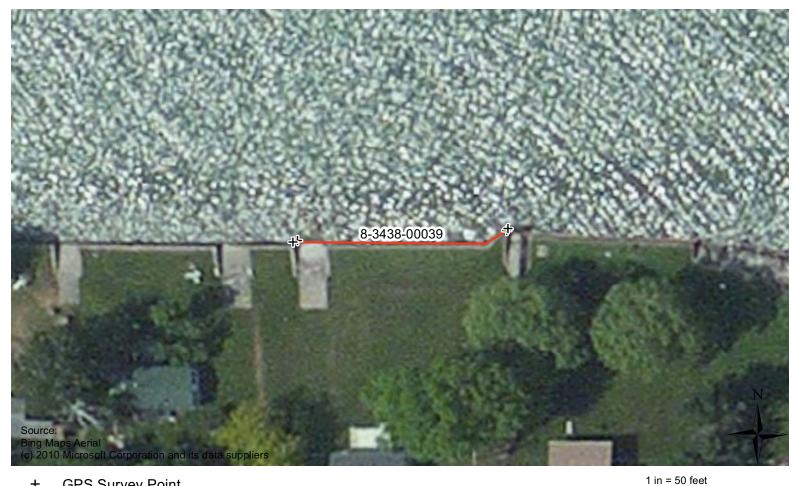
Page: 13 of 49

Condition: Moderate Quality

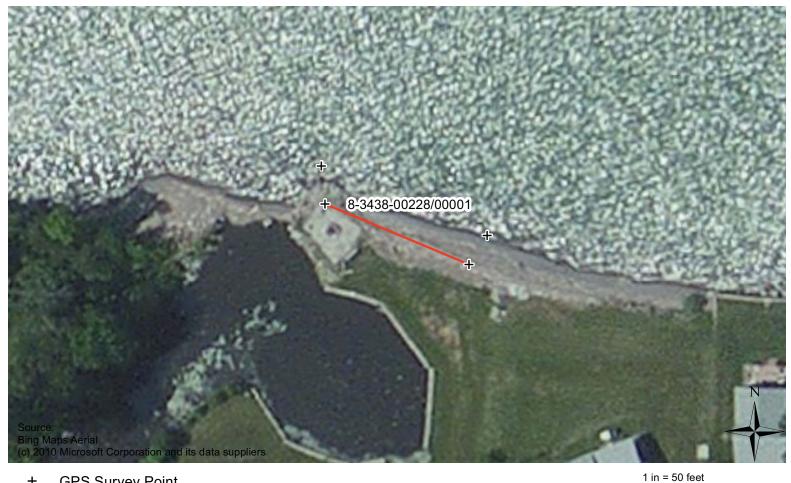
Condition: **Moderate Quality**

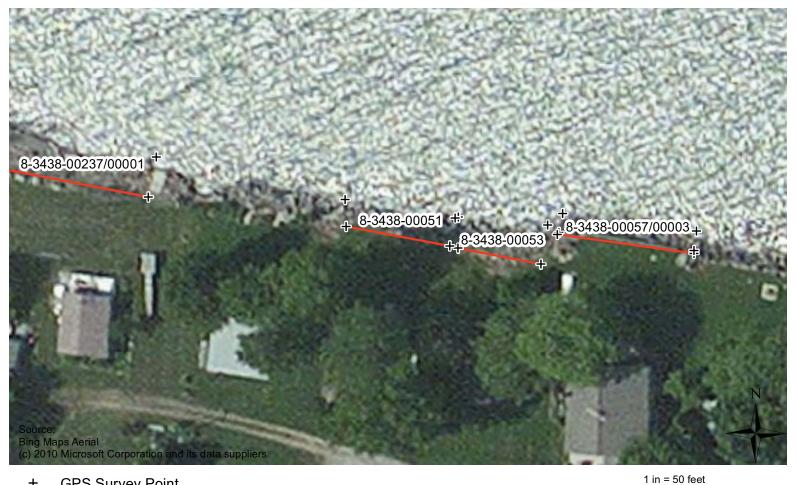
Condition: **Moderate Quality**

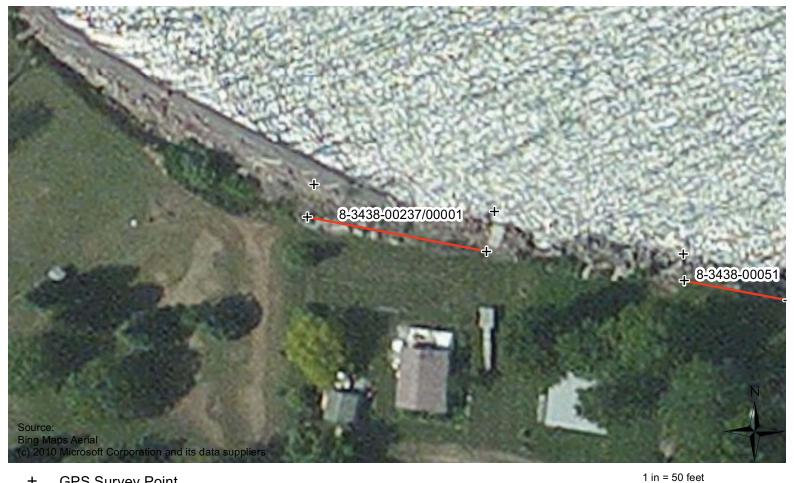
Page: 20 of 49

Condition: **Moderate Quality**

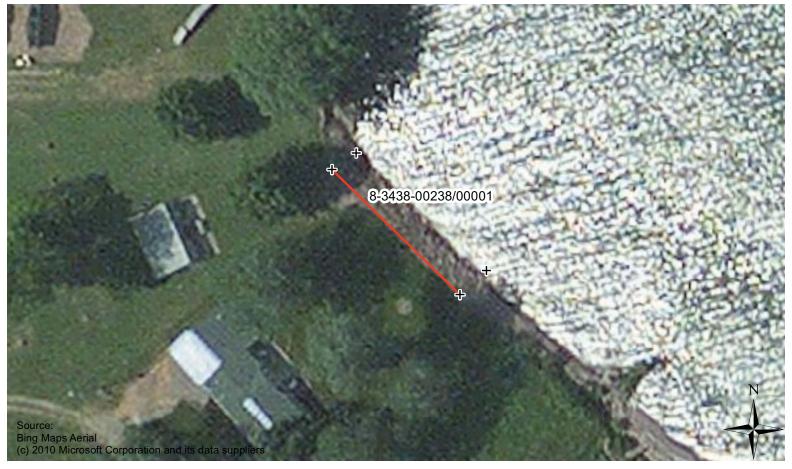
Page: 21 of 49

Condition: Poor Quality

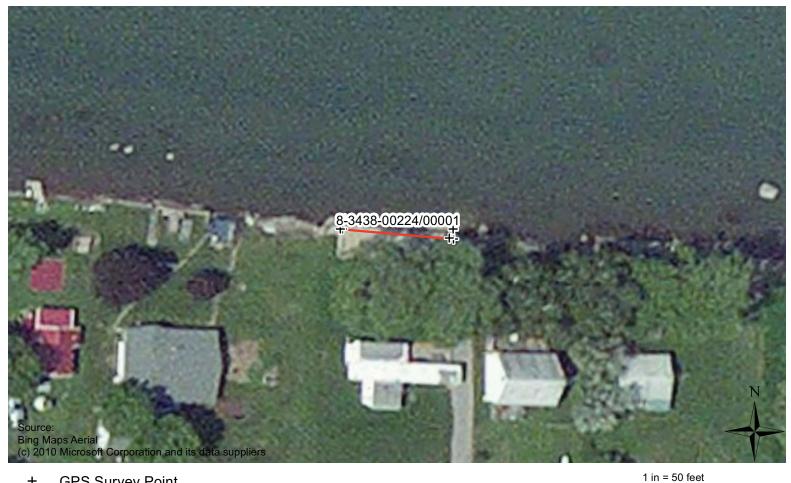
Page: 22 of 49

Condition: Good Quality

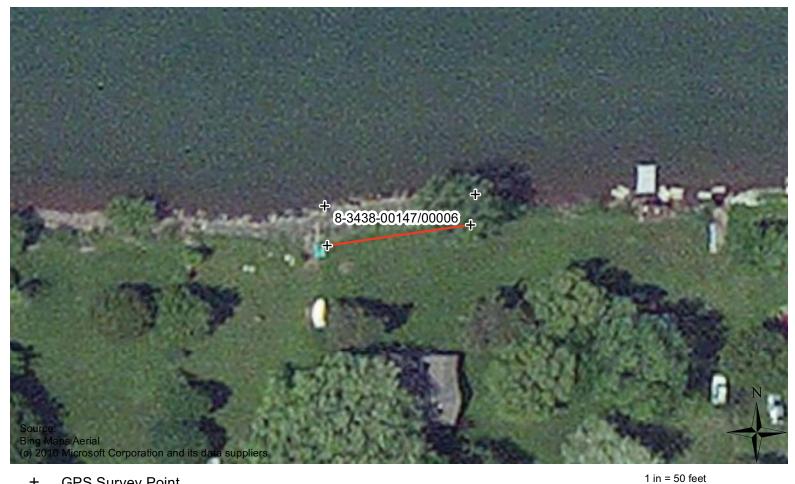
Page: 23 of 49

Condition: Moderate Quality

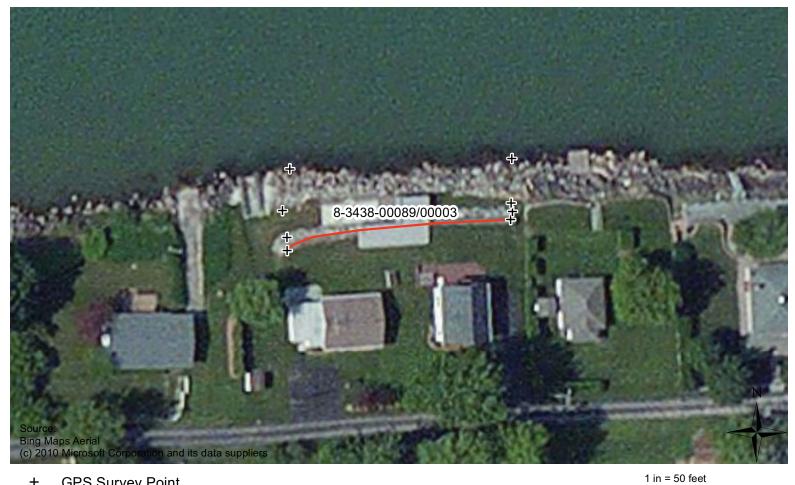
Page: 24 of 49

Condition: **Moderate Quality**

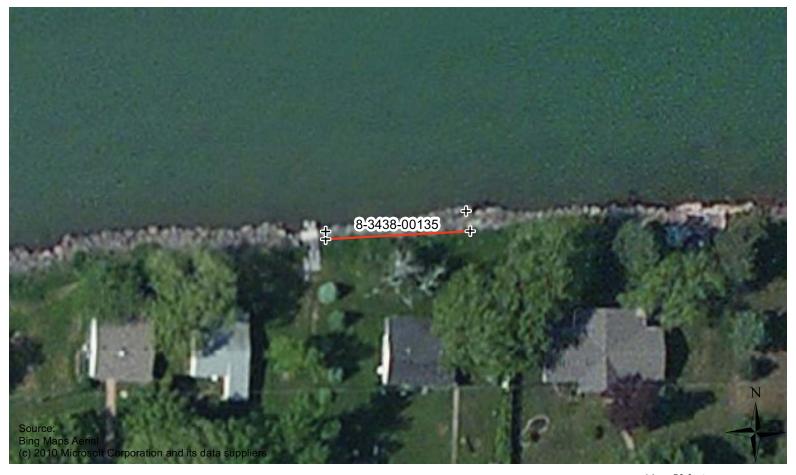
Page: 25 of 49

Condition: Moderate Quality

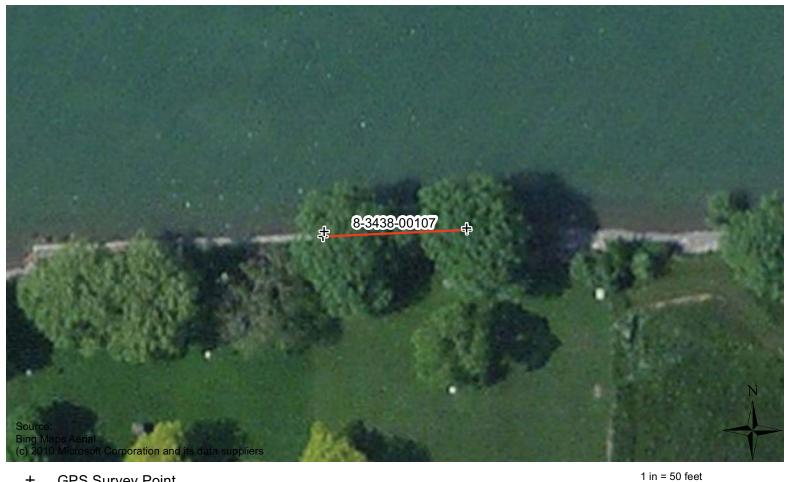
Page: 26 of 49

Condition: Moderate Quality

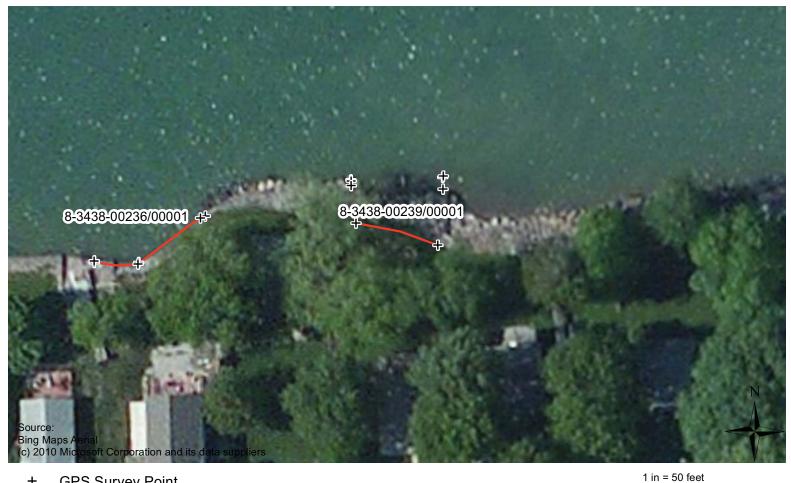
Page: 28 of 49

Condition: **Moderate Quality**

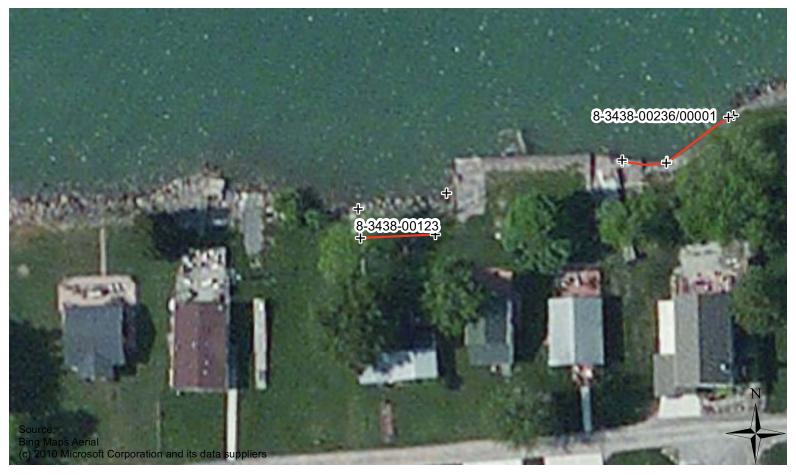
Condition: Poor Quality

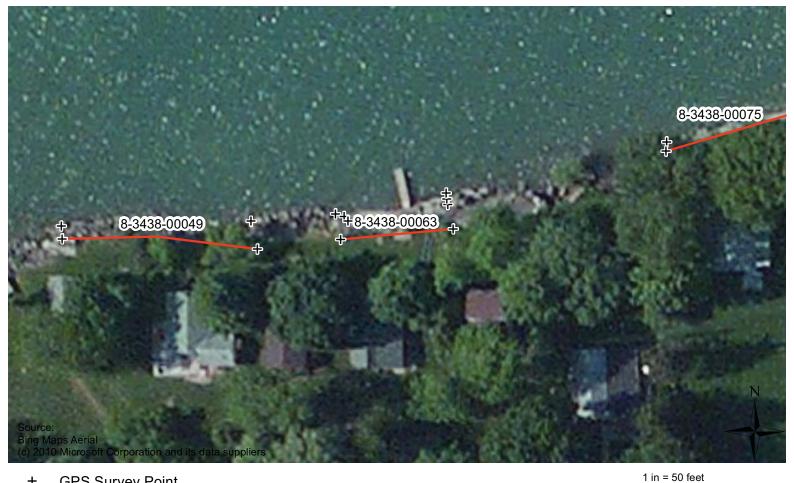
Page: 32 of 49

Condition: Poor Quality

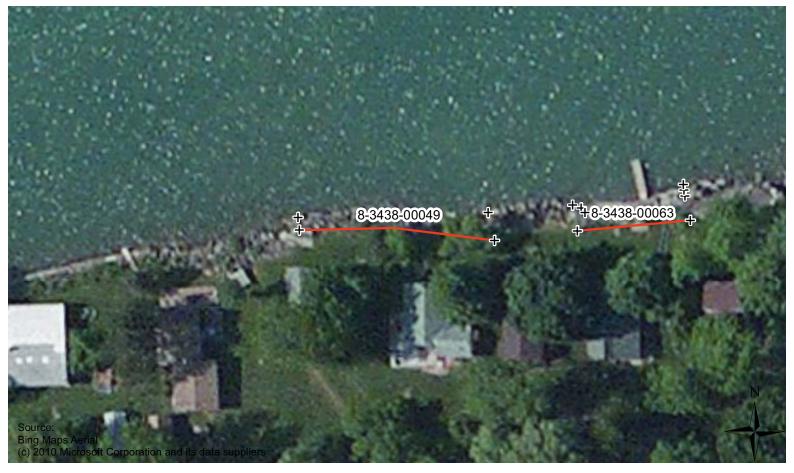
Page: 33 of 49

Condition: Moderate Quality

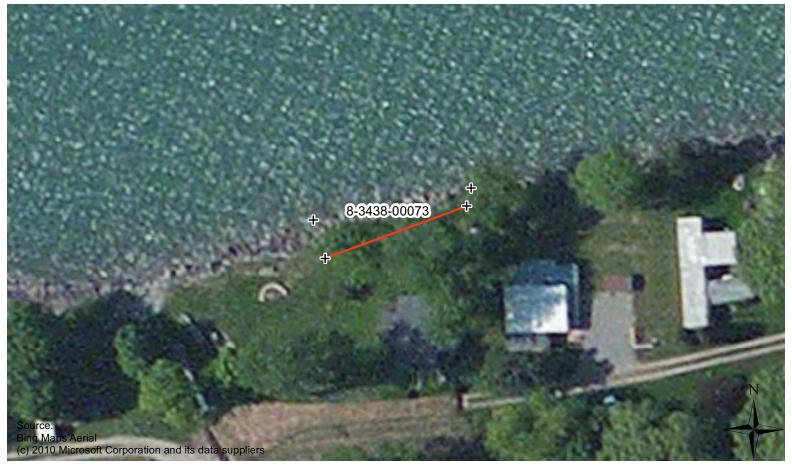
Page: 34 of 49

Condition: **Moderate Quality**

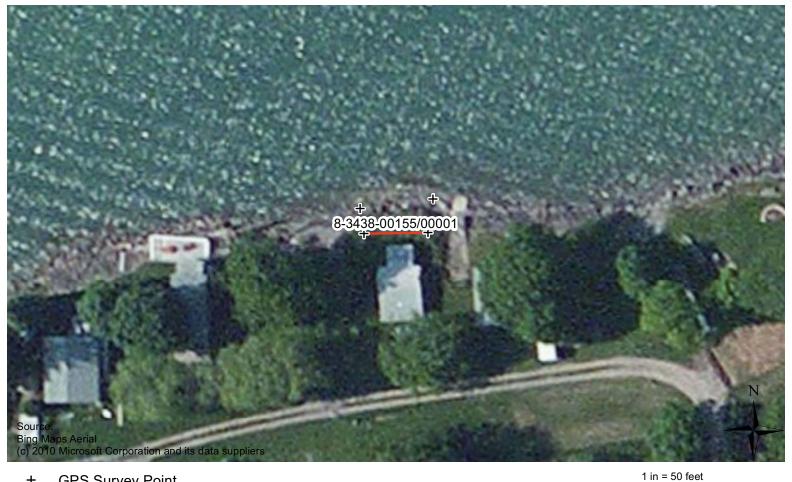
Page: 35 of 49

Condition: **Moderate Quality**

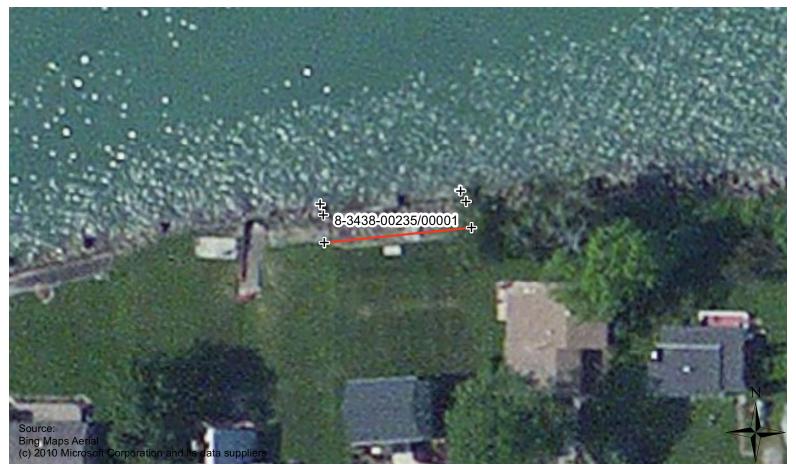
Page: 36 of 49

Condition: Moderate Quality

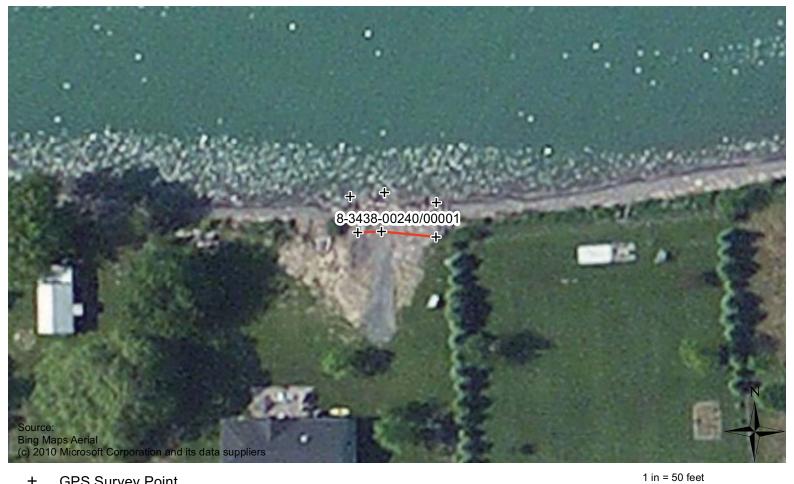
Condition: Poor Quality

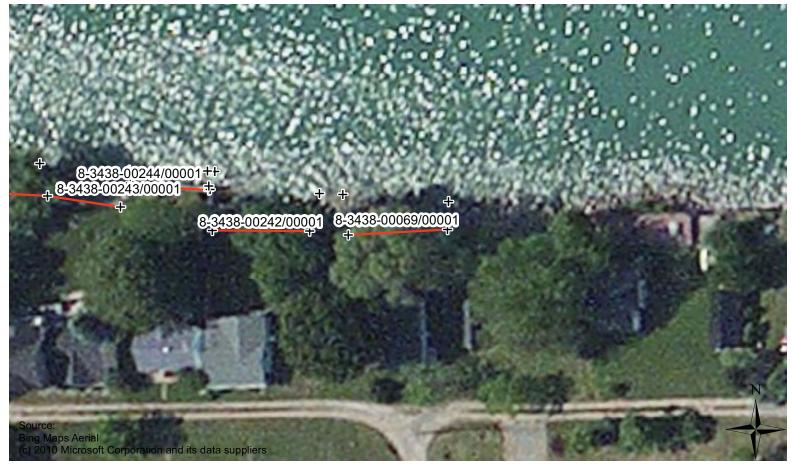
Page: 38 of 49

Condition: **Moderate Quality**

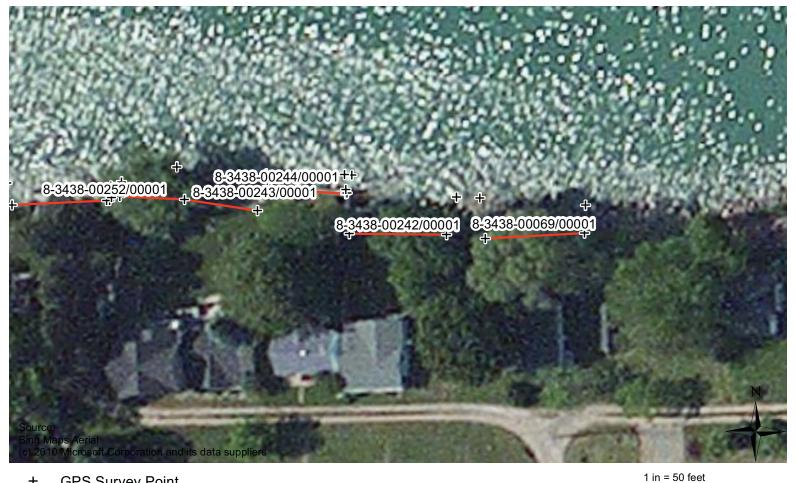
Condition: **Moderate Quality**

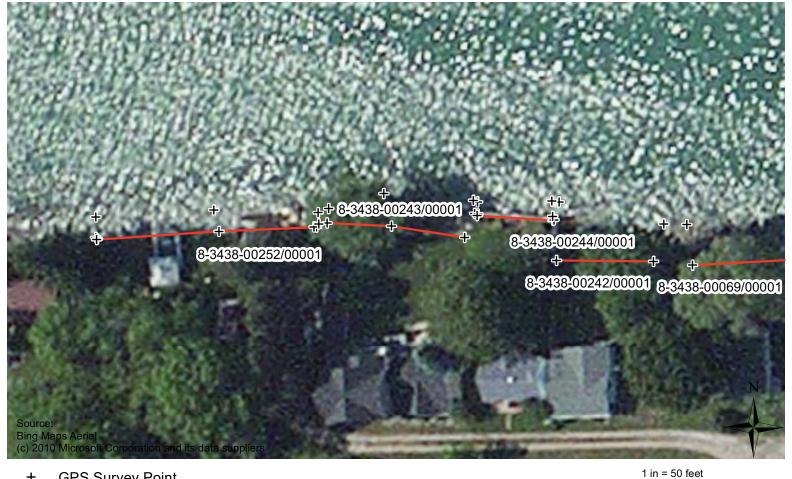
Condition: **Moderate Quality**

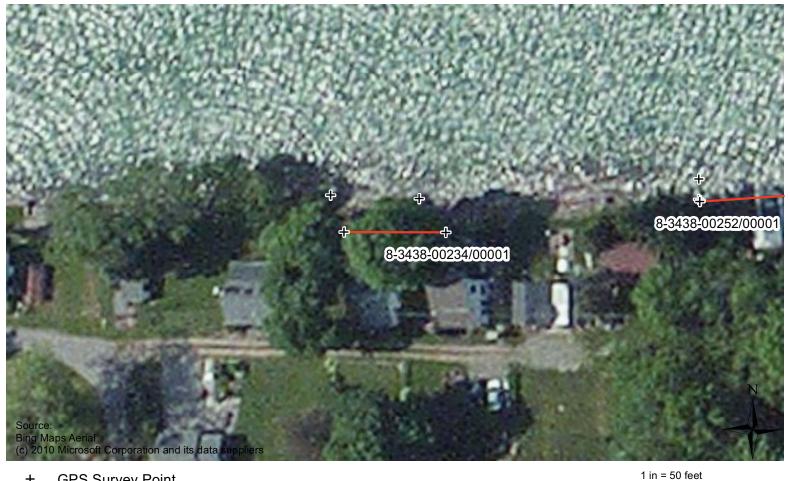
Condition: Moderate Quality

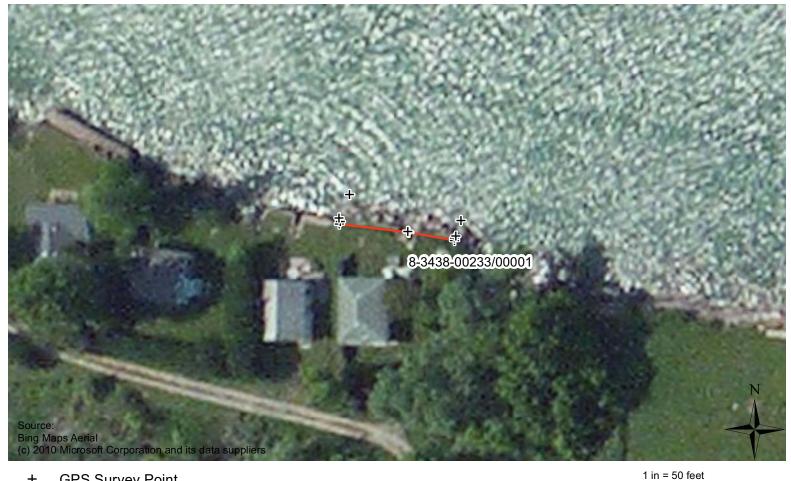
Condition: **Moderate Quality**

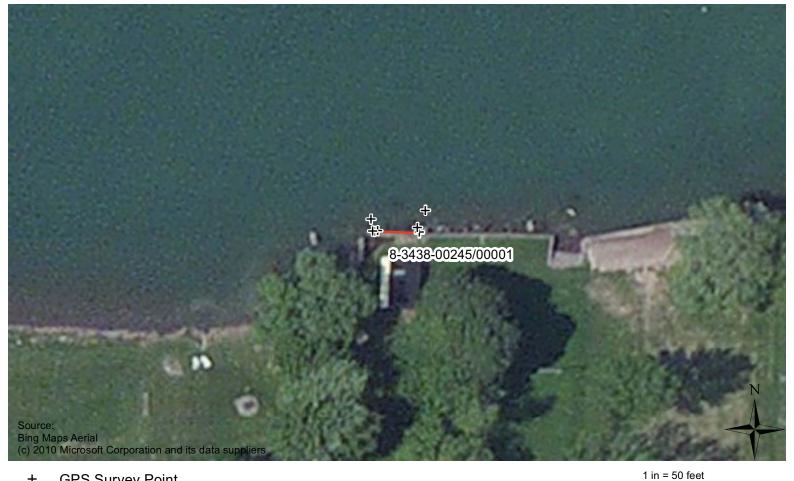
Condition: Poor Quality

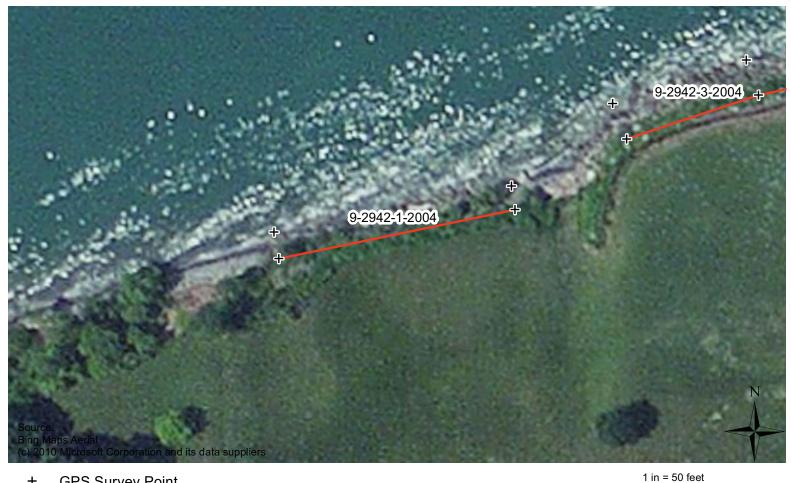
Page: 3 of 43

Condition: **Poor Quality**

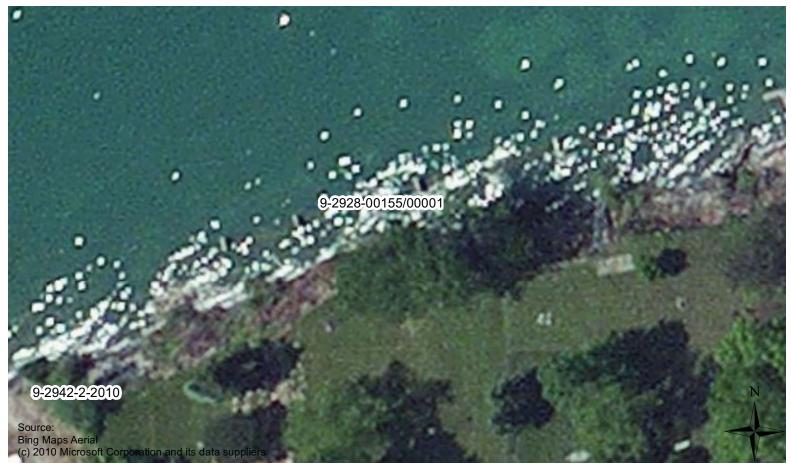
Page: 7 of 43

Condition: Poor Quality

Note: Structure has failed

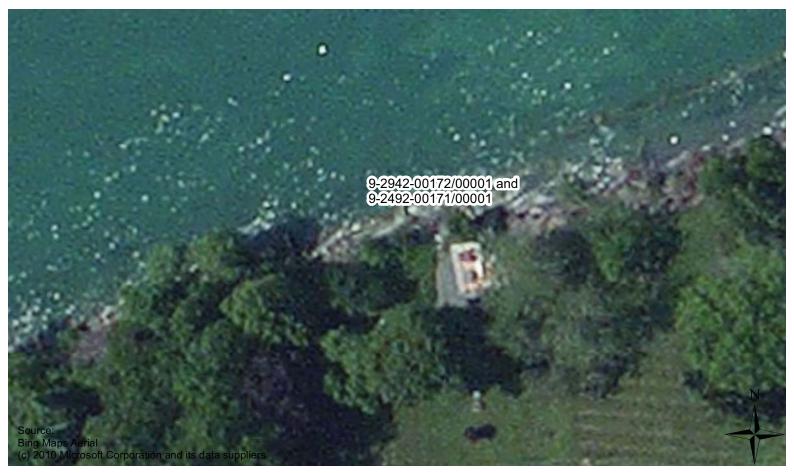
Page: 8 of 43

Condition: Poor Quality

Note: Structure has failed

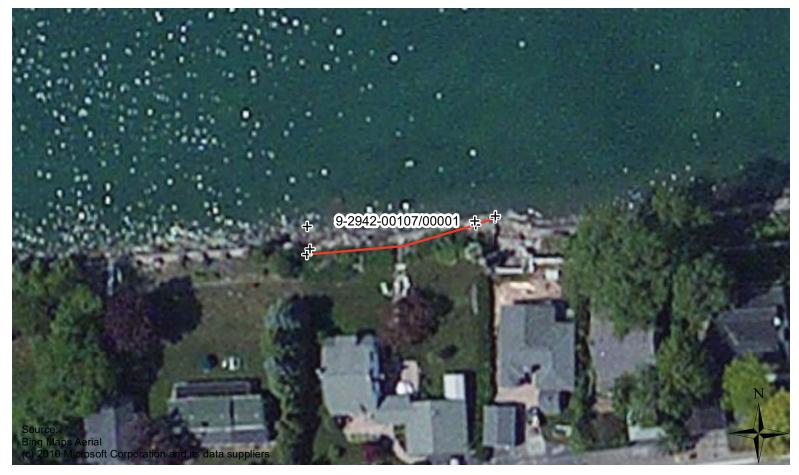
Page: 18 of 43

Condition: Poor Quality

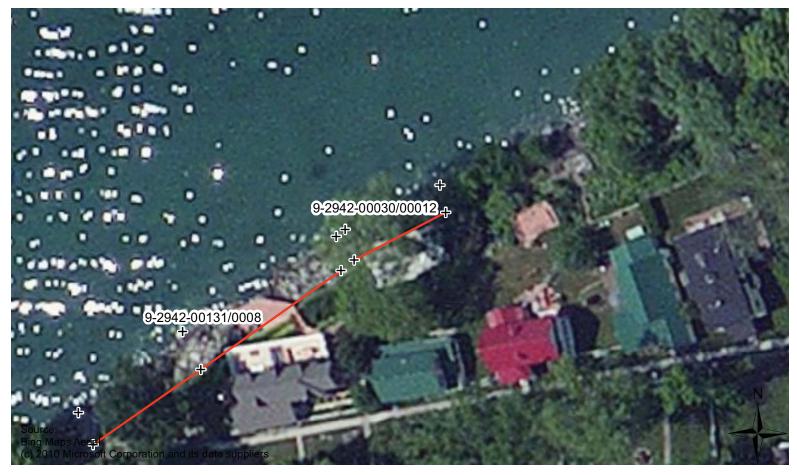
Condition: Poor Quality

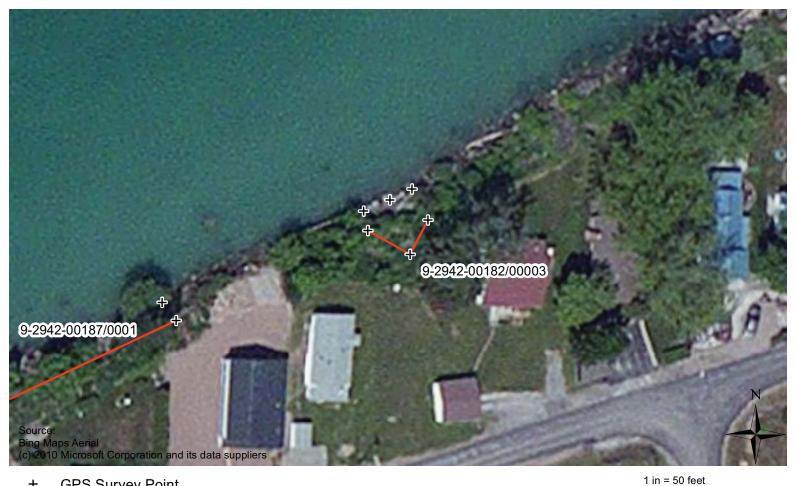
Page: 35 of 43

Condition: Moderate Quality

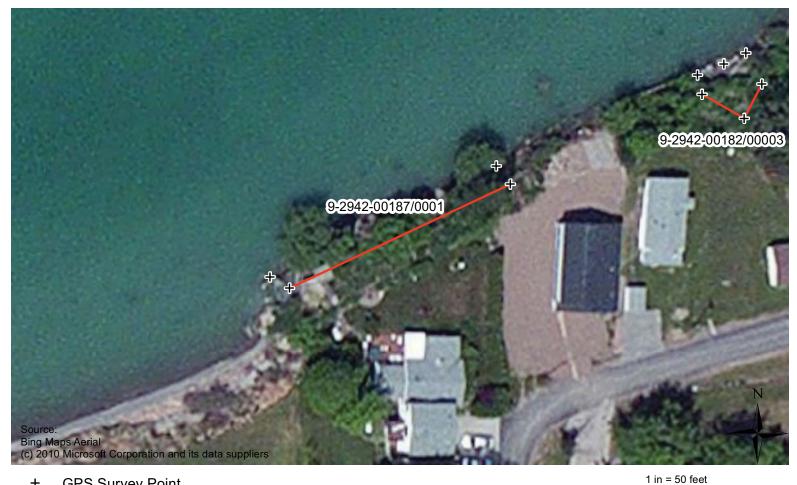
Page: 36 of 43

Condition: **Moderate Quality**

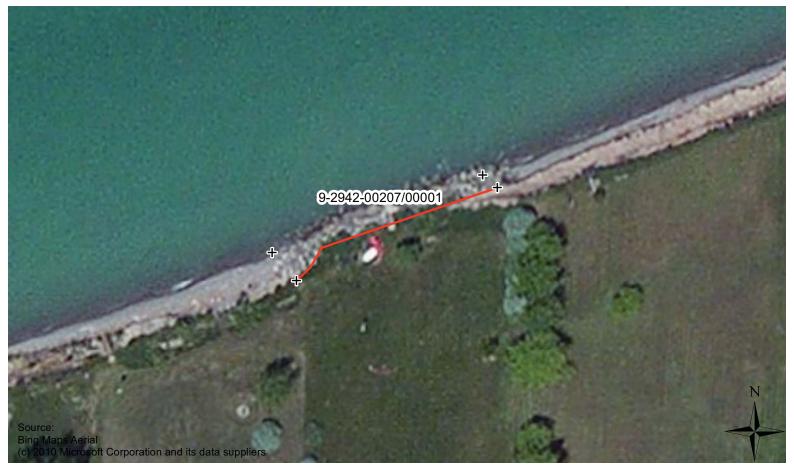
Condition: **Moderate Quality**

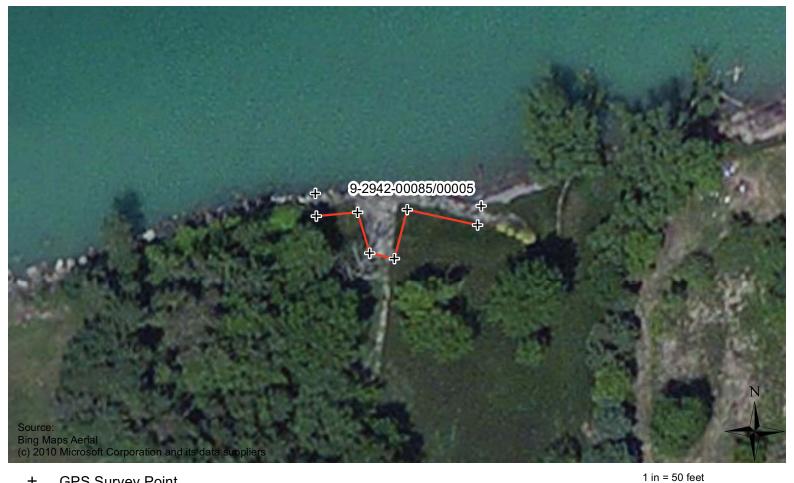
Page: 38 of 43

Condition: **Moderate Quality**

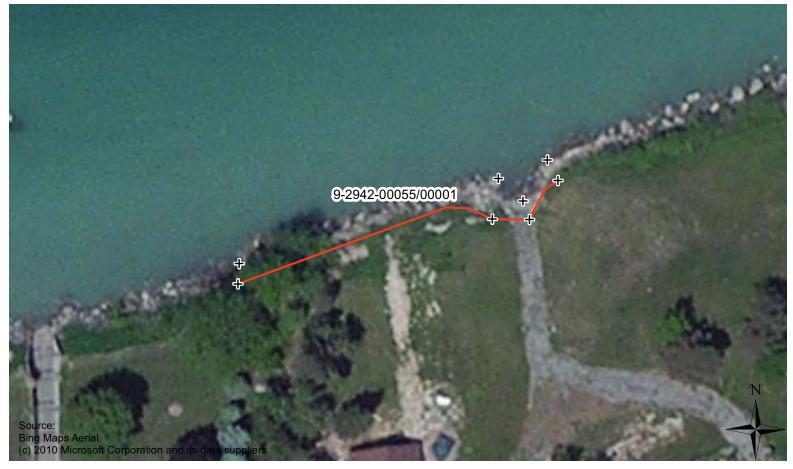
Page: 39 of 43

Condition: **Moderate Quality**

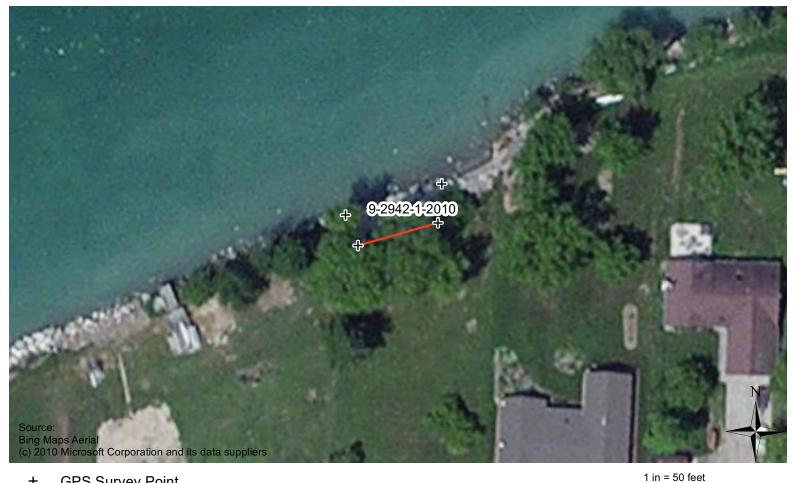
Condition: Poor Quality

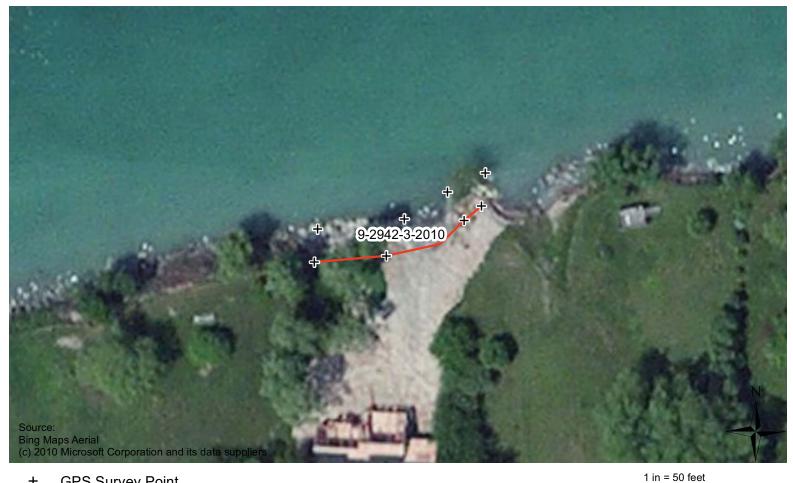
Page: 42 of 43

Condition: Good Quality
